NIST Technical Note XXXX

**Motorcoach Flammability Project
Final Report: Tire Fires - Passenger
Compartment Penetration, Tenability,
Mitigation, and Material Performance**

Erik L. Johnsson
Jiann C. Yang

November 2010

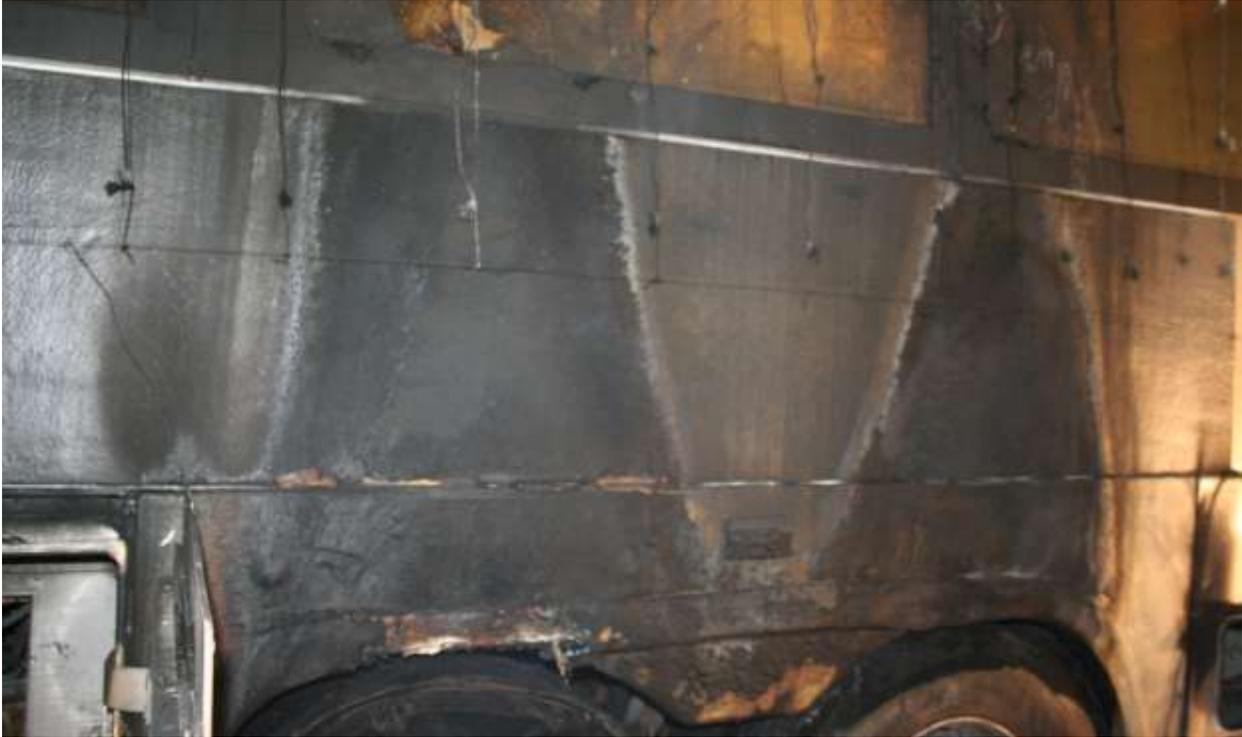
Figure 122 Intumescent coating fire-hardening experiment damage to coated fender and exterior panel.

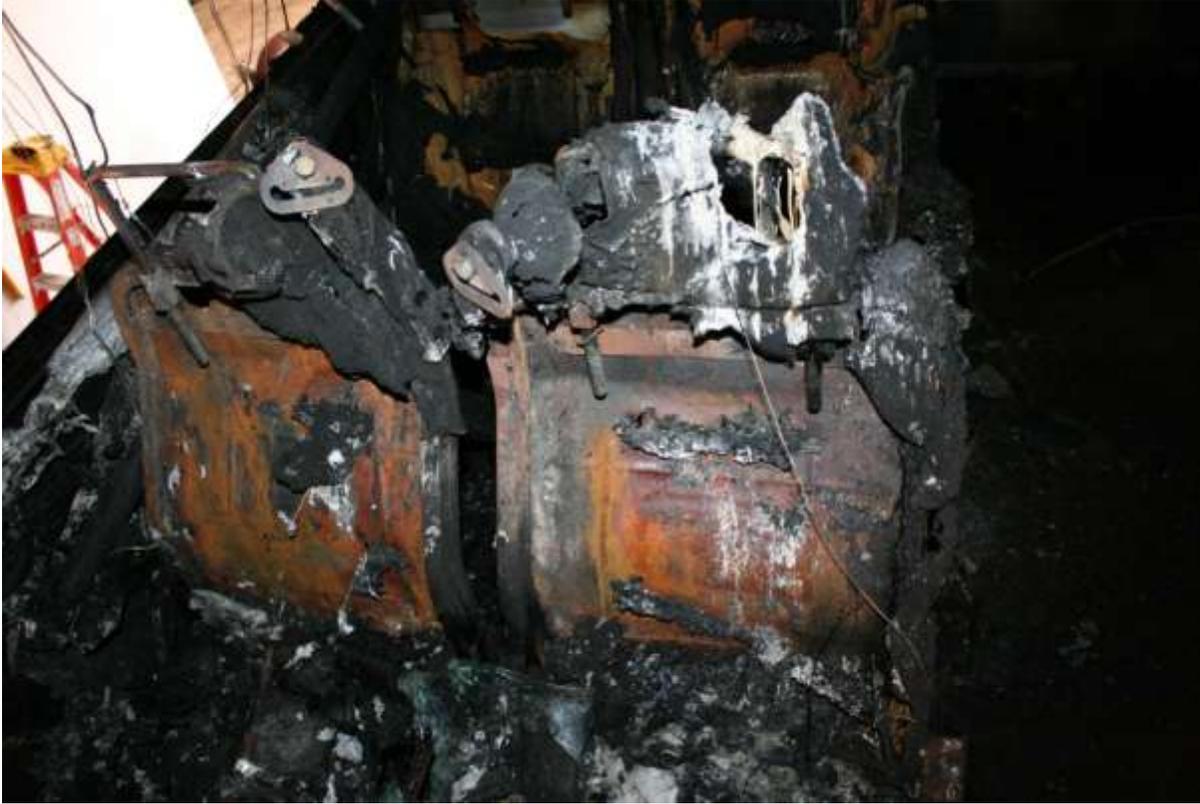
Figure 124 Tenability experiment seat damage from fire.

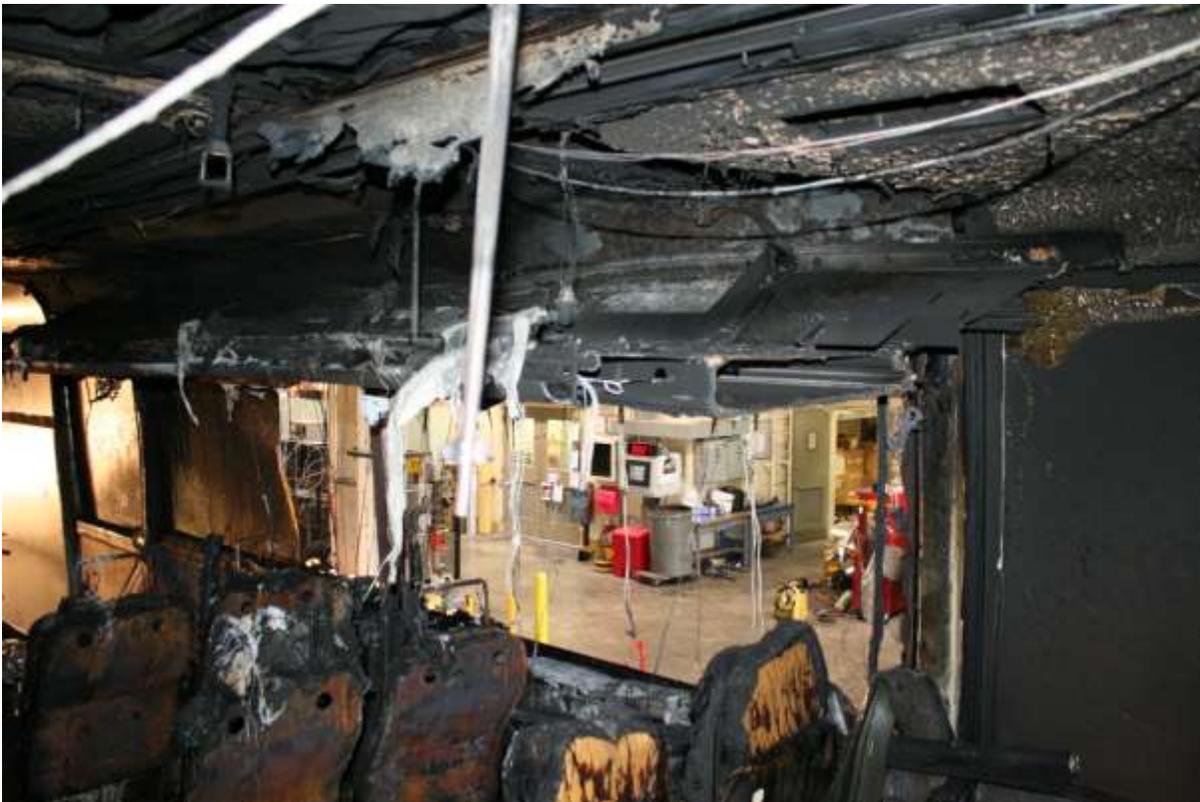
Figure 125 Tenability experiment seat and parcel rack damage from fire.

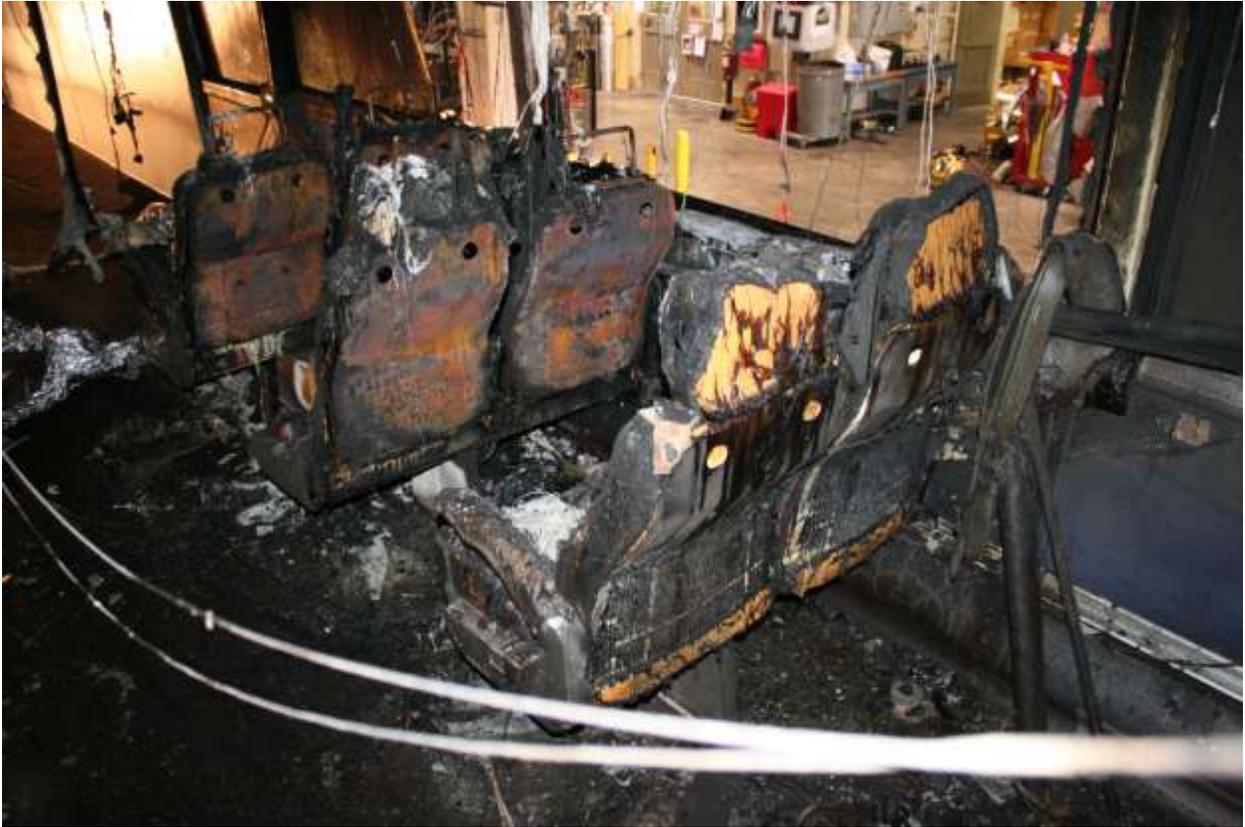
Figure 126 Tenability experiment seat damage from fire.
