U.S. Department  
of Transportation

National Highway  
Traffic Safety  
Administration

**NHTSA Toyota Pre-Crash EDR Field Inspections**  
**During March – August 2010**

**February 2011**

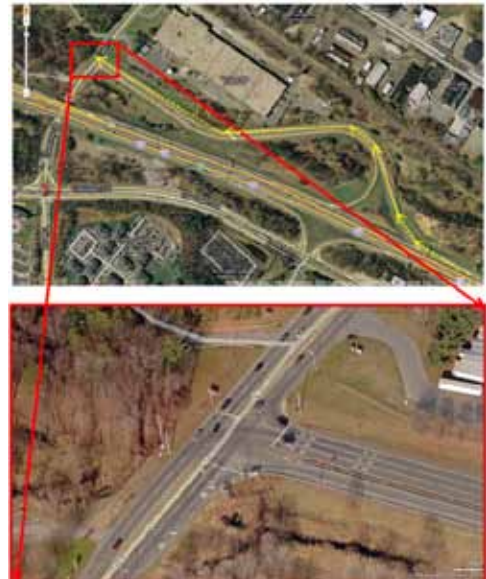
**Figure 1: Case 15 Scene Overview**

One incident (Case 15) turned out to be entrapment of an accelerator pedal by an all weather floor mat. This case was reported to NHTSA by an insurance company and involved a 2007 Lexus ES350 that was on an interstate highway approaching a long exit ramp (Figure 1). According to the driver, some jockeying for position was necessary that included a passing maneuver (accelerator application). The driver further indicated that after releasing the accelerator at the end of the passing

maneuver, he applied his brakes to slow the vehicle, using both feet at one point. He additionally maneuvered the vehicle against a guardrail in an unsuccessful effort to bring it to a stop. At the end of the exit ramp, the vehicle traversed a traffic light- controlled T intersection, left the roadway, struck a curb (deflating the right front tire), and landed in a marsh. The vehicle sustained significant frontal, undercarriage, and right side bodywork damage, and the driver experienced minor injuries. None of the airbags deployed.

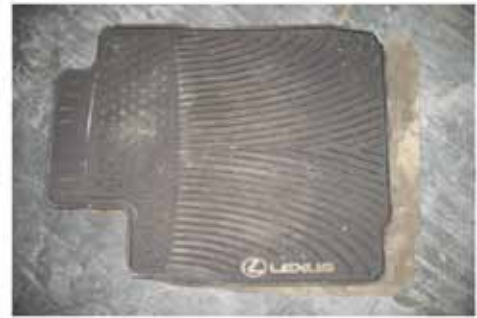
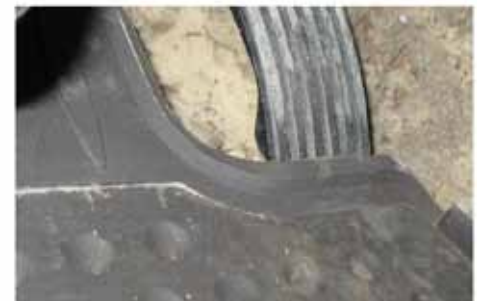
**Figure 2: Case 15 Floor Mats**

Field inspection of the incident vehicle identified three intact tires, a deflated right front tire, and significant lower frontal impact damage. This damage pattern coincides with the terrain and two indicated impacts. Examination of the vehicle interior uncovered evidence that an OE Lexus all weather floor mat had constrained the accelerator pedal after the driver released it at the onset of the incident. When inspected, the subject vehicle's all weather mats were found in the rear seating area. Its OE carpeted floor mats were found secured properly in the footwells. Dirt patterns on the driver's carpeted mat indicated that the all weather mat was typically laid atop it in an (inappropriate) double stack configuration. Using the dirt patterns as a guide (Figure 2), it was possible to recreate the confined accelerator pedal.

Examination of the vehicle showed no other indications of accelerator pedal, throttle body restriction or malfunction. Electronic outputs from the brake light switch and accelerator pedal were verified as within range.

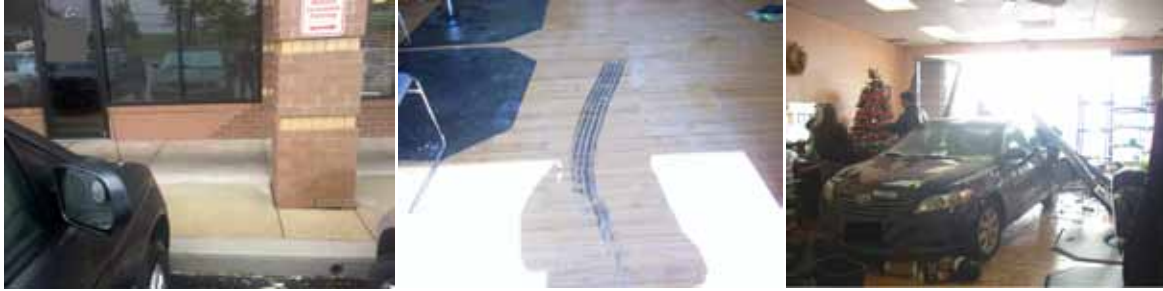
**Figure 3: Case 33 Incident Scene**

The vehicle had received normal maintenance throughout its service life and had accumulated approximately 14,000 miles at the time of the incident. Neither the driver nor the vehicle's service history indicated prior engine control or brake concerns with the vehicle and it did not appear to have been involved in any prior crashes. Physical examination of the vehicle shortly after the incident showed no apparent concerns with the brakes, throttle, or accelerator pedal.

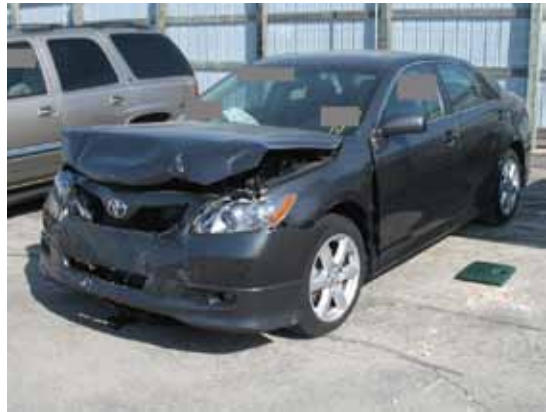
**Figure 4: Case 30 Subject Vehicle**

Case 30 involved a 2007 Camry operated by a female in her fifties striking vehicles stopped in traffic ahead of her during the first half of 2010. The incident took place during daylight hours on a local road with a posted speed limit of 25 mph and on an ascending grade. The driver reported depressing the brake to decelerate and feeling the vehicle accelerate. She reported pressing the pedal harder, causing the Camry to accelerate harder and then strike vehicles stopped ahead of her. The impact was strong enough to deploy both frontal airbags in the Camry and caused injuries to its (restrained) driver as well as an occupant of one of the struck vehicles.

A Carfax report did not indicate any prior collisions. The vehicle, which had accumulated approximately 25,000 miles of service at the time of the incident, had received recall remedies to address sticky pedal and accelerator pedal entrapment.
