Case 405 : Narrative

Case Vehicle (A): 1999 Ford
Type: Ranger Super Cab, 2-door pickup
Driver: 61-year-old male
CDC: 12-FZEN-3, 12-FLGN-7

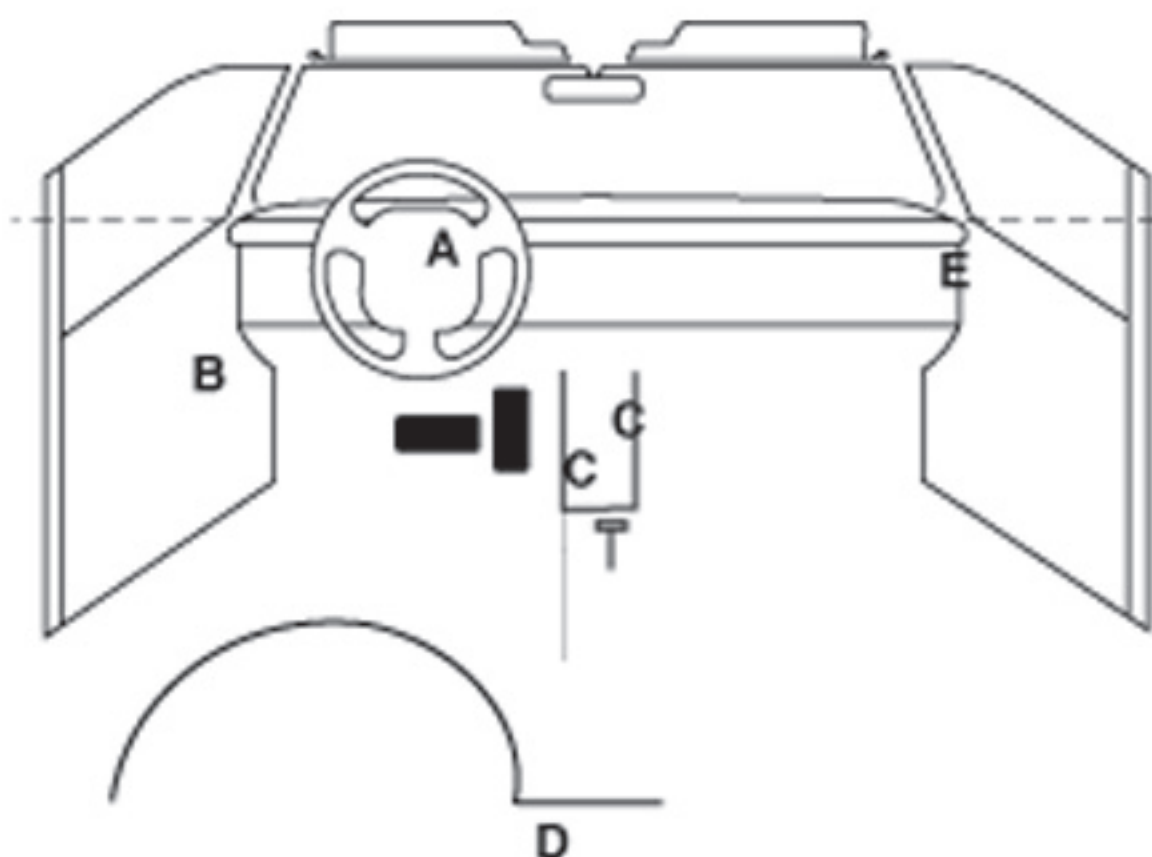
A= steering wheel, deformed

B= driver door, bloodstains

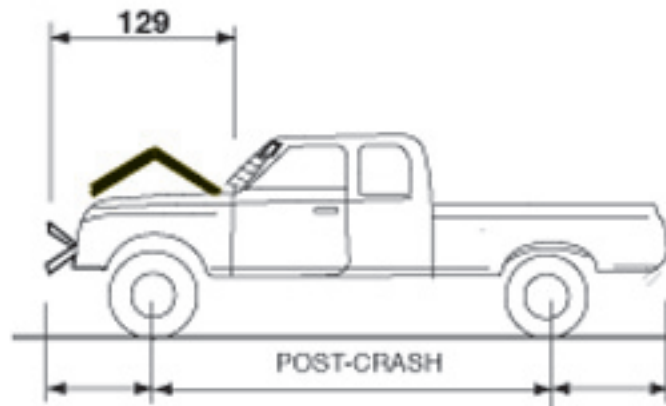
Bumper corner	<u>92</u>	<u>320</u>	<u>101</u>	Bumper corner
Stringline	<u>85</u>		<u>110</u>	Stringline

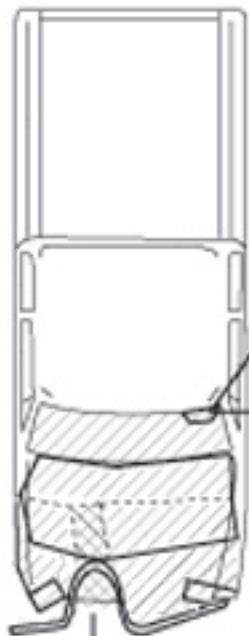
Tree branch
damage
5
Max crush
Impact #2

53
Max crush
Impact #1

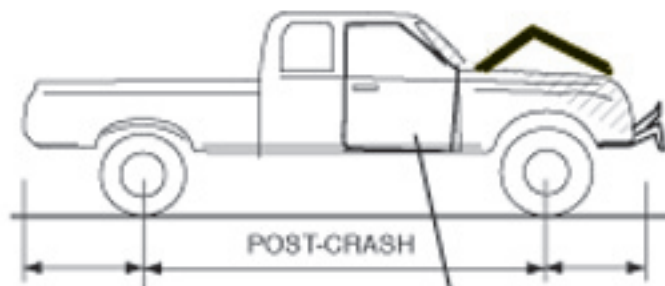
Bumper corner	<u>101</u>	<u>317</u>	<u>89</u>	Bumper corner
Stringline	<u>110</u>		<u>88</u>	Stringline

Door displaced
