## Case 409 : Narrative

Case Vehicle (A): 2000 Kia	Vehicle (B): 2001 Jeep
Type: Sephia, 4-door sedan	Type: Cherokee Sport, 4-door, 4x4
Driver: 40-year-old male	Driver: 63-year-old male
CDC: 12-FDEW-3	CDC: 99-0000-0

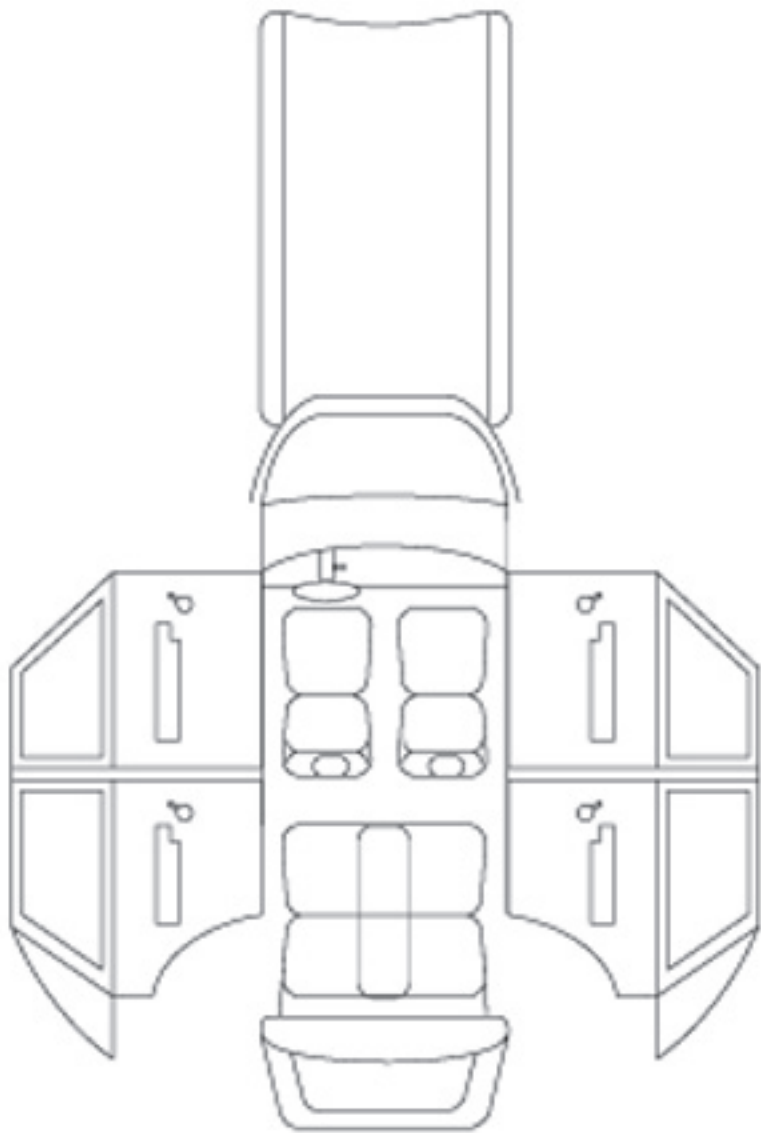
Evidence of belt use: Yes  
 Scratch on D-ring  
 B-pillar lower cover pulled out  
 Up on B-pillar  
 Scratches on continuous loop  
 Transfer on webbing from D-ring

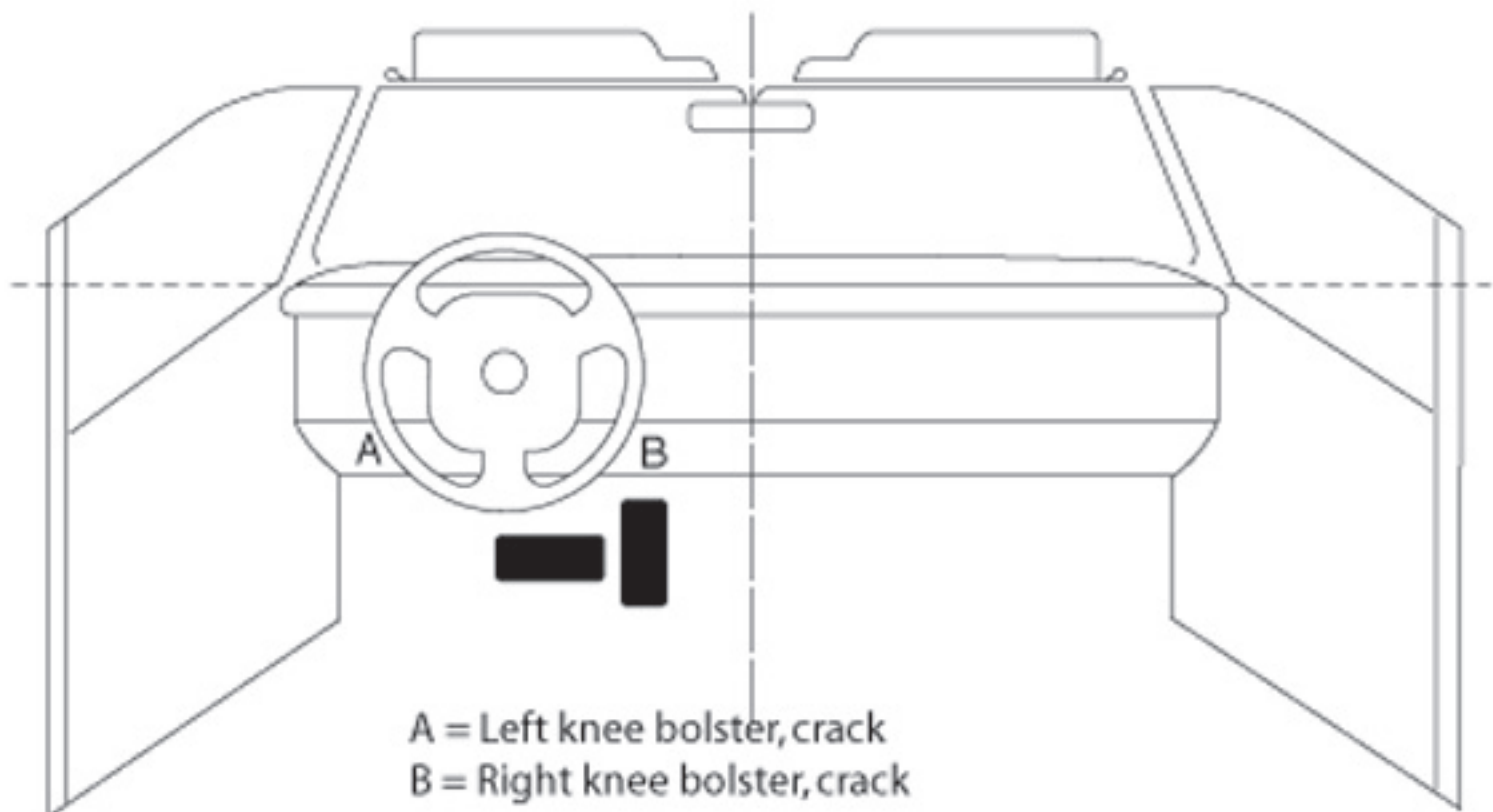
A = Left knee bolster, crack  
 B = Right knee bolster, crack

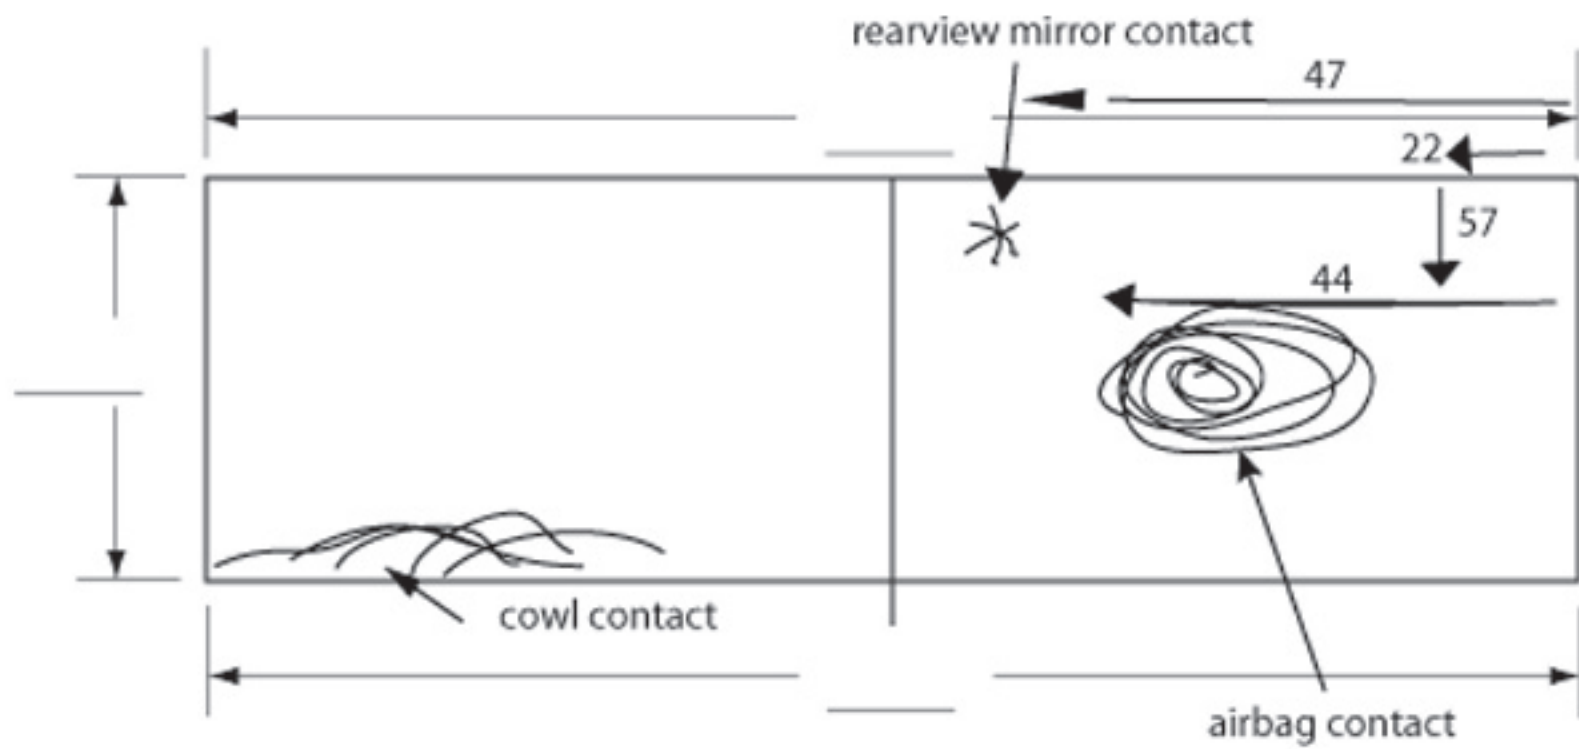
WINDSHIELD MARK ON CASE VEHICLE:

0 AS1 8  
DOT 129 M117  
FW-2073
