Case 411 : Narrative

Case Vehicle (A): 2002 Toyota	Vehicle (B): 1997 Pontiac
Type: Avalon XLS, 4-door sedan	Type: Grand Prix, 2-door coupe
Driver: 70-year-old female	Driver: 55-year-old male
CDC: 12-FDEW-4	CDC: 12-FDEW-4

This is a fatal crash. The right-front passenger of vehicle (B) died as a result of injuries sustained in this collision.

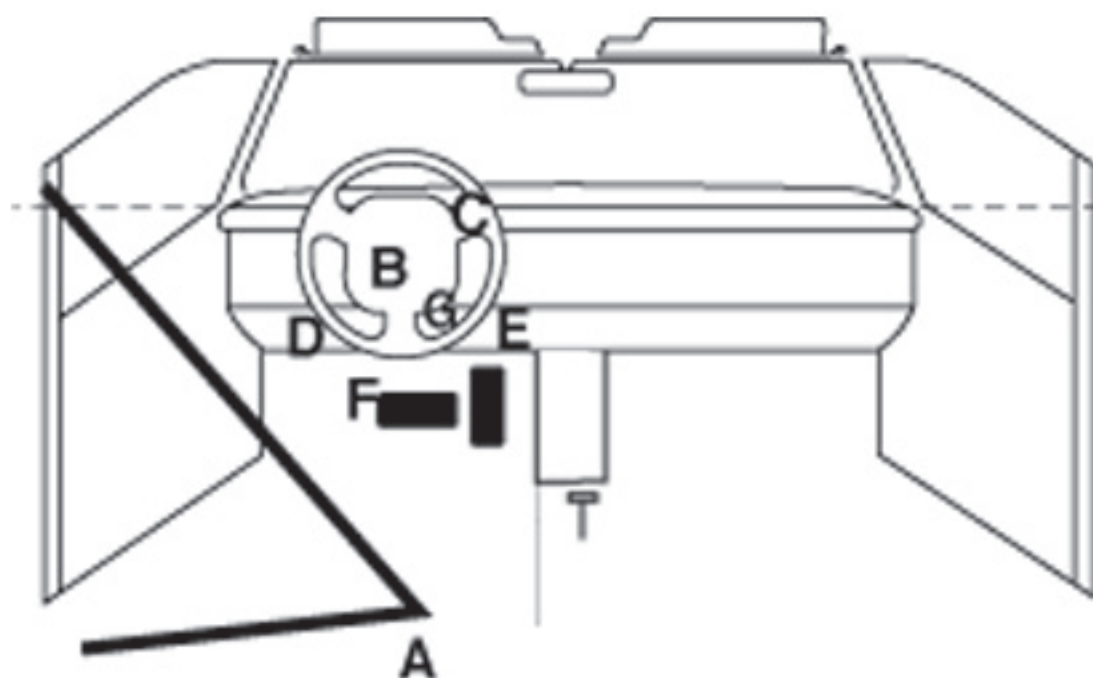
- A = driver seatbelt, scuffmark on D-ring, webbing imprint on sliding latchplate, belt stuck in extended mode**
- B = steering-wheel airbag, blood stains on fabric**
- C = steering-wheel rim, deflected forward**
- D = knee bolster, left side of column, deformed**
- E = knee bolster, right side of column, deformed**
- F = toepan/foot controls, pedals deformed, bloody shoes**
- G = steering column, scuffmark**

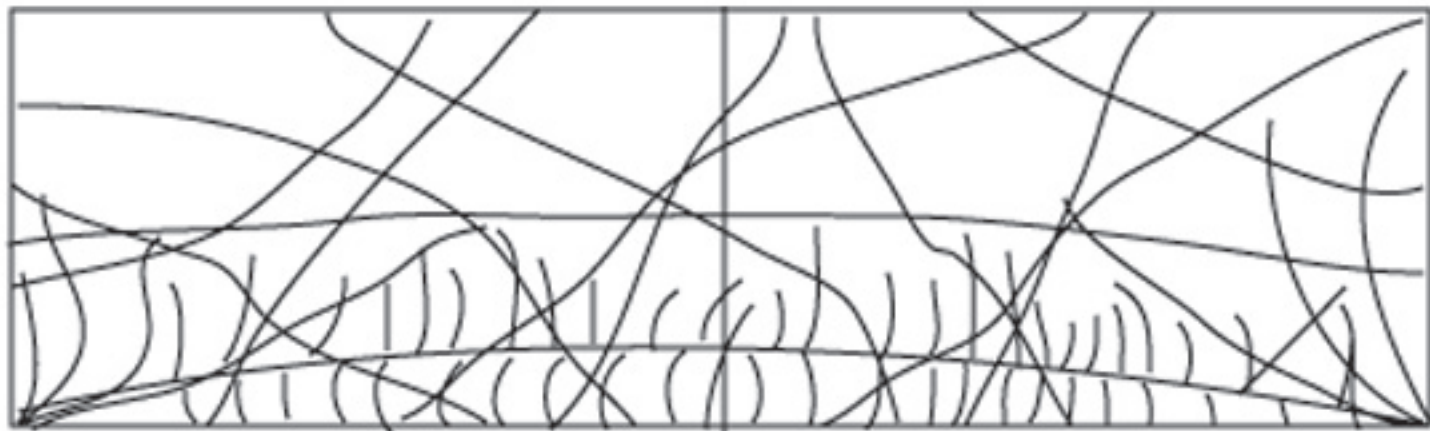
WINDSHIELD MARK ON CASE VEHICLE:

Windshield cracked due to contact by rear edge of hood

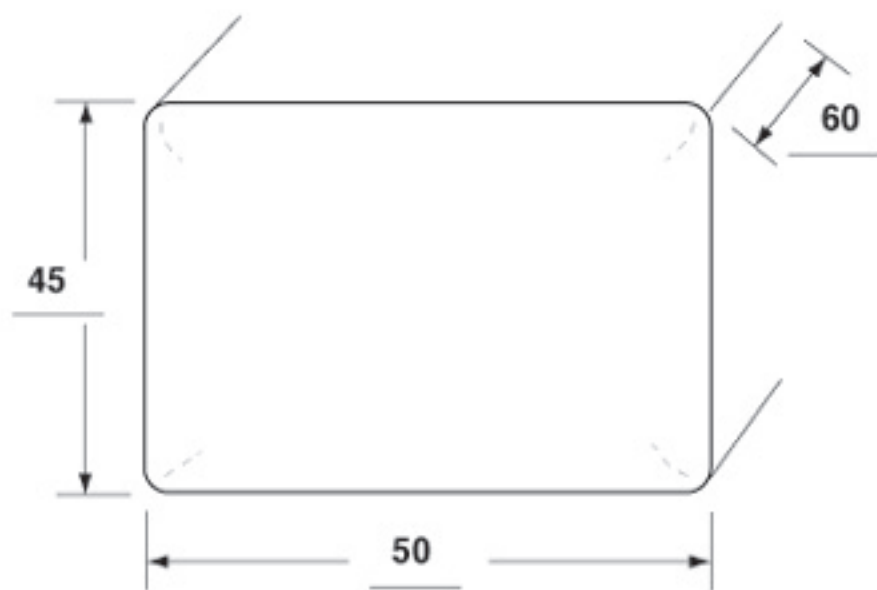
Passenger Airbag

No passenger airbag door, seamless
32 cm wide
