## Case 431 : Narrative

Case Vehicle (A): 2000 Ford	Vehicle (B): 2000 Dodge
Type: Windstar LX, 4x2, 4-door minivan	Type: Intrepid, 4-door sedan
Driver: 38-year-old female	Driver: 27-year-old female
CDC: 12-FDEW-3, 00-TYDO-2	CDC: 10-LYAW-6, 00-TDDO-2

This is a fatal crash. The unbelted driver of vehicle (B) died as a result of head and chest injuries sustained in a left-side T-type impact.

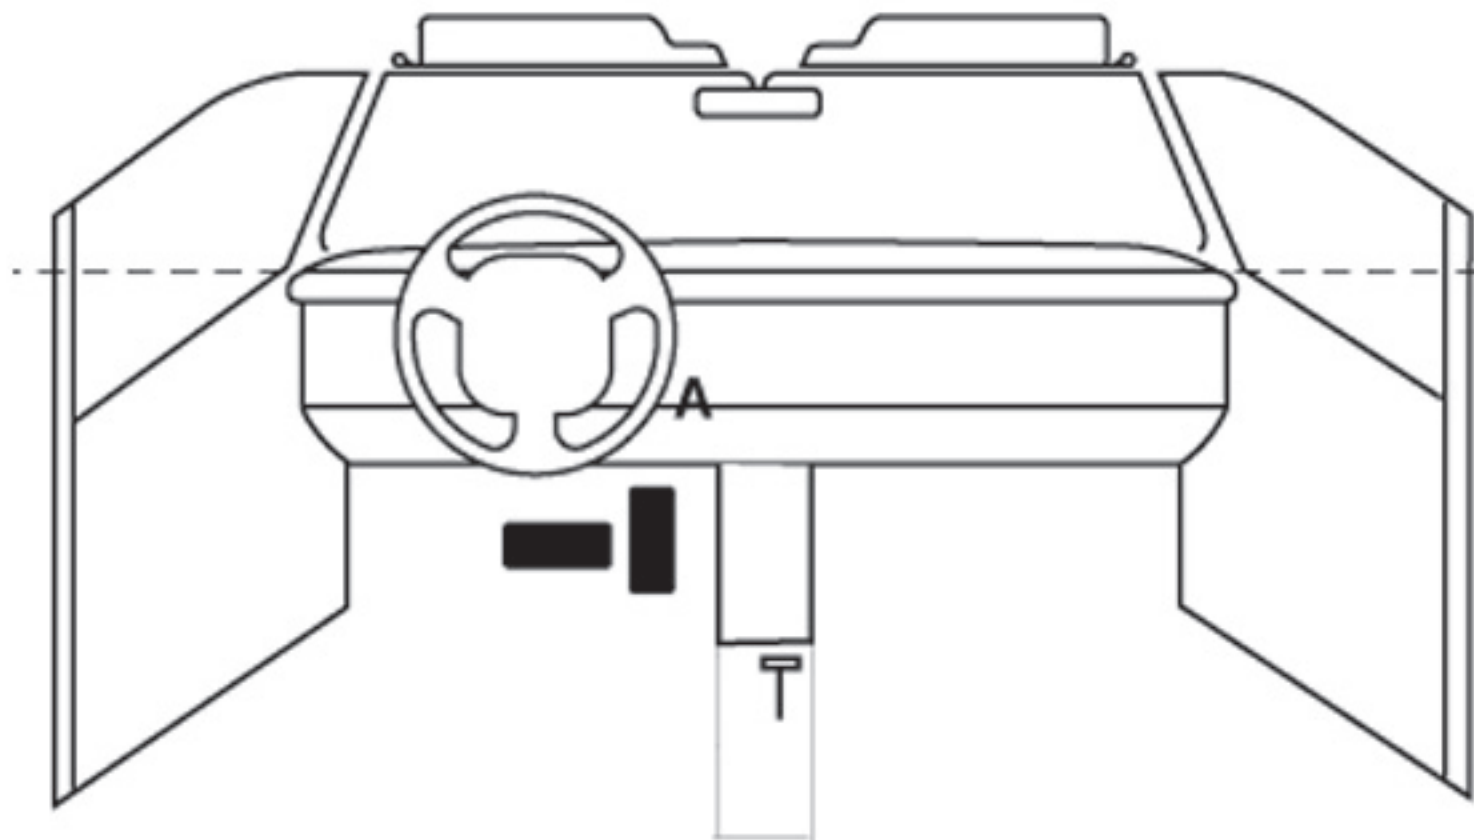
**A = junction of knee bolster, mid instrument panel,  
and vertical console, scuffmark and indentation**

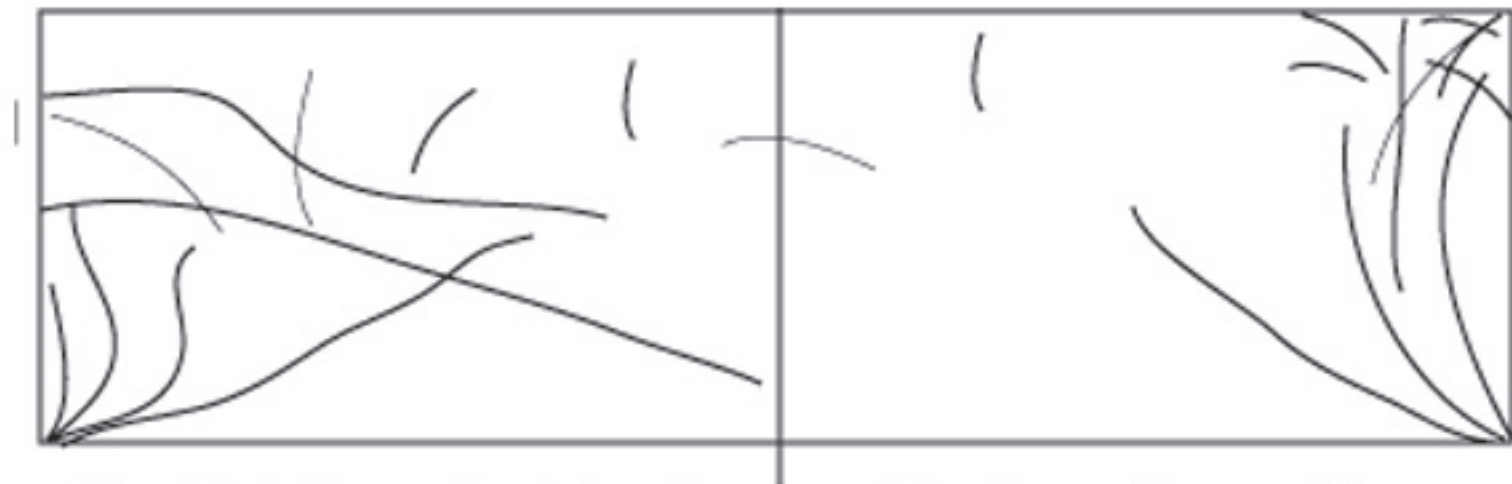
WINDSHIELD MARK ON CASE VEHICLE:

**Windshield cracked due to a combination of impact forces  
and rollover damage**

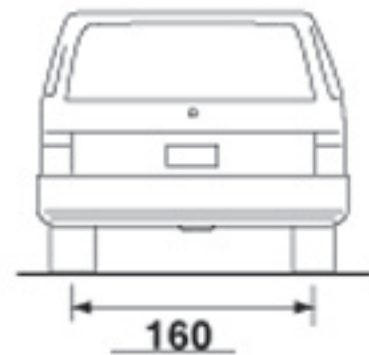
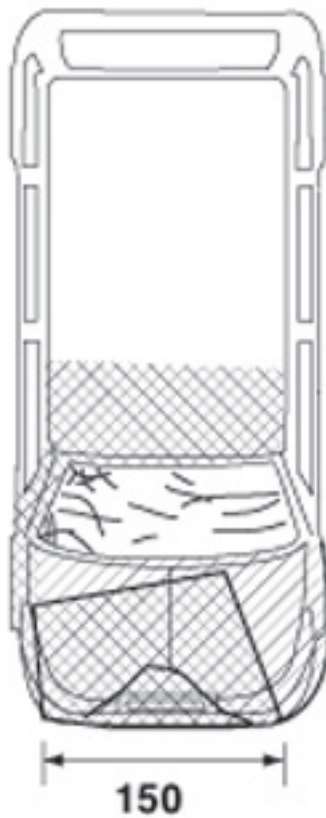
**5** Max. crush to roof from rollover

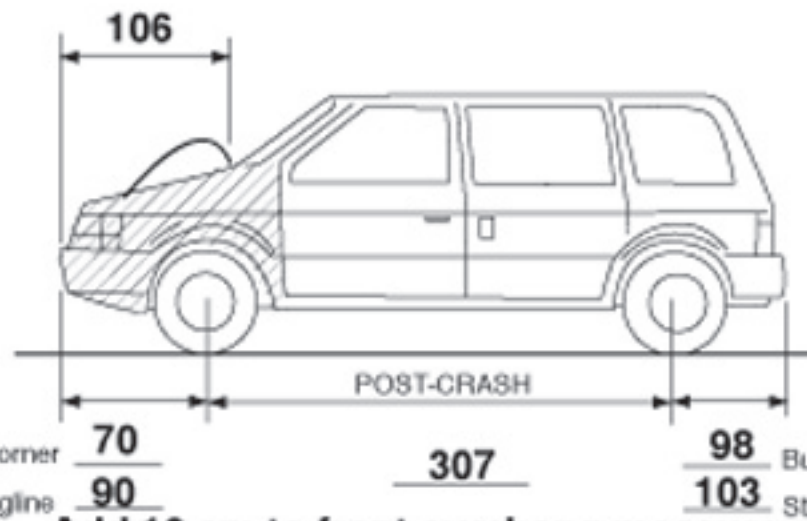
**Width of direct damage to front**

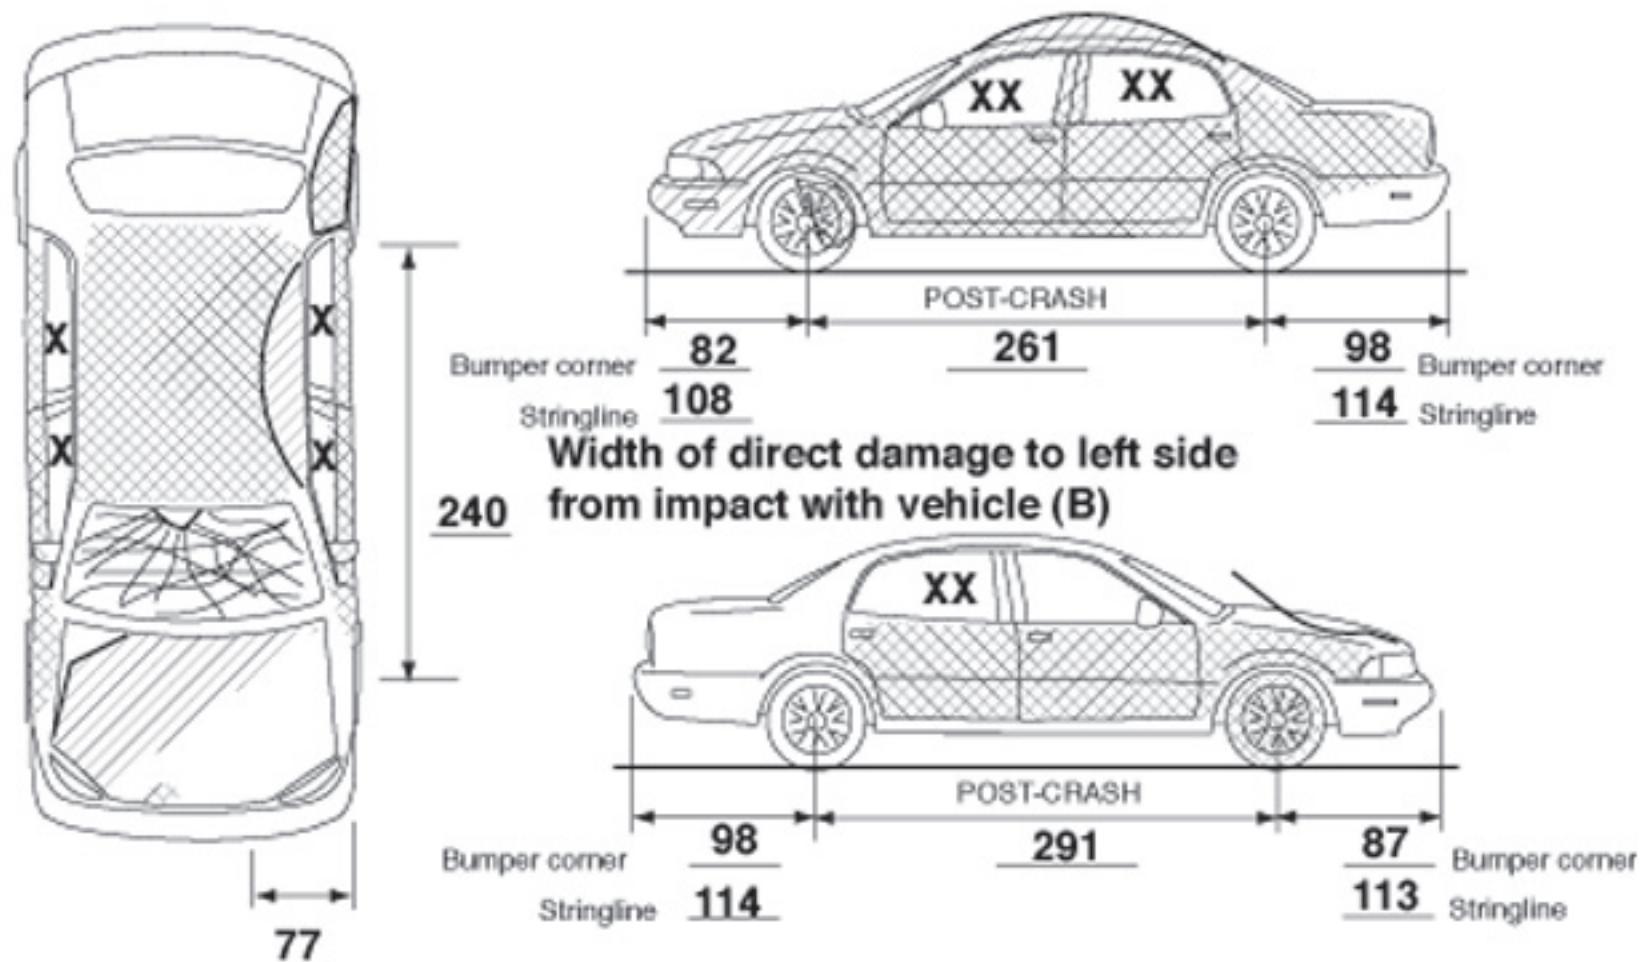
Max. crush to driver door from impact with vehicle (B)
