Case 442 : Narrative

Case Vehicle (A): 2003 Pontiac	Vehicle (B): 2002 Buick
Type: Grand Am SE, 4-door sedan	Type: Century Custom, 4-door sedan
Driver: 82-year-old female	Driver: 34-year-old male
CDC: 01-FDEW-2	CDC: 11-FYEW-2

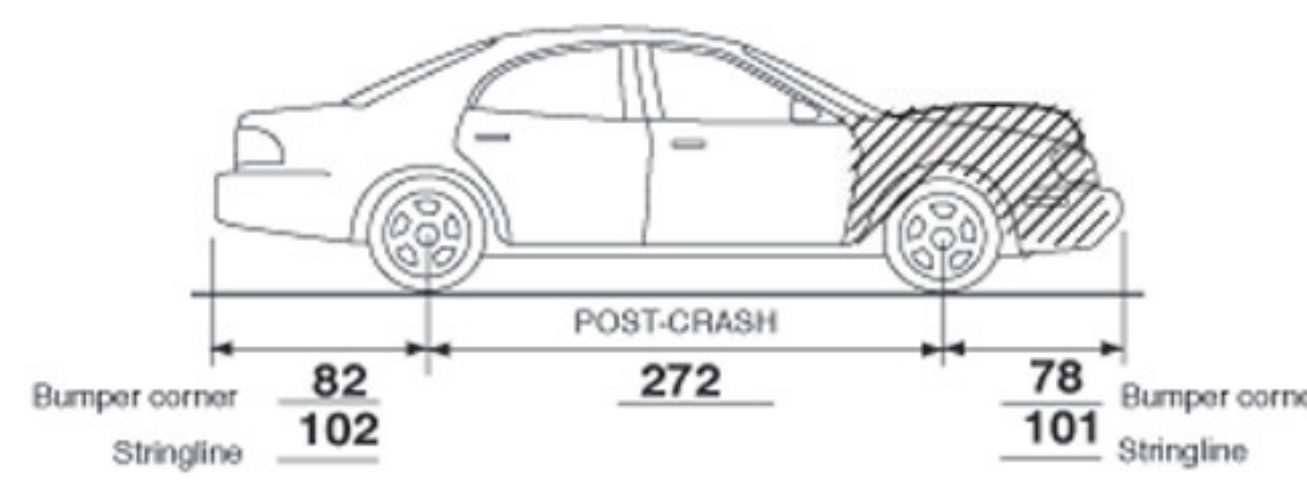
120-cm direct damage
51-cm max crush

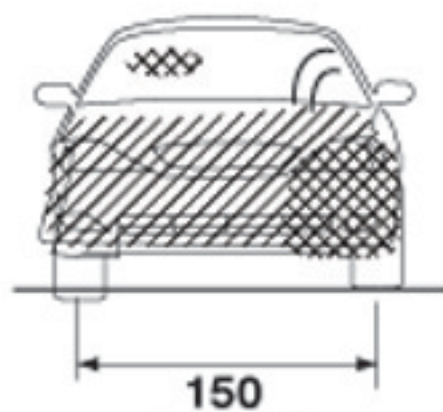
wheel restricted
and pushed to rear

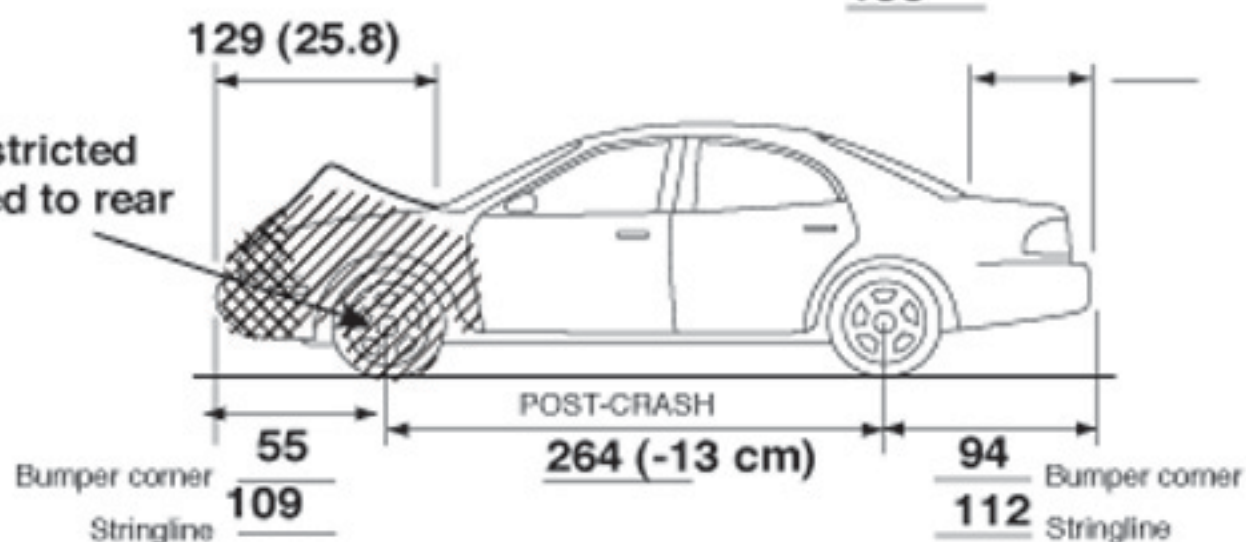
airbag
cover
contact

tire damage may have
occurred during
police pursuit

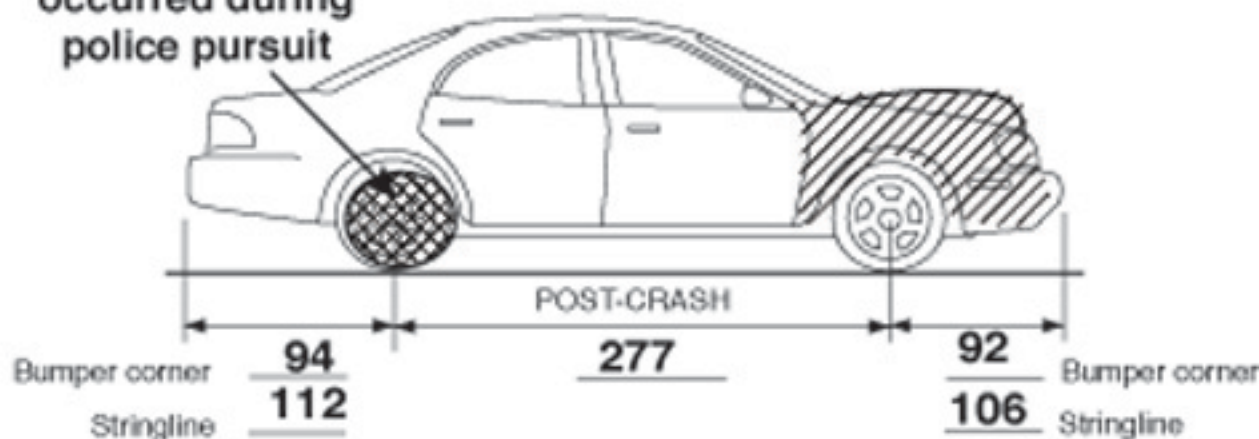
72-cm direct damage
38-cm max crush
