## Case 445 : Narrative

Case Vehicle (A): 2002 Ford	Vehicle (B): 2002 International
E150 Econoline Van, 4x2	Type: 4300 Series Straight truck, 4x2
Driver: 62-year-old female	Driver: 50-year-old male
CDC: 12-FDEW-3	CDC: 99-0000-0

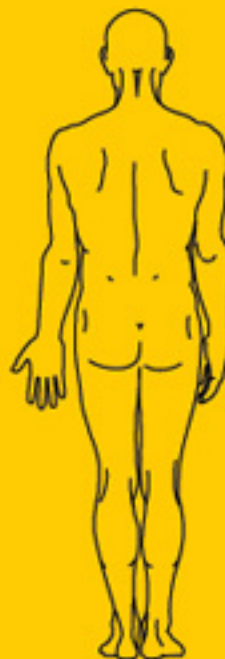
No injury

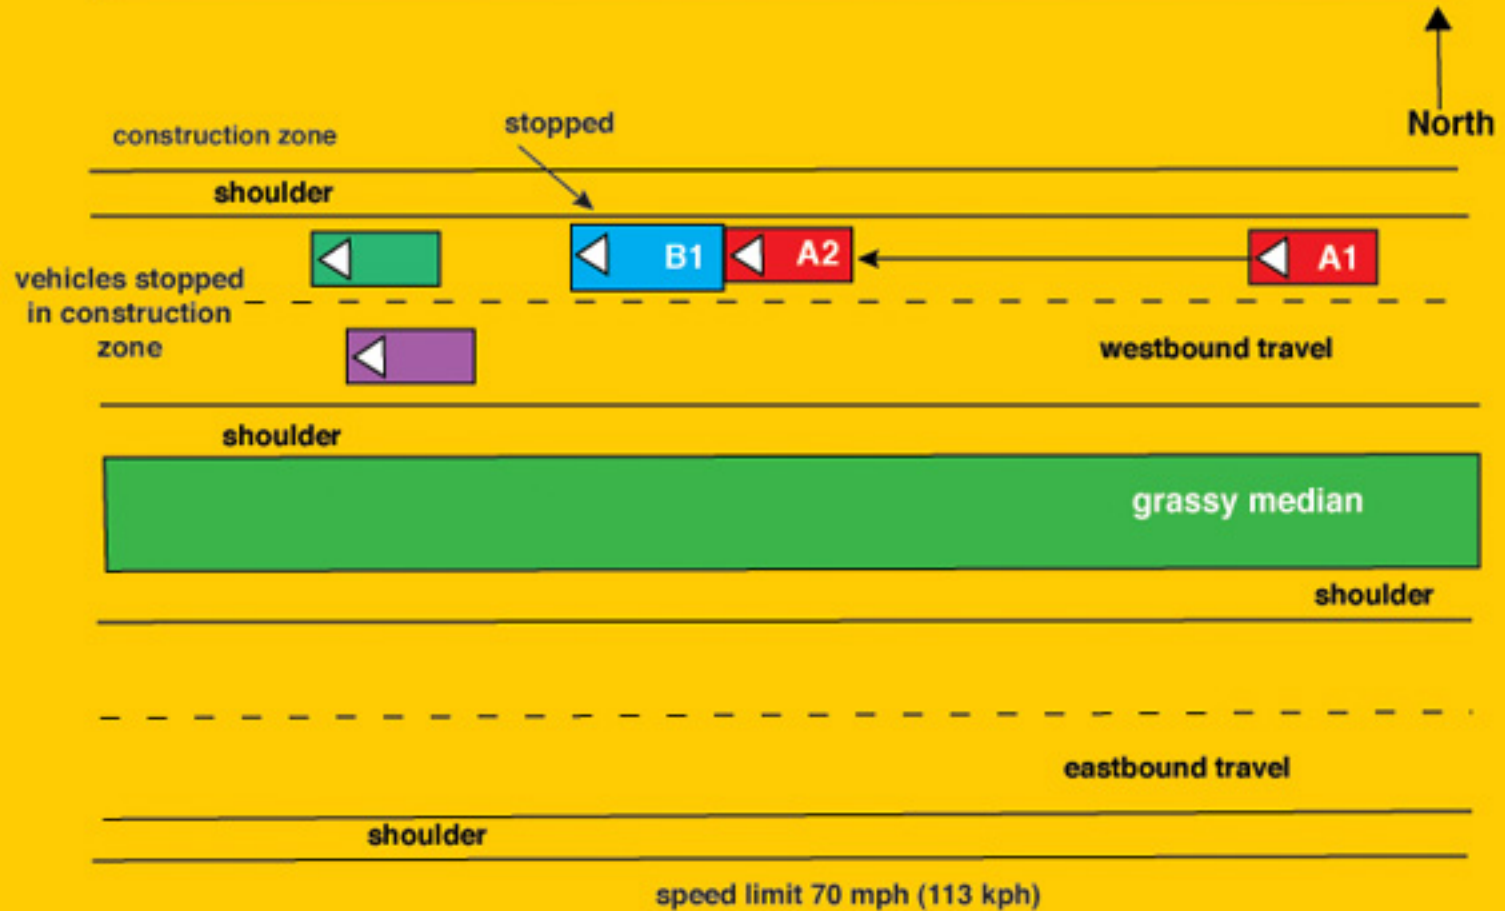
Case No.: 445  
Case Veh. (A): 2002 Ford  
Type: E150 Econoline Van, 4x2  
Driver: 62-year-old female  
Vehicle (B): 2002 International Series Straight truck

Weather: Cloudy  
Road Surface: Dry  
Road Construction: Asphalt  
Light Conditions: Daylight
