Case 446 : Narrative

Case Vehicle (A): 2000 Pontiac	Vehicle (B): 2003 Mack
Type: Grand AM GT, 2-door coupe	Type: CX Series, tractor-trailer
Driver: 25-year-old female	Driver: 35-year-old male
CDC: 01-FDEW-2	CDC: 99-0000-0

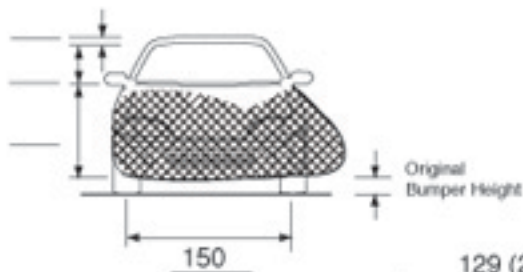
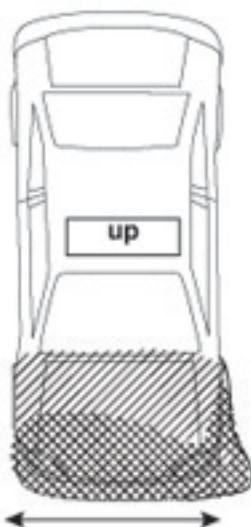
[7](#) Direct damage to the front of case vehicle (A) was moderate and extended 150-cm across the entire front. [8](#) The maximum rearward crush was 39 cm and it occurred 25-cm to the left of the right-front bumper corner.

150-cm direct damage
max crush is 39-cm at C5
