Case 481 : Narrative

Case Vehicle (A): 2004 Ford	Vehicle (B): 2001 GMC
Type: Ranger, 4x4, 4-door pickup	Type: Sierra K1500, 4x4, 4-door pickup
Driver: 17-year-old male	Driver: 20-year-old female
CDC: 12-FDEW-3	CDC: 01-FREW-3

This is a fatal crash. The right-front passenger of vehicle (B) died as a result of multiple chest injuries sustained in an offset-frontal collision.

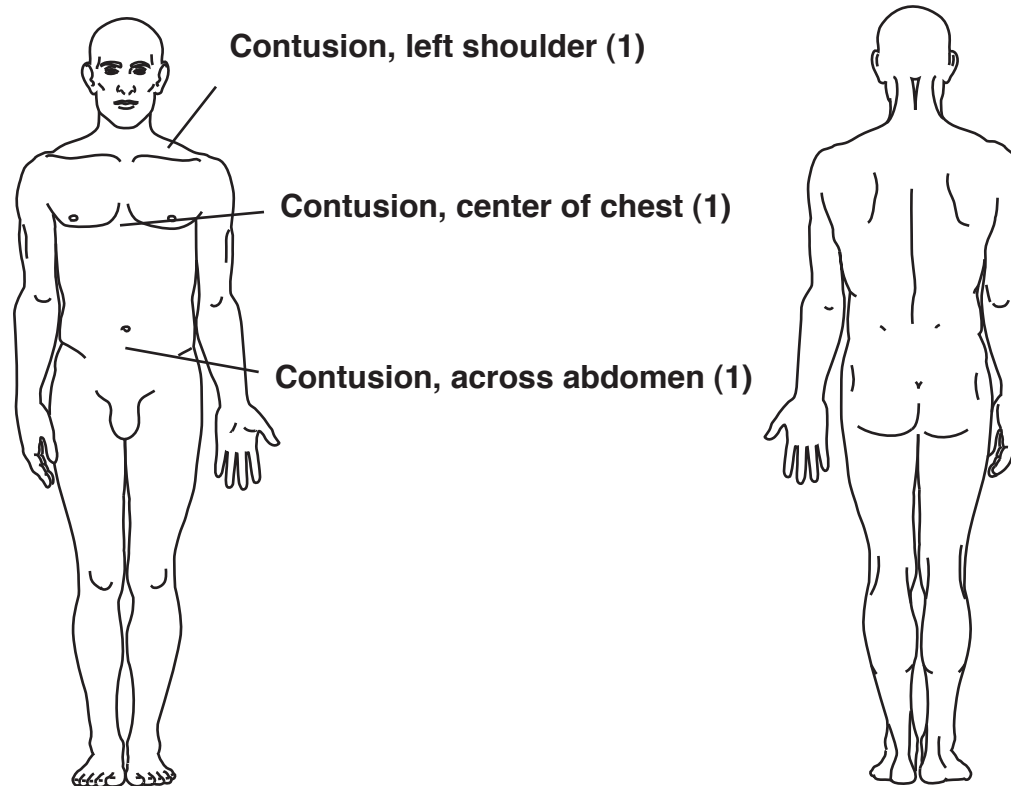
During the frontal impact, the driver moved forward relative to the vehicle interior into the belt restraints and airbag. He sustained contusions to the left shoulder and to the center of the chest from loading by the shoulder belt. He sustained a contusion across the abdomen from loading by the lap belt.

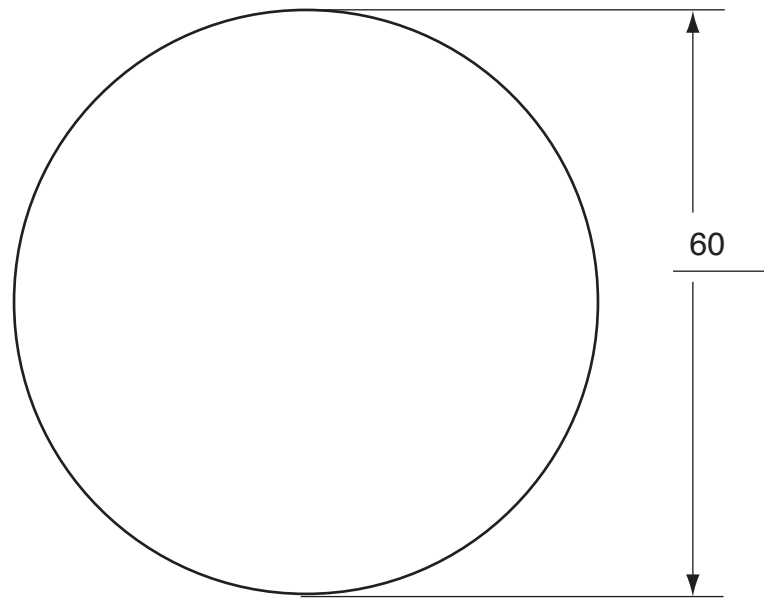
Driver Airbag

Vents: Y N
if yes, how many: 1

Tethers: Y N
if yes, how many: 2

vent located at 12 o'clock

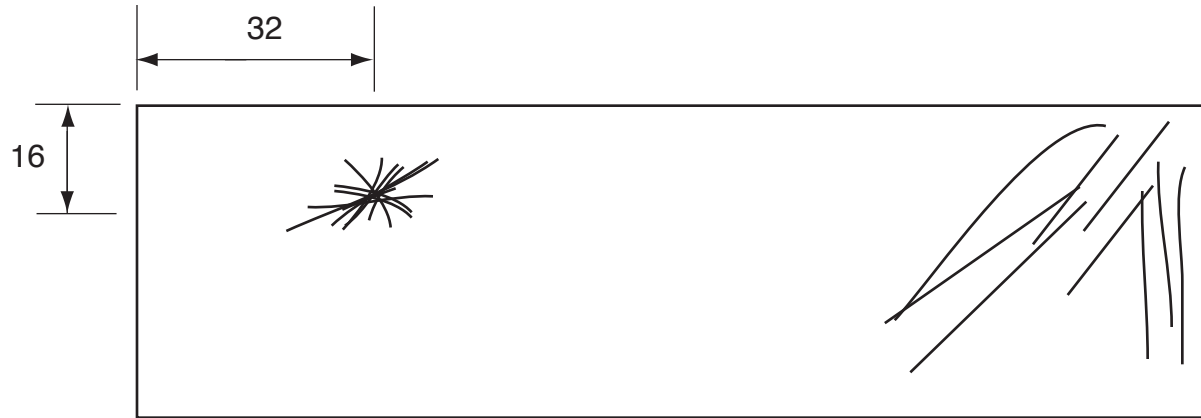
WINDSHIELD MARK ON CASE VEHICLE:

Windshield cracked on left from an unknown source and on right due to roof distortion

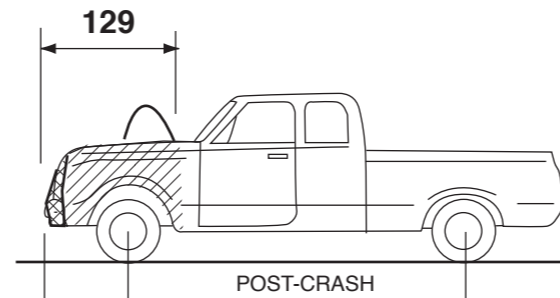
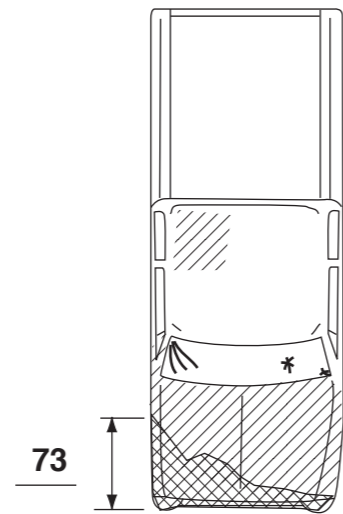
Bumper corner 61 Bumper corner
Stringline 78 Stringline

Max. crush to right-front bumper corner

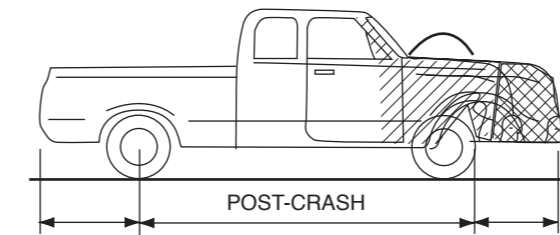
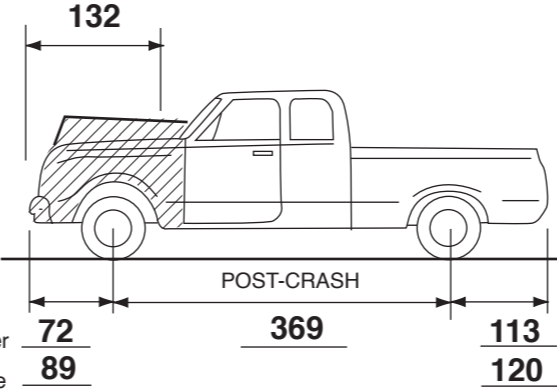
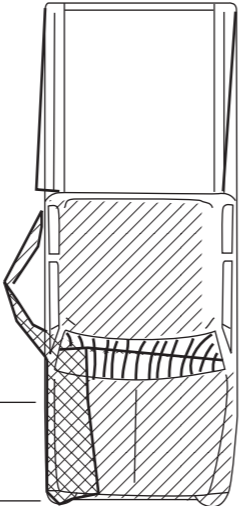
Bumper corner 101 Bumper corner
Stringline 108 Stringline

Max. crush to right-front bumper corner

55

Width of direct damage to front

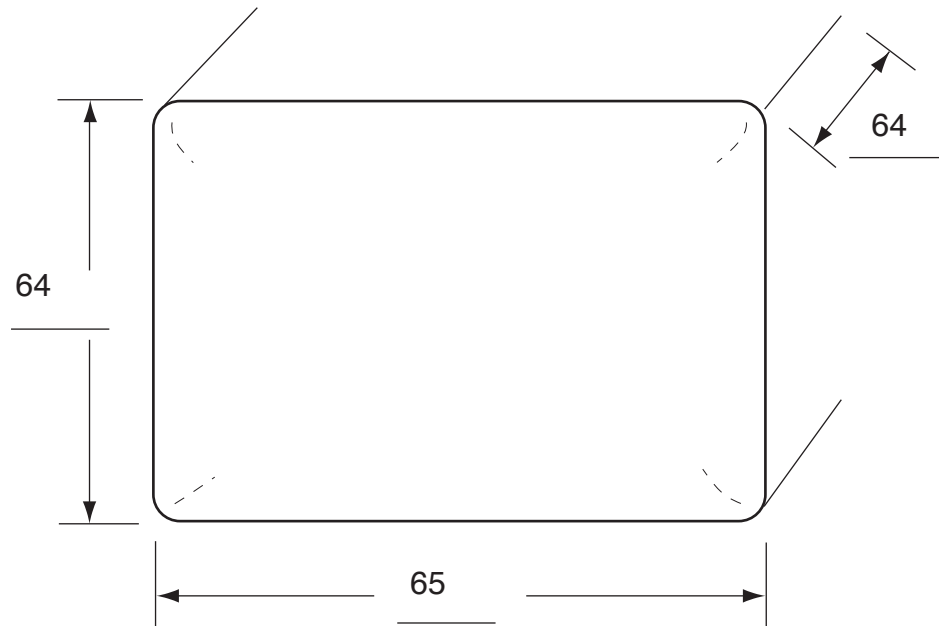
Passenger Airbag

Vents: Y N
if yes, how many: 2
vents at 9 and 3 o'clock
