Case 499 : Narrative

Case Vehicle (A): 2002 Chevrolet	Vehicle (B): 1995 Pontiac
Type: Suburban LS, 4x2, 4-door SUV	Type: Grand Am GT, 2-door coupe
Driver: 36-year-old female	Driver: 21-year-old male
CDC: 12-FZEW-4	CDC: 12-FZEW-5

SITUATION

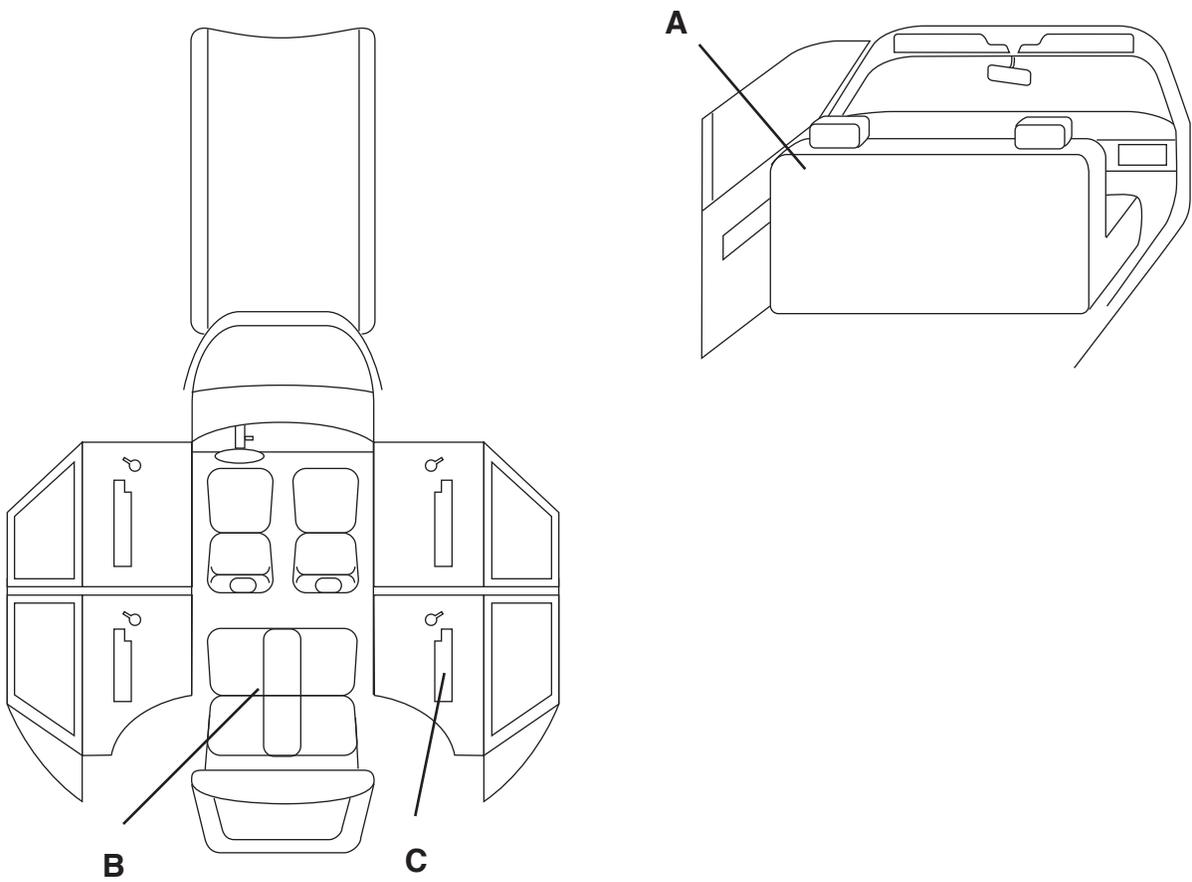
I-Pattern

- A = Driver seatback - scuffmark**
- B = Seatbelt buckle - plastic cover broken off and buckle would not latch**
- C = Right-rear door armrest - scuffmark**

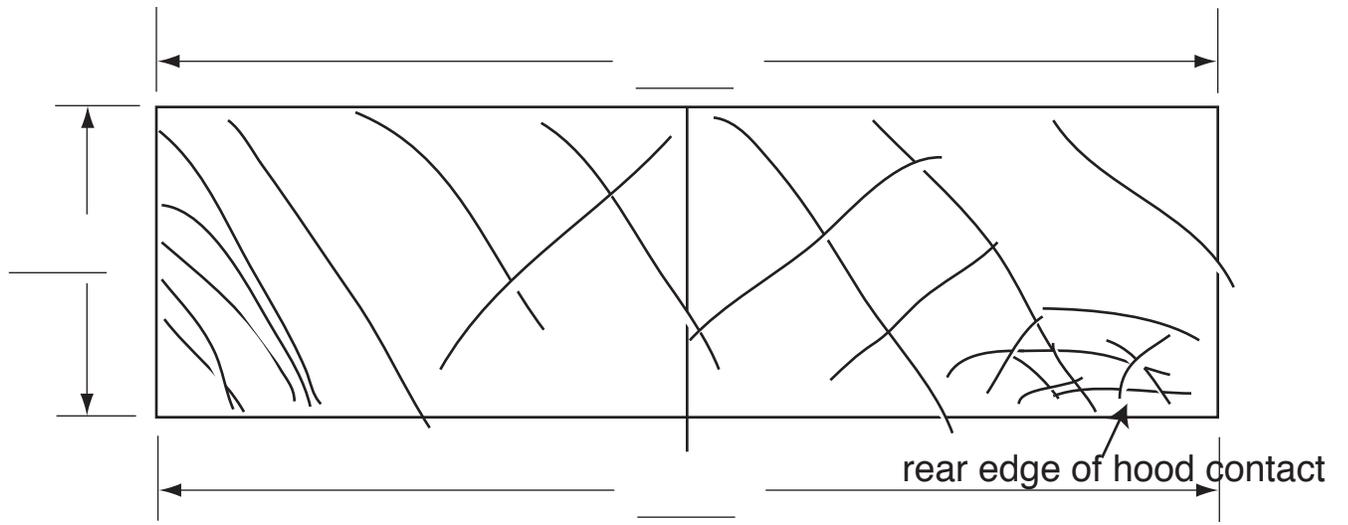
WINDSHIELD MARK ON CASE VEHICLE:

(CANNOT READ ALL OF MARK DUE TO
WINDSHIELD DAMAGE)

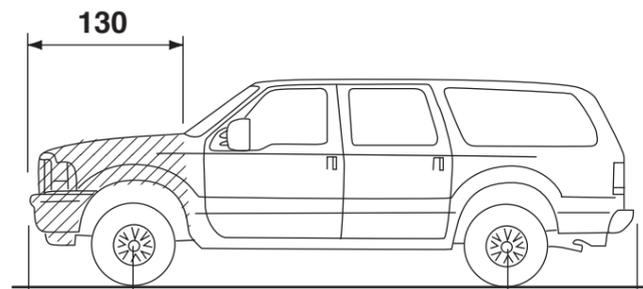
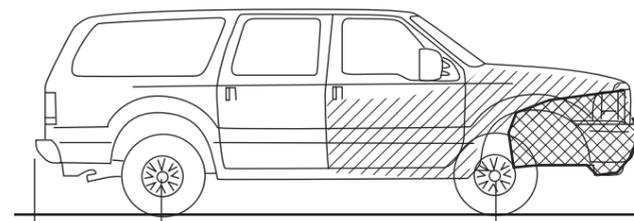
Max. crush to right front bumper corner

[7](#) Damage to the front of case vehicle (A) was moderate to severe. [8](#) Direct damage began at the right-front bumper corner and extended 109-cm to the right, resulting in 60-percent vehicle overlap (% VOL). [9](#) The maximum crush was 94 cm and it occurred at the right-front bumper corner.

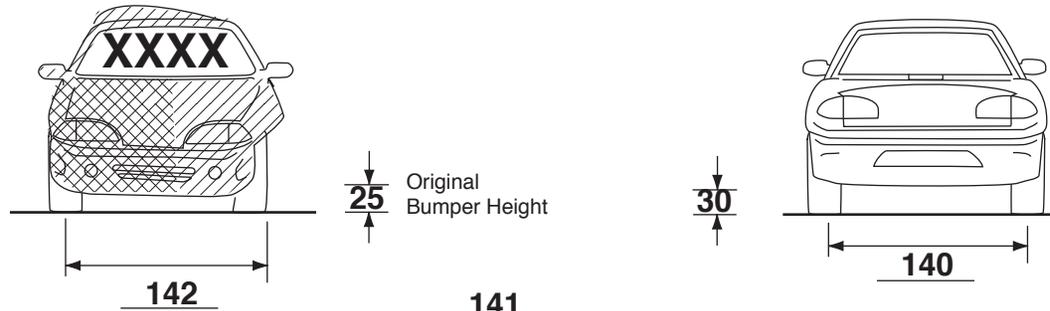
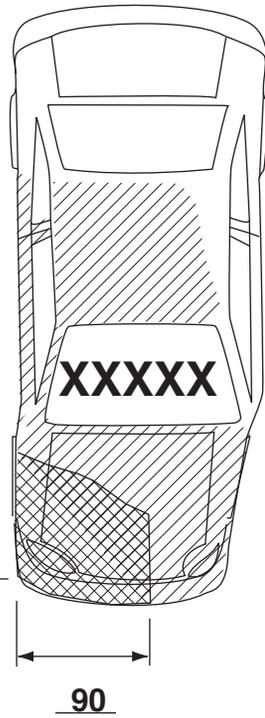
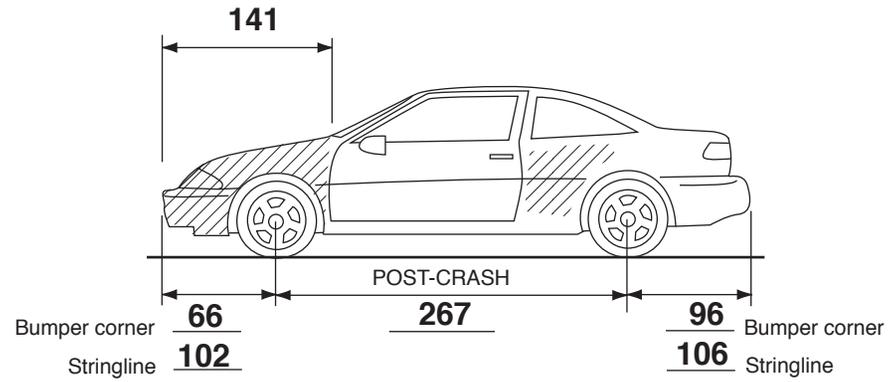
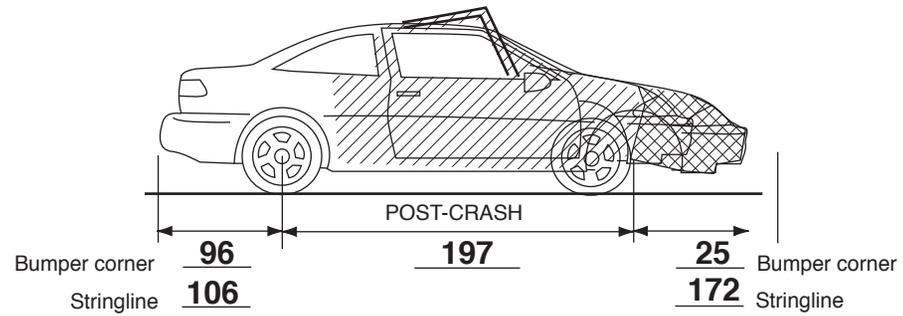
Width of direct damage front

[10](#) Damage to vehicle (B) was very severe. [11](#) Direct damage began at the right-front bumper corner and extended 90-cm to the right, resulting in 61% VOL. [12](#) The maximum crush was 139 cm and it occurred at the right-front bumper corner. [13](#) The right wheelbase was reduced by 66 cm and [14](#) the left wheelbase was increased by 4 cm.
