Case 500 : Narrative

Case Vehicle (A): 1998 Jeep	Vehicle (B): 2003 Mazda
Type: Cherokee Sport, 4-door SUV, 4x4	Type: B3000, 2-door pickup, 4x2
Driver: 78-year-old male	Driver: 43-year-old male
CDC: 12-FDEW-2	CDC: 06-BDEW-1, 12-FDEW-1

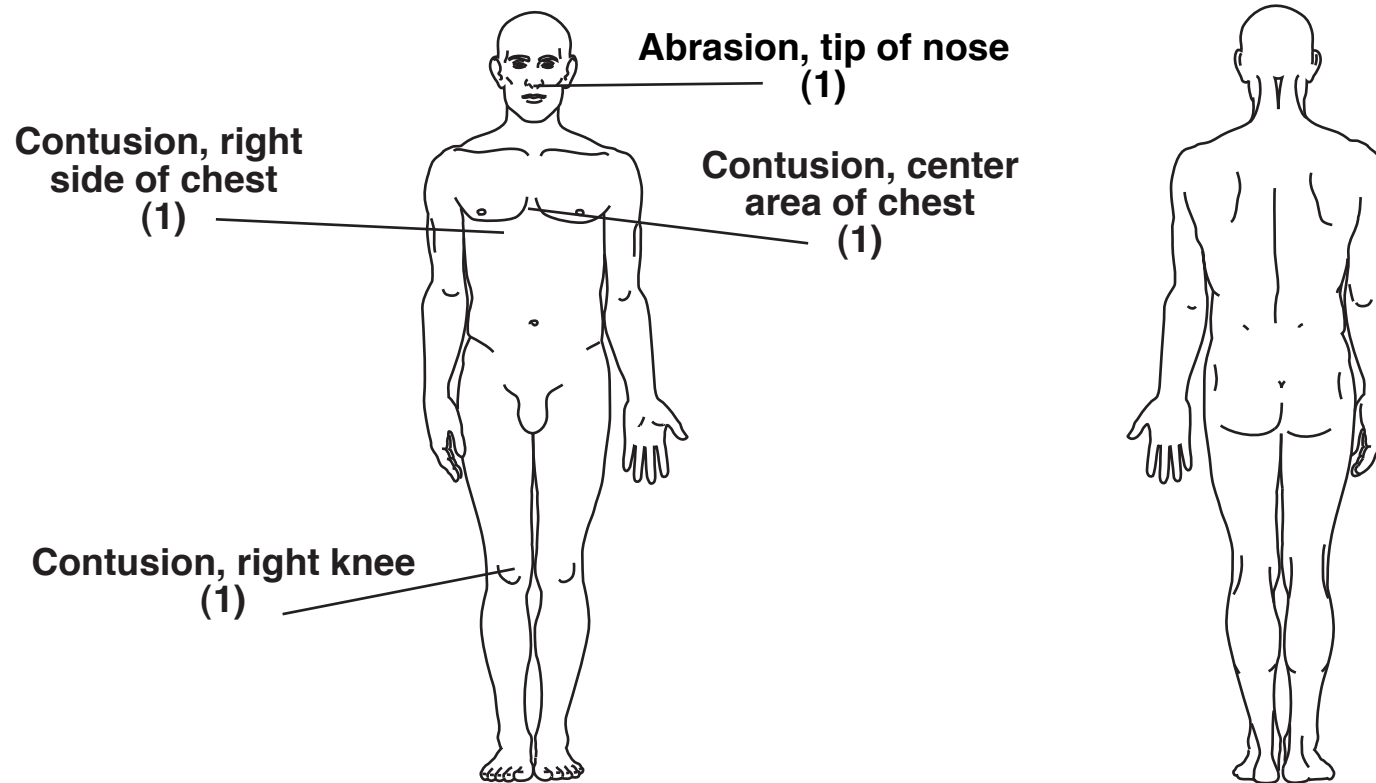
During the frontal impact, the elderly driver moved forward into the belt restraints, the airbag, and the knee bolster. [38](#) He sustained an abrasion to the tip of the nose from contact by the airbag. He sustained a contusion to the right side and center areas of his chest from loading by the shoulder belt, and he sustained a contusion to the right knee from contact with the knee bolster, [43](#) [44](#) as evidenced by scuffmarks on the knee-bolster cover.

Occupant: Driver	Age: 78 years	Gender: Male		
Restraints: 3-point belt; steering-wheel airbag	Stature: 178 cm (5 ft, 10 in)	Mass: 82 kg (180 lb)		
Injury Description	A.I.S.	Injury Source		
—	—	Definite	Probable	Possible
Abrasion, tip of nose	1	Airbag	—	—
Contusion, right side of chest	1	Shoulder belt	—	—
Contusion, center of chest	1	Shoulder belt	—	—
Contusion, right knee	1	Knee bolster	—	—
Maximum A.I.S. Level	1	—	—	—
Injury Severity Score	1	—	—	—

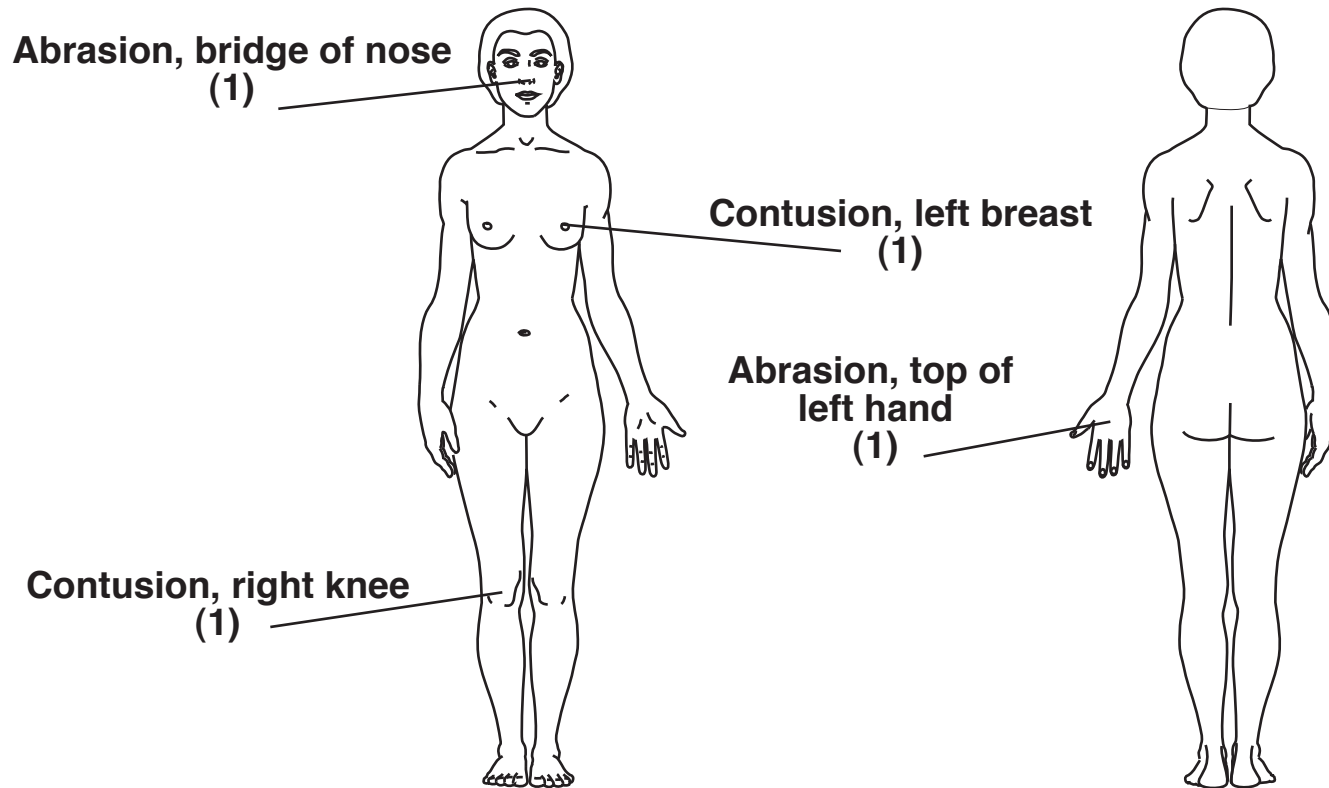
During the frontal impact, the elderly right-front female passenger moved forward into the belt restraints, the airbag, and the glove compartment/knee bolster. She reached forward with her left arm to brace when she saw that the crash was going to occur. She sustained an abrasion to the top of the left hand, [49](#) [50](#) possibly from the airbag flinging her hand into the roof interior. She sustained an abrasion to the bridge of the nose, [49](#) probably from contact by the airbag. She also sustained a contusion to the left breast from loading by the shoulder belt, and she sustained a contusion to the right knee from contact with the glove compartment/knee bolster as [52](#) evidenced by scuffmarks on the glove compartment.

Occupant: Right front	Age: 77 years	Gender: Female		
Restraints: 3-point belt; dash-mounted airbag	Stature: 157 cm (5 ft, 2 in)	Mass: 57 kg (125 lb)		
Injury Description	A.I.S.	Injury Source		
—	—	Definite	Probable	Possible
Abrasion, bridge of nose	1	—	Airbag	—
Contusion, left breast	1	Shoulder belt	—	—
				Roof

Abrasion, top of left hand	1	—	—	interior (airbag fling)
Contusion, right knee	1	Glove compartment/knee bolster	—	—
Maximum A.I.S. Level	1	—	—	—
Injury Severity Score	1	—	—	—

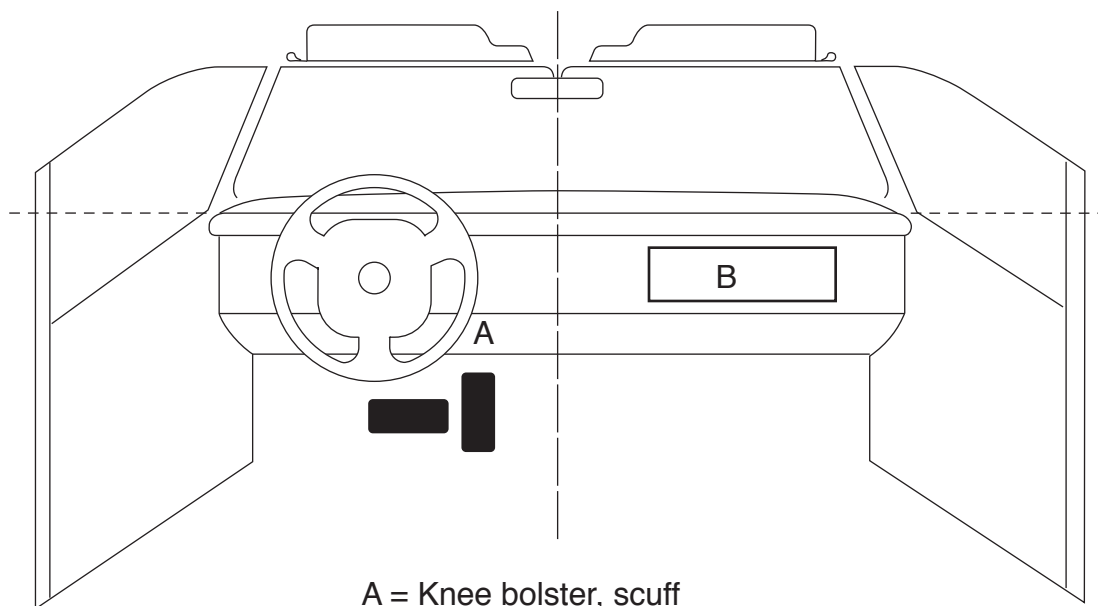
A = Knee bolster, scuff
B = Glove box, scuff

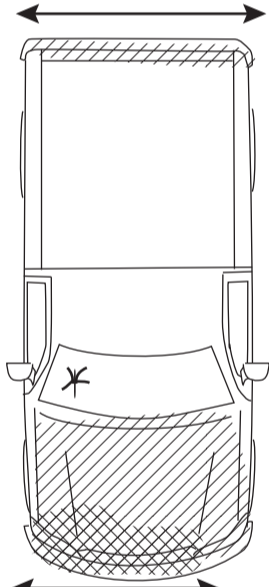
impact #1 to rear
158-cm direct damage
18-cm max crush

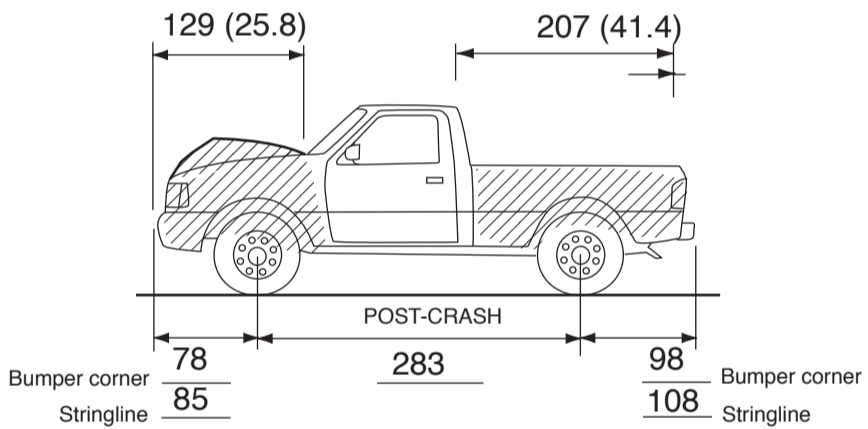
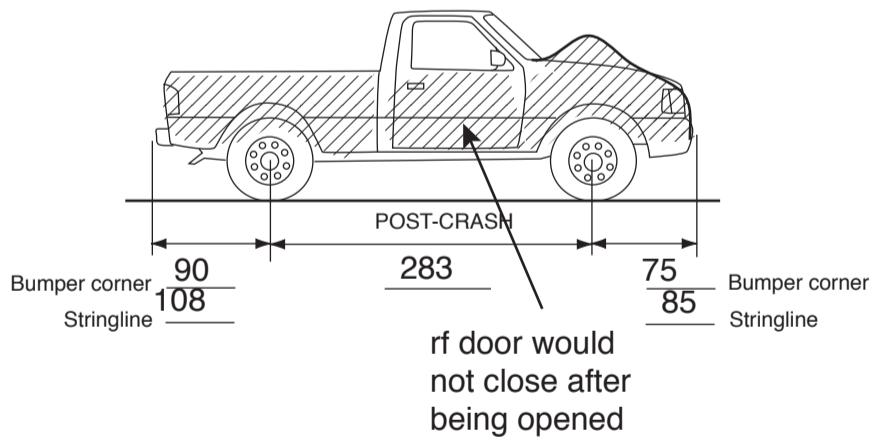
impact #2 to front
121-cm direct damage
17-cm max crush
