Case 505 : Narrative

Case Vehicle (A): 1999 Dodge
Type: Caravan, 4-door minivan
Driver: 18-year-old female
CDC: 12-FCEN-3

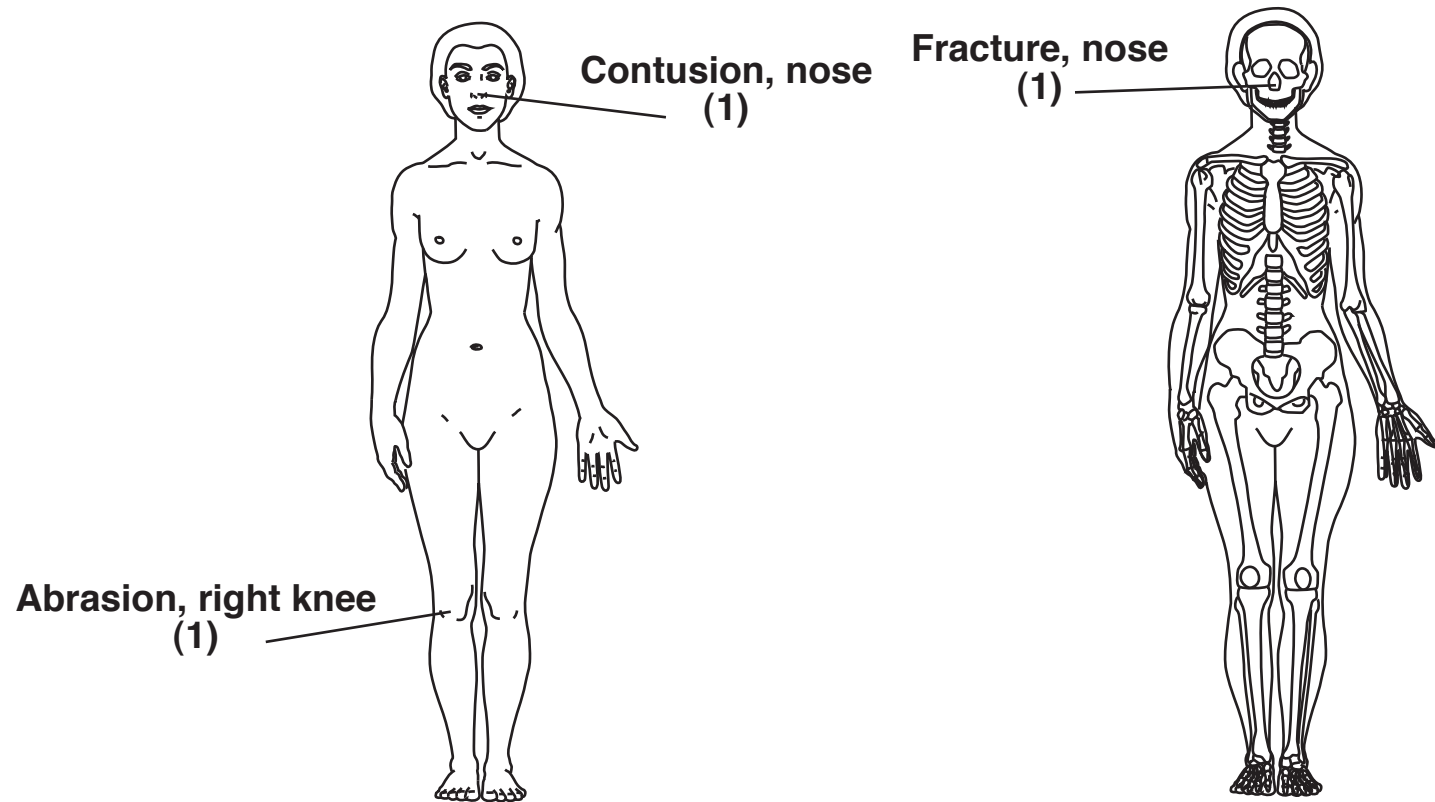
Occupant: Driver	Age: 18 years	Gender: Female		
Restraints: 3-point belt; steering-wheel airbag	Stature: 163 cm (5 ft, 4 in)	Mass: 50 kg (110 lb)		
Injury Description	A.I.S.	Injury Source		
		Definite	Probable	Possible
—	—	—	—	—
Contusion, nose	1	—	Airbag	—
Fracture, nose (prior injury and surgery)	1	—	Airbag	—
Abrasion, right knee	1	Knee bolster	—	—
Maximum A.I.S. Level	1	—	—	—
Injury Severity Score	2	—	—	—
History of nasal surgery	—	—	—	—

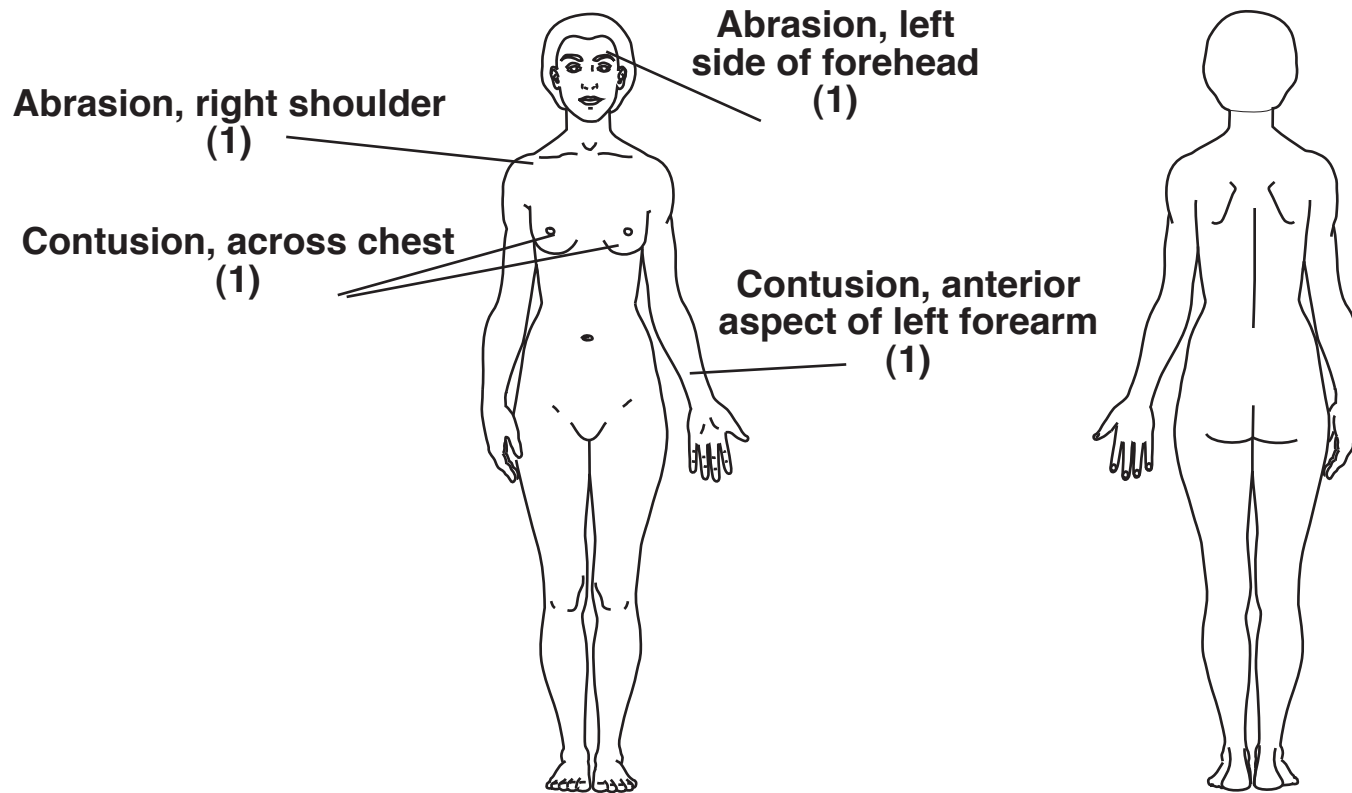
Occupant: Right front	Age: 57 years	Gender: Female		
Restraints: 3-point belt; dash-mounted airbag	Stature: 170 cm (5 ft, 7 in)	Mass: 57 kg (125 lb)		
Injury Description	A.I.S.	Injury Source		
		Definite	Probable	Possible
—	—	—	—	—
Abrasion, left side of forehead	1	—	Airbag	Forearm (airbag fling)
Abrasion, right shoulder	1	Shoulder belt	—	—
Contusion, across chest	1	Shoulder belt	—	—
Contusion, anterior aspect of left forearm	1	—	Airbag	Forehead (airbag fling)
Maximum A.I.S. Level	1	—	—	—
Injury Severity Score	1	—	—	—

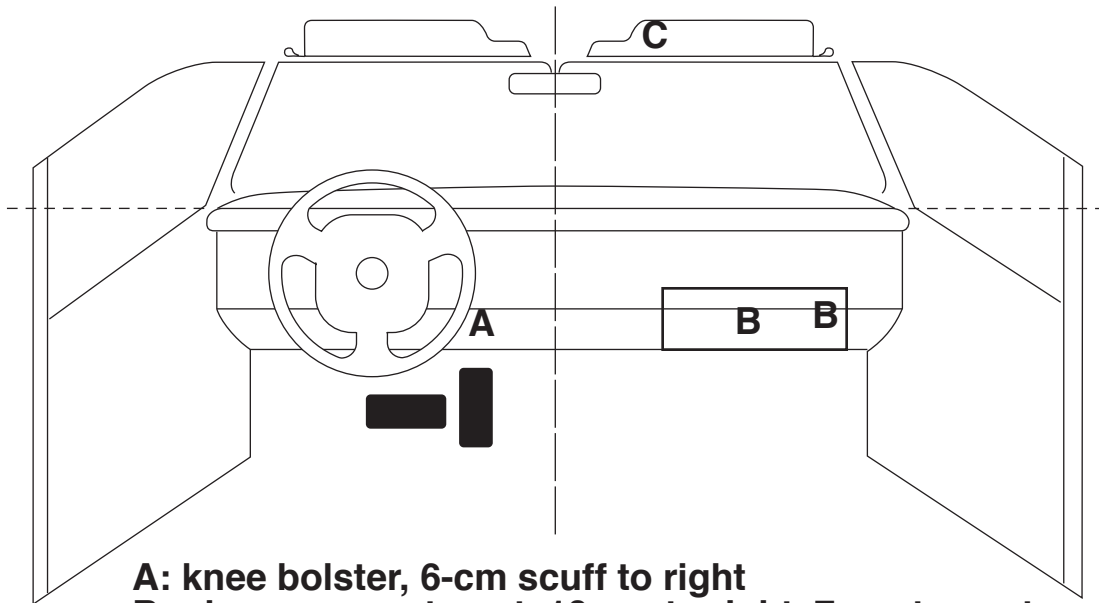
A: knee bolster, 6-cm scuff to right
B: glove compartment, 10-cm to right, 7-cm to center
C: right-front sunvisor, blood
