Case 507 : Narrative

Case Vehicle (A): 2002 Ford	Vehicle (B): 2000 Subaru	Case Vehicle (C): 2005 Mazda
Type: Focus LX, 4-door sedan	Type: Legacy, 4-door wagon	Type: 3, 4-door sedan
Driver: 34-year-old male	Driver: 31-year-old male	Driver: 29-year-old female
CDC: 12-FYEW-3, 03-RFEW-2, 09-LPEW-3	CDC: 99-0000-0	CDC: 99-0000-0

507: Vehicle Report

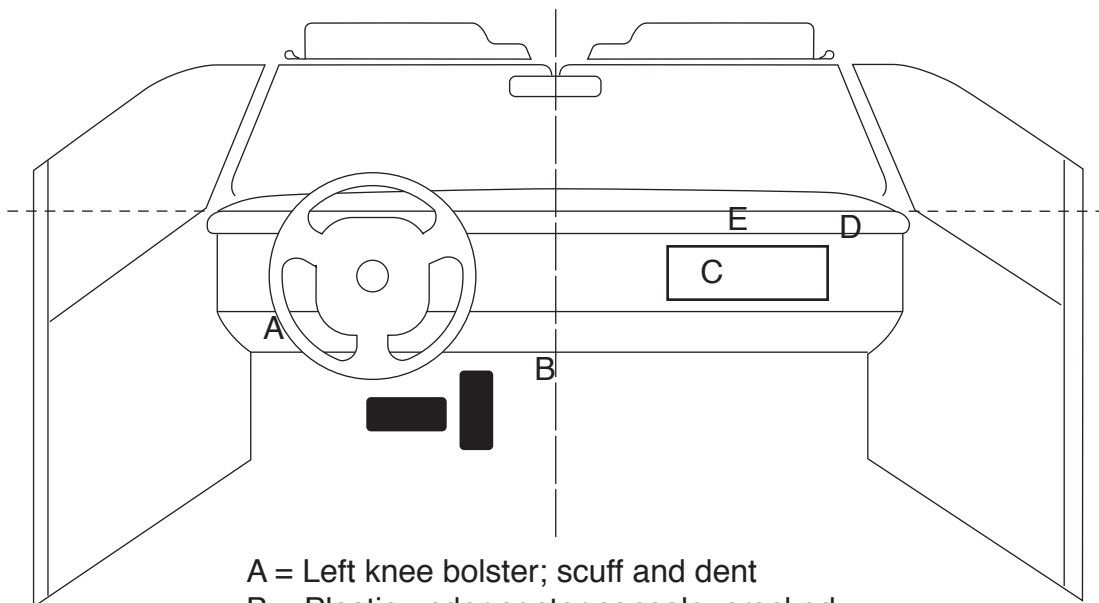
- A = Left knee bolster; scuff and dent
- B = Plastic under center console; cracked
- C = Glove box; 7-cm scuff
- D = Instrument panel above glove box; cracked
- E = Dash-mounted airbag; lipstick and facial makeup
- F = Center left console/armrest; bent to left
