CALSPAN REMOTE AIR BAG DEPLOYMENT INVESTIGATION

CALSPAN CASE NO. 95-15

VEHICLE #1 - 1993 LEXUS LS 400

VEHICLE #2 - 1991 LINCOLN TOWN CAR

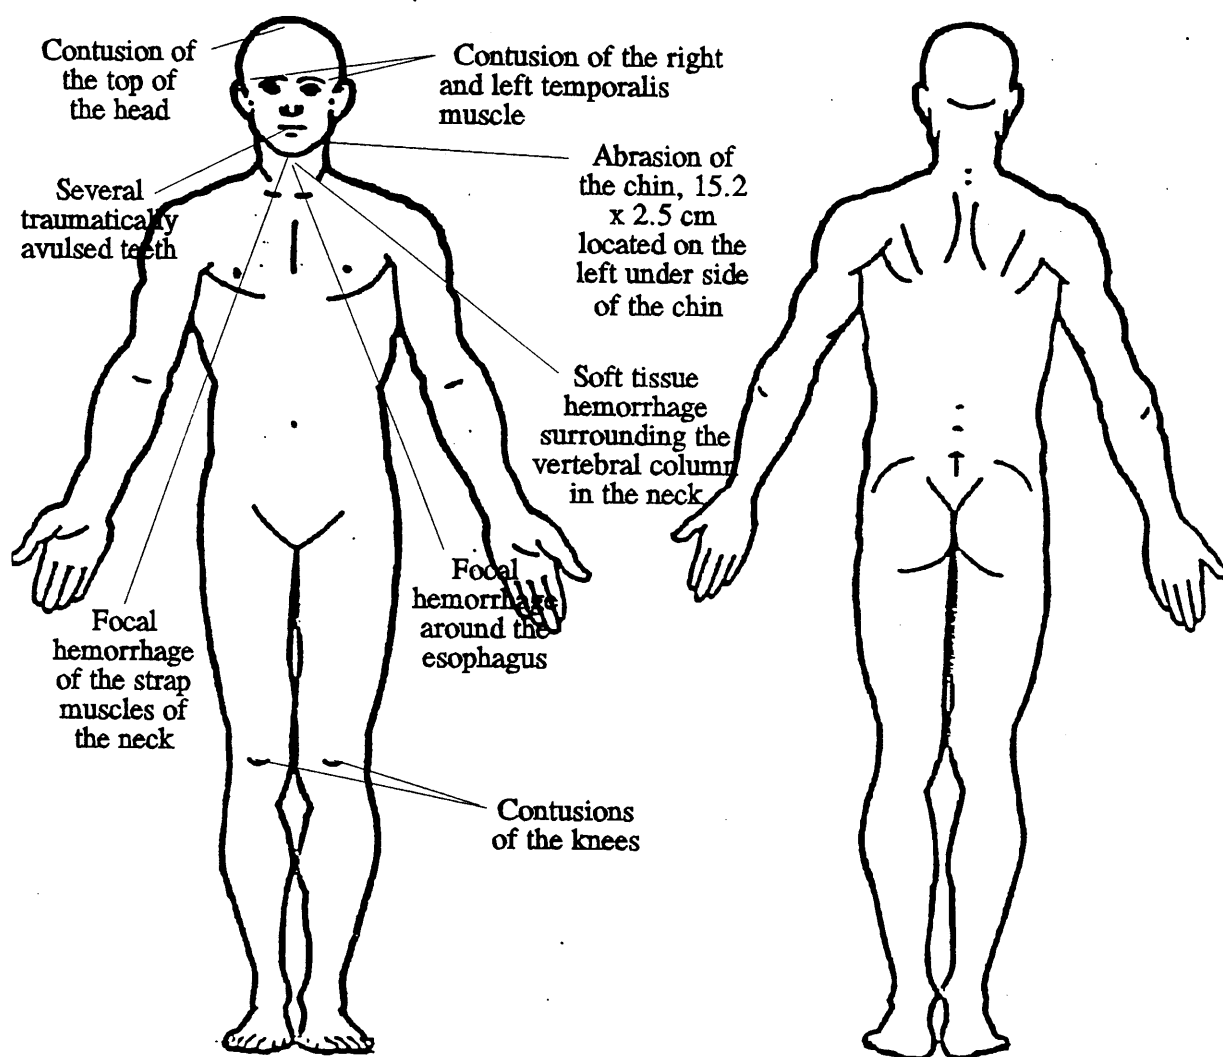
OFFICIAL INJURY DATA - SOFT TISSUE INJURIES

RIGHT FRONT OCCUPANT INJURIES	SEVERITY (OIC/AIS)	SOURCE*
Contusion of the right and left temporalis muscle Contusion of the left mandible <i>Purple color located mid to left portion of mandible which measured 3.2 cm x 1.3 cm (1.25" x 0.5")</i>	290402.11 290402.12	Passenger side air bag
Fracture of the left mandible <i>Fracture located at the mid portion of the mandible</i>	250612.22	Passenger side air bag module cover and air bag
Faint contusion of the top portion of the head in the midline parietal region	190402.19	Windshield,
Separation of the atlanto-occipital	650208.26	Passenger side air bag module cover and air bag
Soft tissue hemorrhage surrounding the vertebral column in the neck	390402.15	Passenger side air bag module cover and air bag
Focal hemorrhage around the esophagus	440802.24	Passenger side air bag module cover and air bag
Focal hemorrhage of the strap muscles of the neck	Not a codeable injury	Passenger side air bag module cover and air bag

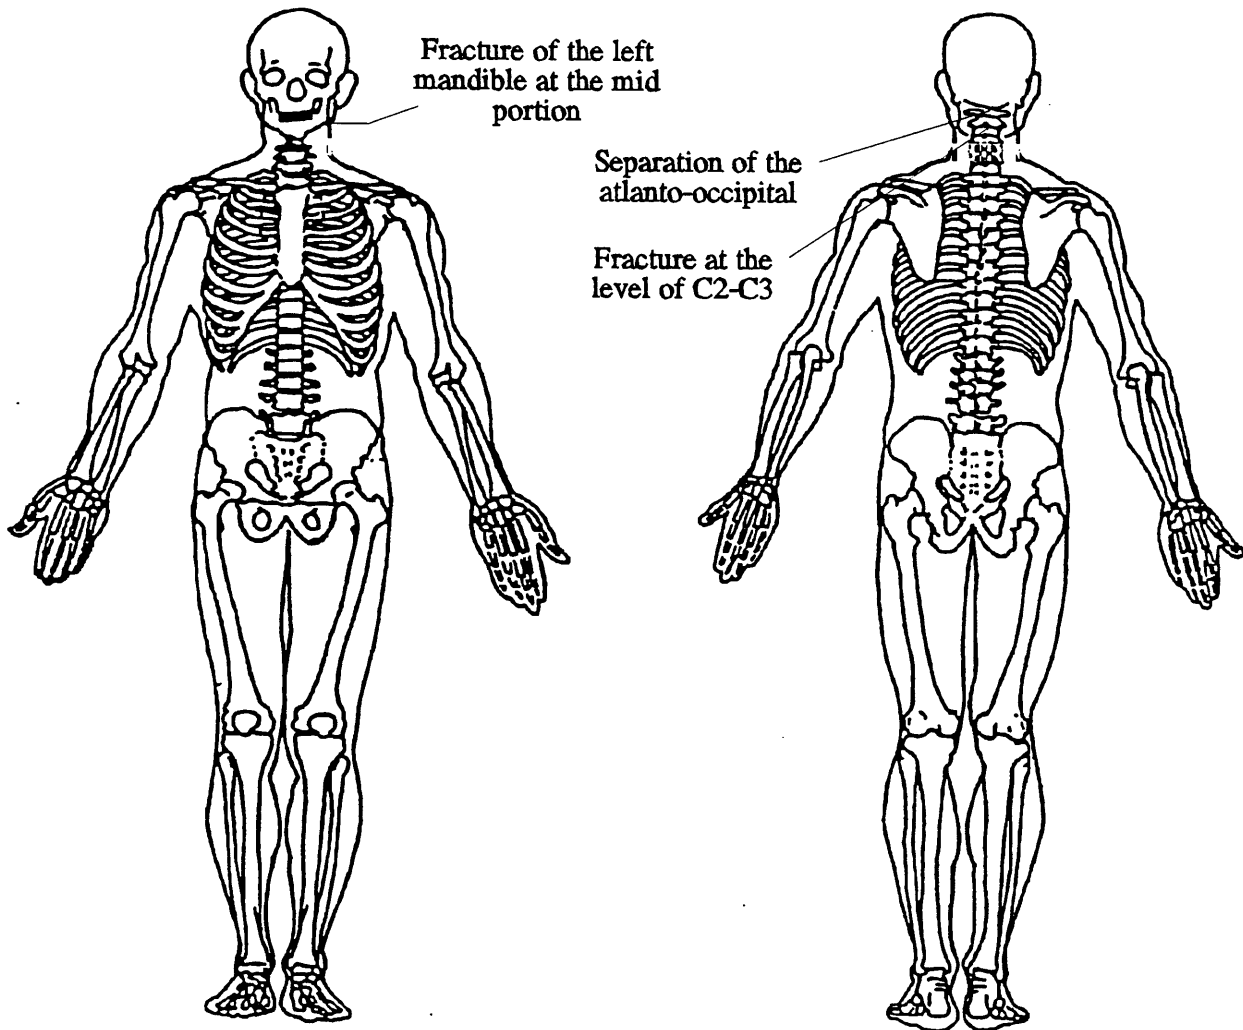
OFFICIAL INJURY DATA - SKELETAL INJURIES

Contusion of the spinal cord in the region of C ₂ -C ₃ <i>Apparent necrosis</i> Fracture at the level of C ₂ -C ₃	640204.36	Passenger side air bag module cover and air bag
Contusions of the knees <i>Two small contusions were noted of the knee</i>	890402.13	Glove compartment door

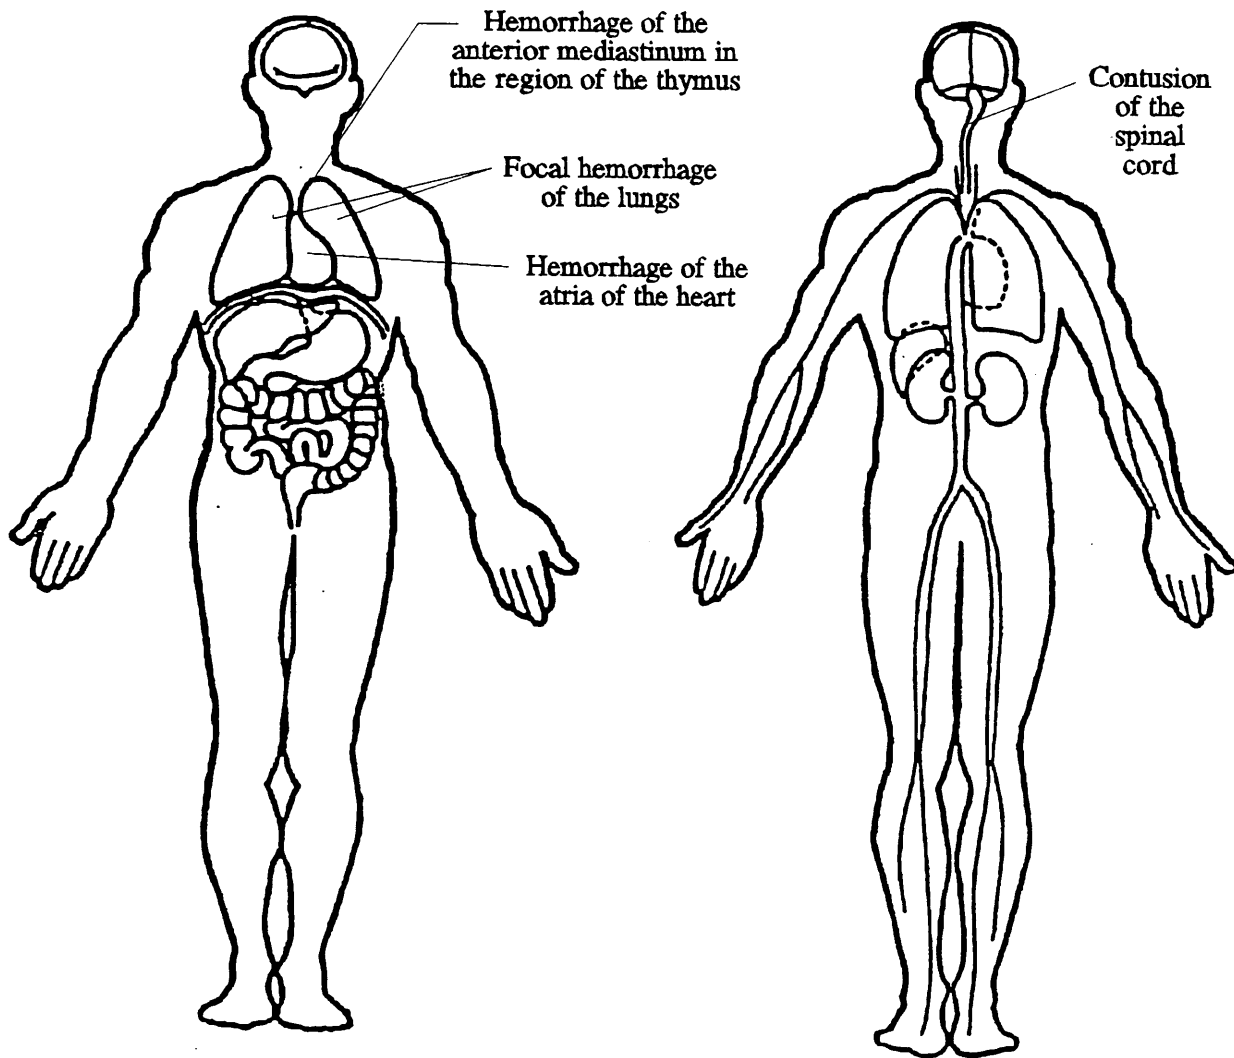
OFFICIAL INJURY DATA - INTERNAL INJURIES

RIGHT FRONT OCCUPANT INJURIES	SEVERITY (OIC/AIS)	SOURCE*
Hemorrhage of the anterior mediastinum in the region of the thymus	Not a codeable injury	Passenger side air bag
Small amount of hemorrhage of the atria of the heart	441002.34	Passenger side air bag
Focal small amounts of hemorrhage are noted of the lungs	441402.33	Passenger side air bag
