**CALSPAN ON-SITE NON-DEPLOYED AIR BAG INVESTIGATION
CALSPAN CASE NO. 96-4
LOCATION: CONNECTICUT
VEHICLE: 1995 CHEVROLET K1500 PICKUP TRUCK**

Contract No. DTNH22-94-D-07058

TECHNICAL REPORT STANDARD TITLE PAGE

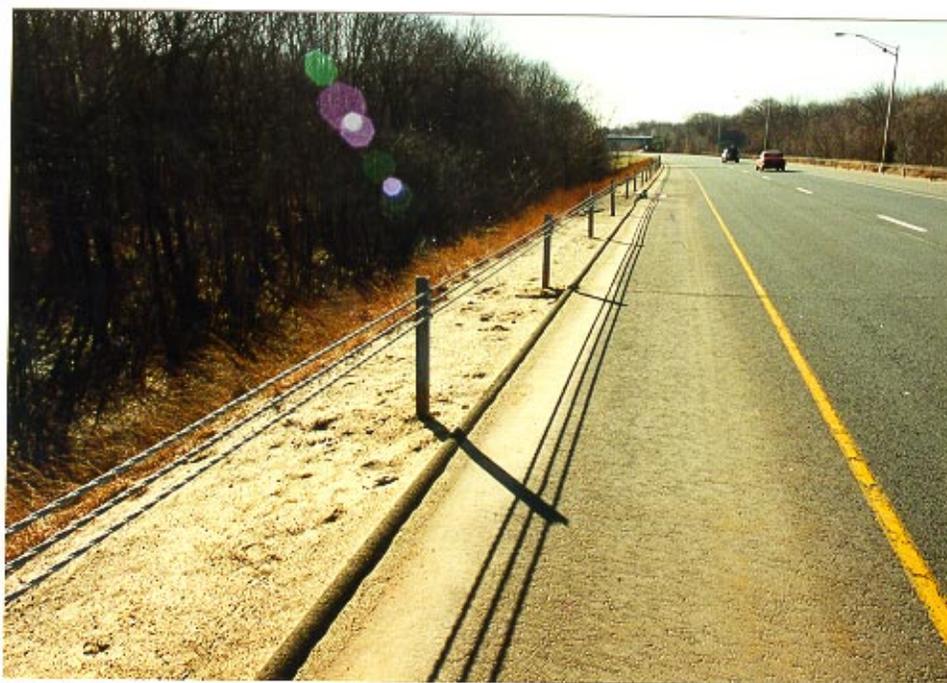
4. Cable guardrail and posts (replaced) struck by the snow plow.

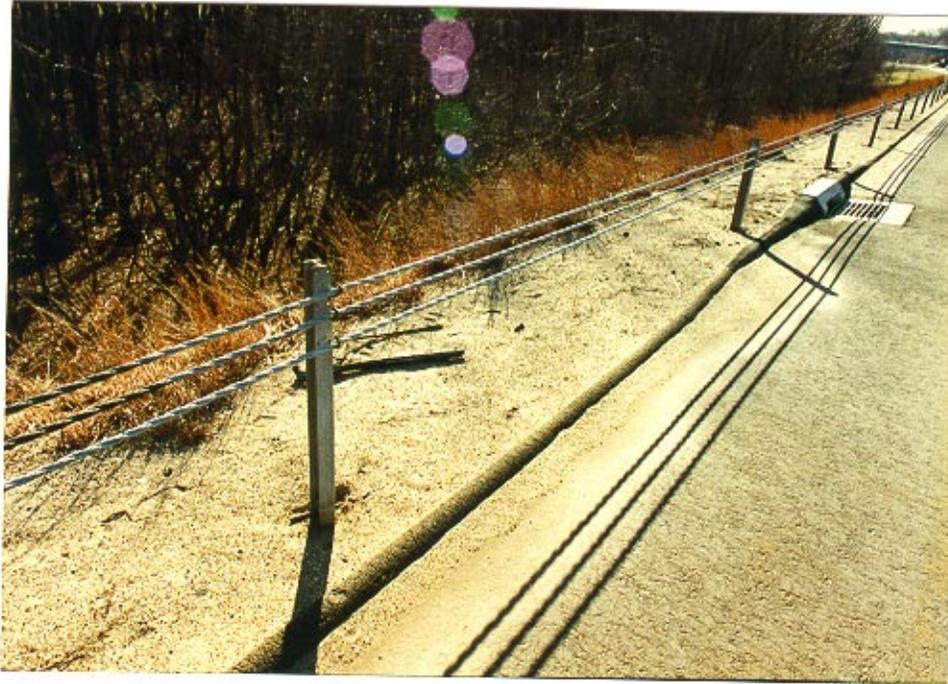
5. Cable guard rails and post struck by the frontal area of the Chevrolet pickup truck.

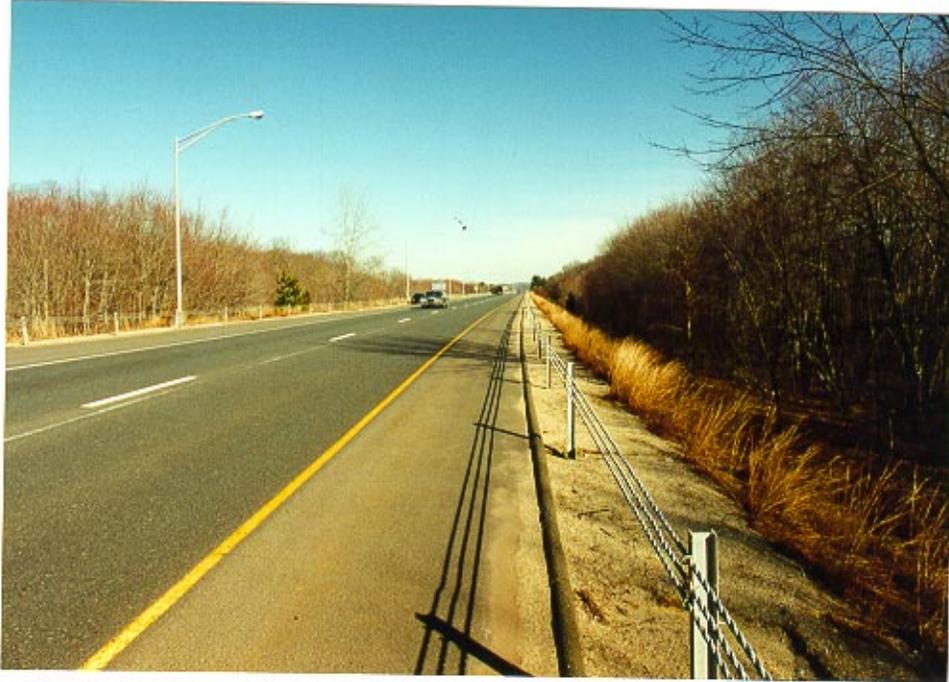
7. Lookback view of the crash scene.

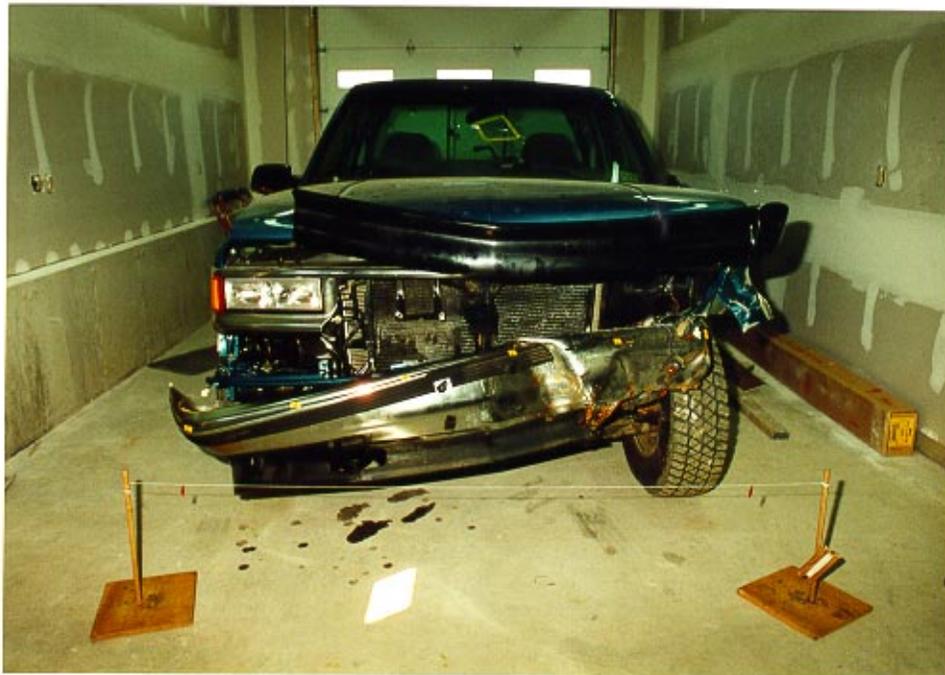
The 1995 Chevrolet 1500 series pickup truck sustained moderate frontal damage as a result of its initial impact sequence with the wing snow plow that was mounted to the right side of vehicle #2. Maximum crush was 28.2 cm (11.1") located at the left corner of the front bumper. The direct contact damage began 13.3 cm (5.25") left of center and extended 76.2 cm (30.0") to the left bumper corner. The off-set frontal impact deformed the entire width of the frontal structure resulting in a combined induced and direct damage length (Field L) of 170.2 cm (70.0"). Crush values at bumper level were as follows: $C_1 = 28.2$ cm (11.1"), $C_2 = 25.1$ cm (9.9"), $C_3 = 23.1$ cm (9.1"), $C_4 = 9.5$ cm (3.75"), $C_5 = 0.6$ cm (0.25"), $C_6 = 0$ cm (-2.9").

Damaged components from the frontal impact sequence included the bumper, grille, left headlamp assembly, hood, aftermarket bug deflector, radiator support panel, radiator and air conditioning condenser, left front fender, and the left frame rail (vertical and rearward displacement).

8. Frontal damage to the Chevrolet pickup truck.

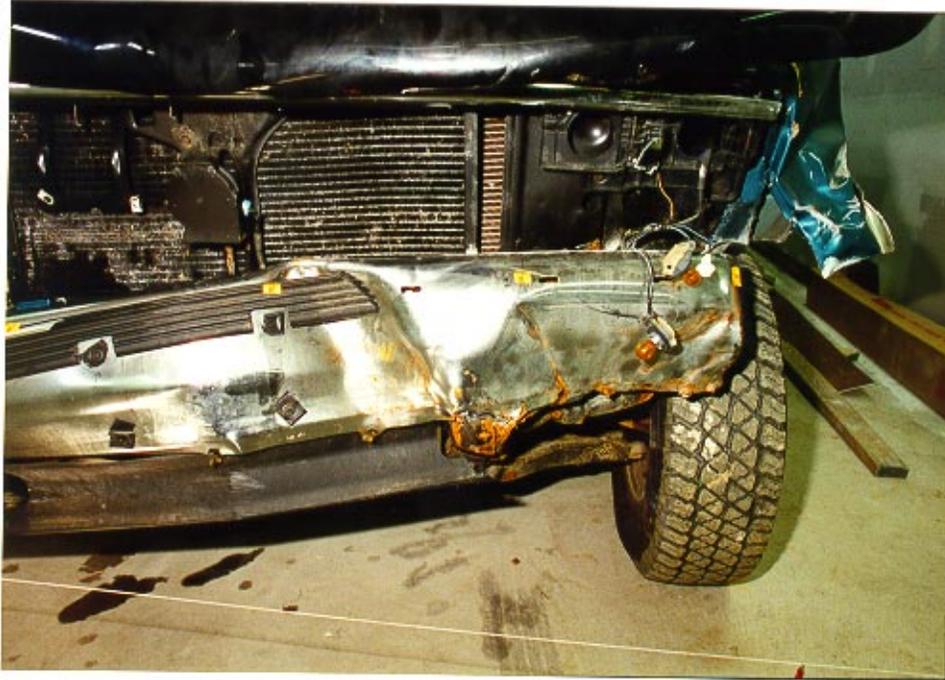
9. Close-up view of the of the damage that resulted from contact with the snow plow.

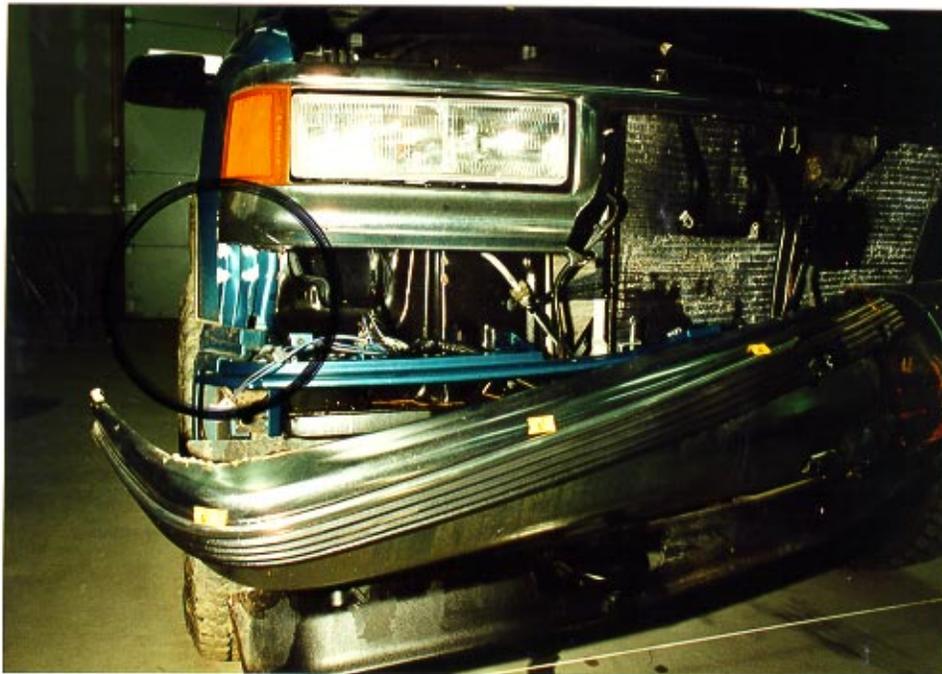
The secondary damage to the Chevrolet pickup truck resulted from an impact sequence with a cable guardrail system. Following the initial crash with the snow plow, the Chevrolet pickup truck yawed in a counterclockwise (CCW) direction and crossed the westbound travel lanes. The vehicle departed the travel lanes and struck the cable system with the frontal area. Although the guardrail system consisted of three individual cables, only two cable imprints were visible across the frontal area of the vehicle (refer to Photograph No. 10). The cable contact extended 168.9 cm (66.5") across the full width of the vehicle and was located at grille height between the bumper and headlamp assemblies. The cable gouges were spaced on 3.8 cm (1.5") centers. There was no evidence of guardrail post contact to the bumper of the pickup truck.

10. Cable guardrail damage (circled) across the front of the Chevrolet pickup truck.

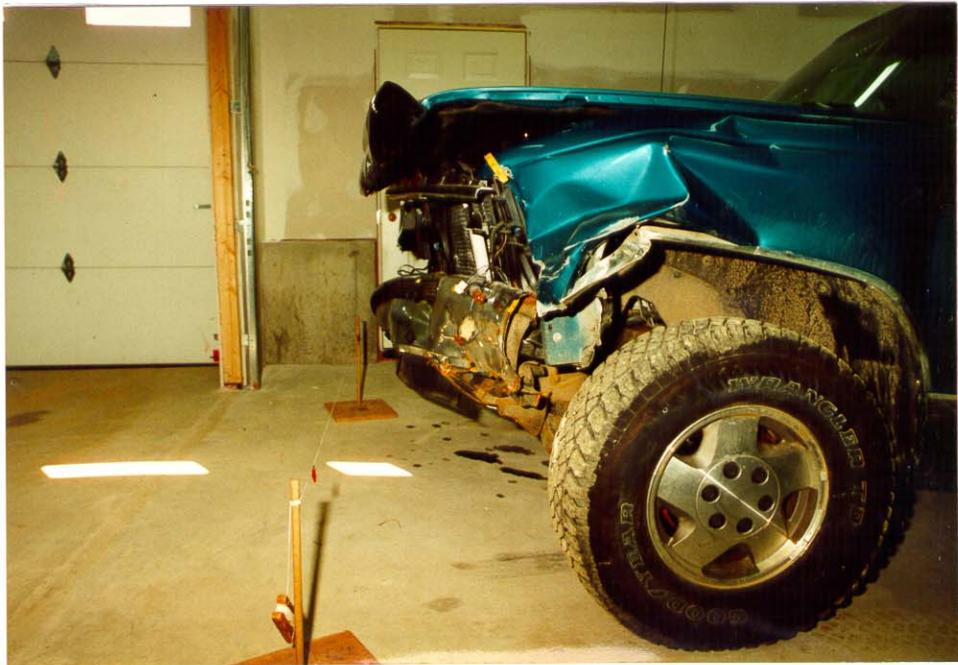
12. Profile view documenting the extent of frontal crush.

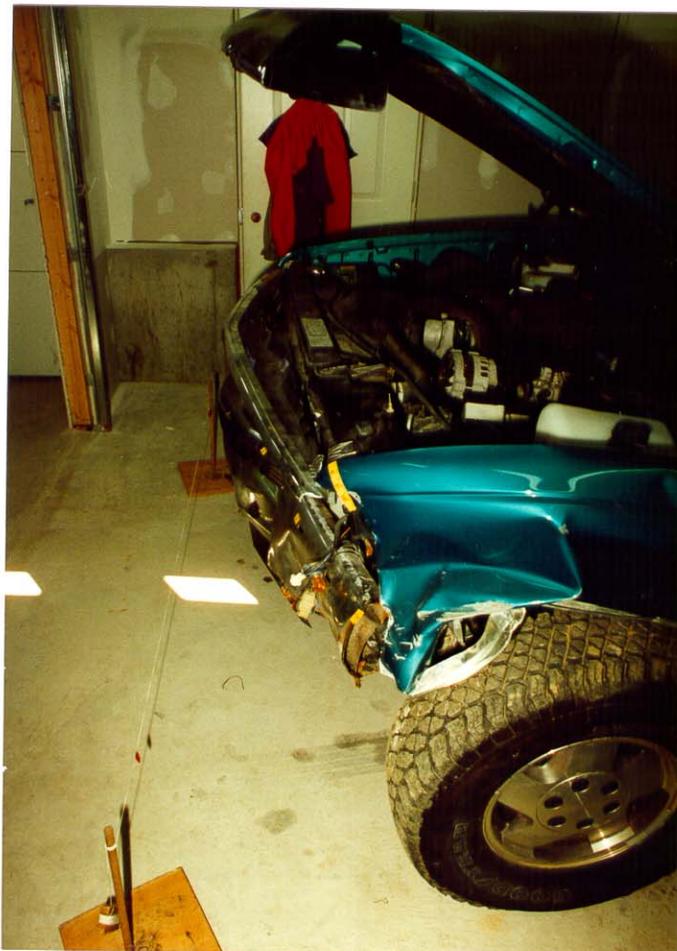
13. Additional profile view documenting the frontal damage pattern.

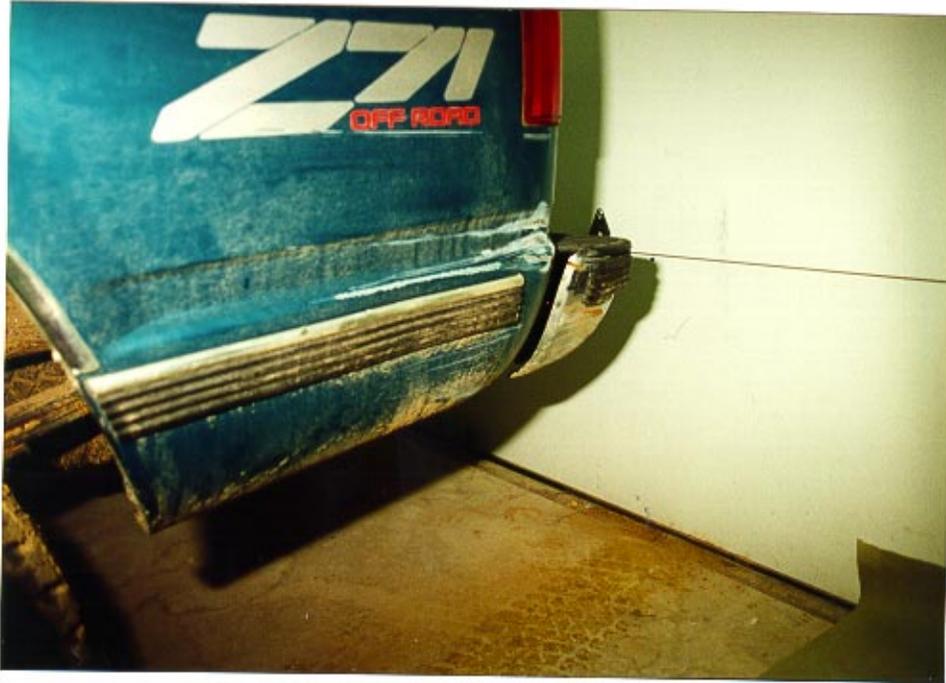
resulted in minor sideswipe-type damage to the quarter panel and rear bumper corner. The damage began 64.8 cm (25.5") rearward of the left rear axle position and extended 51.8 cm (20.4") to the left rear bumper corner. Maximum crush was 1.3 cm (0.5") located on the quarter panel at the rub strip (refer to Photograph No. 15).

15. Secondary guardrail contact damage to the left rear side area.

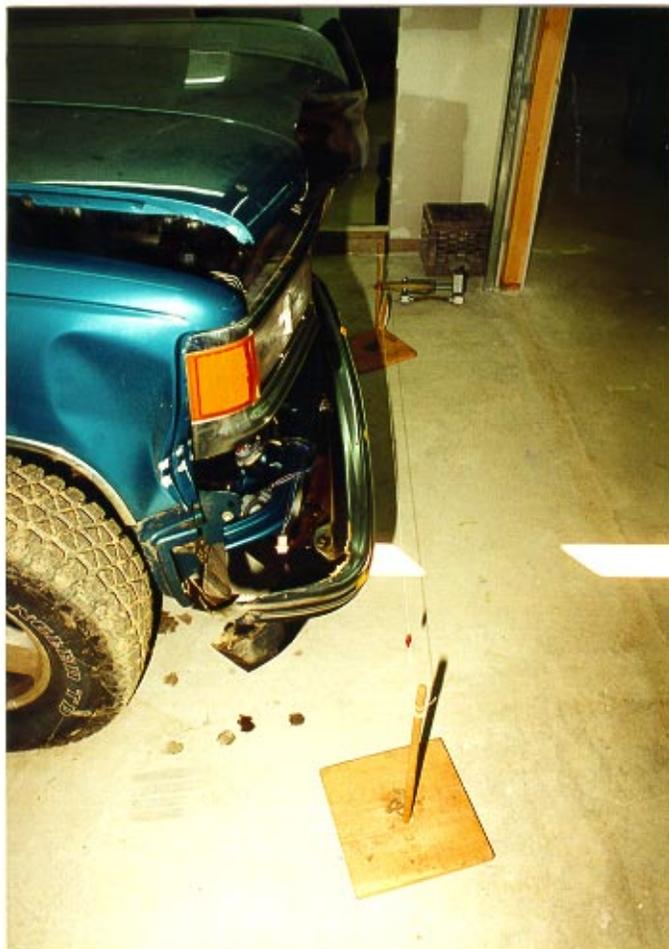
18. Right profile view documenting the frontal damage patterns.

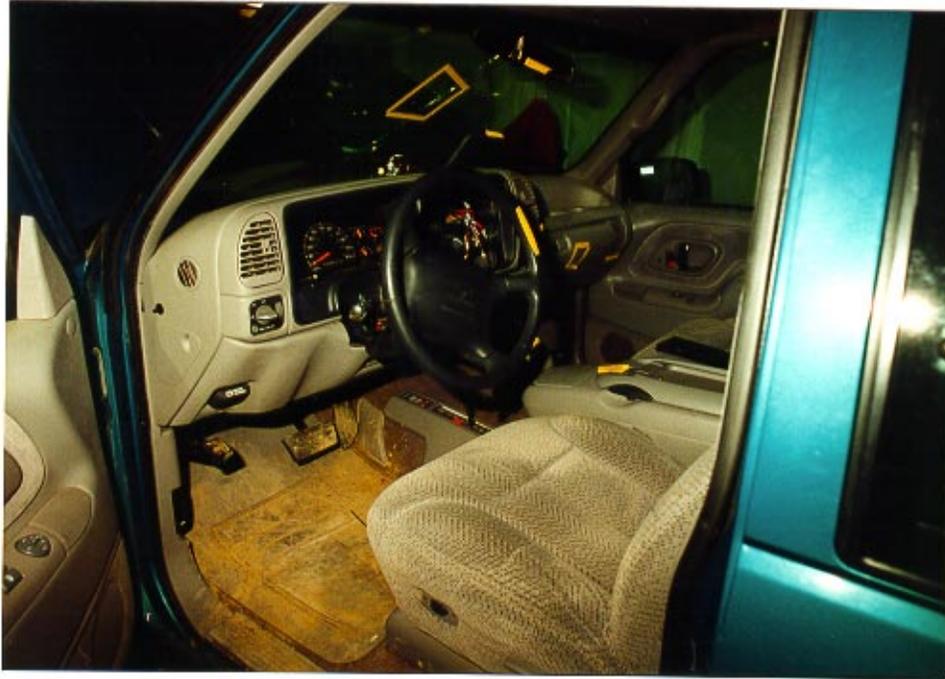
The interior of the Chevrolet pickup truck sustained moderate damage that was associated solely with occupant contact. There was no interior component intrusion or deformation associated with the exterior damage. The driver was not wearing the manual 3-point lap and shoulder belt system. At impact with the snow plow, he initiated a forward trajectory and contacted the right side of the steering wheel rim and the column mounted transmission selector lever. Although no wheel damage occurred, the contact sequence fractured the selector lever from the steering column. It should be noted that there was no compression of the energy absorbing steering column. The driver's forehead subsequently contacted the rear view mirror and windshield. As a result of the forehead contact, the mirror glass was cracked and the laminated windshield was cracked 2.5 cm (1.0") left of center and 17.8 cm (7.0") above the upper instrument panel. Surrounding the windshield crack was a tissue transfer with an oily smudge which extended 8.3-13.3 cm (3.25-5.25") left of center and 14.0-17.1 cm (5.5-6.75") above the upper panel. The driver's right hand and/or arm contacted and separated the pull-out cup holder from the center mid instrument panel. No damage occurred to the plastic cup holder or the slide mechanism.

19. Overall view of the interior and occupant contacts points within the Chevrolet pickup truck.

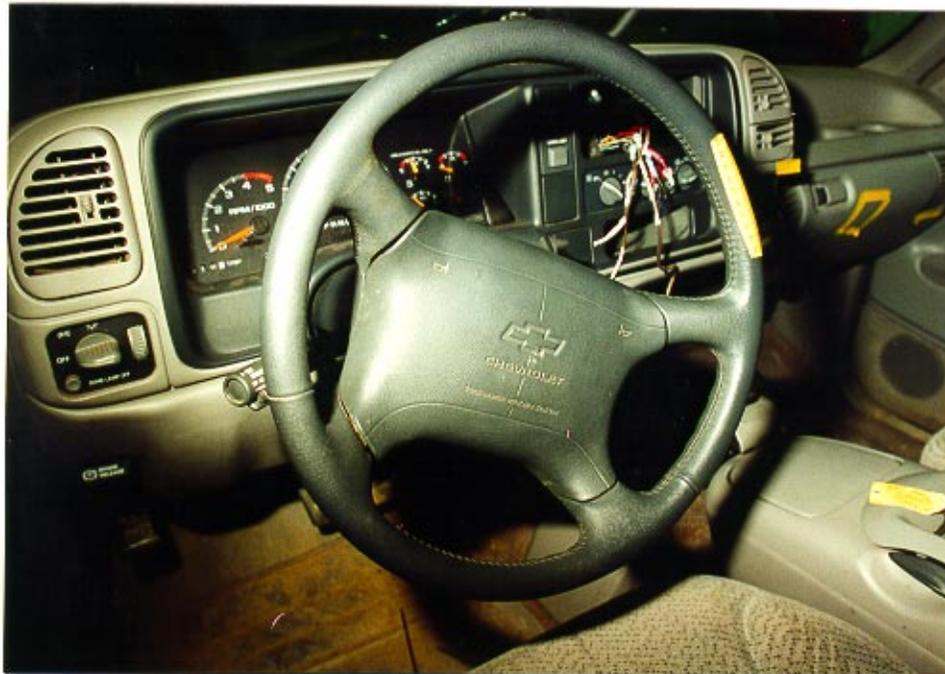
As previously noted, the SIR in this pickup truck did not deploy following the vehicle's frontal impact sequence with the right side mounted wing snow plow. Deployment thresholds for this vehicle ranged from longitudinal barrier equivalent speeds of 16-26 km/h (10-16 mph). This range indicates that at barrier equivalent speeds of less than 16 km/h (10 mph), the SRS will not deploy, however, at barrier equivalent speeds of ≥ 26 km/h, all systems will deploy. This crash resulted in a SMASH generated barrier equivalent speed of 23 km/h (14 mph) which was below the upper threshold required for deployment.

20. Non-deployed driver's side air bag module.

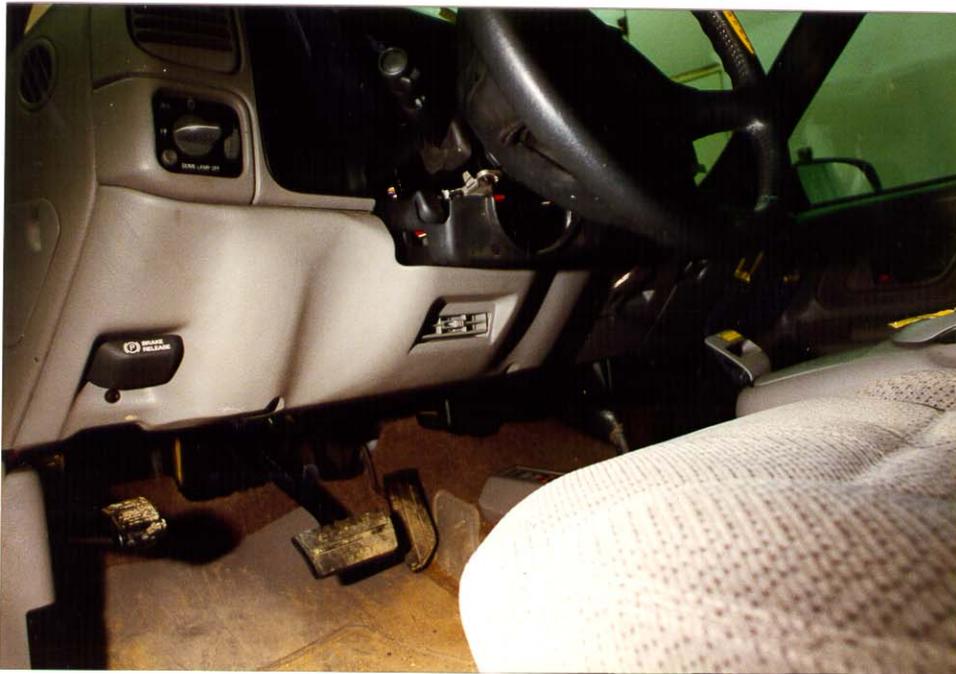
22. Knee bolster; no evidence of driver contact.

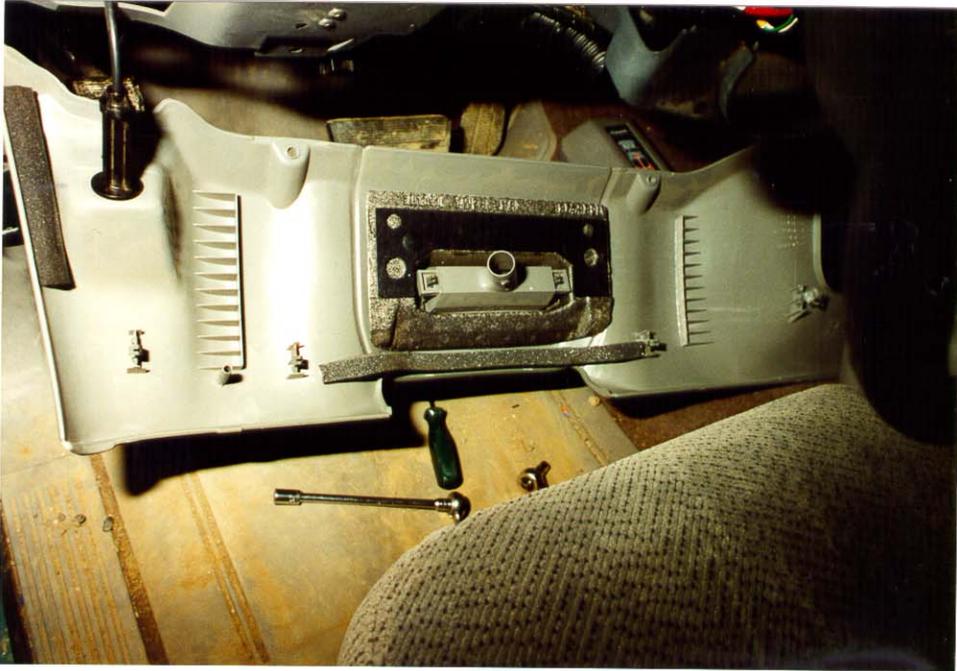
23. Back side of the knee bolster with no evidence of damage.

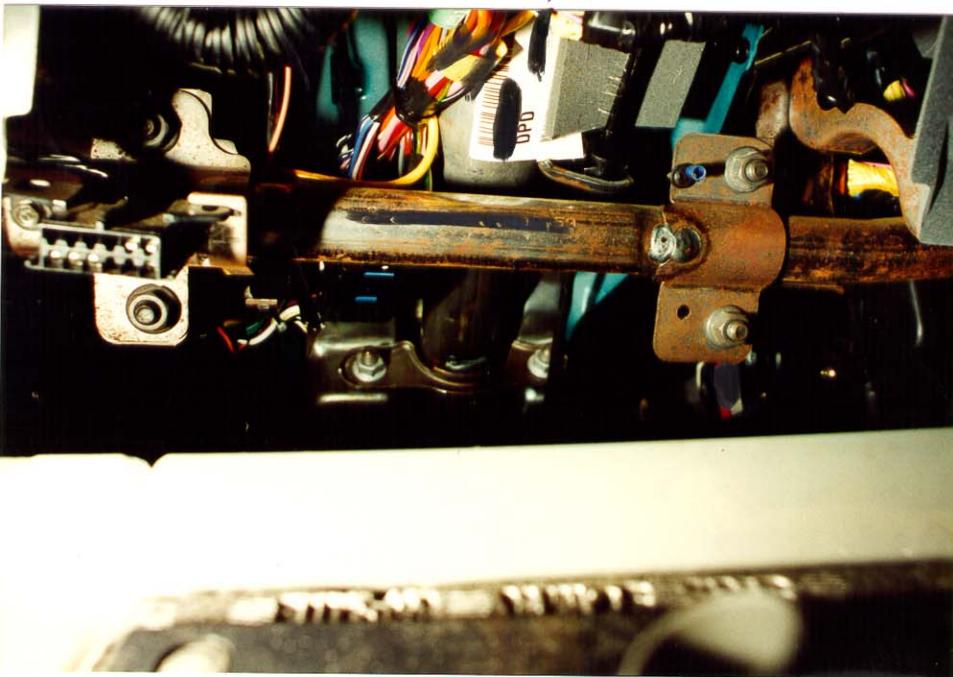
24. Energy absorbing steering column; no compression.

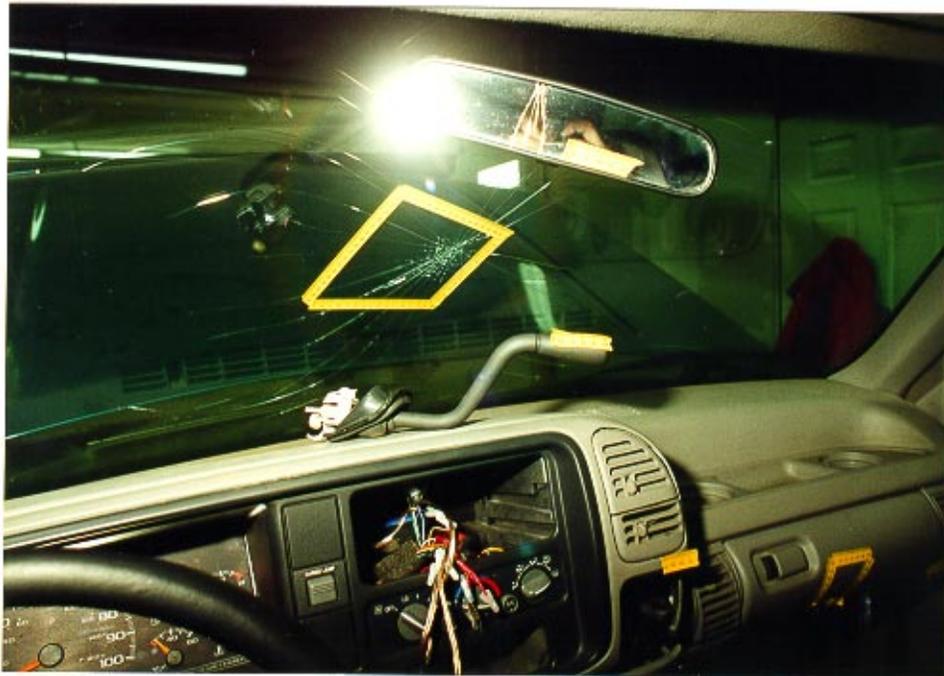
The driver continued forward to the right of the steering wheel rim and impacted the rearview mirror with his forehead. The contact fractured the glass of the mirror and displaced the mirror to the right. His head continued forward and impacted the laminated windshield with sufficient force to crack the glazing 2.5 cm (1.0") left of the vehicle's centerline and 17.8 cm (7.0") above the upper instrument panel. In addition to the crack, a tissue transfer was noted to the glazing 1.3-7.4 cm (0.5-2.9") left of center and 13.3-16.5 cm (5.25-6.5") above the instrument panel. Adjacent to the tissue transfer was a skin oil transfer located 8.3-13.3 cm (3.25-5.25") left of center and 14.0-17.1 cm (5.5-6.75") above the referenced panel (refer to Photograph Nos. 26). As a result of the windshield contact, the driver sustained a laceration with abrasion to the mid superior forehead.

26. Driver's head contact to the rear view mirror and windshield.

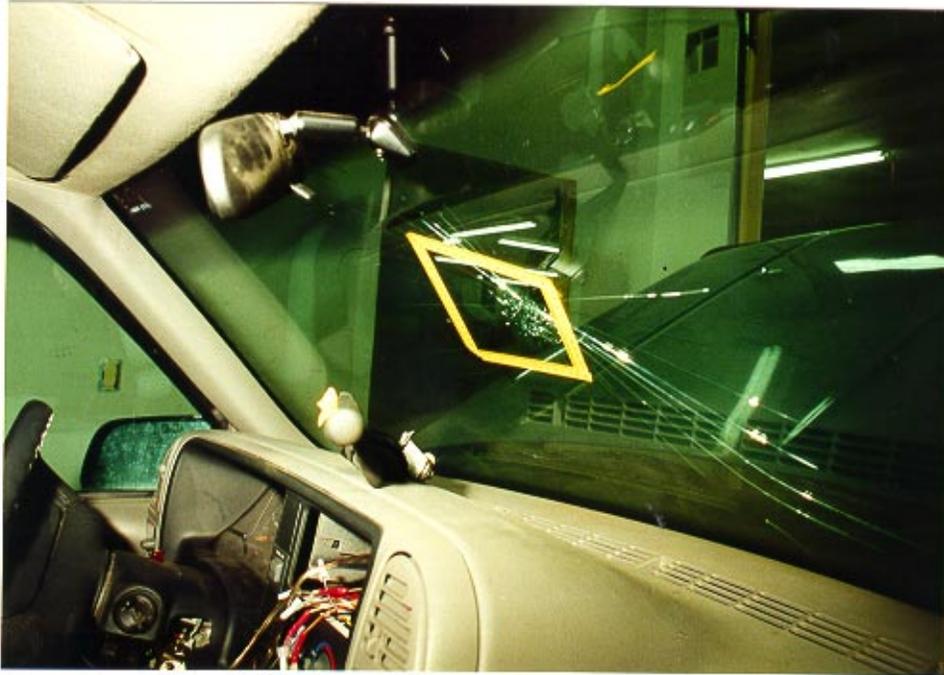
27. Head contact damage and tissue transfers to the windshield.

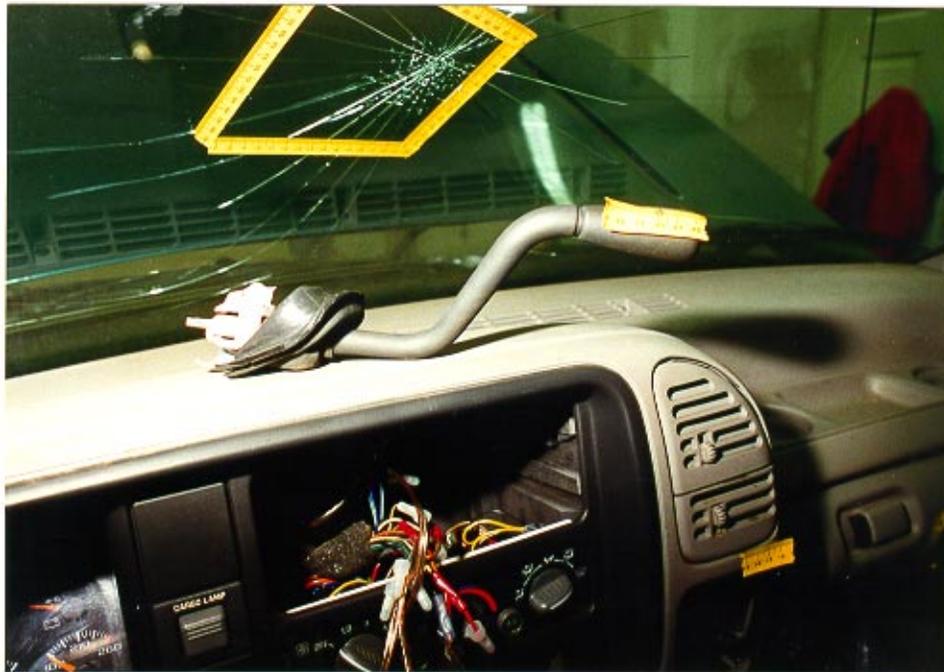
28. Driver's left thoracic contact and subsequent separation of the transmission selector lever from the steering column.

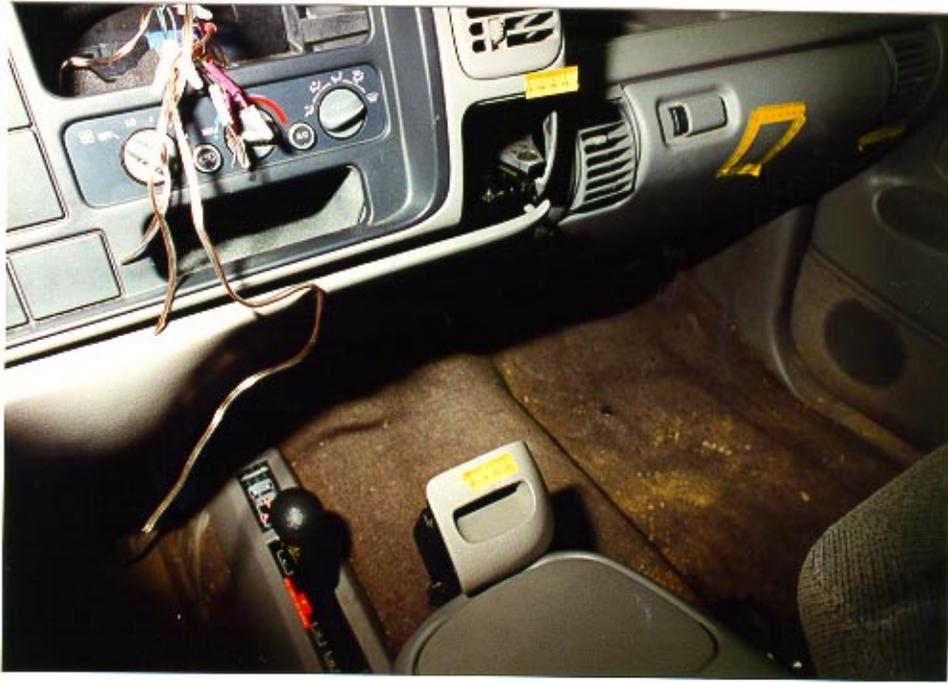
The driver's right hand or arm contacted the center pull-out cup holder that was extended from the center mid instrument panel (refer to Photograph No. 29). The contact separated the cup holder from the slide mount, however, there was no damage to the components. He rebounded into the left front seat back where he came to rest. The driver's rebound contact rotated the seat back in a clockwise direction and loosened the seat track mechanism which resulted in fore and aft movement of the seat assembly.

29. Probable right hand contact to the instrument panel mounted pullout cup holder.

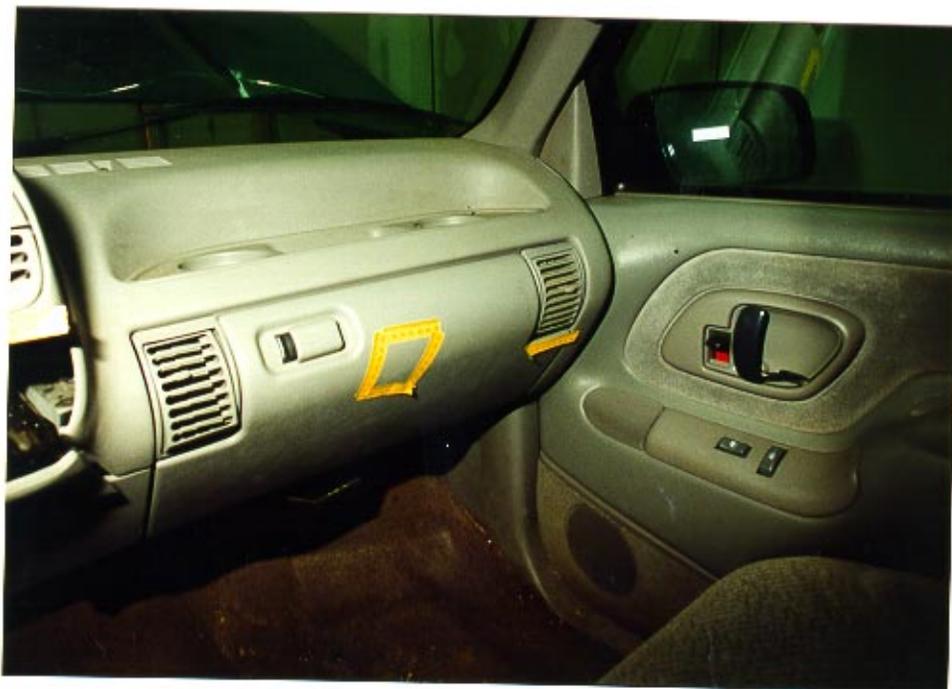
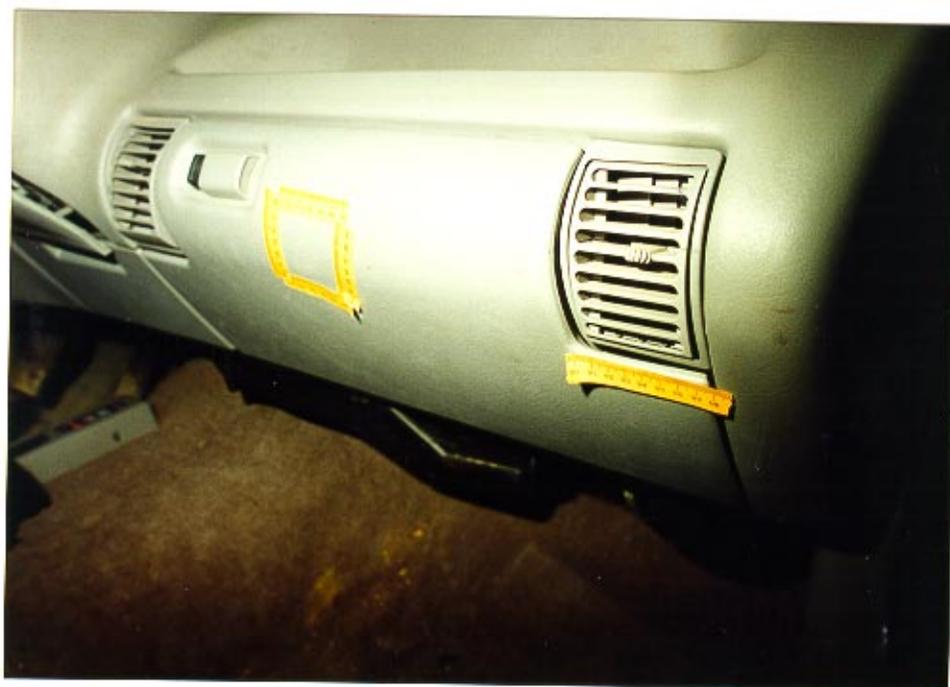
The right front passenger of the vehicle was not restrained by the manual 3-point lap and shoulder belt system. His left knee contacted and scuffed the mid aspect of the glove box door 43.2-47.0 cm (17.0-18.5") right of center and 10.8-14.0 cm (4.25-5.5") below the upper instrument panel. The passenger's right knee contacted the right side of the glove box door at the right air vent louver. This contact did not result in damage, however, the louver cover had separated from the mid panel. His right shoulder subsequently contacted the right upper A-pillar and passenger assist handle. The latter contact sequence did not produce interior damage.

31 & 32. Right front occupant's knee contacts to the glove box door and vent louver.

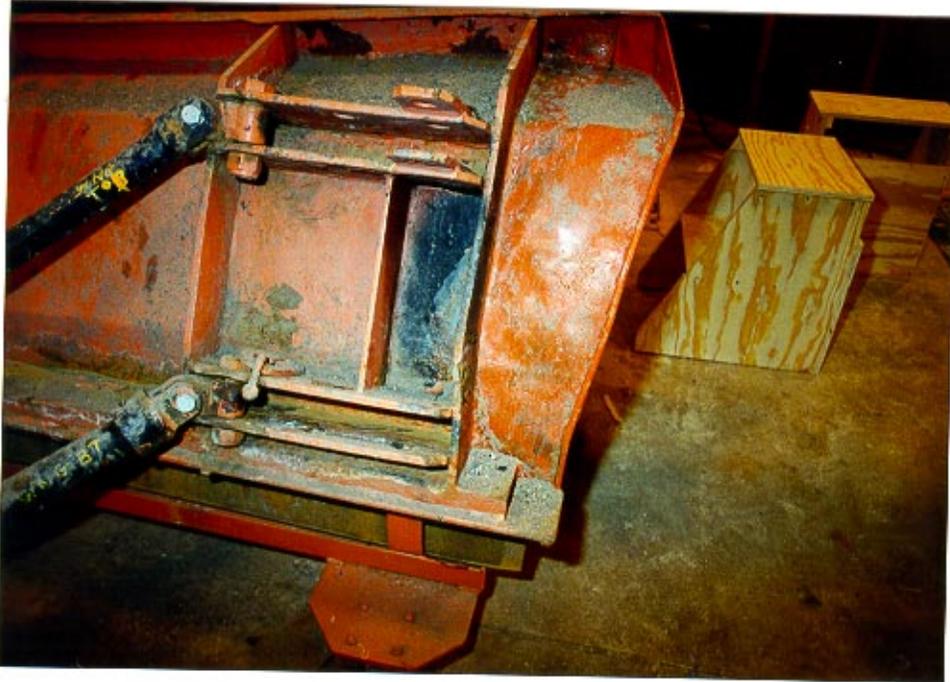
Although the plow was removed from the vehicle and repaired prior to our inspection, the driver stated that the upper arm was deformed by the impact sequence and that the dampening spring was fractured.

35. Repaired damage to the outboard aspect of the wing plow.
