REPORT NUMBER 216-GTL-04-002

**SAFETY COMPLIANCE TESTING FOR
FMVSS NO. 216
ROOF CRUSH RESISTANCE**

**DAIMLERCHRYSLER CORPORATION
2004 CHRYSLER PACIFICA, MPV
NHTSA NO. C40301**

**GENERAL TESTING LABORATORIES, INC.
1623 LEEDSTOWN ROAD
COLONIAL BEACH, VIRGINIA 22443**

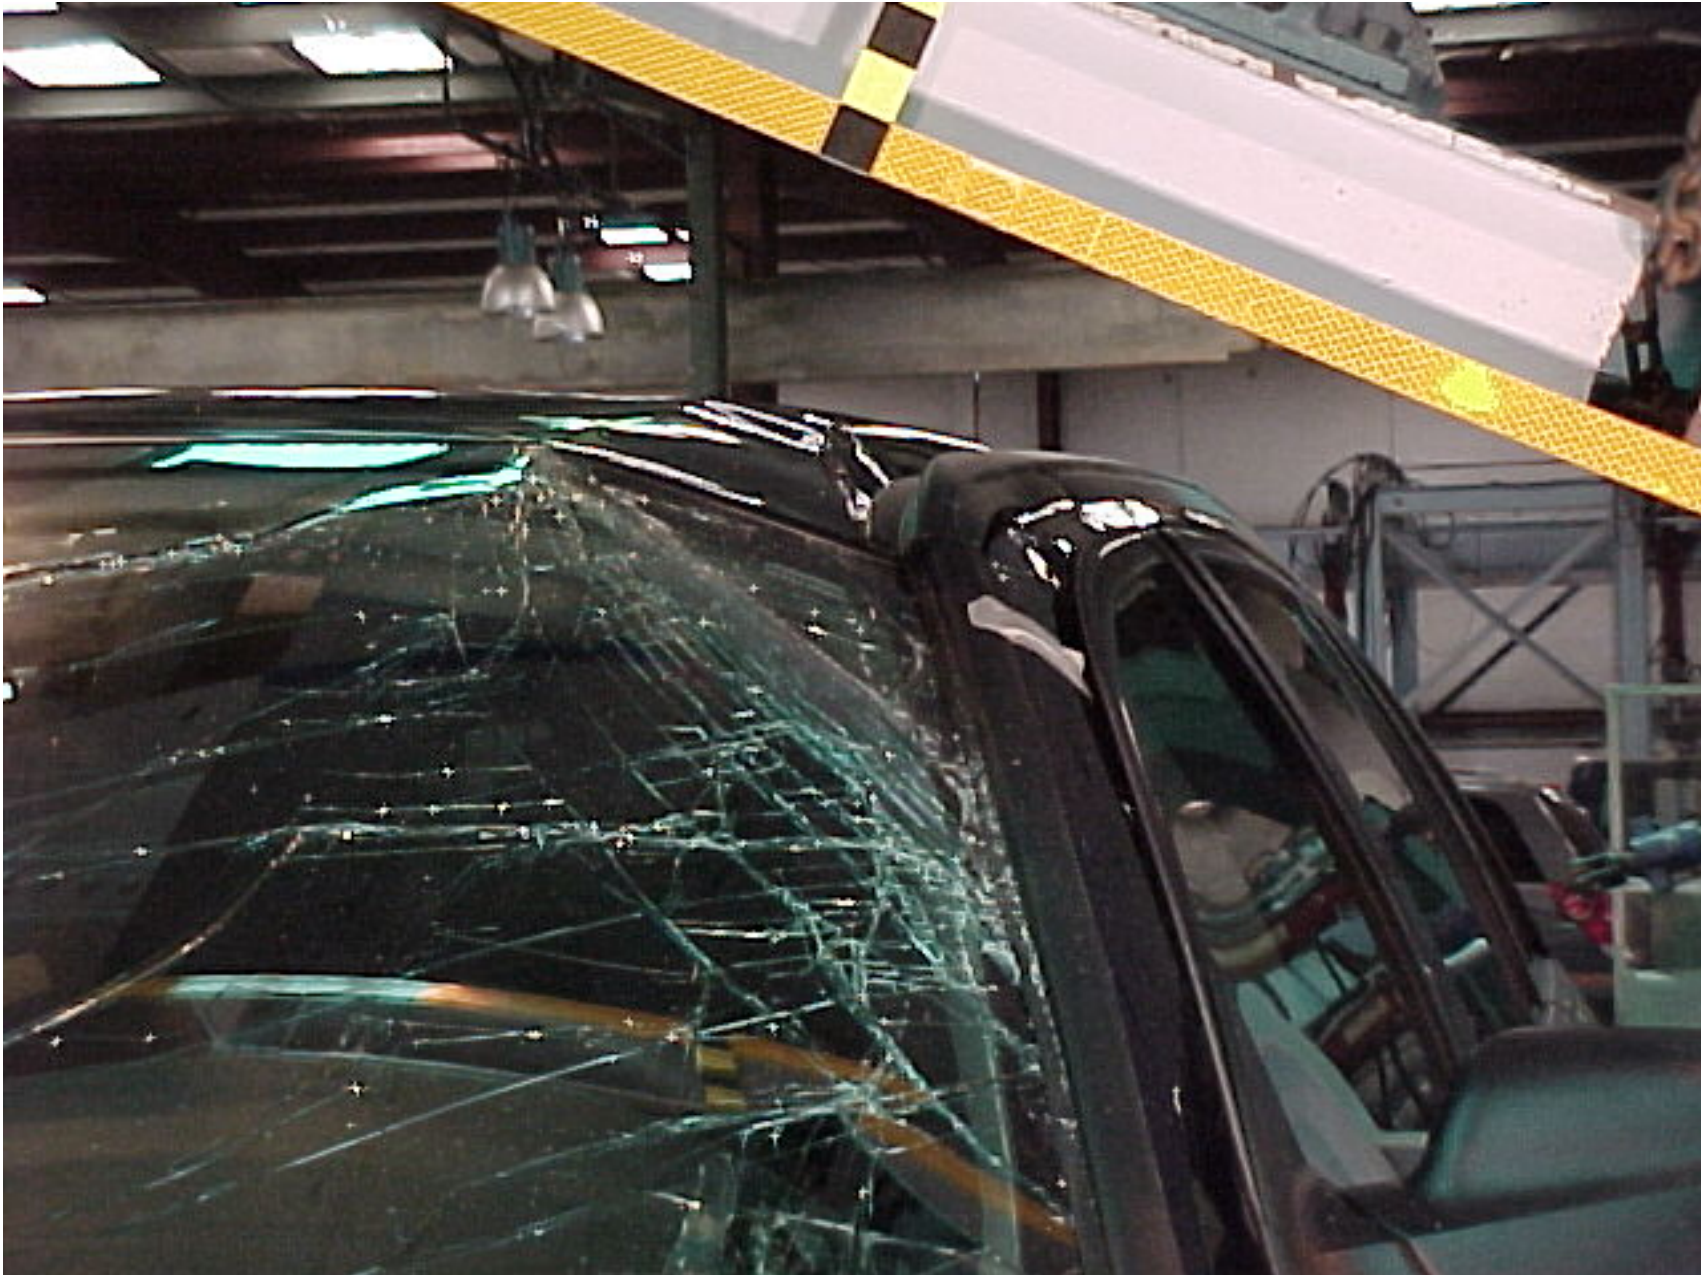
FIGURE 5.27
FRONT VIEW POST TEST

Roof over driver head pushed down approximately 2.5". Windshield cracked. Roof metal bent from corner of windshield rearward 44".

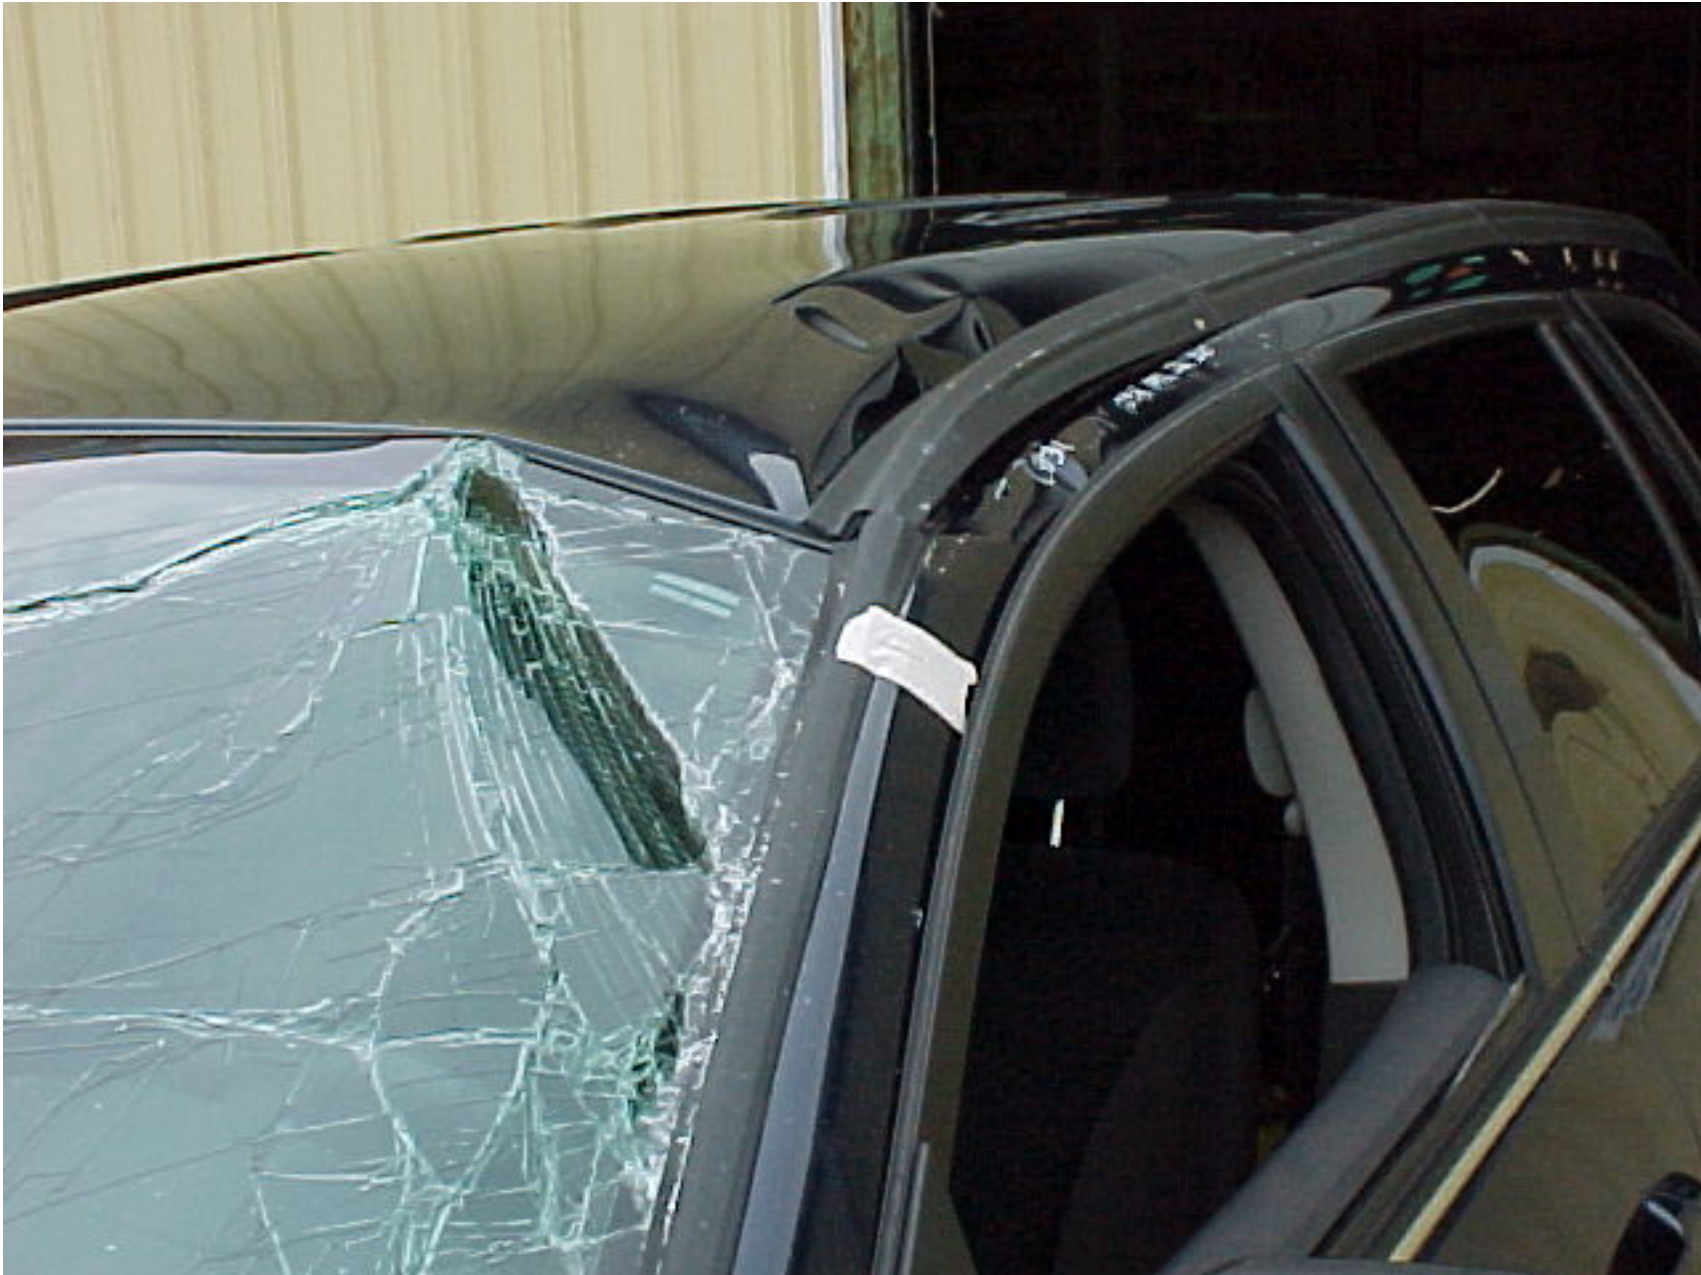
FIGURE 5.34
CLOSE-UP OF ROOF POST TEST

RESULTS: Roof over driver head pushed down approximately 2.5". Windshield cracked. Roof metal bent from corner of windshield rearward 44".

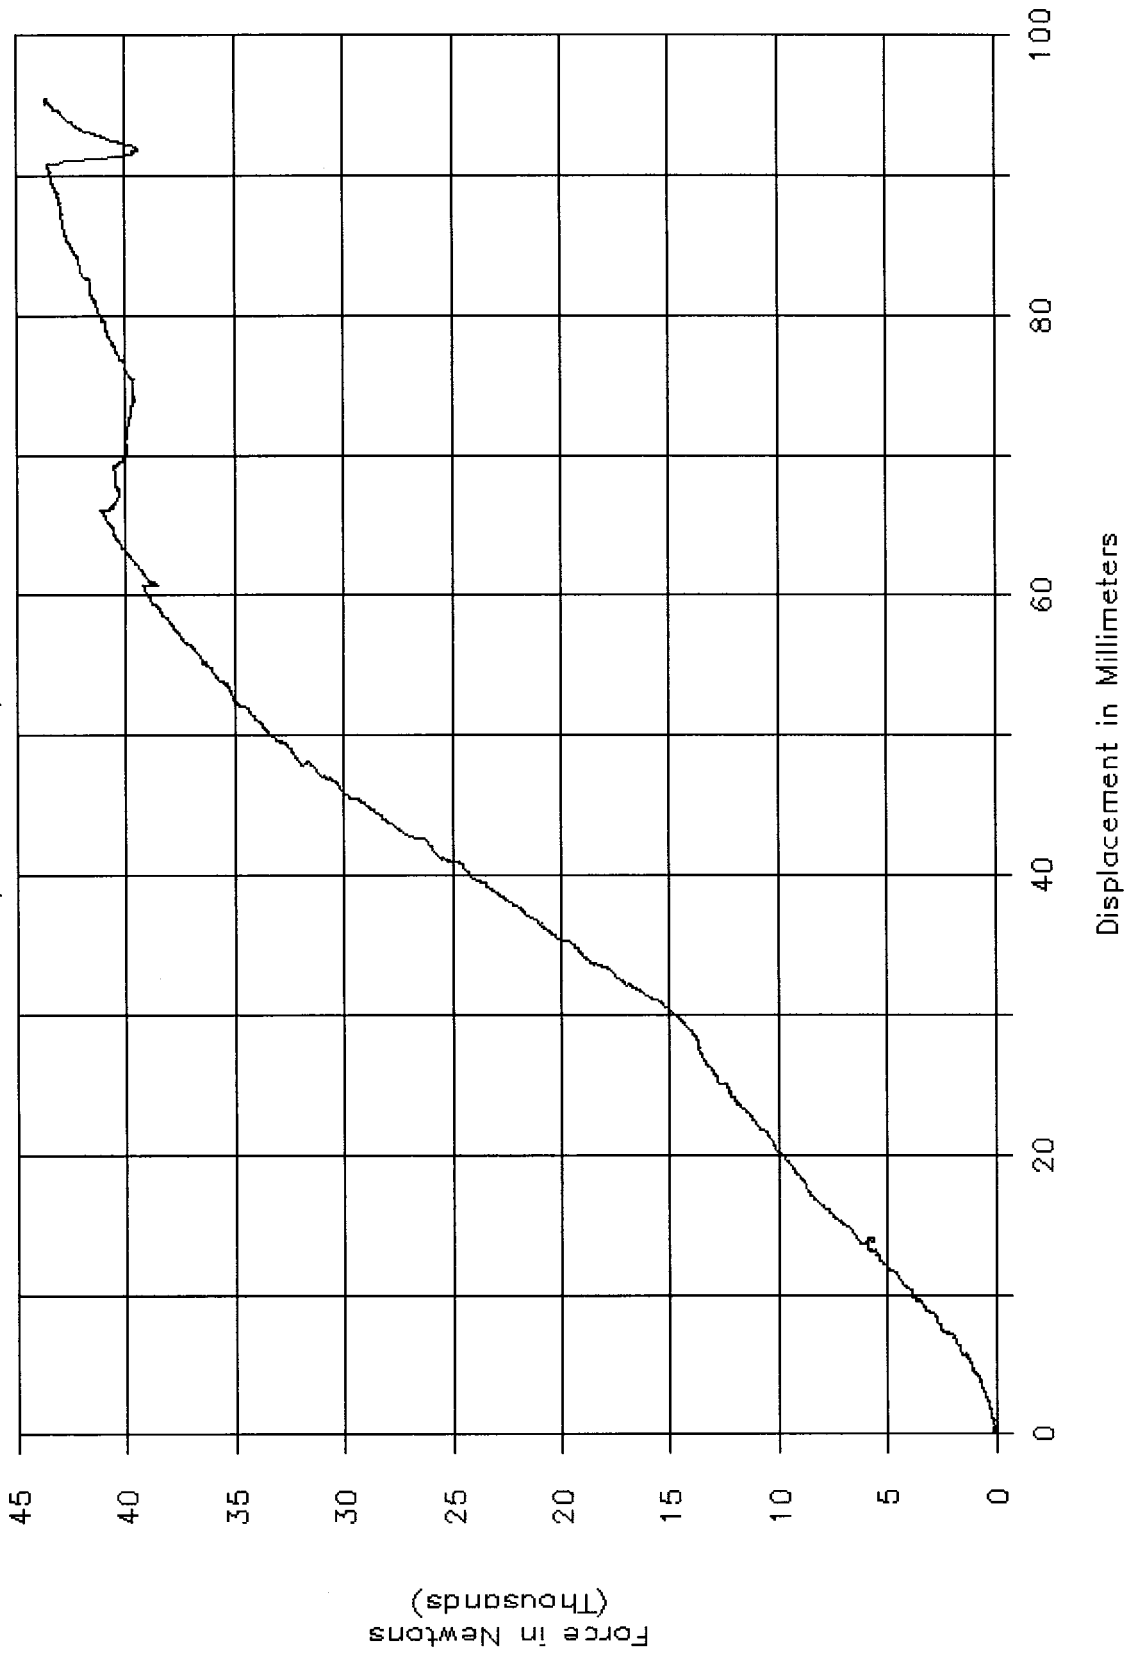
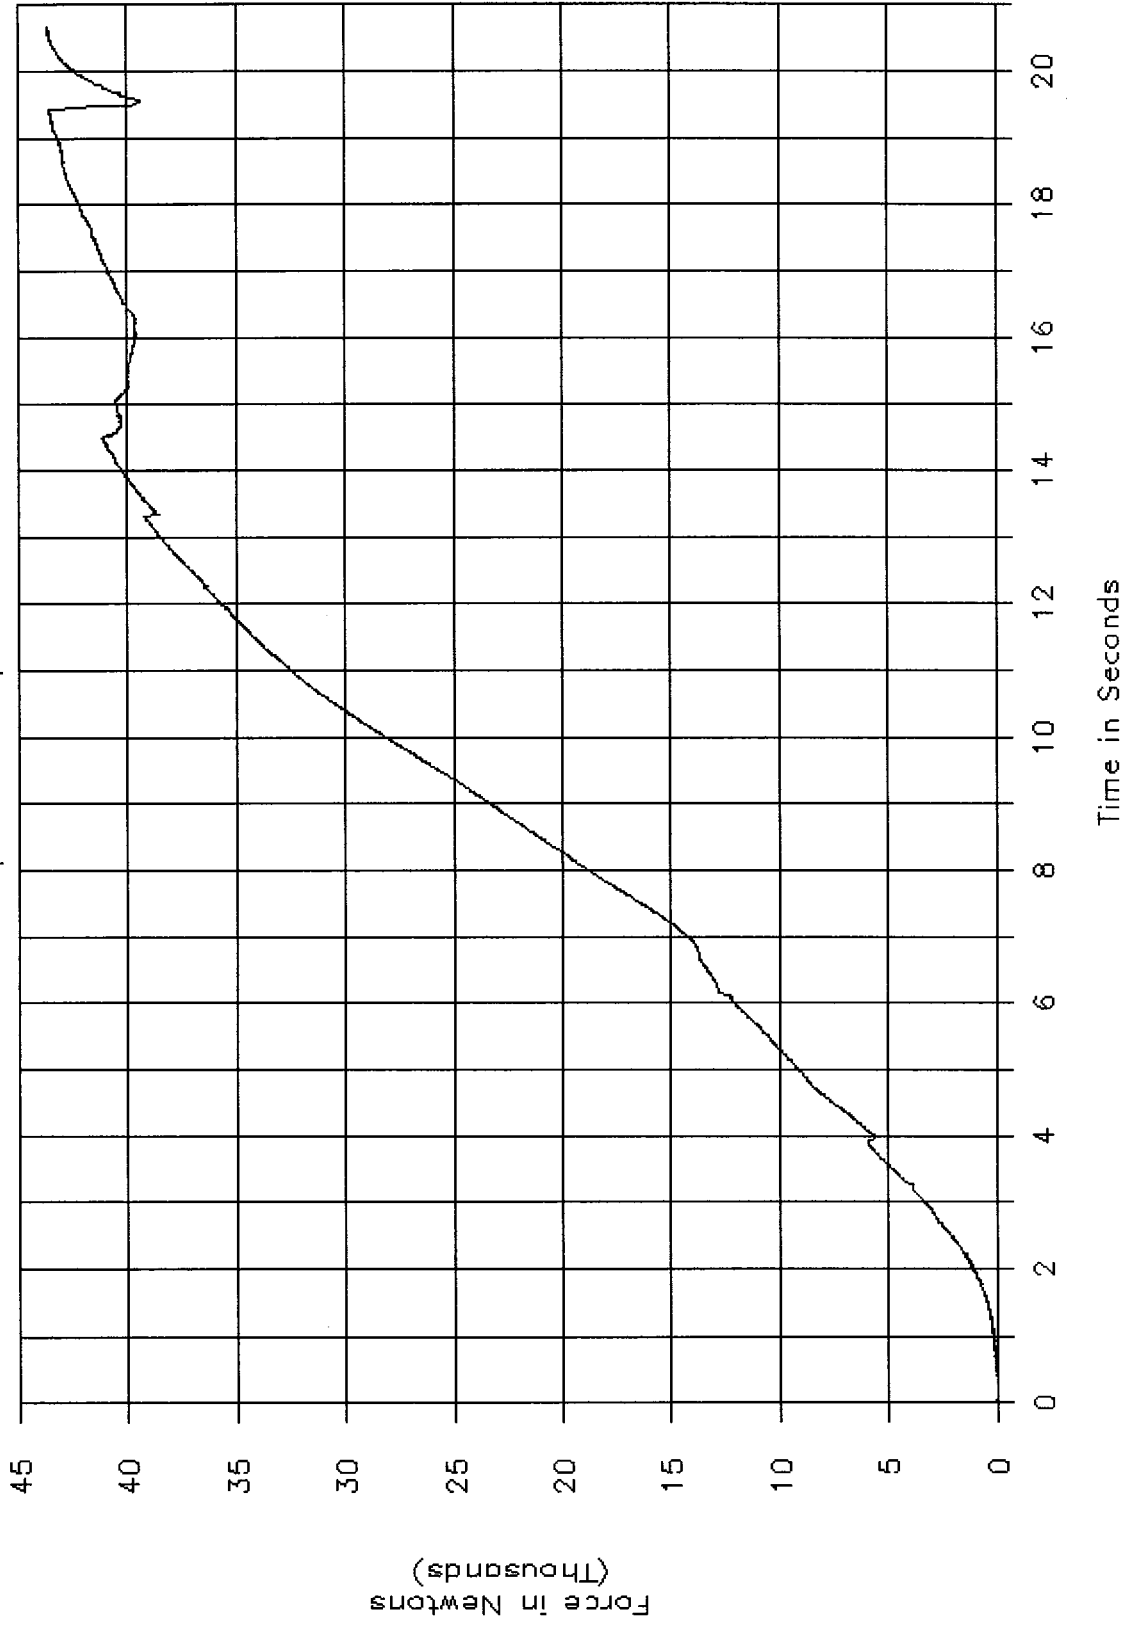
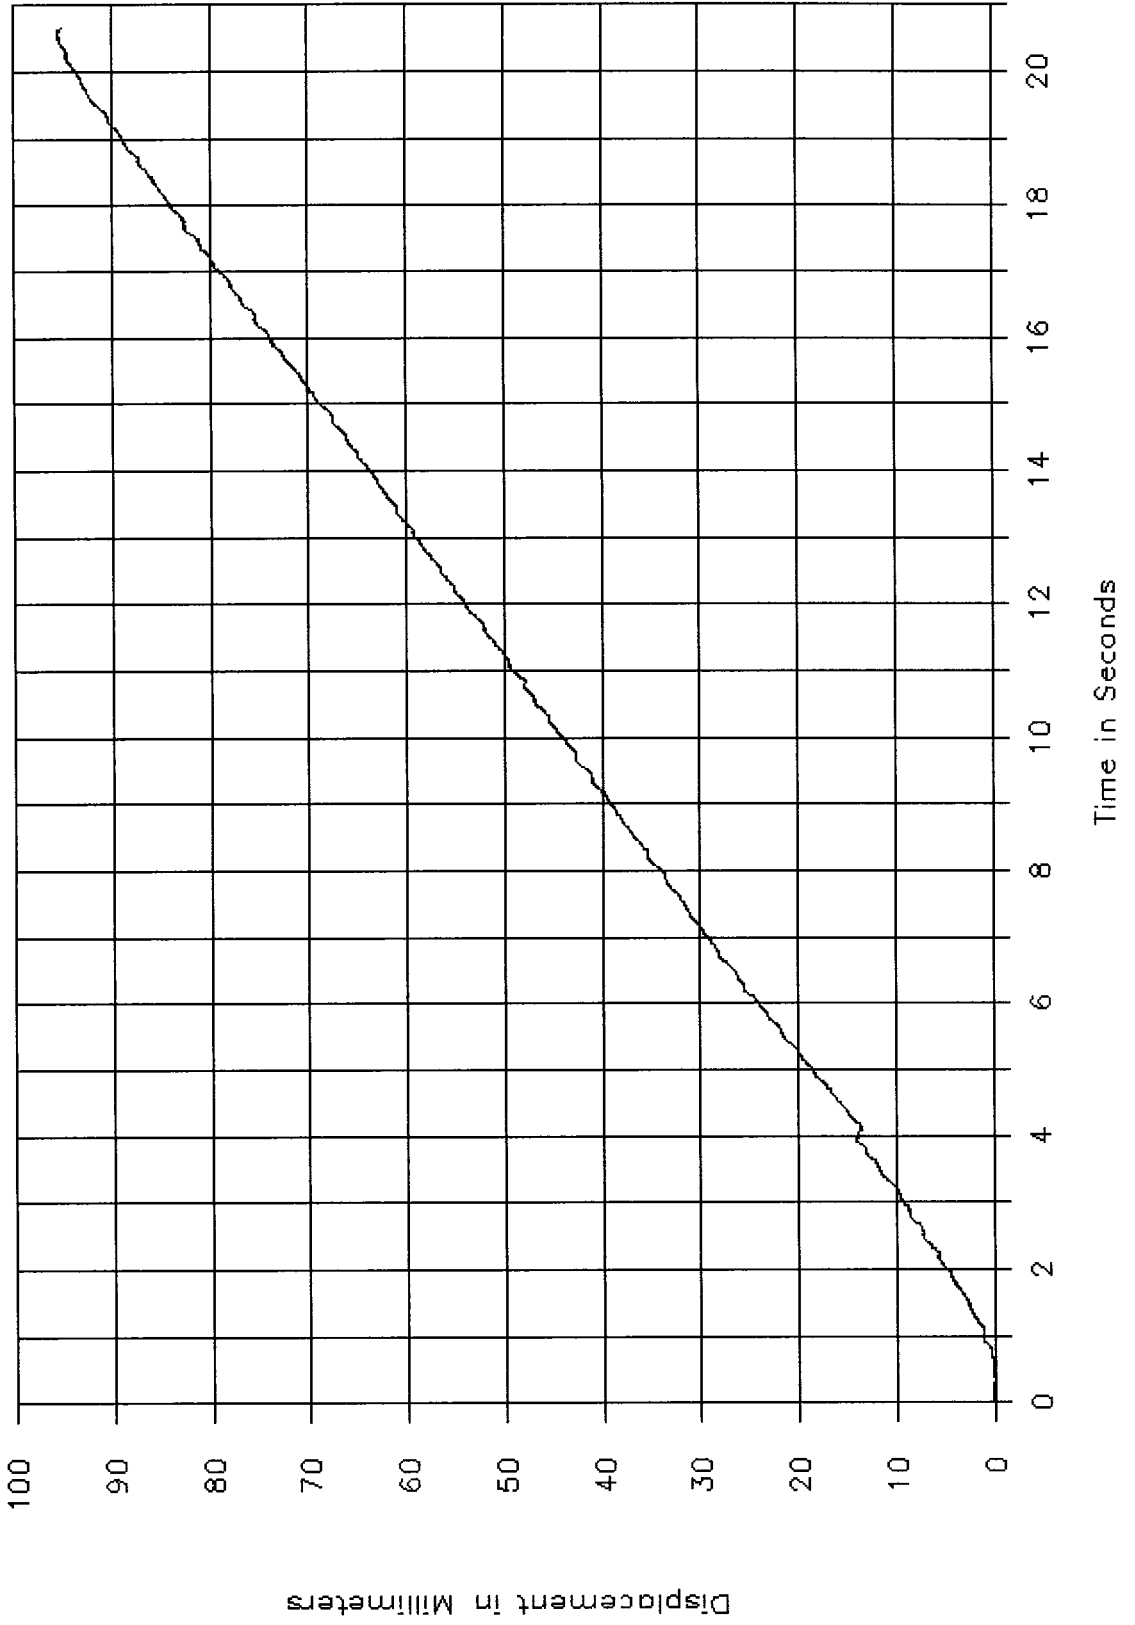
216, Roof Crush, Driver Side.

- (1) The maximum roof crush resistance was 43,706 N at 95.7 mm
- (2) The rate of loading was 5.08 mm/sec (.2 in/sec)
- (3) The required roof crush resistance of 29,665 N was at 45.5 mm
