REPORT NUMBER 111-GTL-06-004

# SAFETY COMPLIANCE TESTING FOR FMVSS NO. 111 REARVIEW MIRRORS

FUJI HEAVY INDUSTRIES LTD.  
2006 SUBARU B9 TRIBECA, MPV  
NHTSA NO. C65501

**FINAL REPORT**

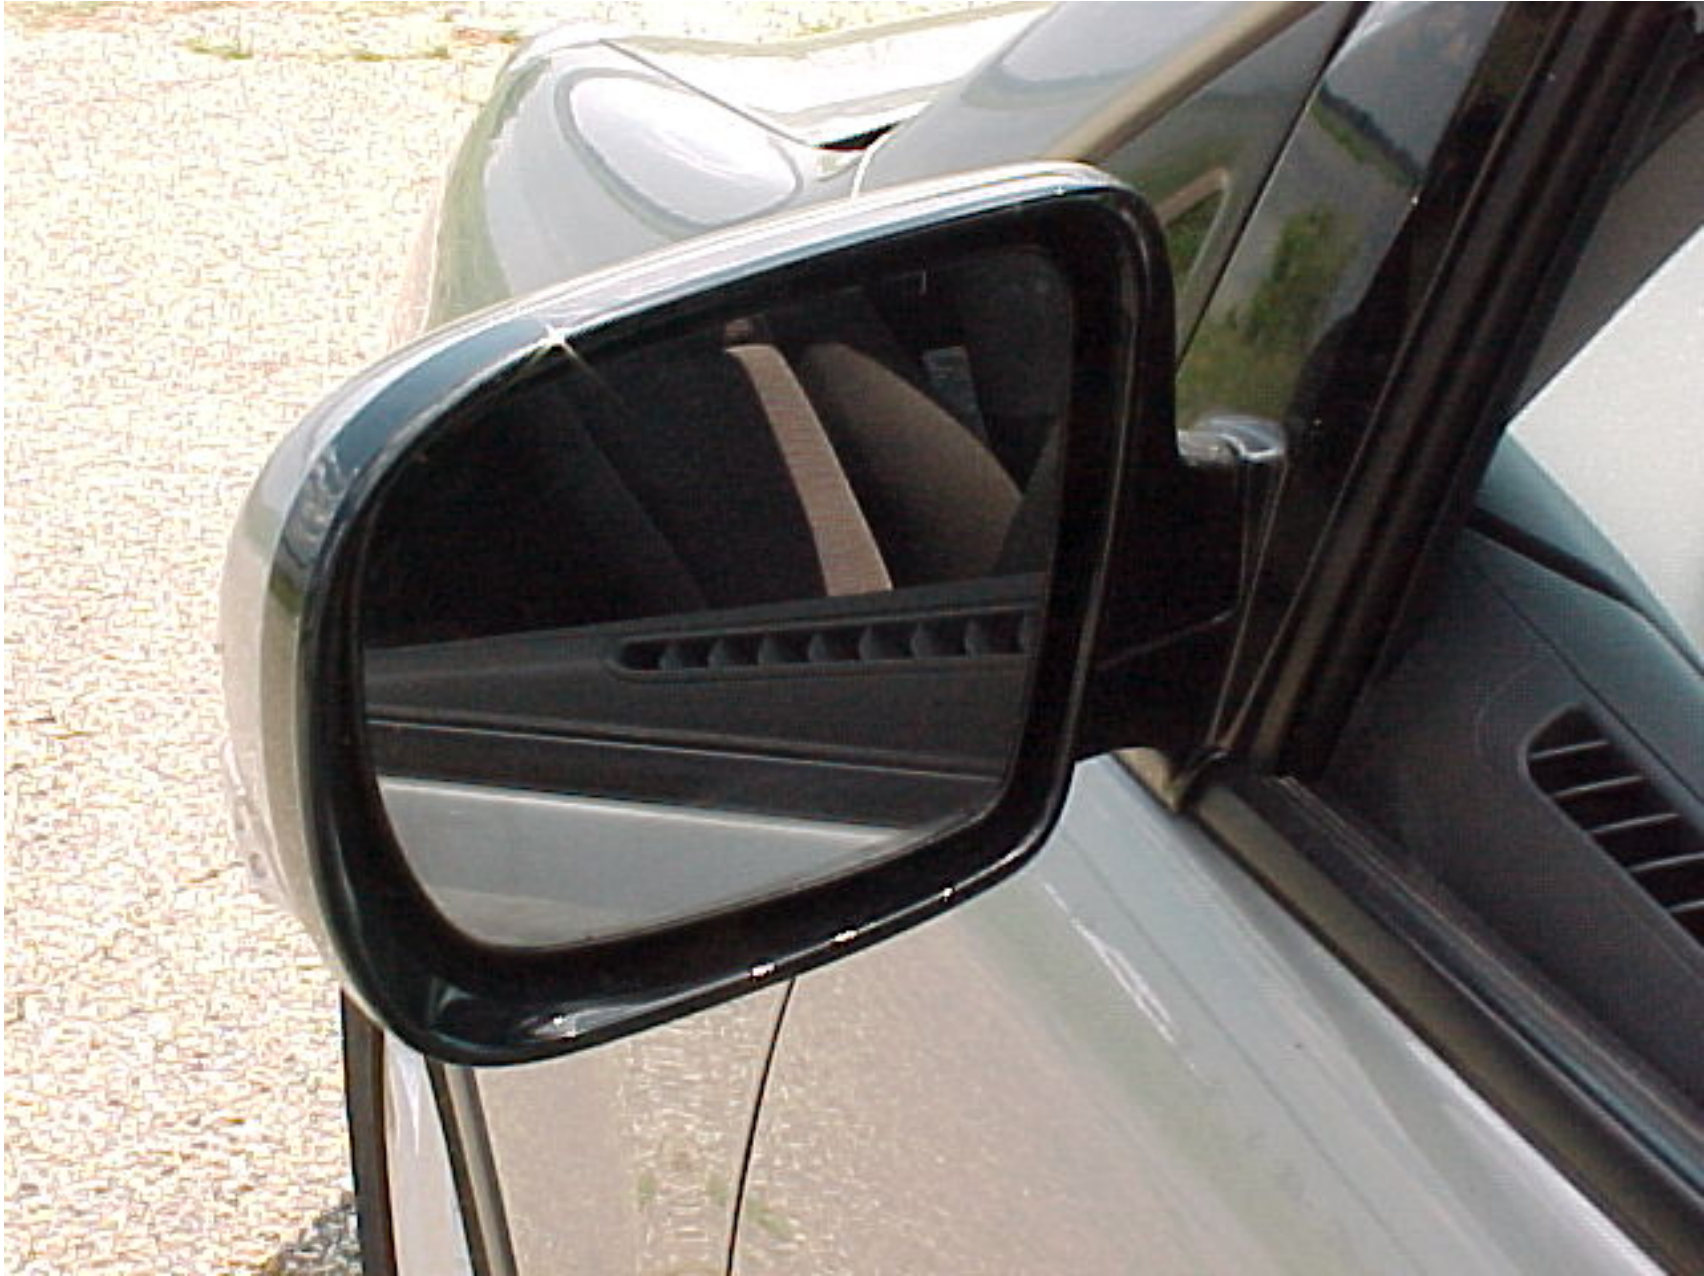
FIGURE 5.7  
DRIVER SIDE REARVIEW MIRROR AND MOUNTING

PASS	FAIL	COMMENTS
STABLE SUPPORT	X		See Remarks
DOES NOT PROTRUDE BEYOND VEHICLE BODY	X		Mirror does protrude farther than the widest part of the vehicle body but the protrusion is required to meet the field of view requirements.
NOT OBSCURED BY UNWIPED PORTION OF WINDSHIELD	X		
ADJUSTABLE BY TILTING	X		
ADJUSTABLE FROM DRIVER SEAT	X		
FREE OF SHARP EDGES	X		
FIELD-OF-VIEW	X		
REFLECTANCE	X		
UNIT MAGNIFICATION	X

DRIVER'S SIDE OUTSIDE: 4-WAY ELECTRIC POWERED FLAT GLASS  
POWER ADJUSTABLE

MIRROR DESCRIPTION: 160 mm x 114 mm FLAT GLASS MIRROR

REFLECTANCE = Voltage (Refl)/Voltage (Cal) = 0. 661 x 100 = 66 percent  
(Minimum Requirement = 35 percent)

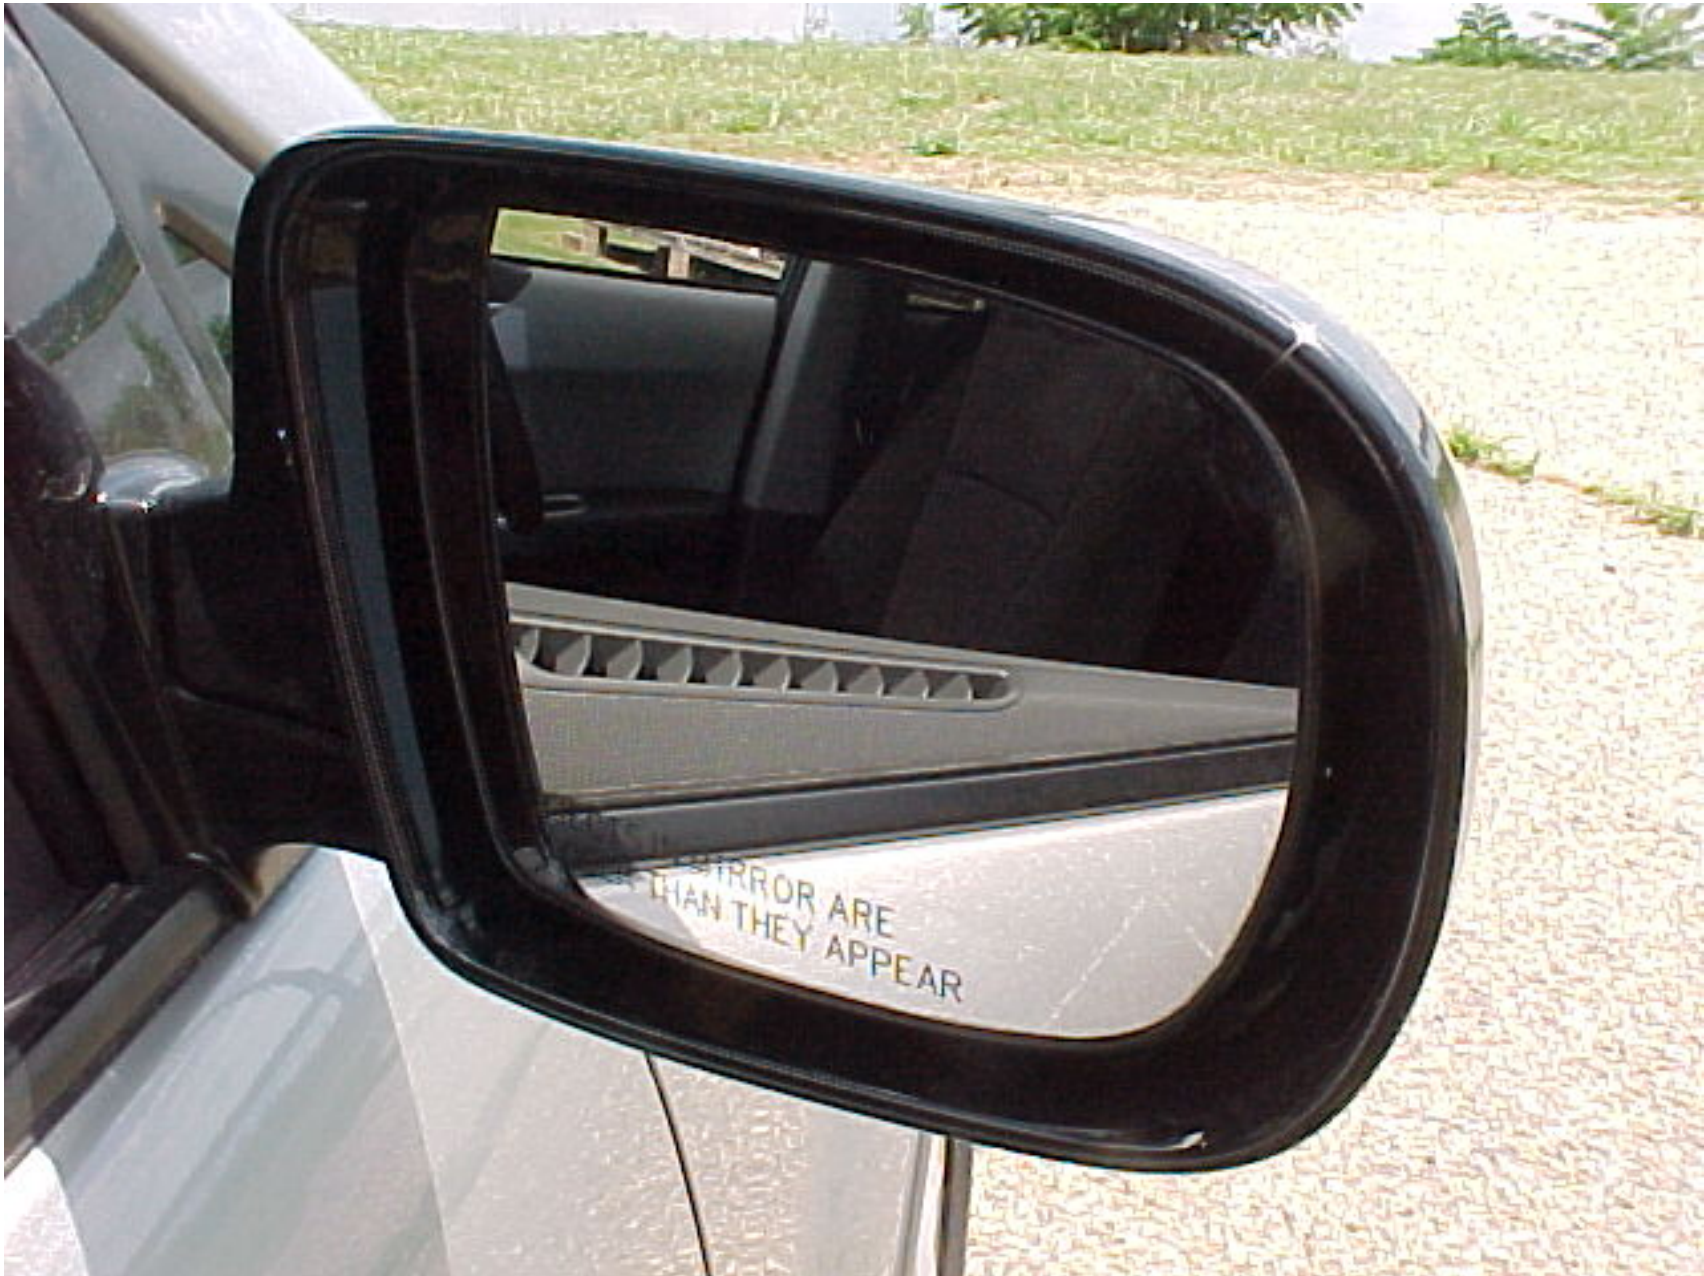
FIGURE 5.8  
PASSENGER SIDE REARVIEW MIRROR AND  
MOUNTING

PASSENGER'S SIDE OUTSIDE: 4-WAY ELECTRIC POWERED CONVEX GLASS  
POWER ADJUSTABLE

MIRROR DESCRIPTION: 160 mm x 114 mm CONVEX GLASS MIRROR

REFLECTANCE (Day) = Voltage (Refl)/Voltage (Cal) = 0. 663 x 100 = 66 percent  
(Minimum Requirement = 35 percent)

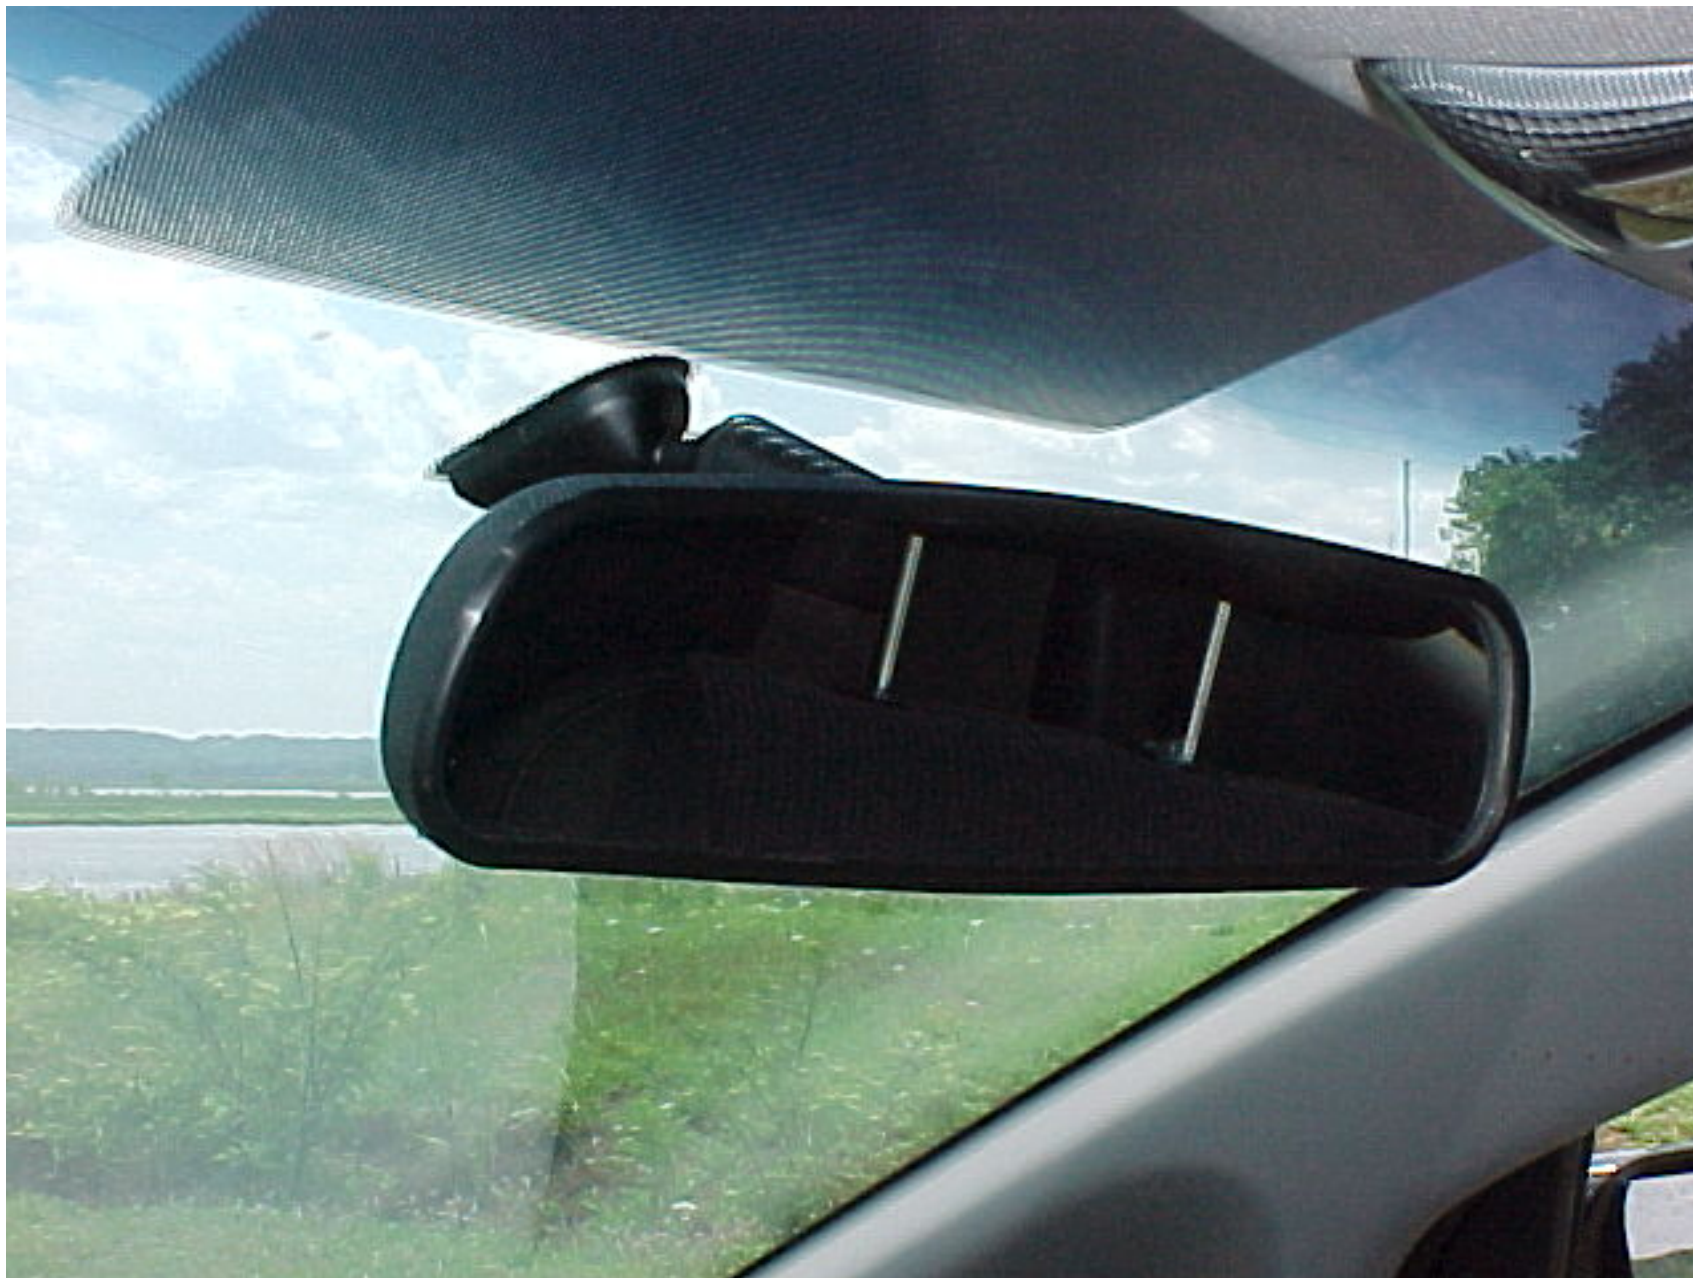
FIGURE 5.9  
INSIDE REARVIEW MIRROR AND MOUNTING

INSIDE REARVIEW: FLAT GLASS OMNI DIRECTIONAL, MANUAL DAY/NIGHT  
ADJUSTABLE

DUAL PIVOT BALL LINKS TO MOUNT ON WINDSHIELD GLASS WHICH IS ATTACHED TO GLASS WITH ADHESIVE.

DESCRIPTION OF MIRROR MOVEMENT (DEFLECT, COLLAPSE OR BREAKAWAY):  
MIRROR PIVOTS ON BALL LINK JOINTS.

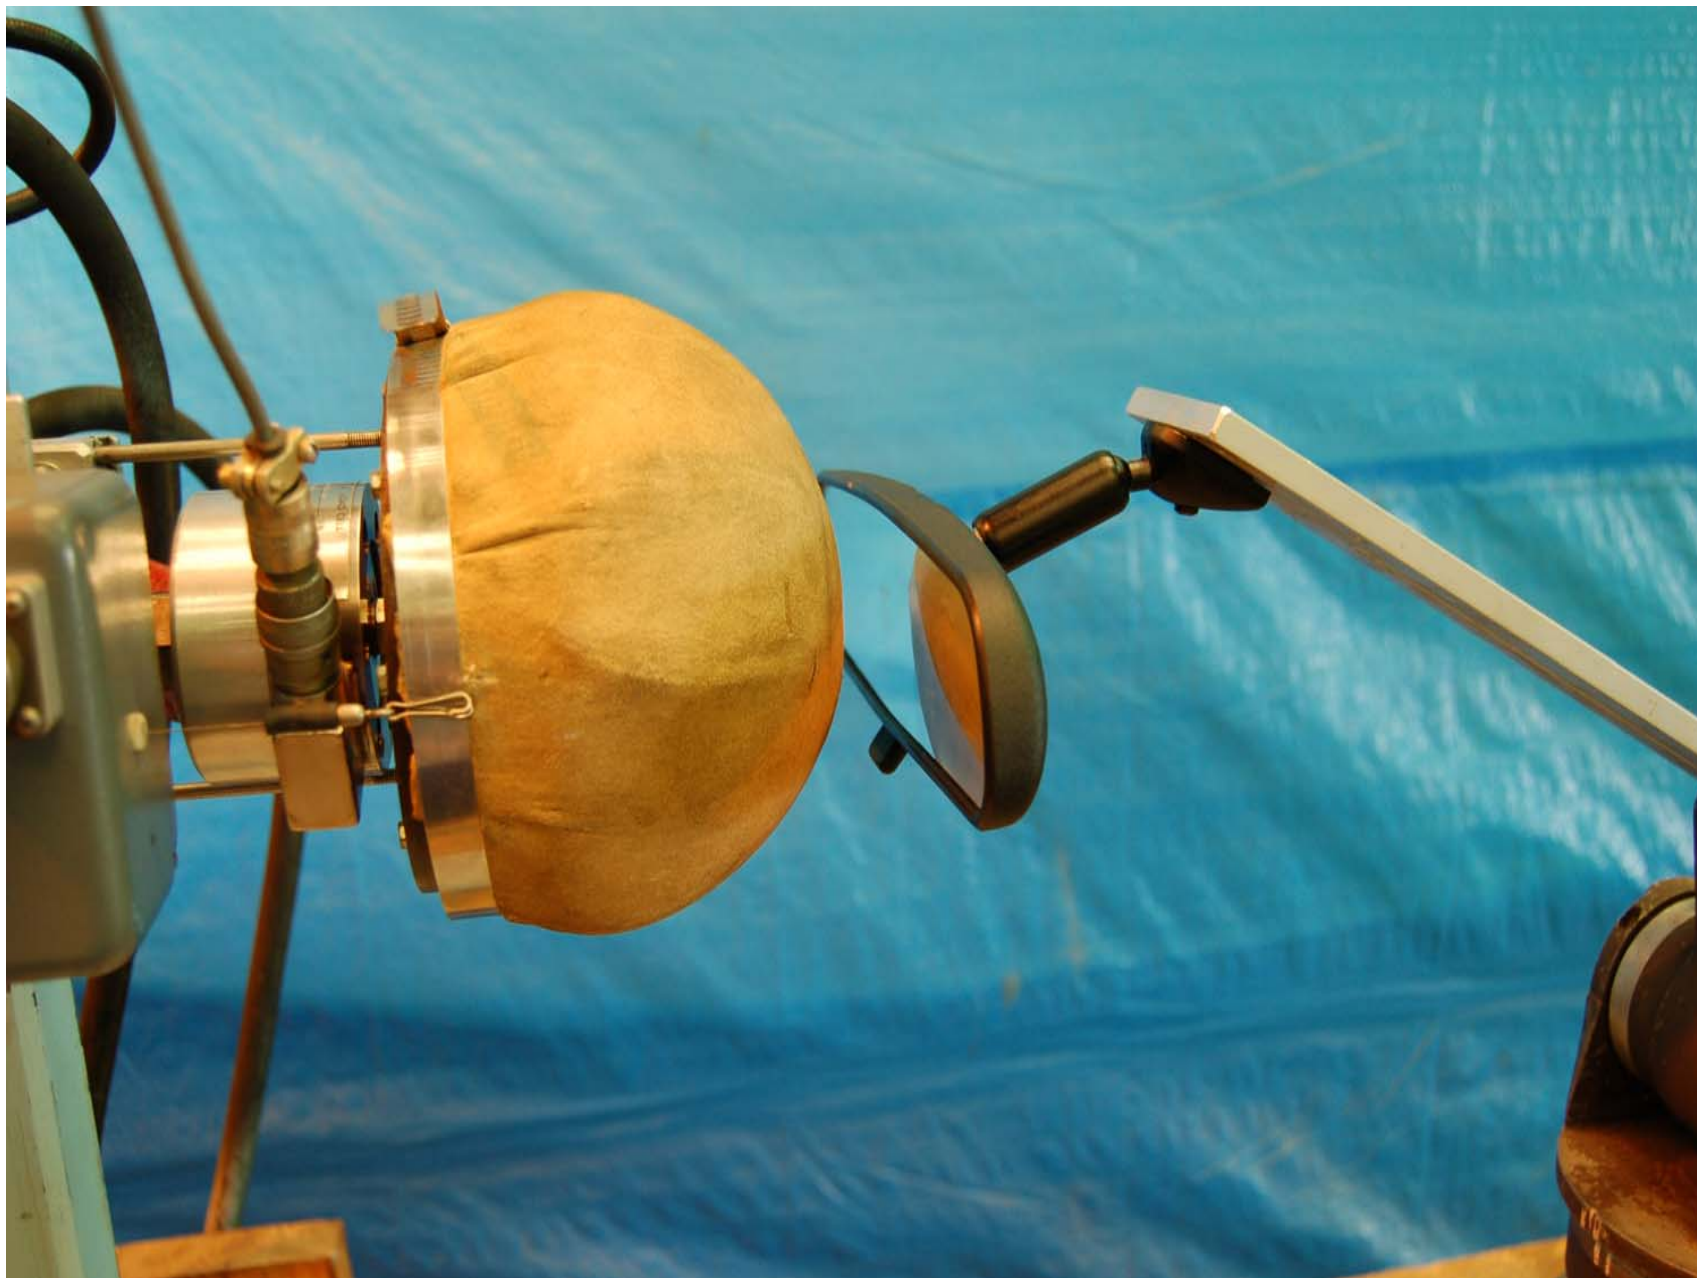
FIGURE 5.12  
BREAK-AWAY TEST SET-UP

TEST NO	LOAD DIRECTION (Vertical/Horizontal)	MAXIMUM FORCE (N)	PASS	FAIL
1 (GTL 5565)	-45°/+45°	49	X	
2 (GTL 5566)	-45°/90°	62	X	
3 (GTL 5567)	-45°/-45°	40	X	
4 (GTL 5568)	+45°/-45°	80	X	
5 (GTL 5569)	+45°/90°	102	X	
6 (GTL 5570)	+45°/+45°	80	X	
7 (GTL 5571)	0°/90°	151	X

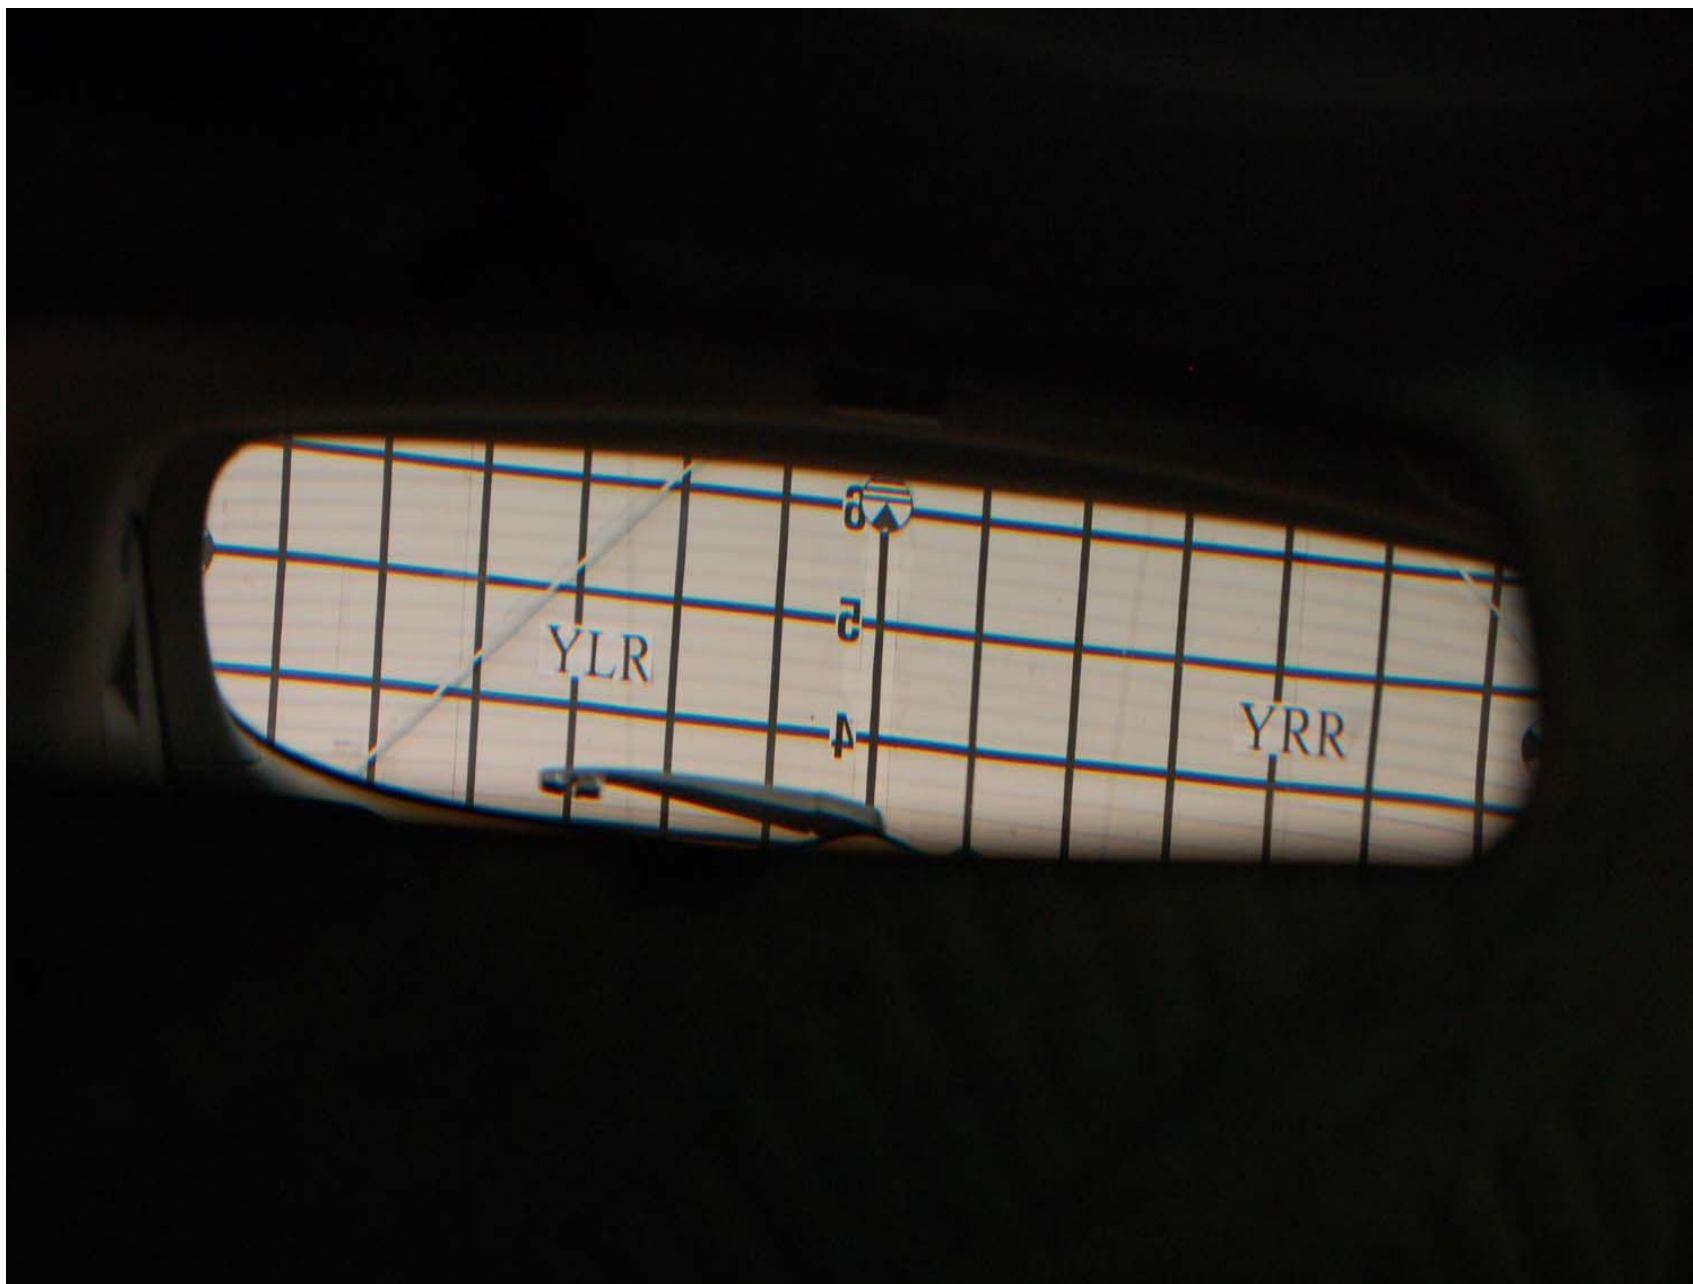
FIGURE 5.13  
INSIDE MIRROR RIGHT EYE FIELD OF VIEW

<b>MONOCULAR DATA (ALR &amp; ARL Are Angles)</b>				
EYE LOCATION	YL	YR	ALR	ARL
LEFT EYE POINT	1.93 m	2.19 m		10.5°
RIGHT EYE POINT	2.13 m	2.01 m	10.2°

$$\text{ANGLE AB} = \text{ANGLE ALR} + \text{ANGLE ARL} = \underline{20.7^\circ} \text{ (20 degrees minimum)}$$

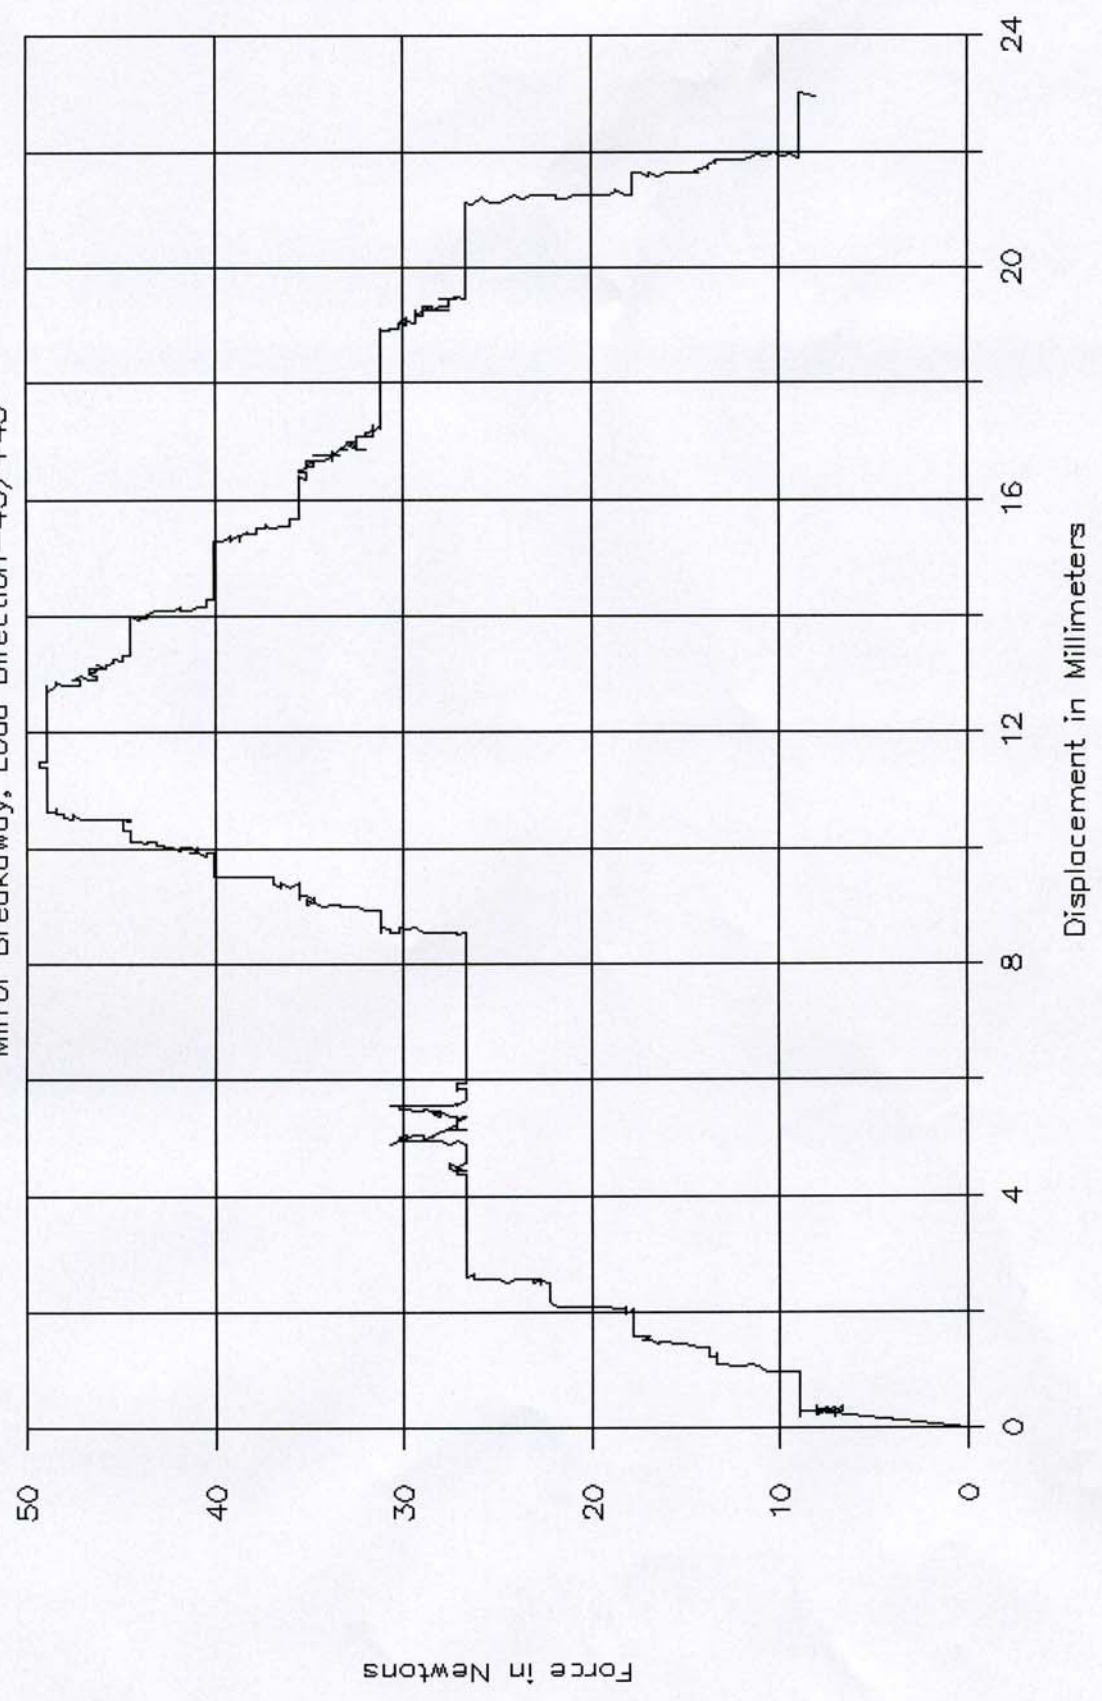
### GTL 5565

Mirror Breakaway, Load Direction -45/+45

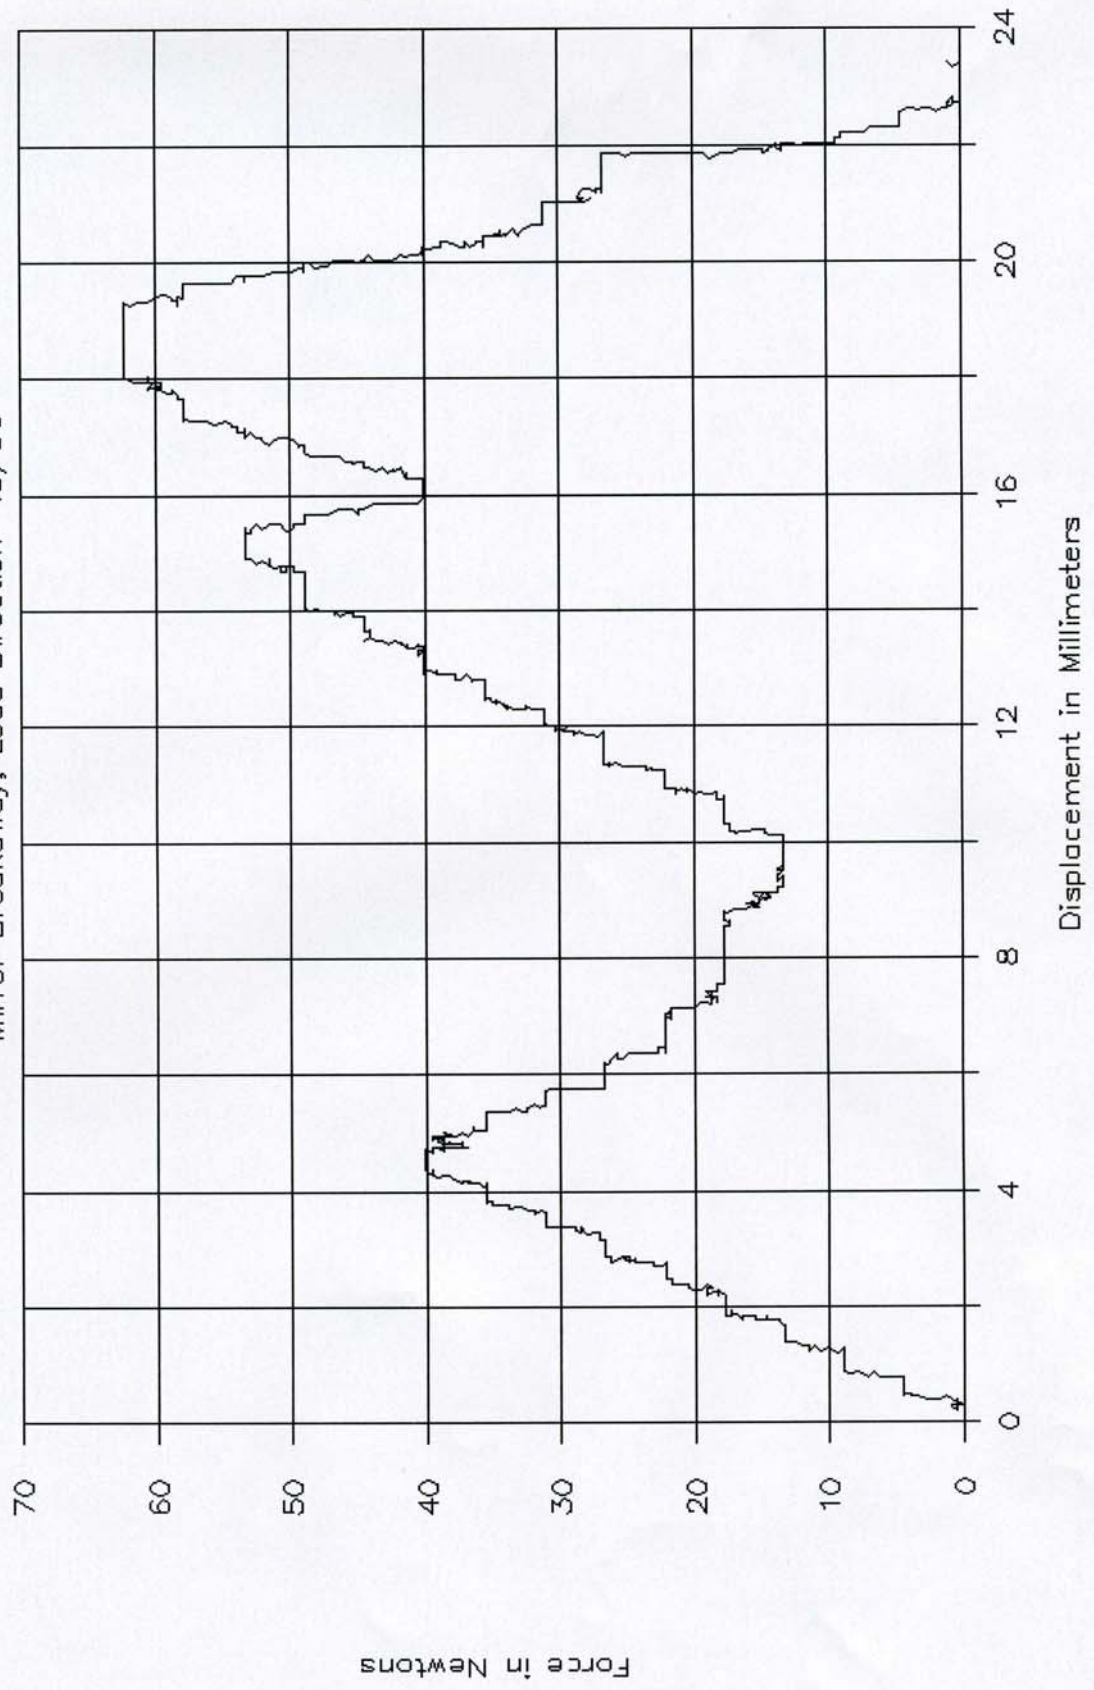
GTL 5566

Mirror Breakaway, Load Direction -45/90

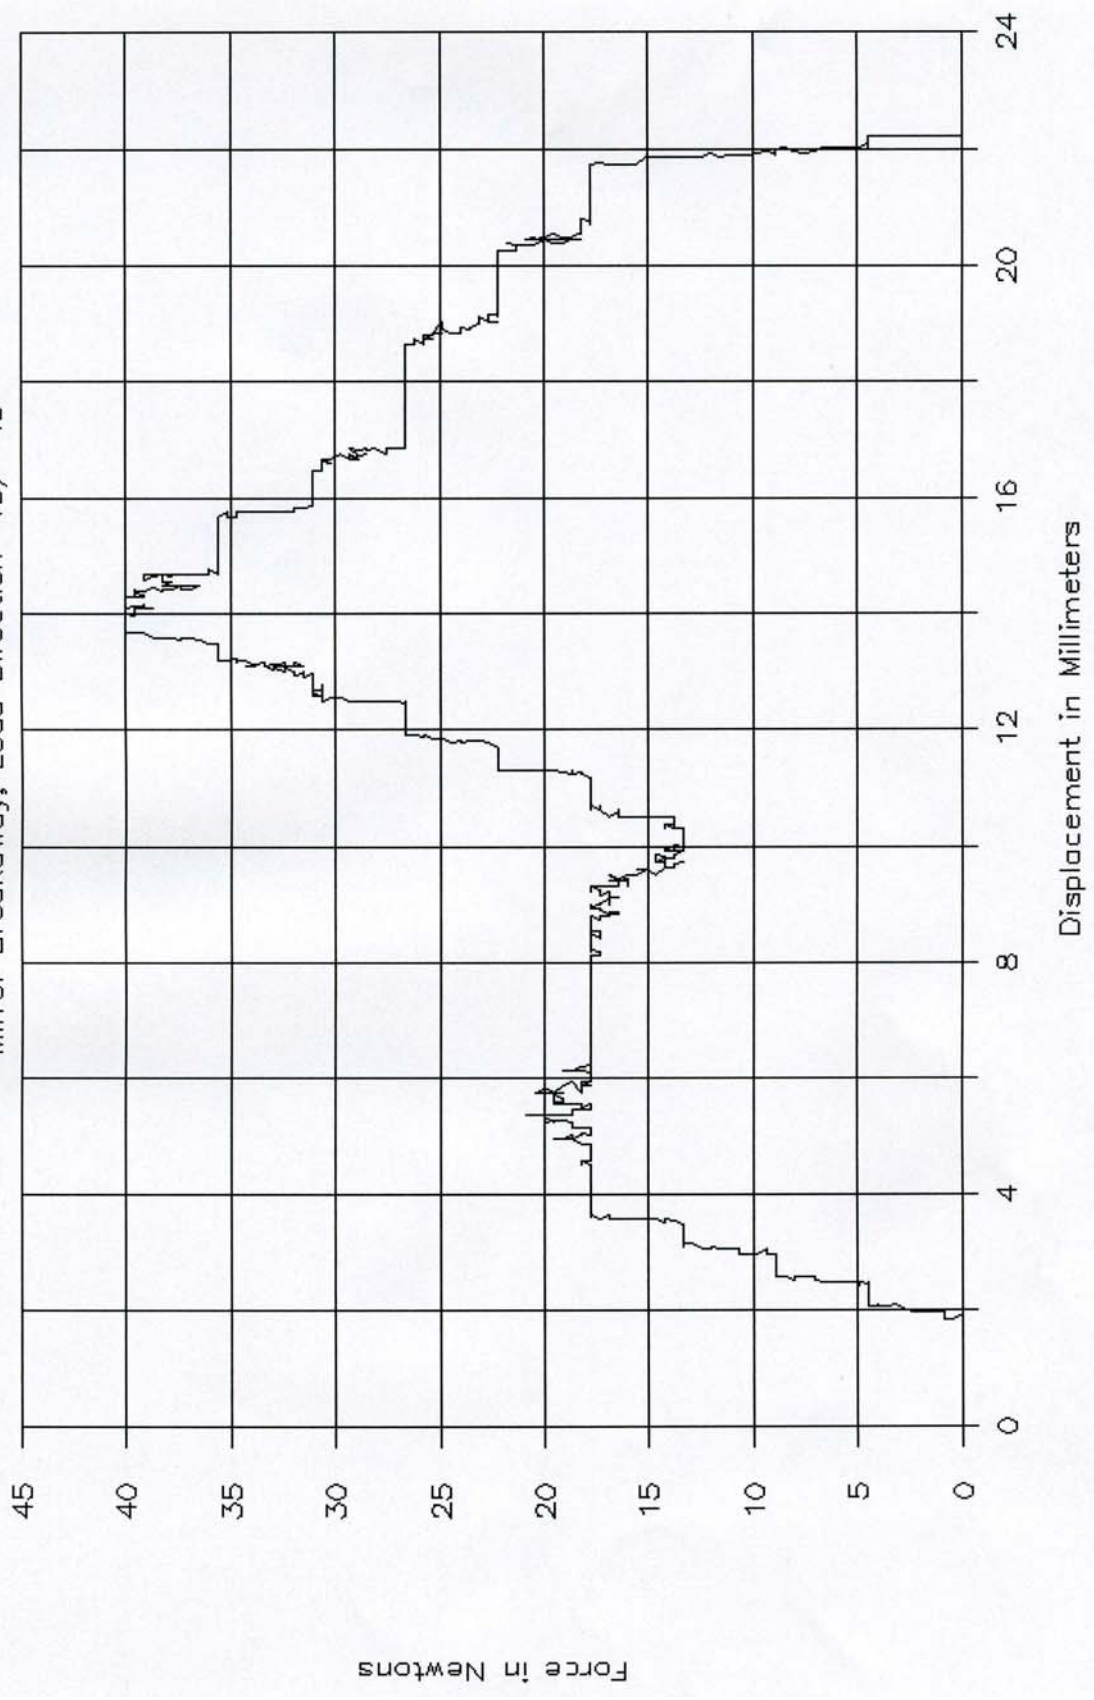
GTL 5567

Mirror Breakaway, Load Direction -45/-45

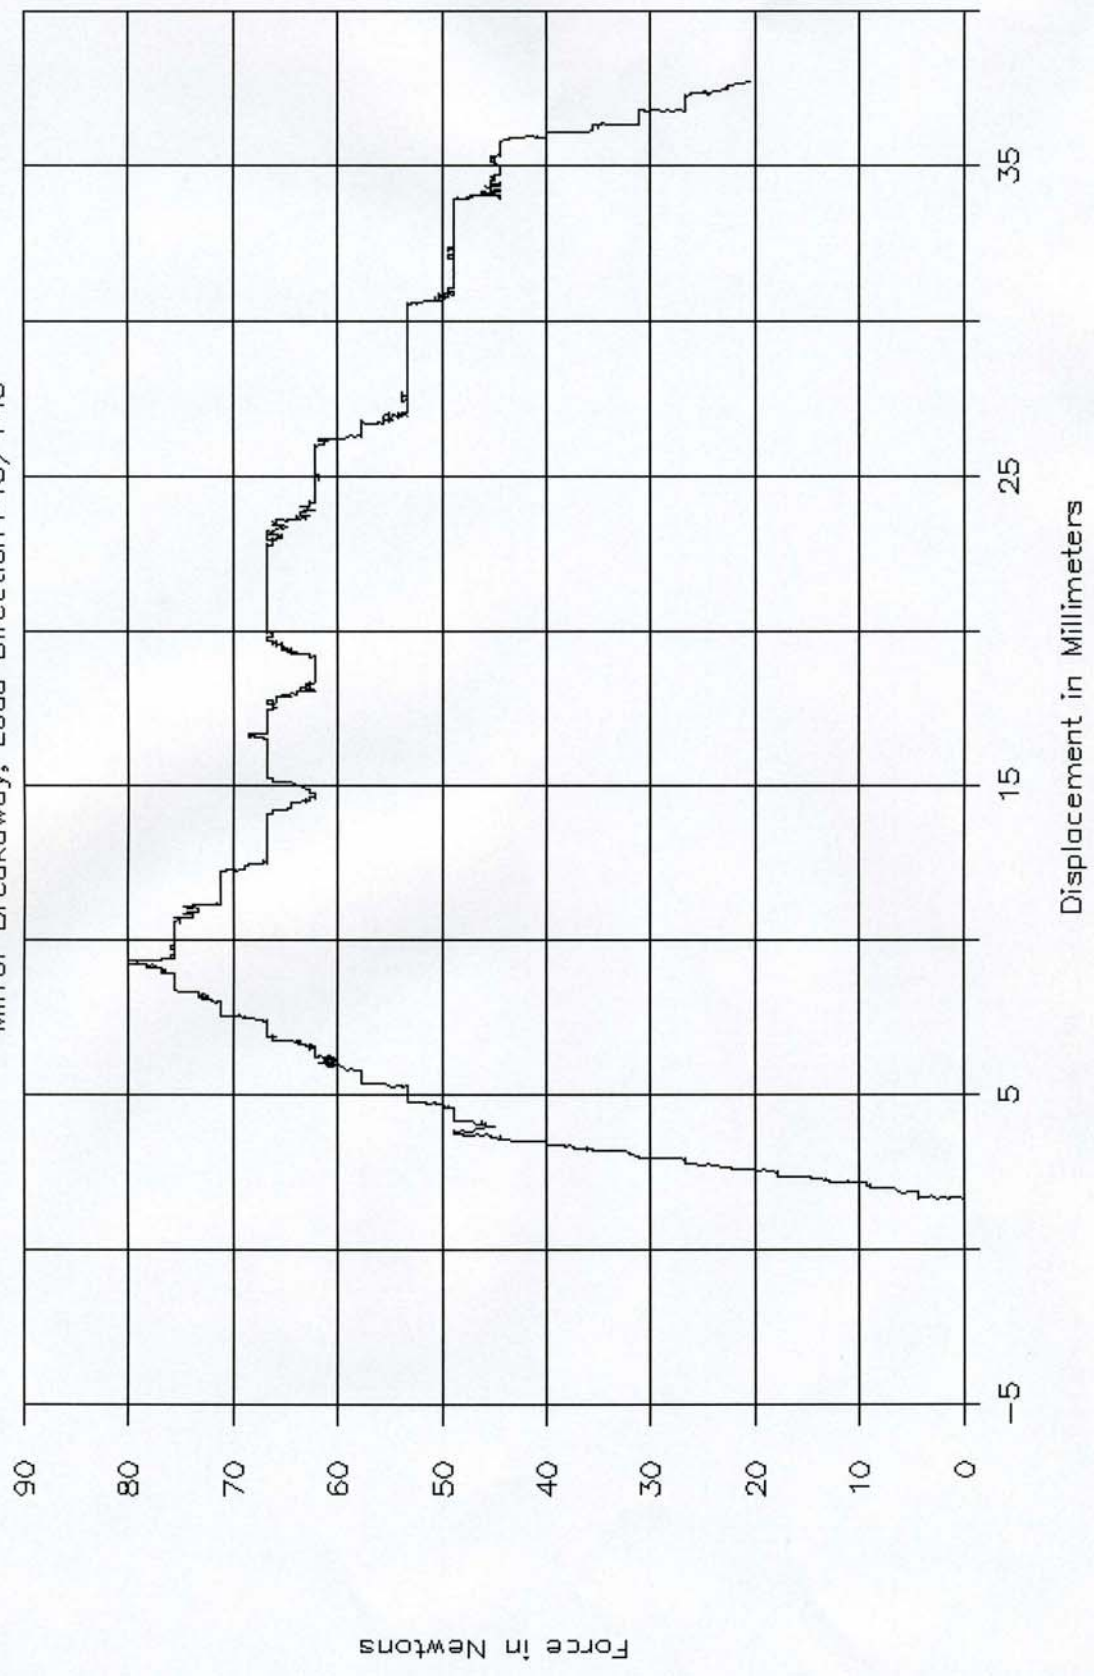
### GTL 5570

Mirror Breakaway, Load Direction +45/+45
