REPORT NUMBER: 301S-MGA-2007-004

**SAFETY COMPLIANCE TESTING FOR
FMVSS NO. 301S
FUEL SYSTEM INTEGRITY - SCHOOL BUSES**

**IC CORPORATION
2007 IC BE 200 SCHOOL BUS
NHTSA NO. C70901**

**PREPARED BY:
MGA RESEARCH CORPORATION
5000 WARREN ROAD
BURLINGTON, WI 53105**

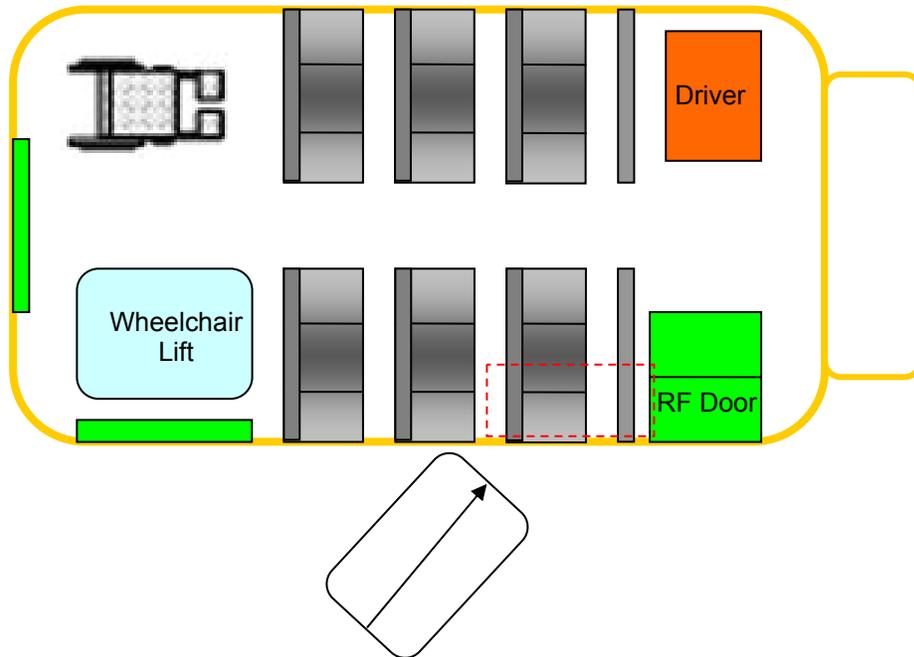
INDICATE IMPACT POINT BELOW:

LEGEND: Red dotted line indicates location of fuel tank
Arrow indicates point and angle of barrier impact (C_L of arrow coincides with C_L of monorail).

DESCRIPTION: Fuel tank is located just behind the stairwell on the right side of the vehicle.
