REPORT NUMBER: 305-CAL-07-04

**SAFETY COMPLIANCE TESTING FOR FMVSS 305  
ELECTRIC POWERED VEHICLES: ELECTROLYTE SPILLAGE  
AND ELECTRICAL SHOCK PROTECTION**

HONDA MOTOR COMPANY  
2007 HONDA CIVIC  
4-DOOR SEDAN

NHTSA NUMBER: C75303

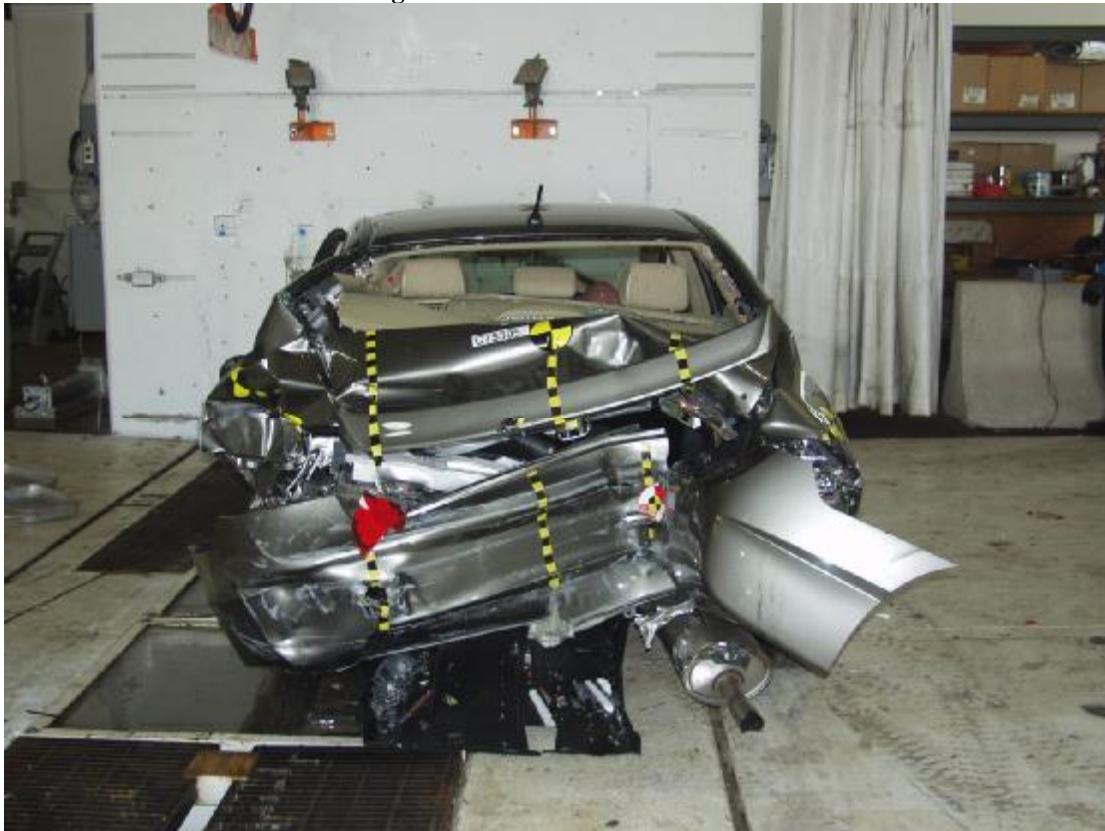
**Figure A-22: Post-Test Rear View**

Left Side	Centerline	Right Side
Pre-Test	4426	4498	4426
Post-Test	3814	3878	3973
Crush	612	620	453

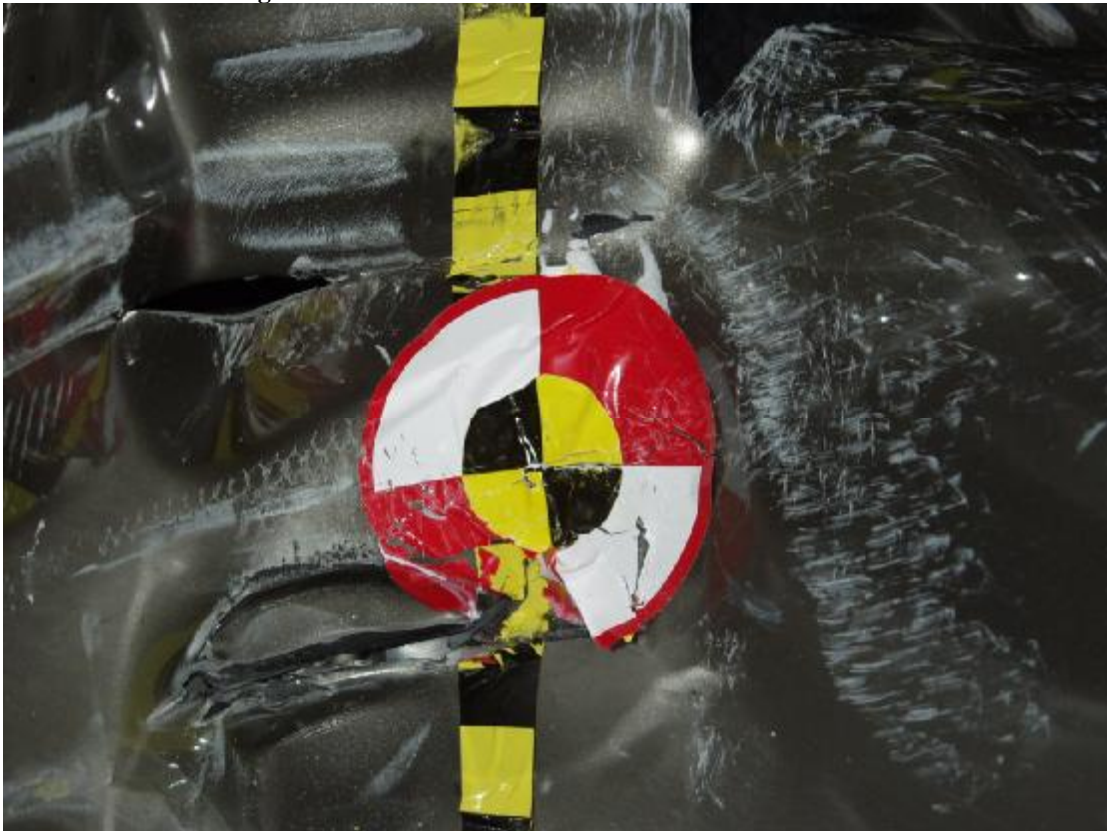
**Figure A-32: Post-Test Impact Target View**

2                      Vertical distance from target center (+ is above) Tolerance: ±40 mm

-2                      Horizontal distance from target center (+ is right) Tolerance: ±50 mm

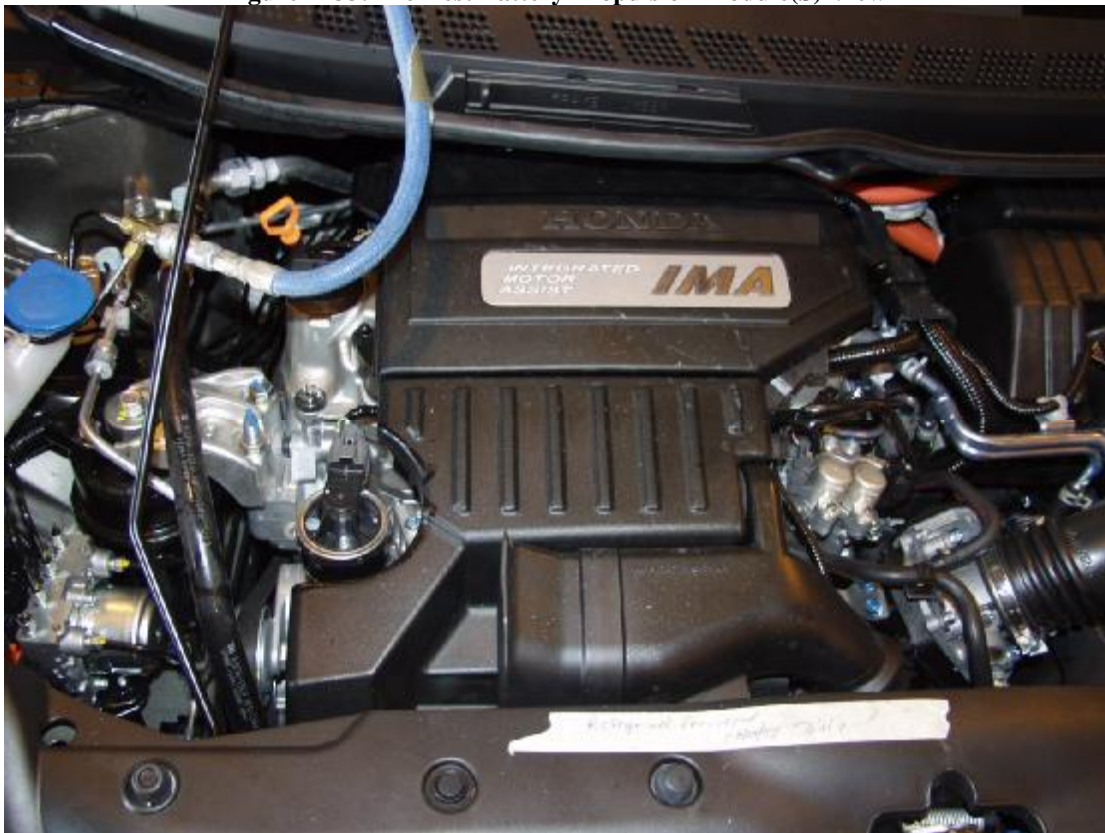
**Figure A-34: Post-Test Battery Propulsion Module(S) View**

Has the Propulsion Battery Module moved within the occupant compartment?  -  Yes(Fail)  x  No

Has an outside Propulsion Battery Component intruded into the occupant compartment?  -  Yes(Fail)  x  No

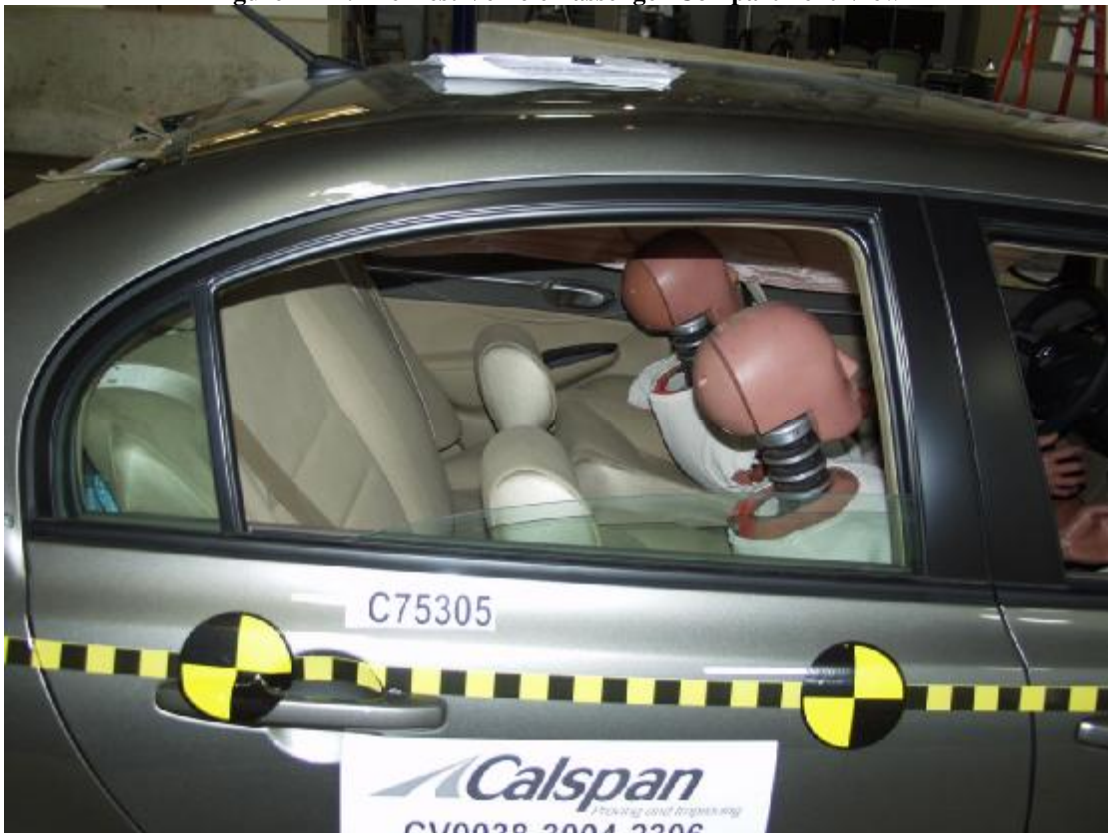
**Figure A-48: Post-Test Vehicle Passenger Compartment View**

Is Propulsion Battery electrolyte spillage visible in the occupant compartment?  -  Yes(Fail)  x  No
