REPORT NUMBER: 305-CAL-07-05

**SAFETY COMPLIANCE TESTING FOR FMVSS 305  
ELECTRIC POWERED VEHICLES: ELECTROLYTE SPILLAGE  
AND ELECTRICAL SHOCK PROTECTION**

HONDA MOTOR COMPANY  
2007 HONDA ACCORD  
4-DOOR SEDAN

NHTSA NUMBER: C75304

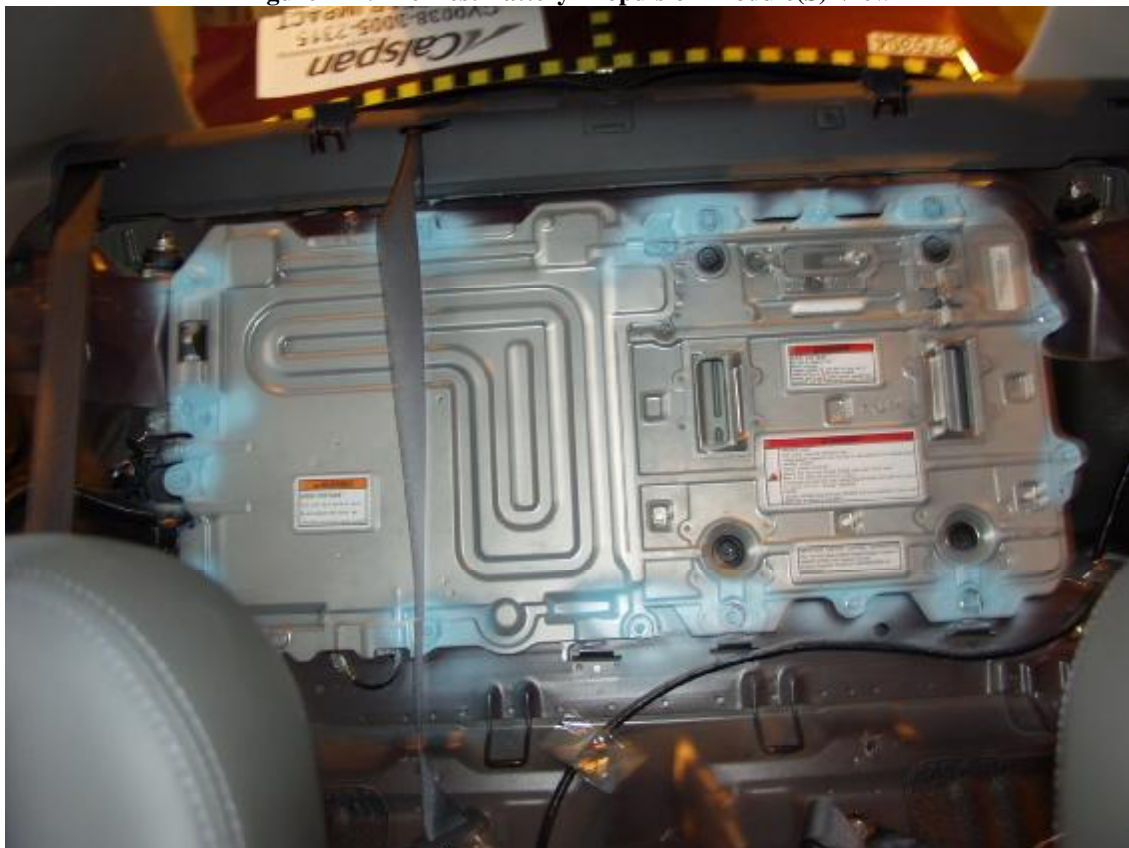
**Figure A-8: Post-Test Battery Propulsion Module(S) View**

Has the Propulsion Battery Module moved within the occupant compartment?  -  Yes(Fail)  x  No

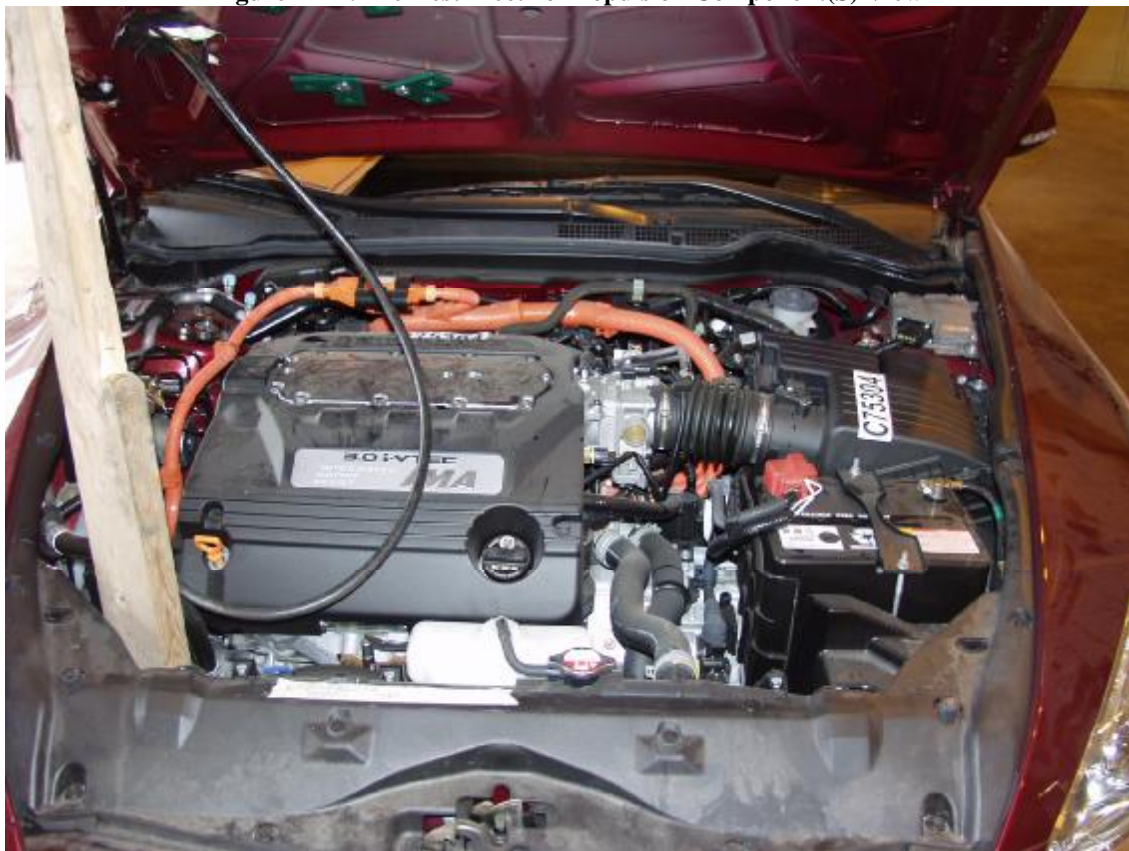
**Figure A-18: Post-Test Electric Propulsion Component(S) View**

Has an outside Propulsion Battery Component intruded into the occupant compartment?  -  Yes(Fail)  x  No

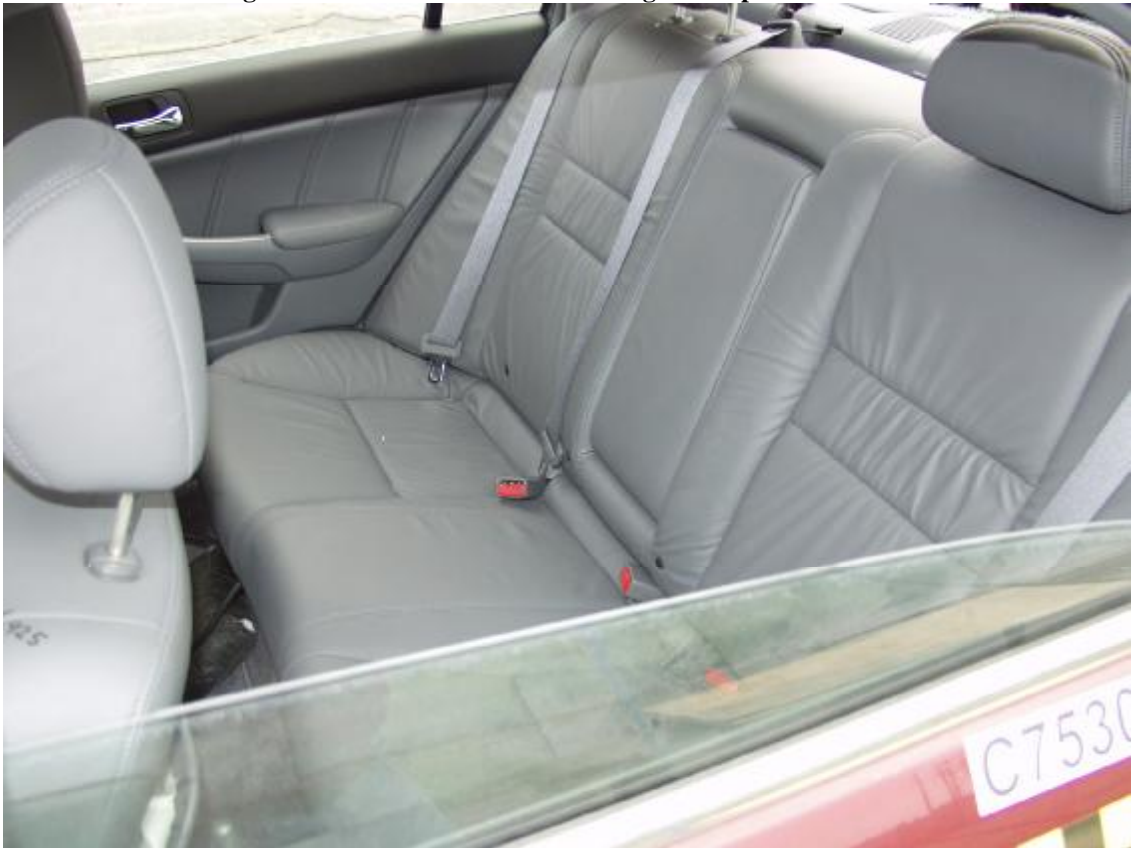
**Figure A-22: Post-Test Vehicle Passenger Compartment View**

Is Propulsion Battery electrolyte spillage visible in the occupant compartment?  -  Yes(Fail)  x  No

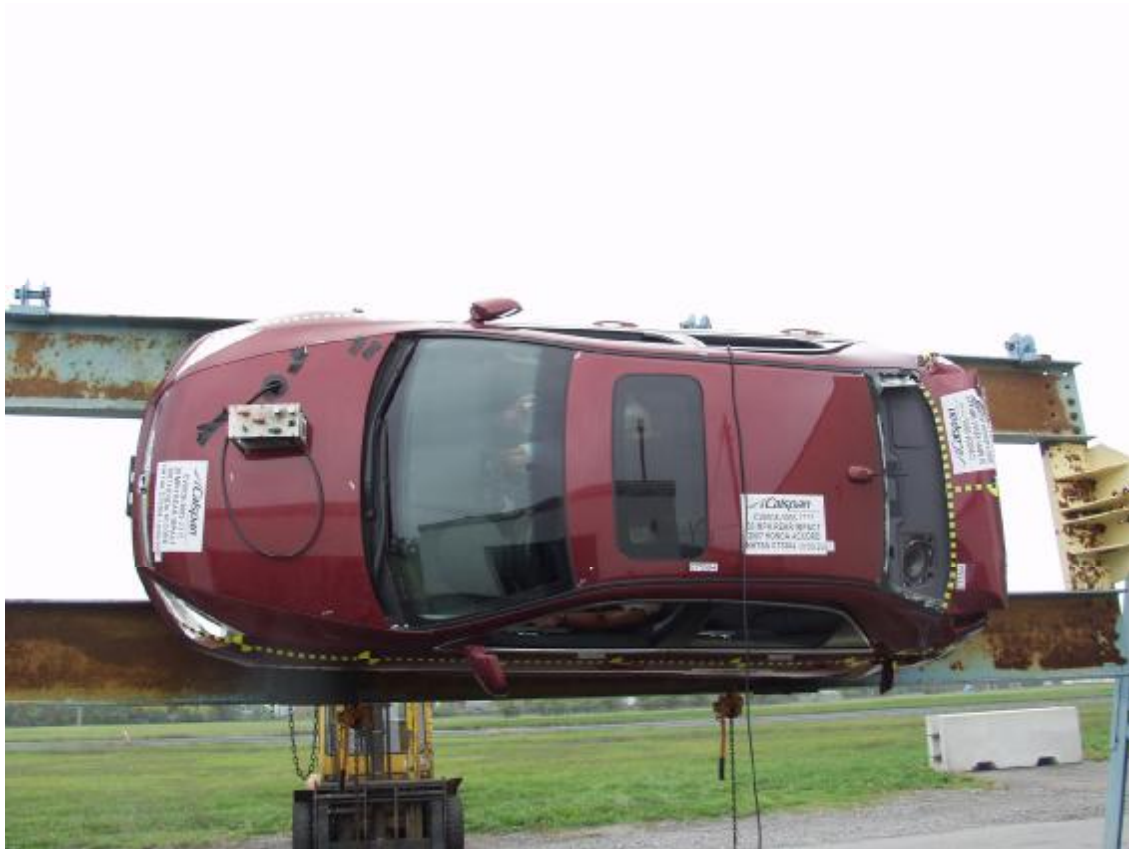
**Figure A-24: Rollover View - 90° Highlighting Propulsion Battery Location**

Rollover Stage	Propulsion Battery Electrolyte Spillage (L)	Spillage Location
0-90°	0	None
90-180°	0	None
180-270°	0	None
270-360°	0	None
