REPORT NUMBER: 221-MGA-2007-004

**SAFETY COMPLIANCE TESTING FOR
FMVSS NO. 221
SCHOOL BUS BODY JOINT STRENGTH**

**US BUS CORPORATION
2006 US BUS STURDIBUS SCHOOL BUS
NHTSA NO.: C60900**

**PREPARED BY:
MGA RESEARCH CORPORATION
5000 WARREN ROAD
BURLINGTON, WI 53105**

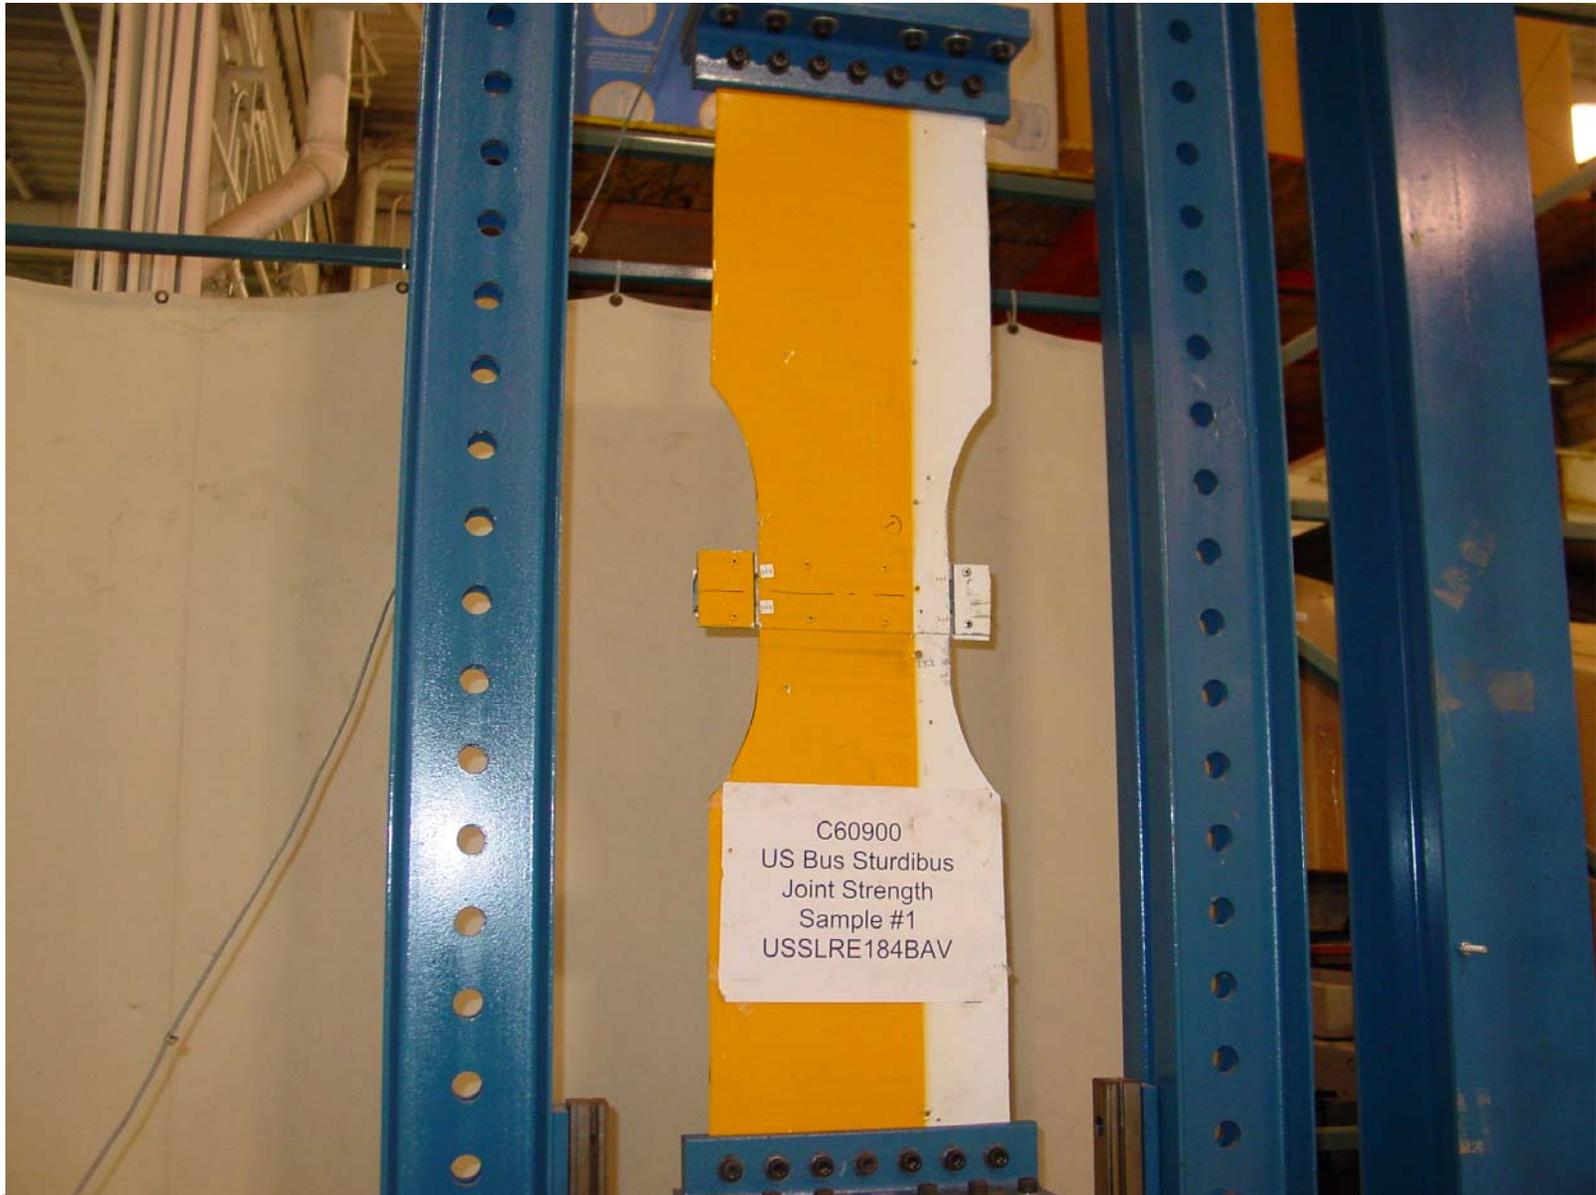
Pre-Test of Joint #1

Specimen Description:	Side Rear Exterior		
Joint Number:	USSLRE184BAV	Test Number:	1

Weaker Member	Stronger Member
Material	3003 H-14 Aluminum	N/A
Tensile Strength (MPa)	137.9	N/A
Thickness (mm)	1.270	N/A
Fastener Holes (No./Diameter – mm.)	4 / 5.11	N/A
Net Area (Sq. mm.)	232.1	N/A
Material Strength (N)	32009.4	N/A
60% of Material Strength (N)	19205.6	N/A
Maximum Load From Tensile Test of Joint (N)	35448.7	N/A
PASS/FAIL	PASS	N/A

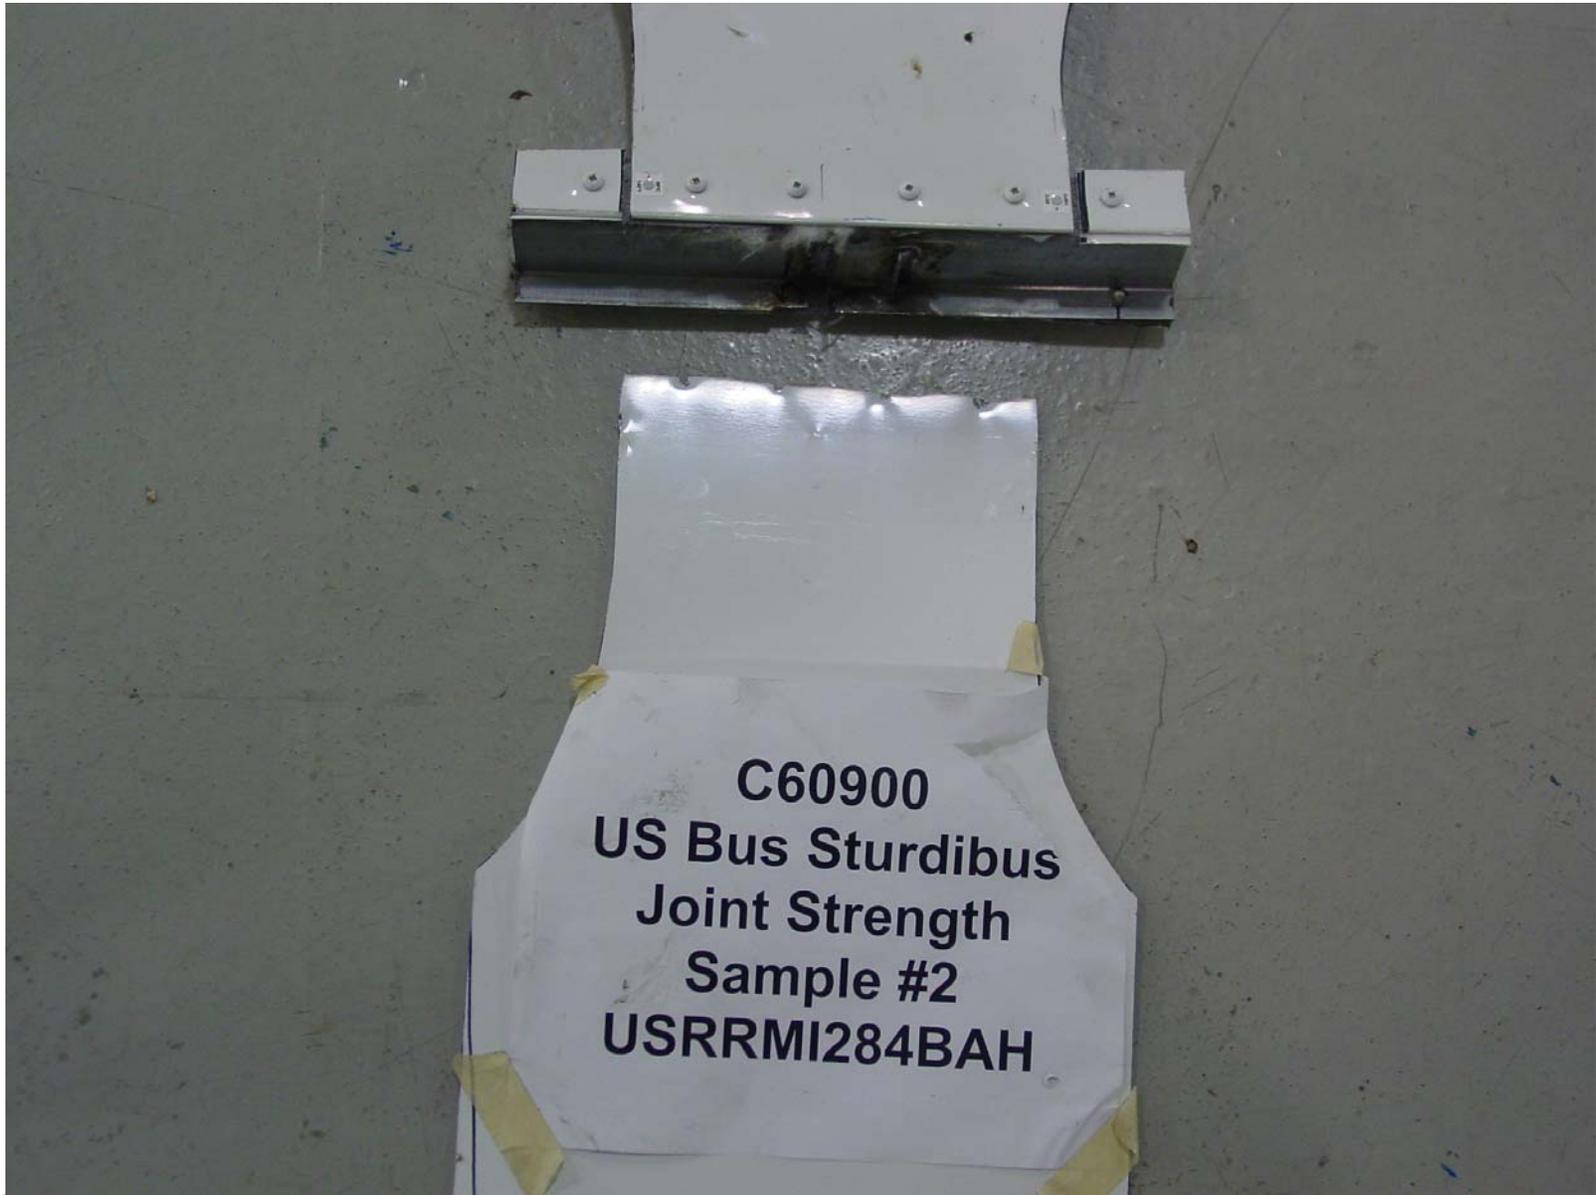
Post-Test of Joint #2

Specimen Description:	Roof Mid Interior 1		
Joint Number:	USRRMI284BAH	Test Number:	2

Weaker Member	Stronger Member
Material	3003 H-14 Aluminum	N/A
Tensile Strength (MPa)	137.9	N/A
Thickness (mm)	1.016	N/A
Fastener Holes (No./Diameter – mm.)	4 / 5.11	N/A
Net Area (Sq. mm.)	185.7	N/A
Material Strength (N)	25607.5	N/A
60% of Material Strength (N)	15364.5	N/A
Maximum Load From Tensile Test of Joint (N)	27620.3	N/A
PASS/FAIL	PASS	N/A

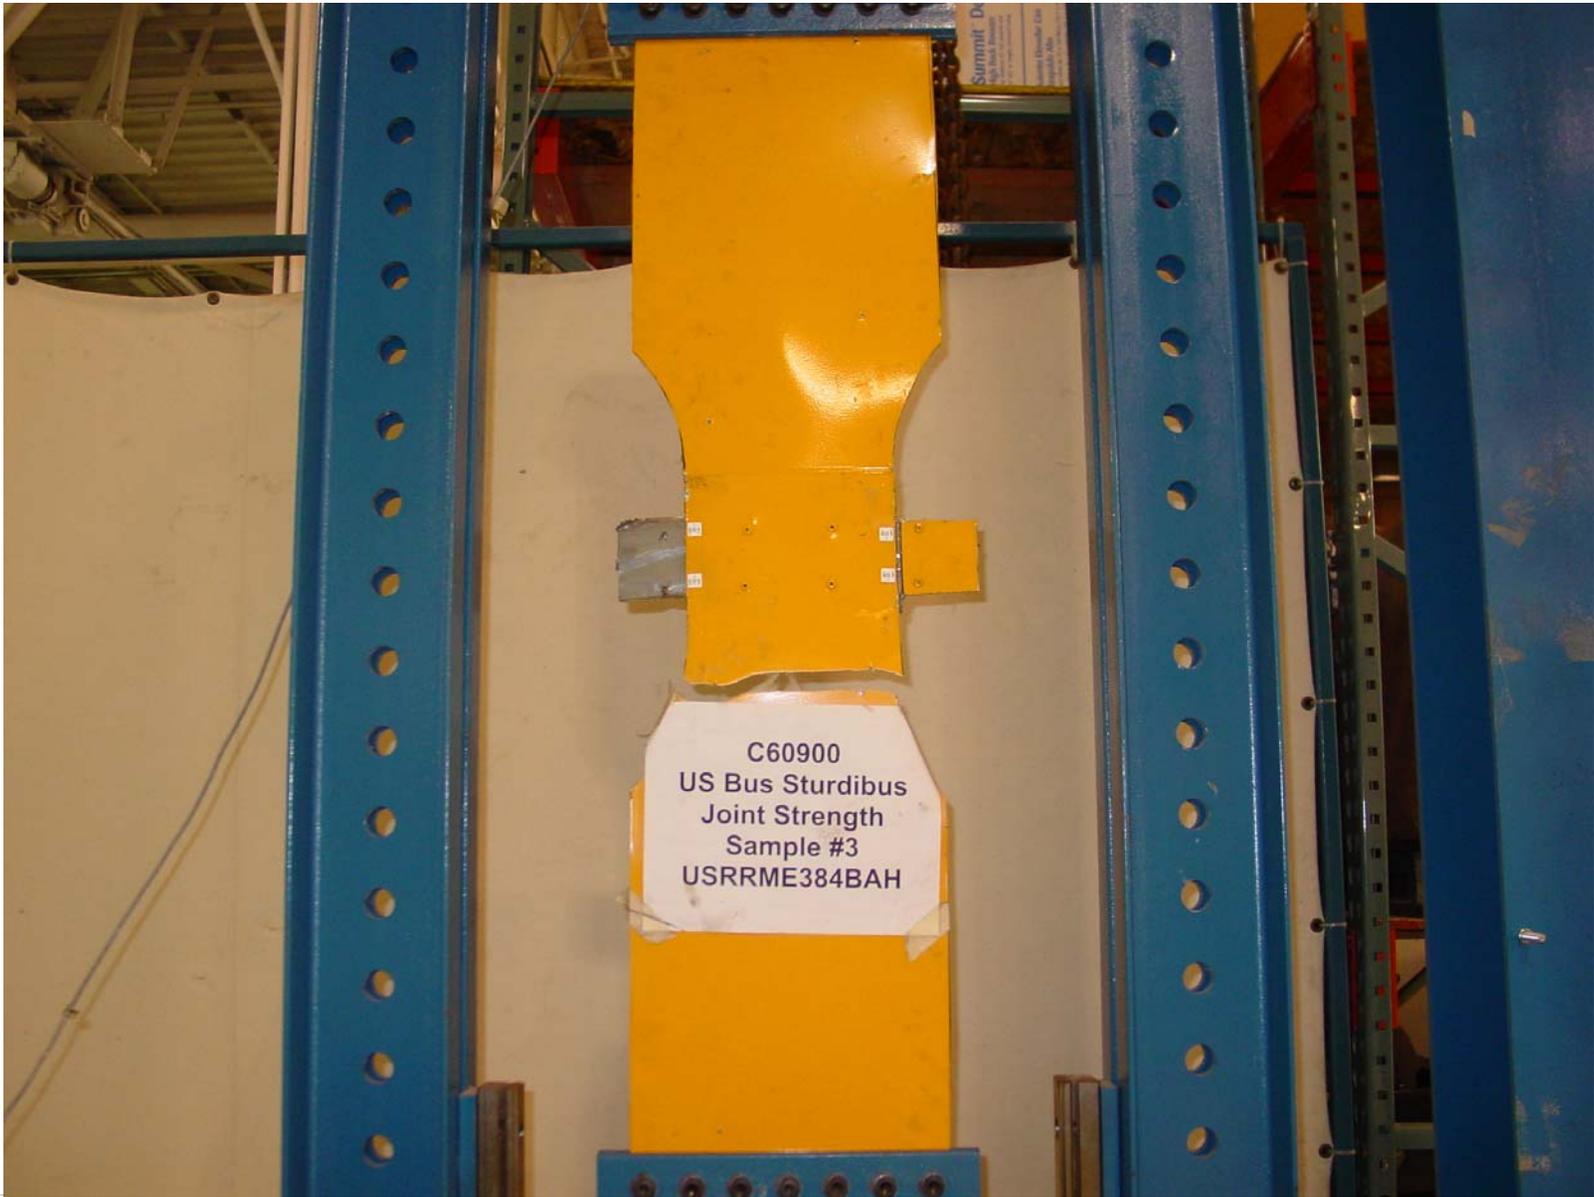
Post-Test of Joint #3

Specimen Description:	Roof Mid Exterior		
Joint Number:	USRRME384BAH	Test Number:	3

Weaker Member	Stronger Member
Material	3003 H-14 Aluminum	N/A
Tensile Strength (MPa)	137.9	N/A
Thickness (mm)	1.270	N/A
Fastener Holes (No./Diameter – mm.)	4 / 5.11	N/A
Net Area (Sq. mm.)	232.1	N/A
Material Strength (N)	32009.4	N/A
60% of Material Strength (N)	19205.6	N/A
Maximum Load From Tensile Test of Joint (N)	26275.9	N/A
PASS/FAIL	PASS	N/A

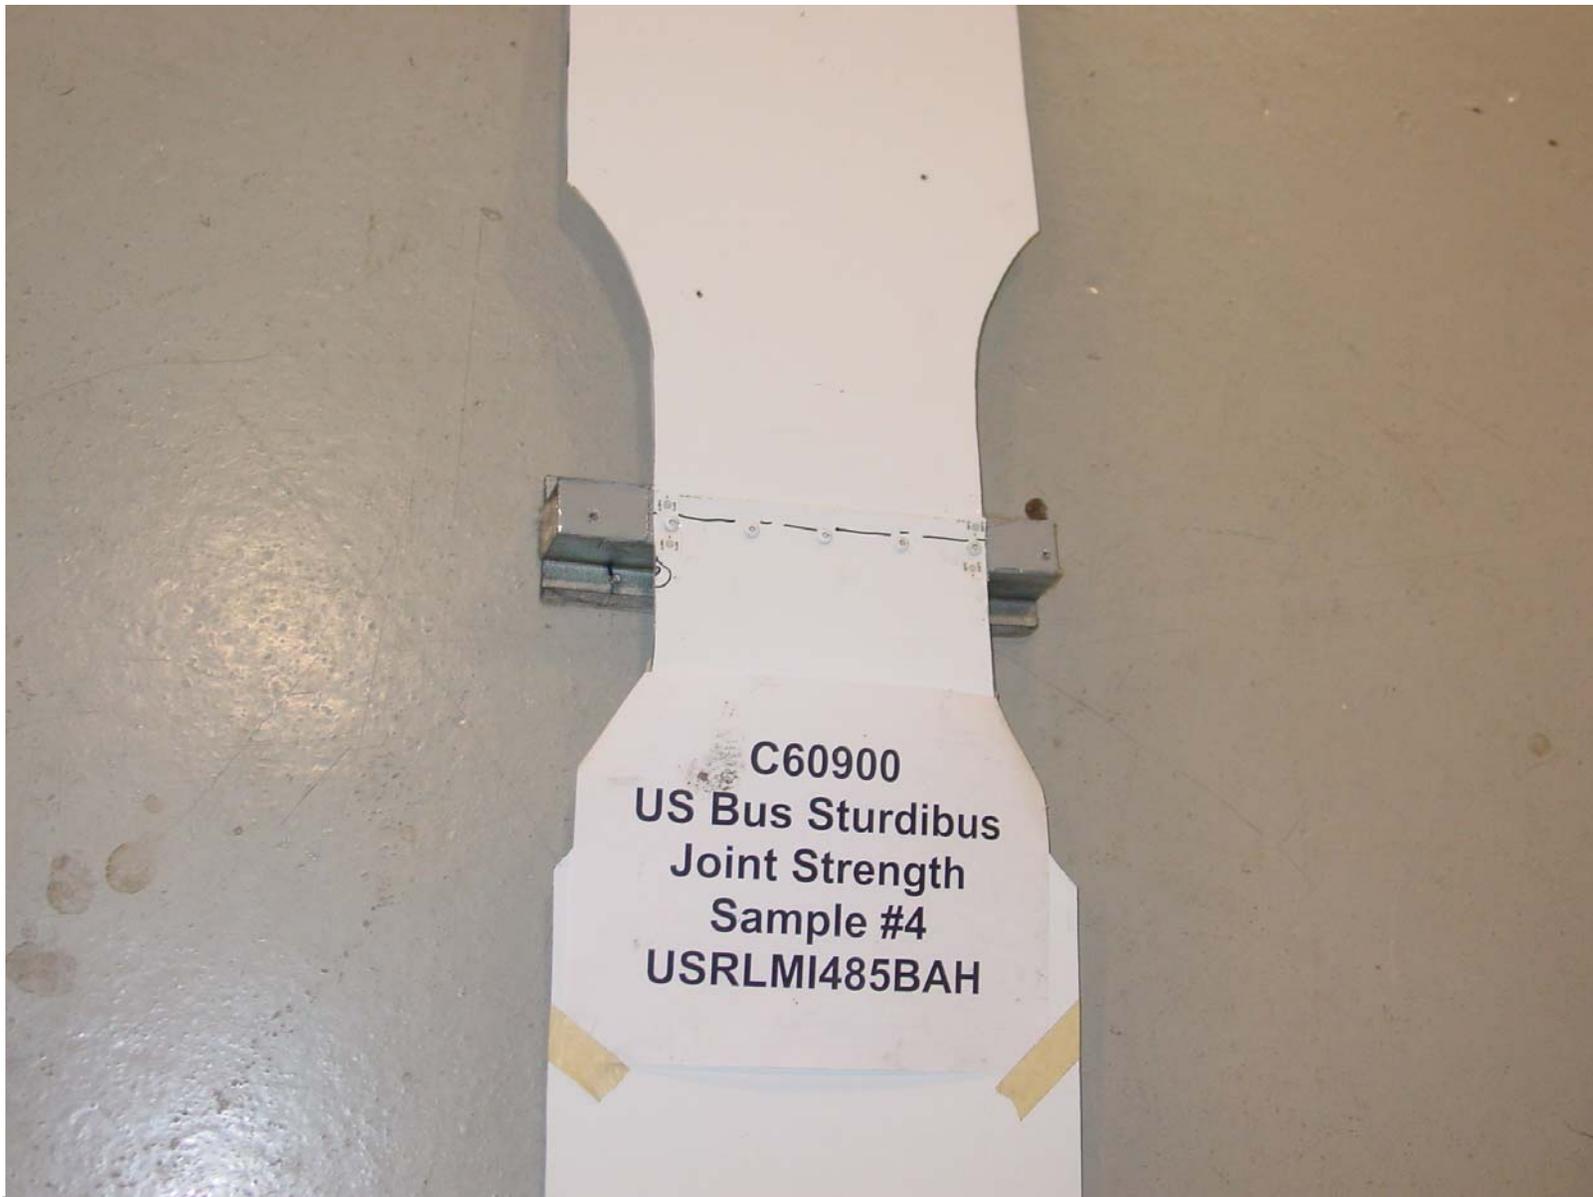
Post-Test of Joint #4

Specimen Description:	Roof Mid Interior 2		
Joint Number:	USRLMI485BAH	Test Number:	4

Weaker Member	Stronger Member
Material	3003 H-14 Aluminum	N/A
Tensile Strength (MPa)	137.9	N/A
Thickness (mm)	1.016	N/A
Fastener Holes (No./Diameter – mm.)	5 / 5.11	N/A
Net Area (Sq. mm.)	180.5	N/A
Material Strength (N)	24892.2	N/A
60% of Material Strength (N)	14935.3	N/A
Maximum Load From Tensile Test of Joint (N)	25843.8	N/A
PASS/FAIL	PASS	N/A
