**REPORT NO. 111-KAR-08-005**

**SAFETY COMPLIANCE TESTING  
FOR FMVSS 111**

**2009 TOYOTA COROLLA LE  
4-DOOR SEDAN**

**NHTSA NO: C95103**

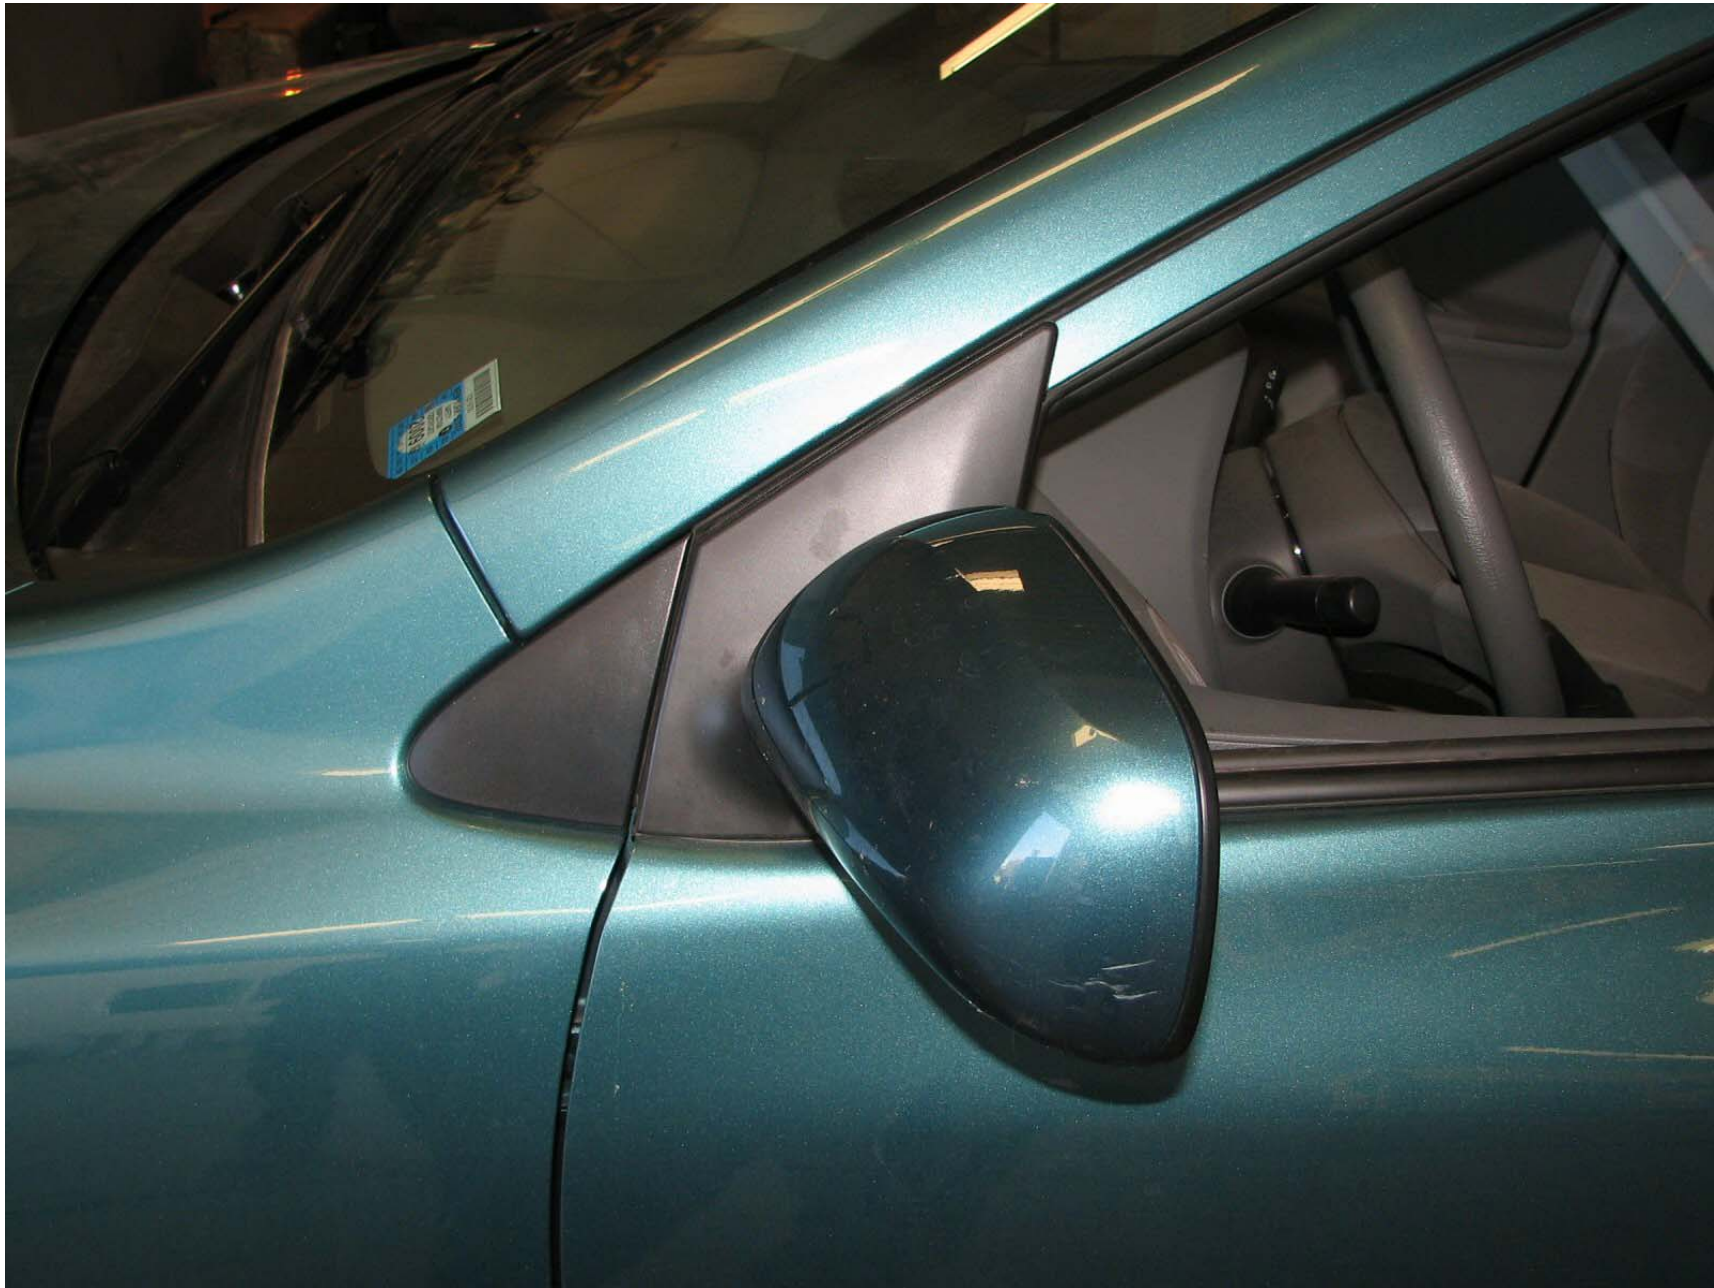
FIGURE 7: DRIVER SIDE REARVIEW MIRROR AND MOUNTING

OUTSIDE DRIVER SIDE MIRROR	PASS	FAIL	COMMENTS
STABLE SUPPORT	X		
DOES NOT PROTRUDE BEYOND VEHICLE BODY	X		
NOT OBSCURED BY UNWIPED PORTION OF WINDSHIELD	X		
ADJUSTABLE BY TILTING	X		
ADJUSTABLE FROM DRIVER SEAT	X		
FREE OF SHARP EDGES	X		
FIELD-OF-VIEW	X		
REFLECTANCE	X		
UNIT MAGNIFICATION	X

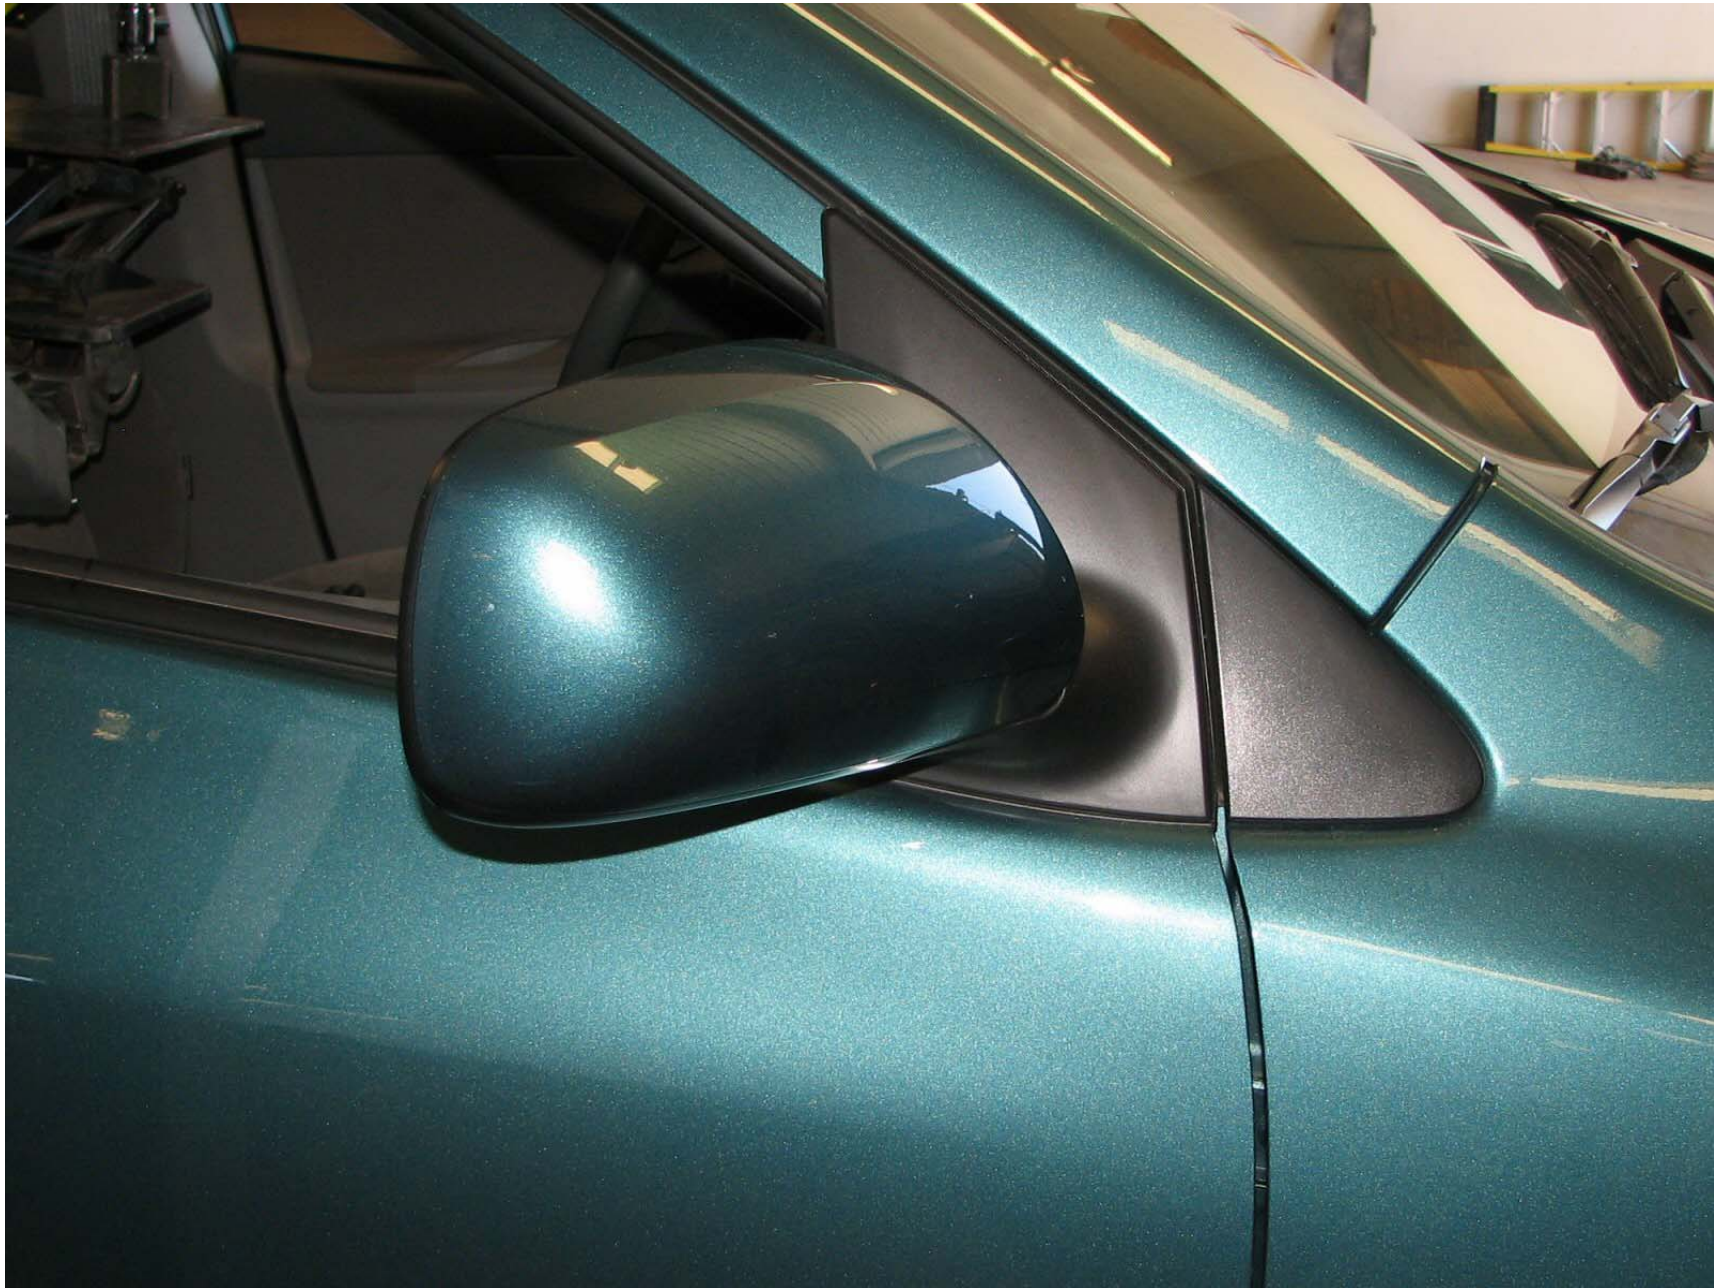
FIGURE 8: PASSENGER SIDE REARVIEW MIRROR AND MOUNTING

OUTSIDE PASSENGER MIRROR*	PASS	FAIL	COMMENTS
STABLE SUPPORT	X		
ADJUSTABLE BY TILTING	X		
FREE OF SHARP EDGES	X		
UNIT OR CONVEX			Convex
LABELING	X		
REFLECTANCE	X

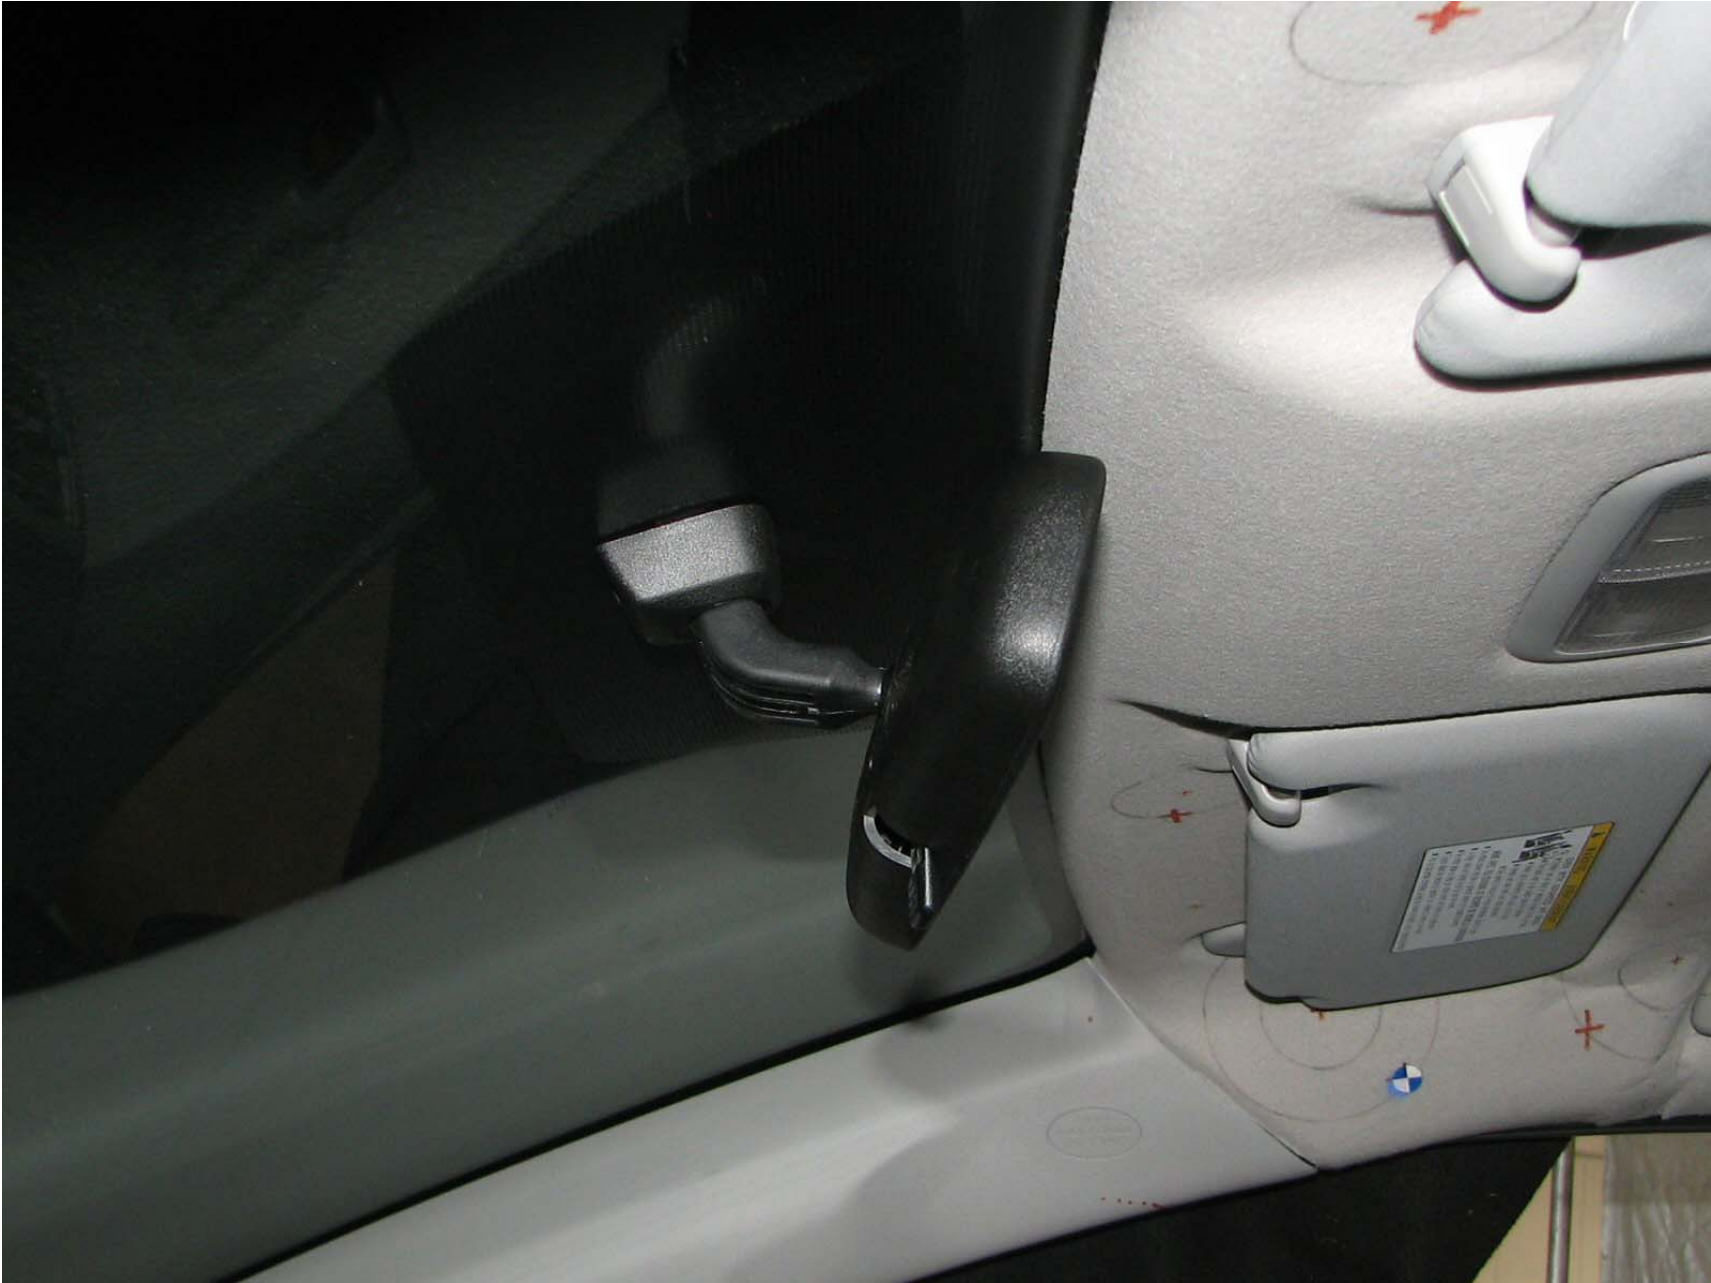
FIGURE 9: INSIDE REARVIEW MIRROR AND MOUNTING

INSIDE REARVIEW MIRROR	PASS	FAIL	COMMENTS
STABLE SUPPORT	X		
ADJUSTABLE BY TILTING	X		
FIELD-OF-VIEW	X		
REFLECTANCE	X		
BREAK AWAY	X		
UNIT MAGNIFICATION	X
