REPORT NUMBER: 201-CAL-09-01

**SAFETY COMPLIANCE TESTING FOR FMVSS 201
OCCUPANT PROTECTION IN INTERIOR IMPACT**

**NISSAN MOTOR COMPANY, LTD.
2009 NISSAN SENTRA**

NHTSA NUMBER: C95206

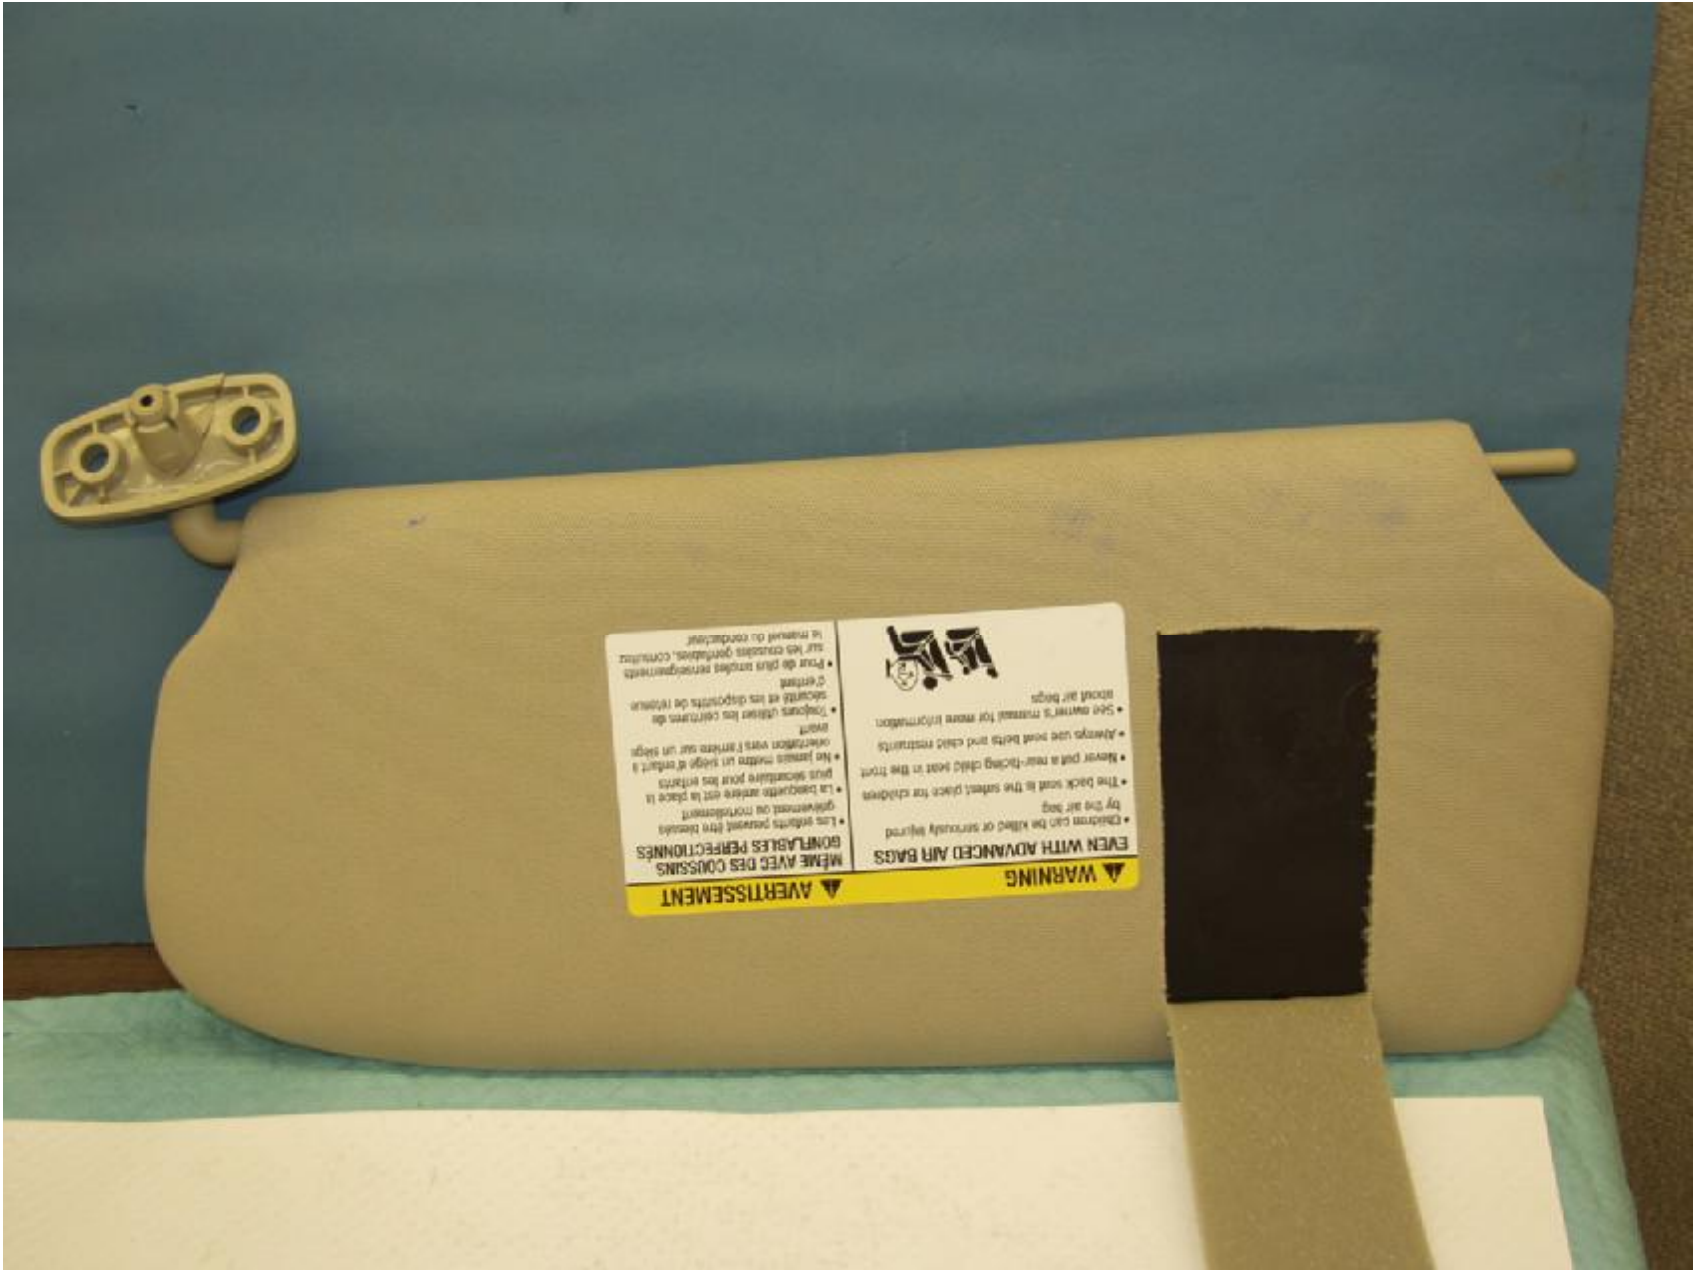
Figure A-7 : SUN VISOR CONSTRUCTION

1. Are sun visors constructed of or covered with energy absorbing material?

YES (PASS): X

2. Are any edges statically contactable by a spherical 165 mm (6.5 inch) diameter head form of radius less than 31.75 mm (1.25 inch)?

NO (PASS): X

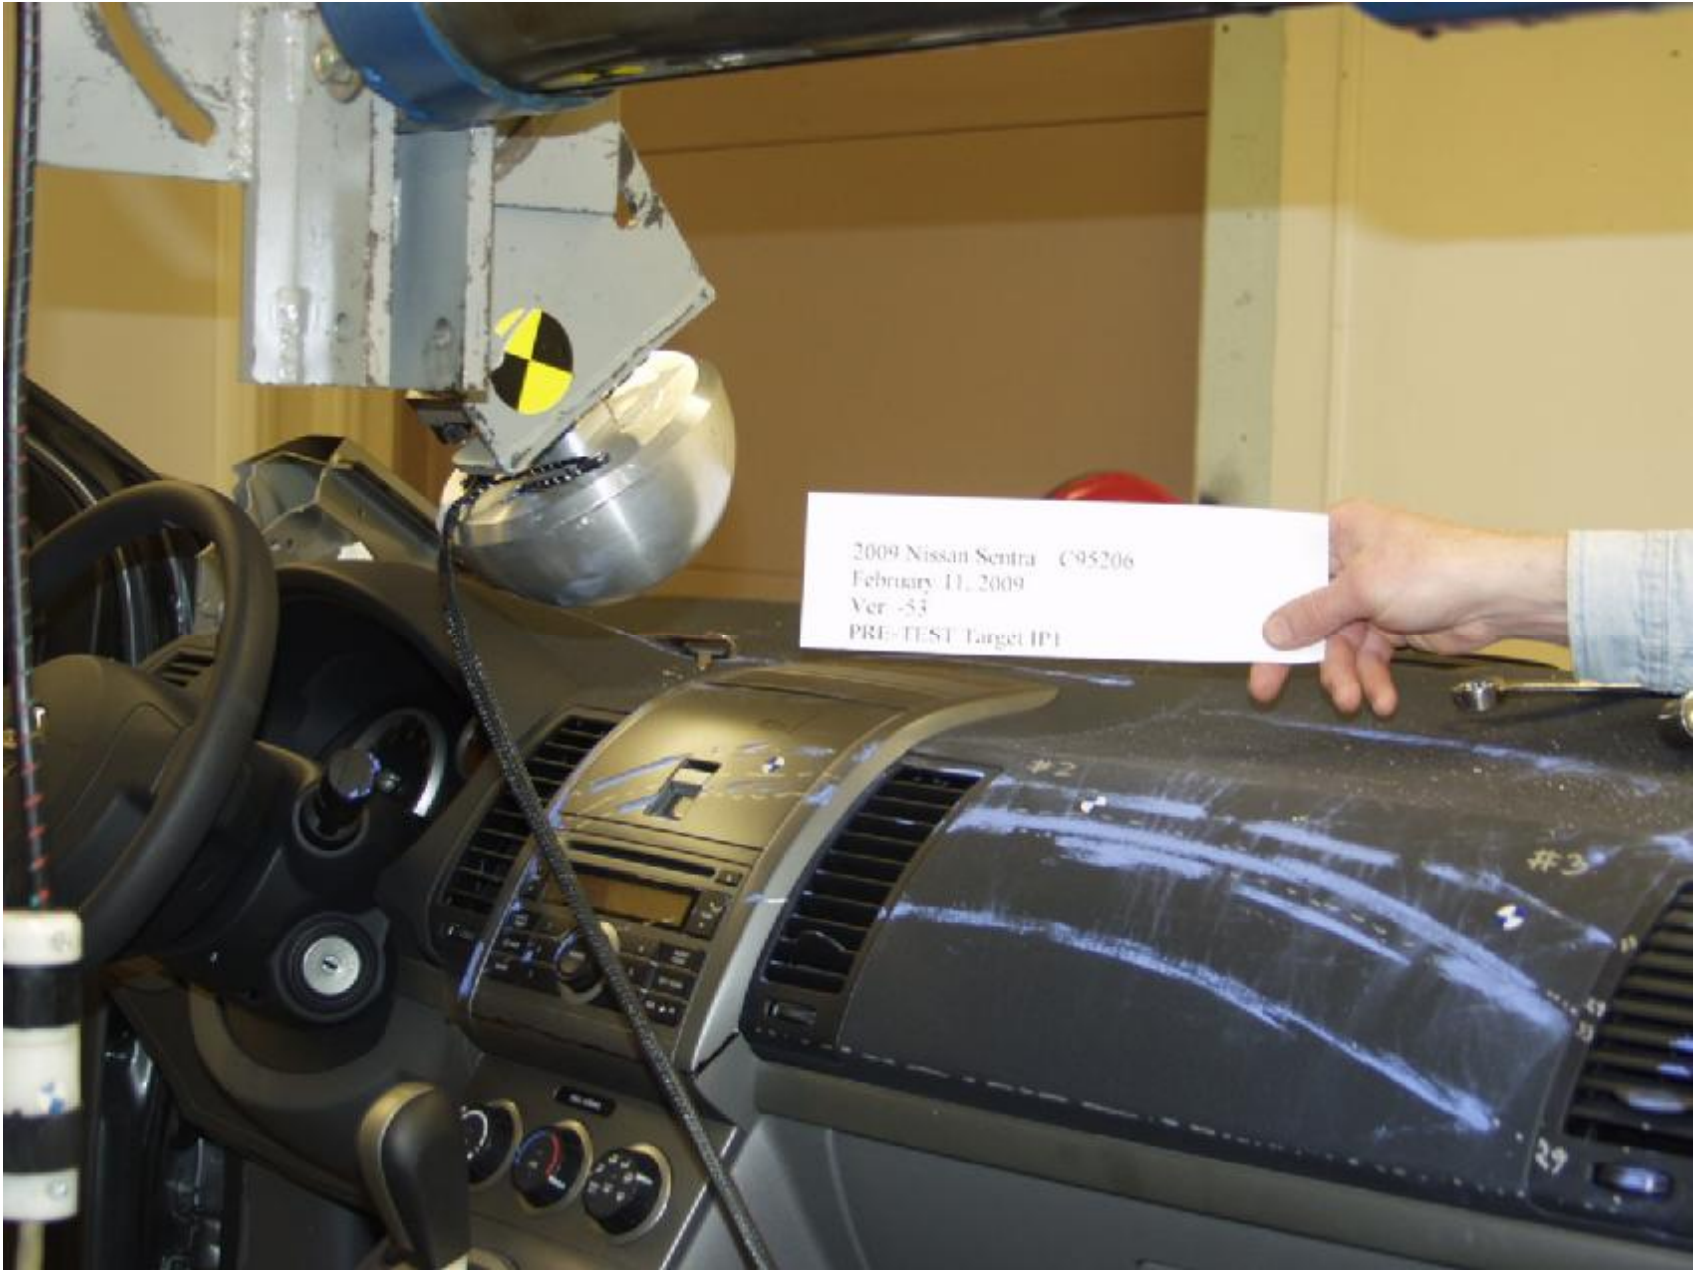
Figure A-15 : INSTRUMENT PANEL IMPACT #1 PRE-TEST

IMPACT LOCATION AND NUMBER				VELOCITY (kph)	PEAK ACCELERATION (3 ms Clip) Gs
TARGET	X (mm)	Y (mm)	ANGLE (degrees)		
LEFT DASH BELOW AIRBAG PANEL	635	283	57	18.7	58.39
RIGHT DASH BELOW AIRBAG PANEL	642	538	47	18.9	63.15
INSTRUMENT PANEL STORAGE BIN	665	76.9	53	18.8	60.77

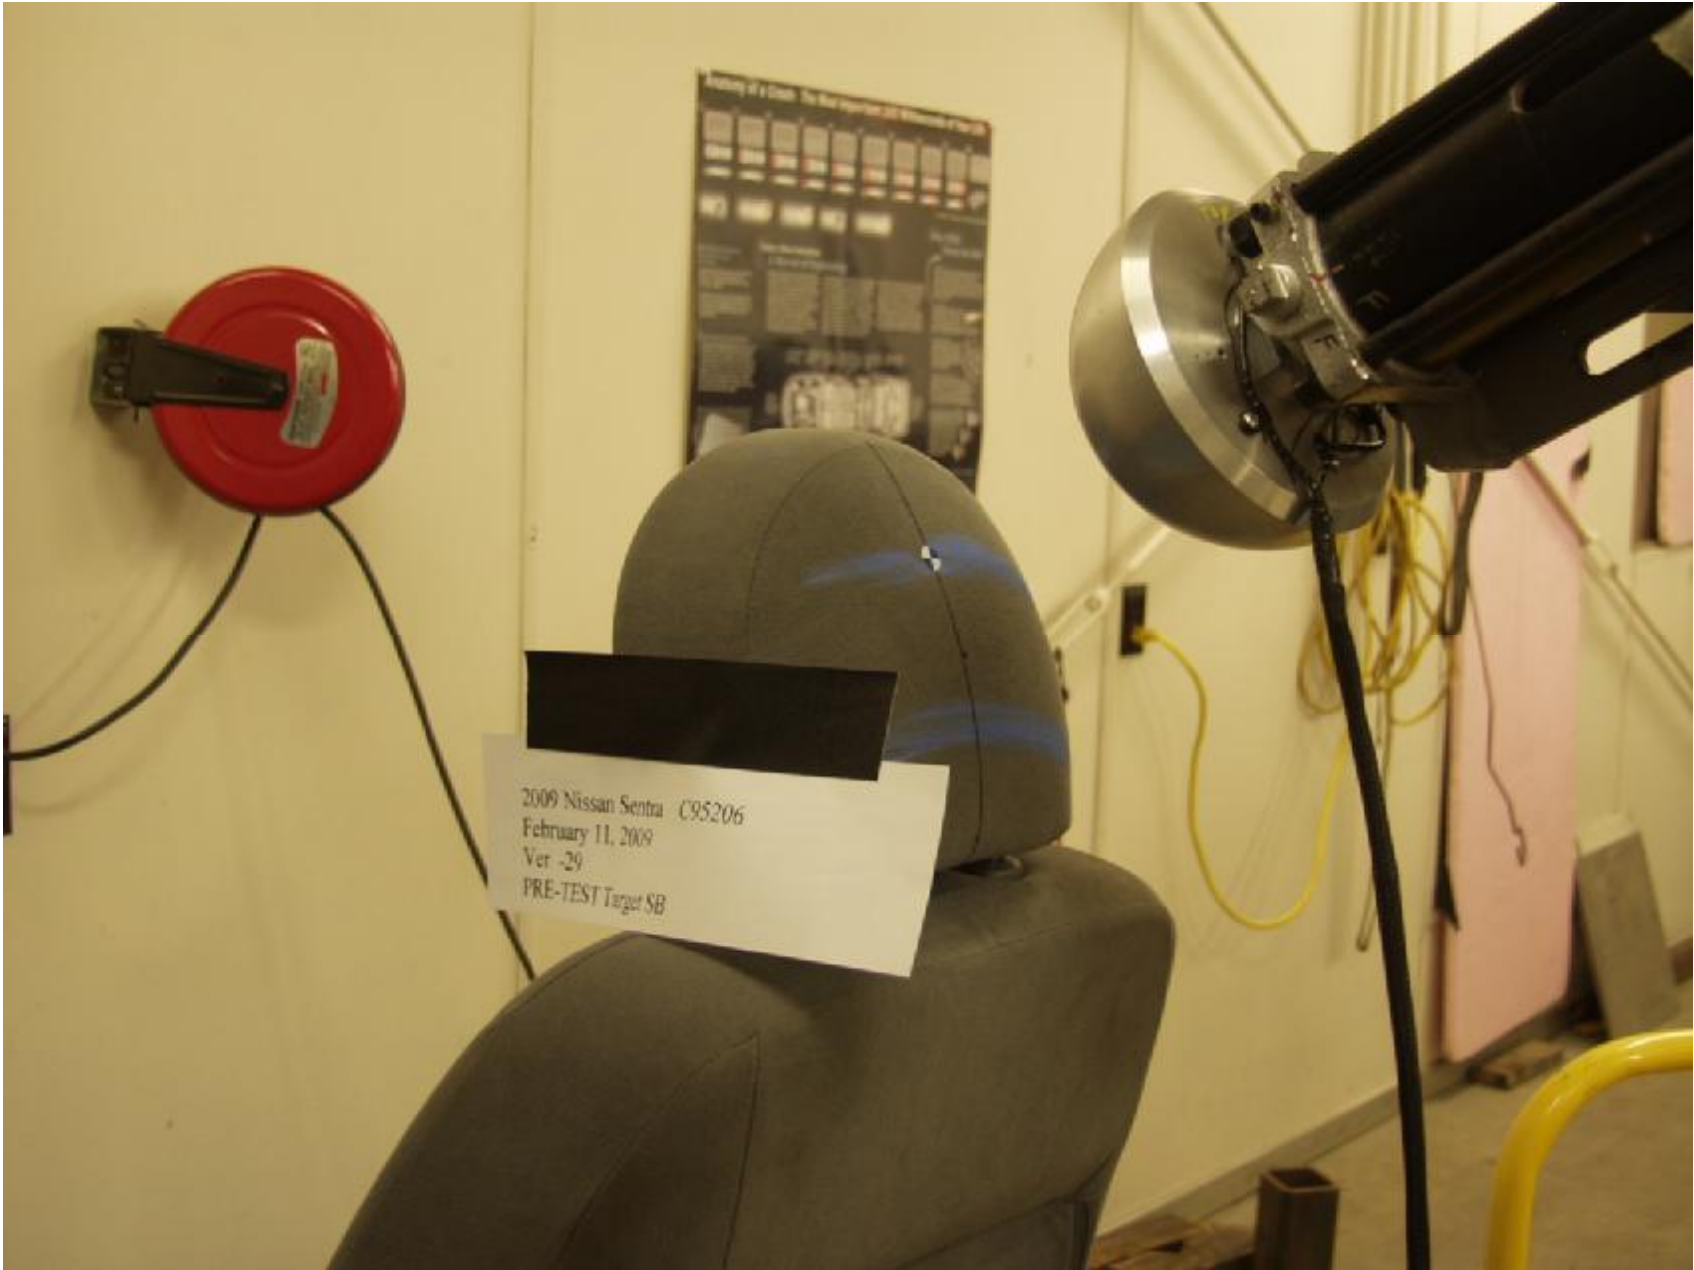
Figure A-22 : HEAD RESTRAINT IMPACT AREA PRE-TEST

IMPACT LOCATION AND NUMBER				VELOCITY (kph)	PEAK ACCELERATION (3 ms Clip) Gs
NUMBER	X (mm)	Y (mm)	ANGLE (degrees)		
PASSENGER SIDE FRONT SEAT HEAD RESTRAINT	1719	362	29.0	23.5	38.35

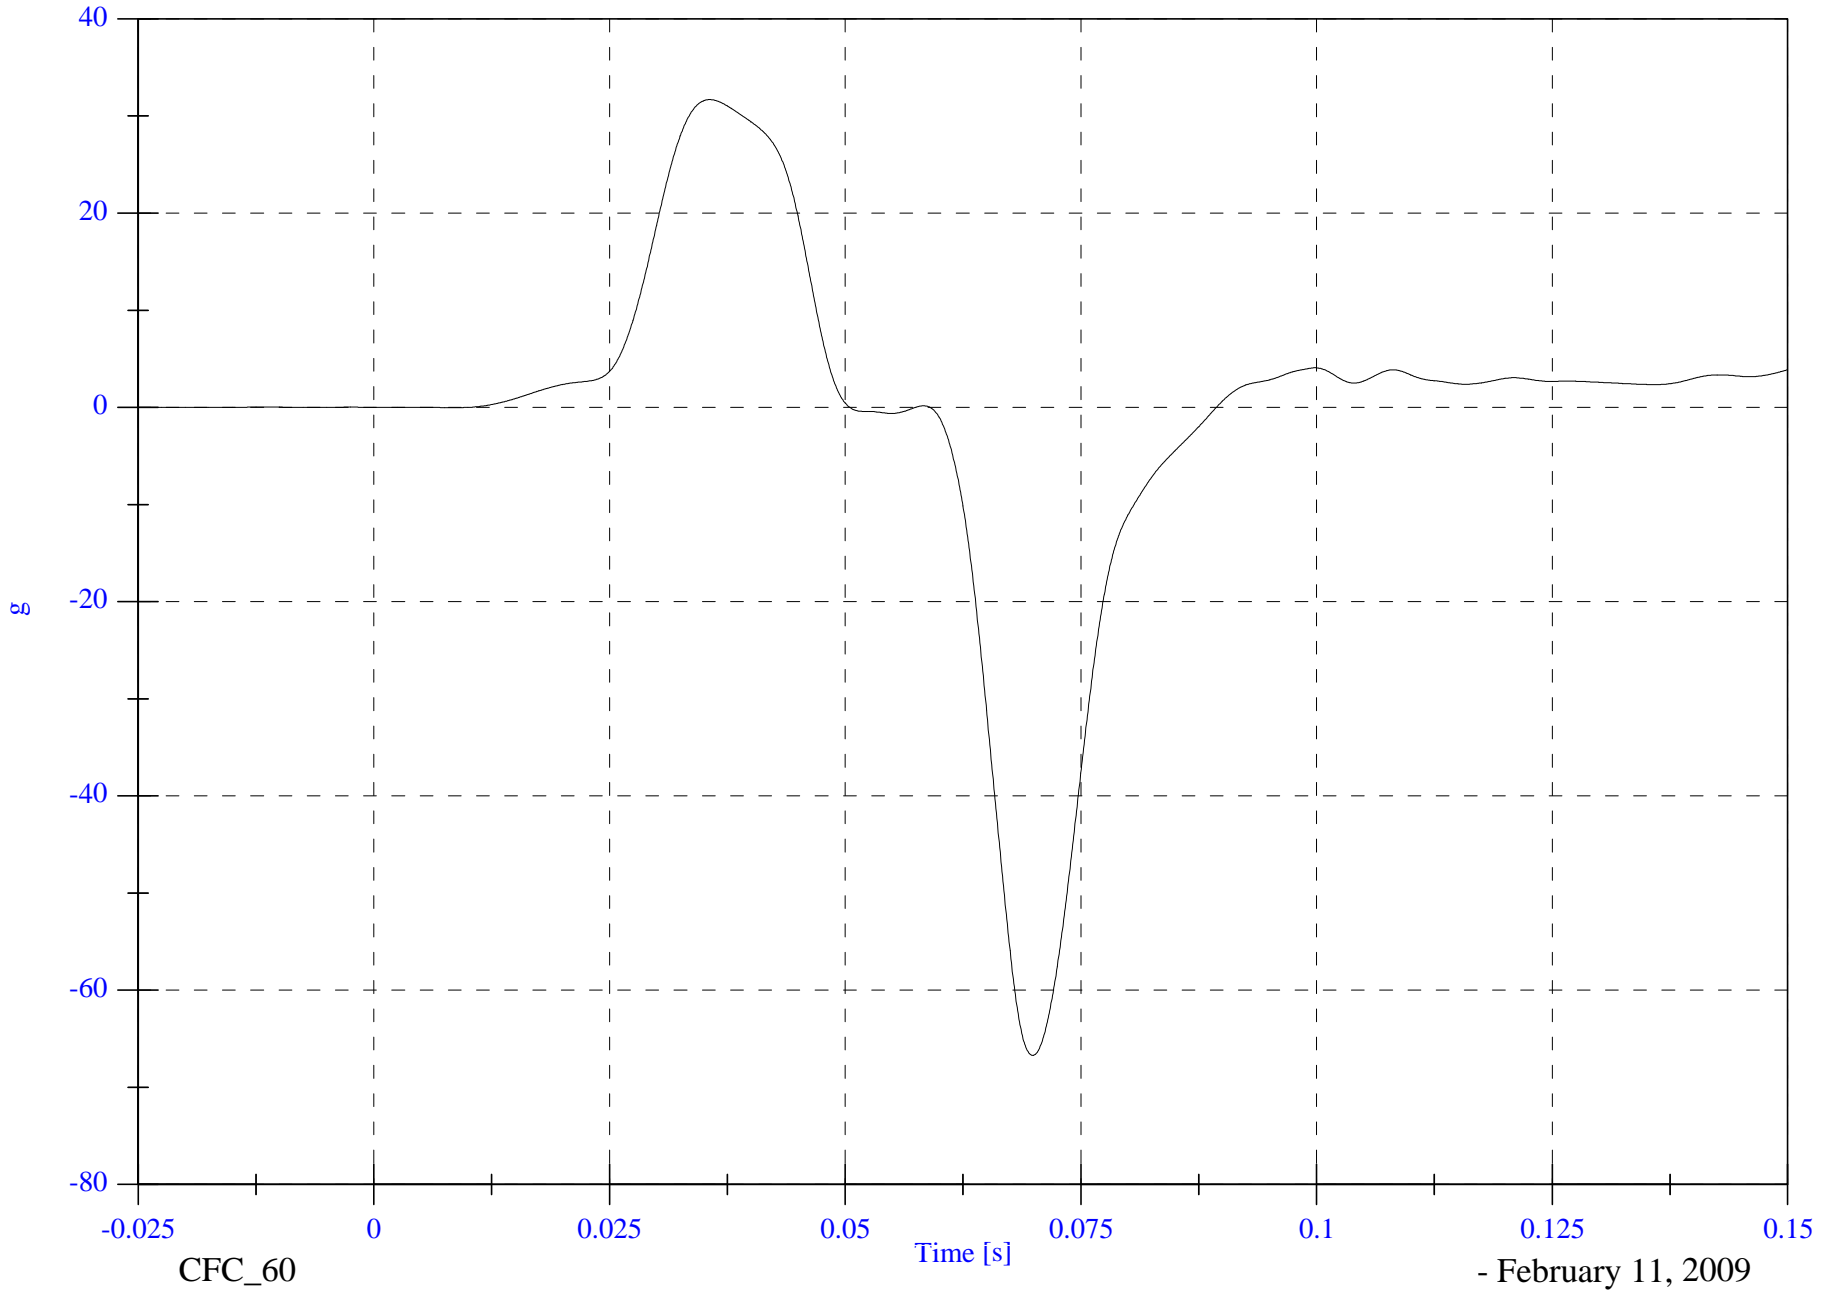
C95206 IP1 STORAGE BIN IMPACT PLOT #1

Max: 31.7 [g] at 0.036 [s]

Min: -66.7 [g] at 0.070 [s]

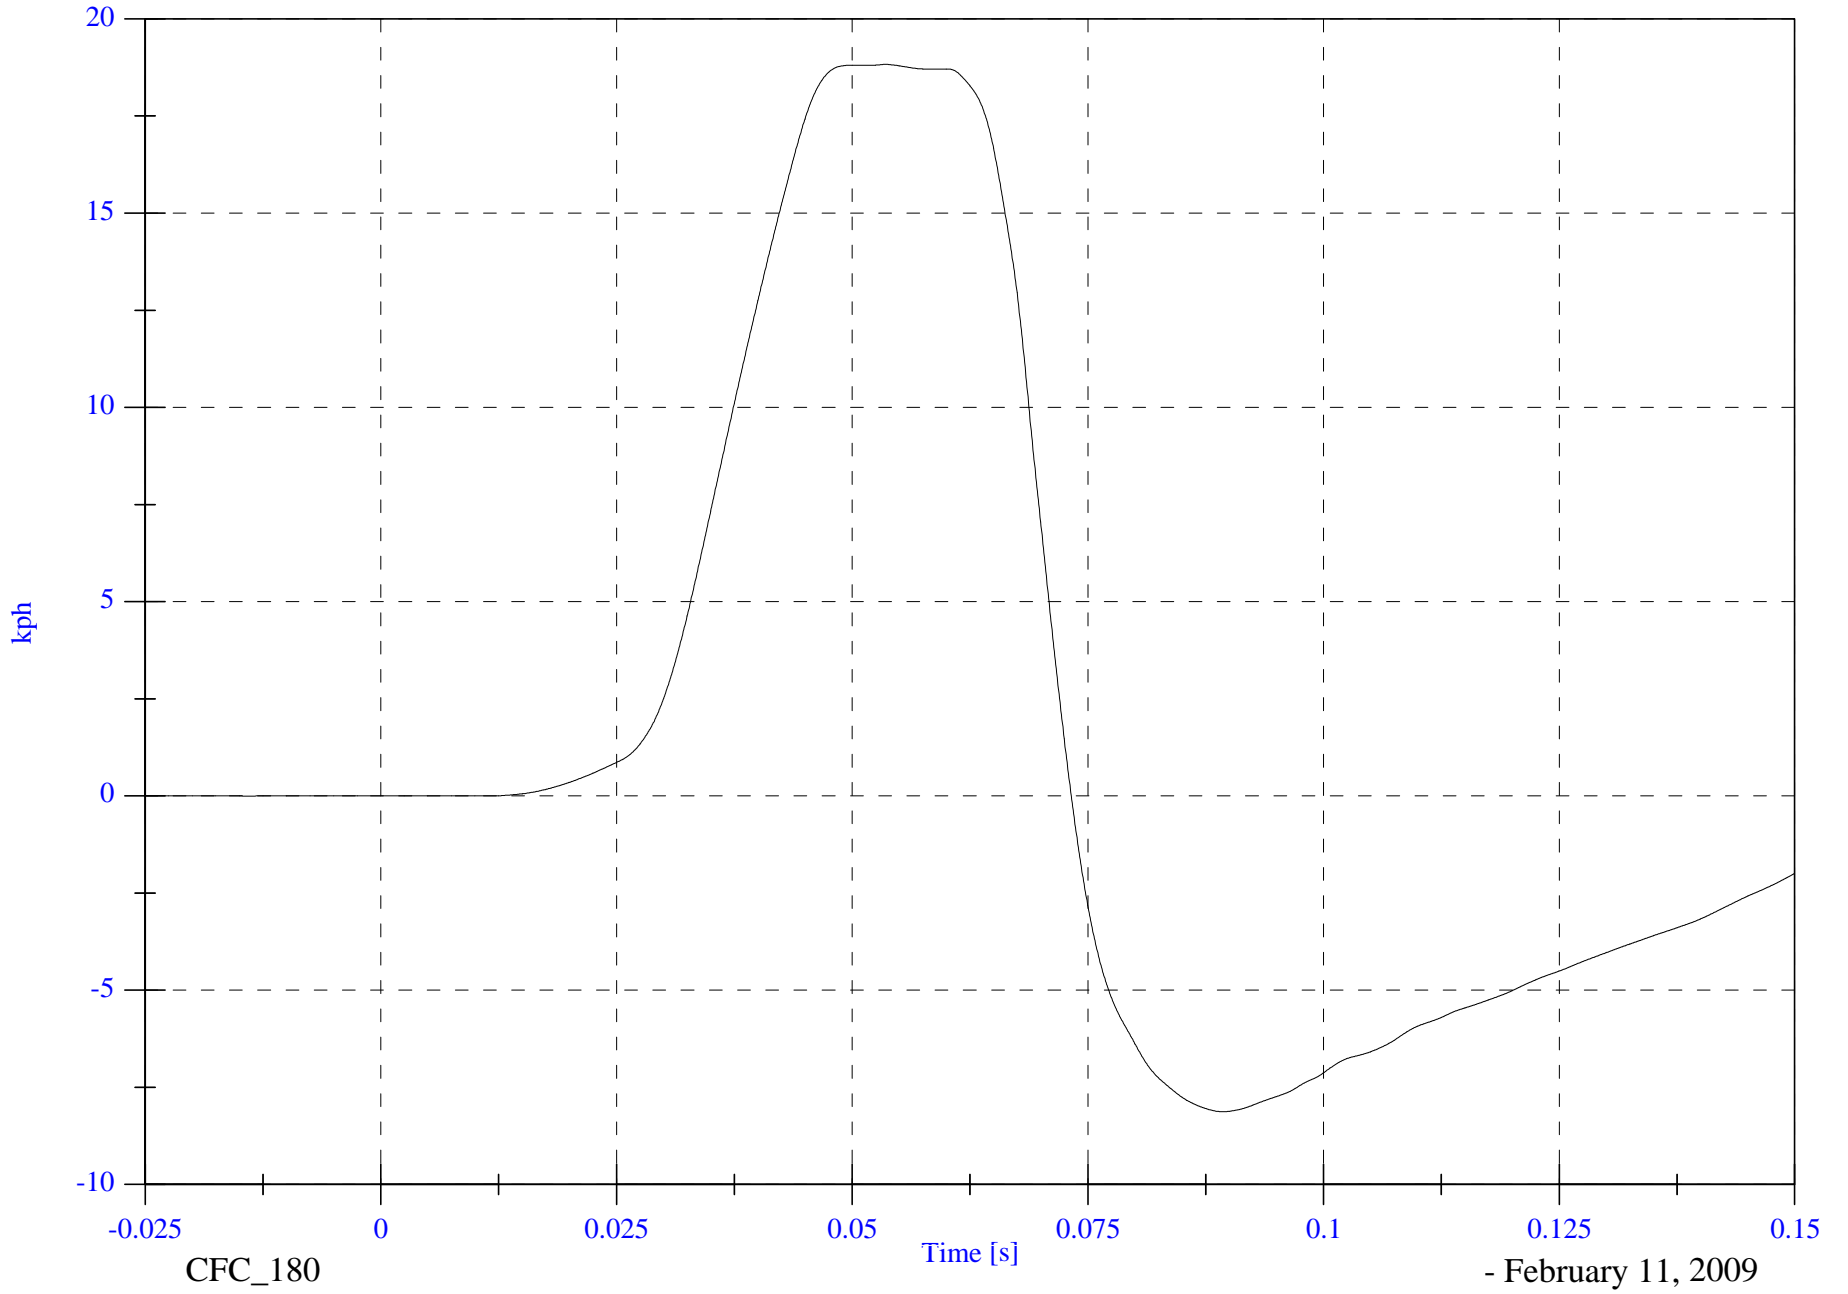
C95206 IP1 STORAGE BIN IMPACT PLOT #2

Max: 18.8 [kph] at 0.054 [s]

Min: -8.1 [kph] at 0.089 [s]

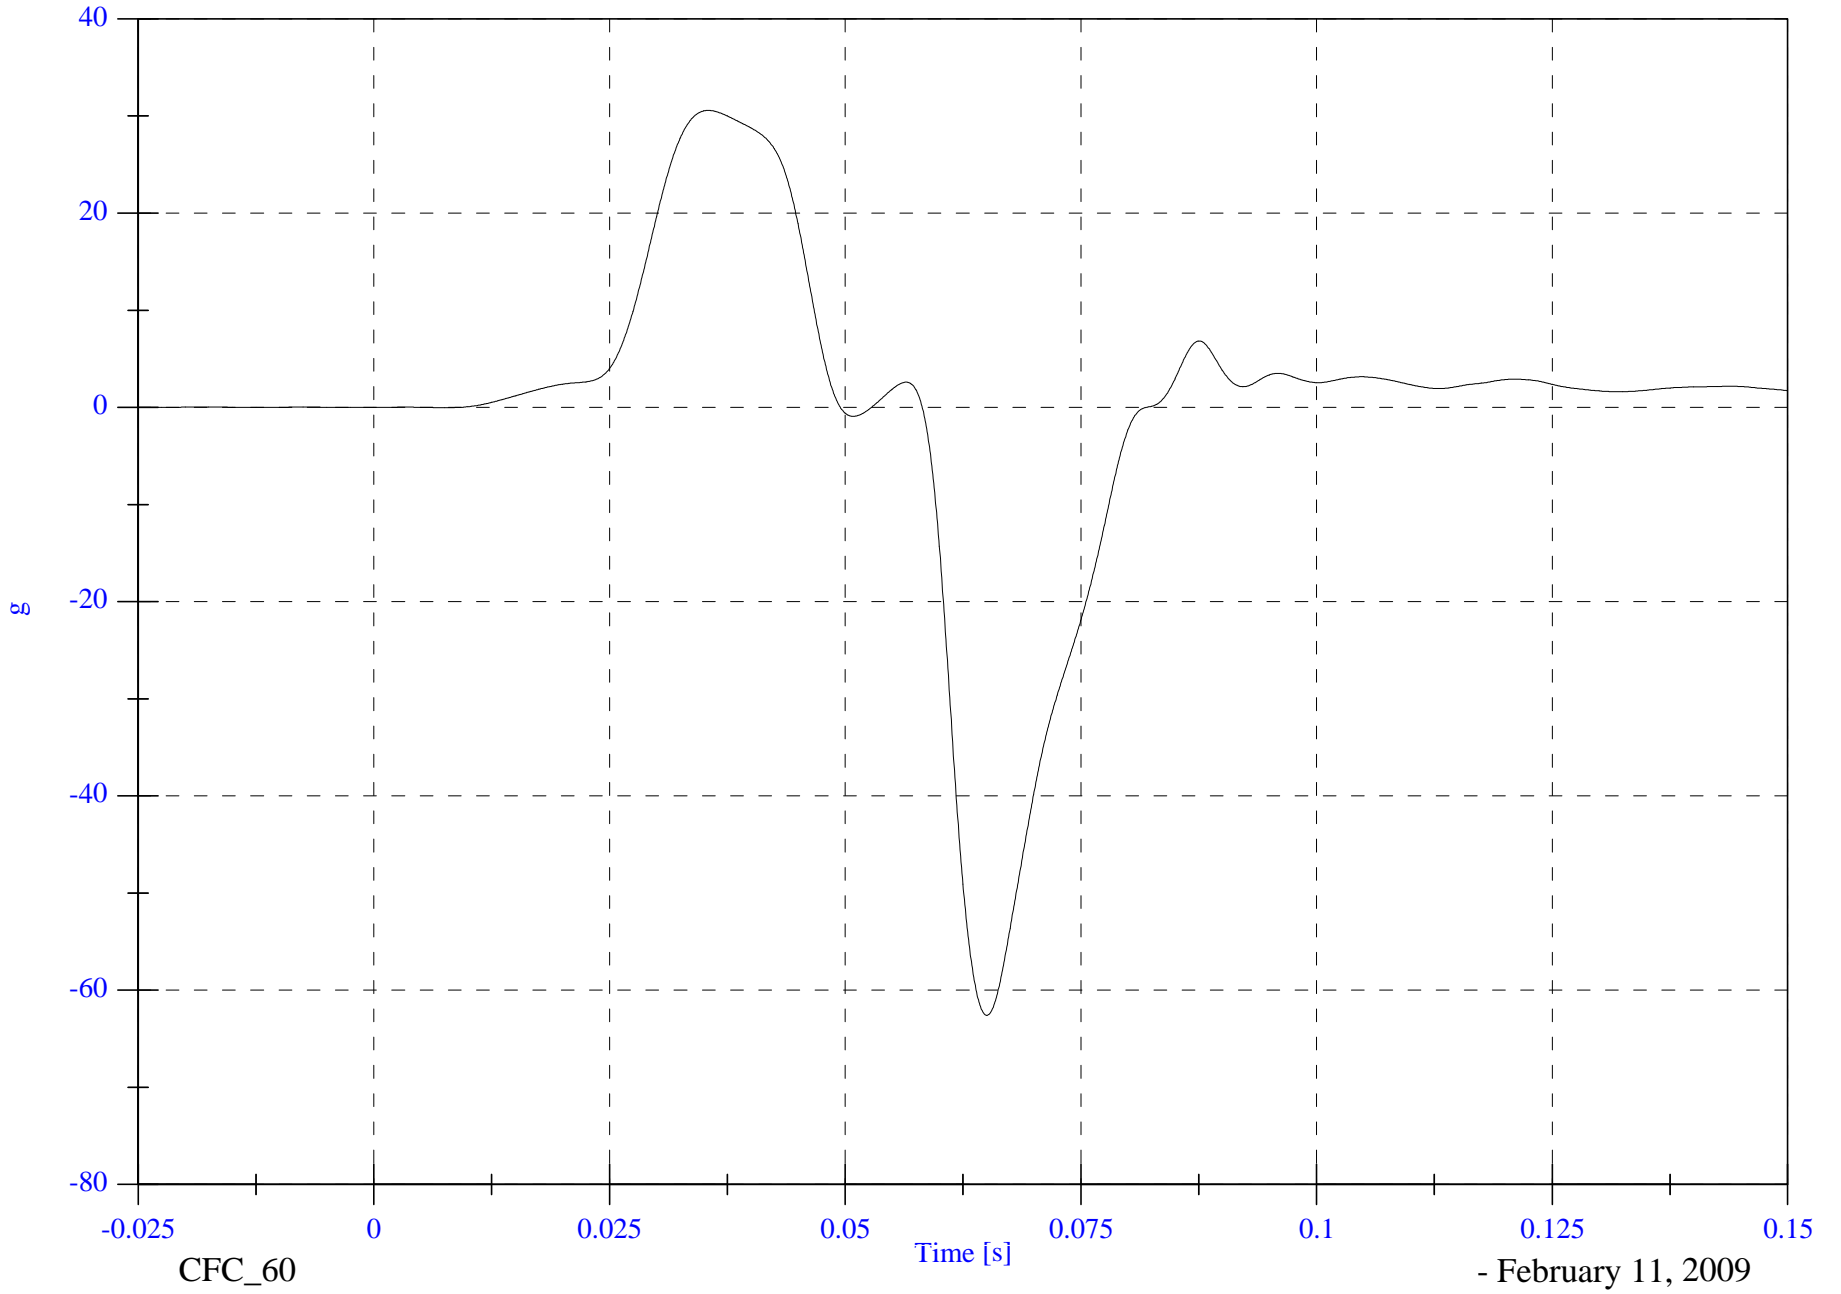
C95206 IP2 LEFT AIRBAG COVER IMPACT PLOT #1

Max: 30.6 [g] at 0.035 [s]

Min: -62.6 [g] at 0.065 [s]

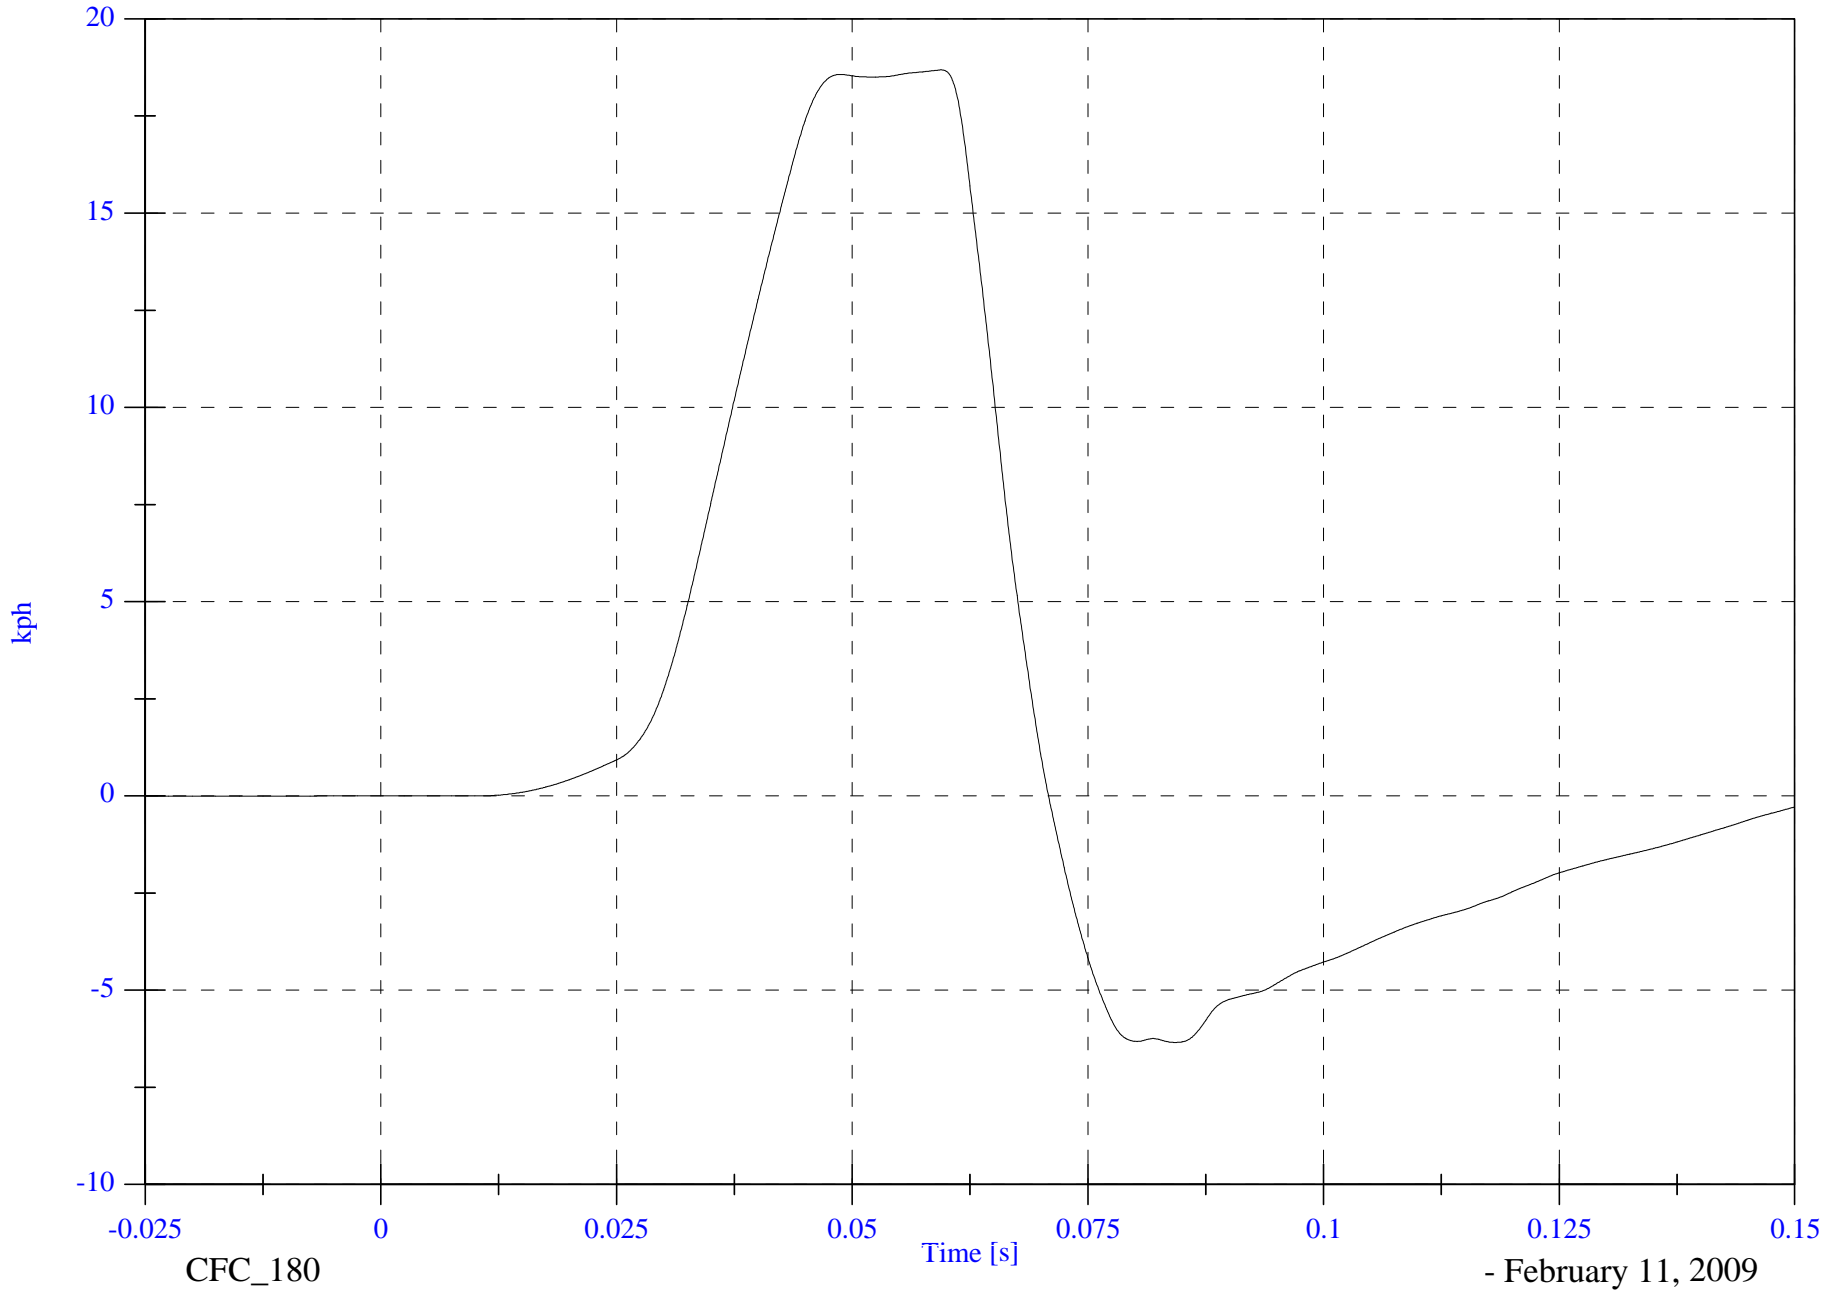
C95206 IP2 LEFT AIRBAG COVER IMPACT PLOT #2

Max: 18.7 [kph] at 0.059 [s]

Min: -6.3 [kph] at 0.084 [s]

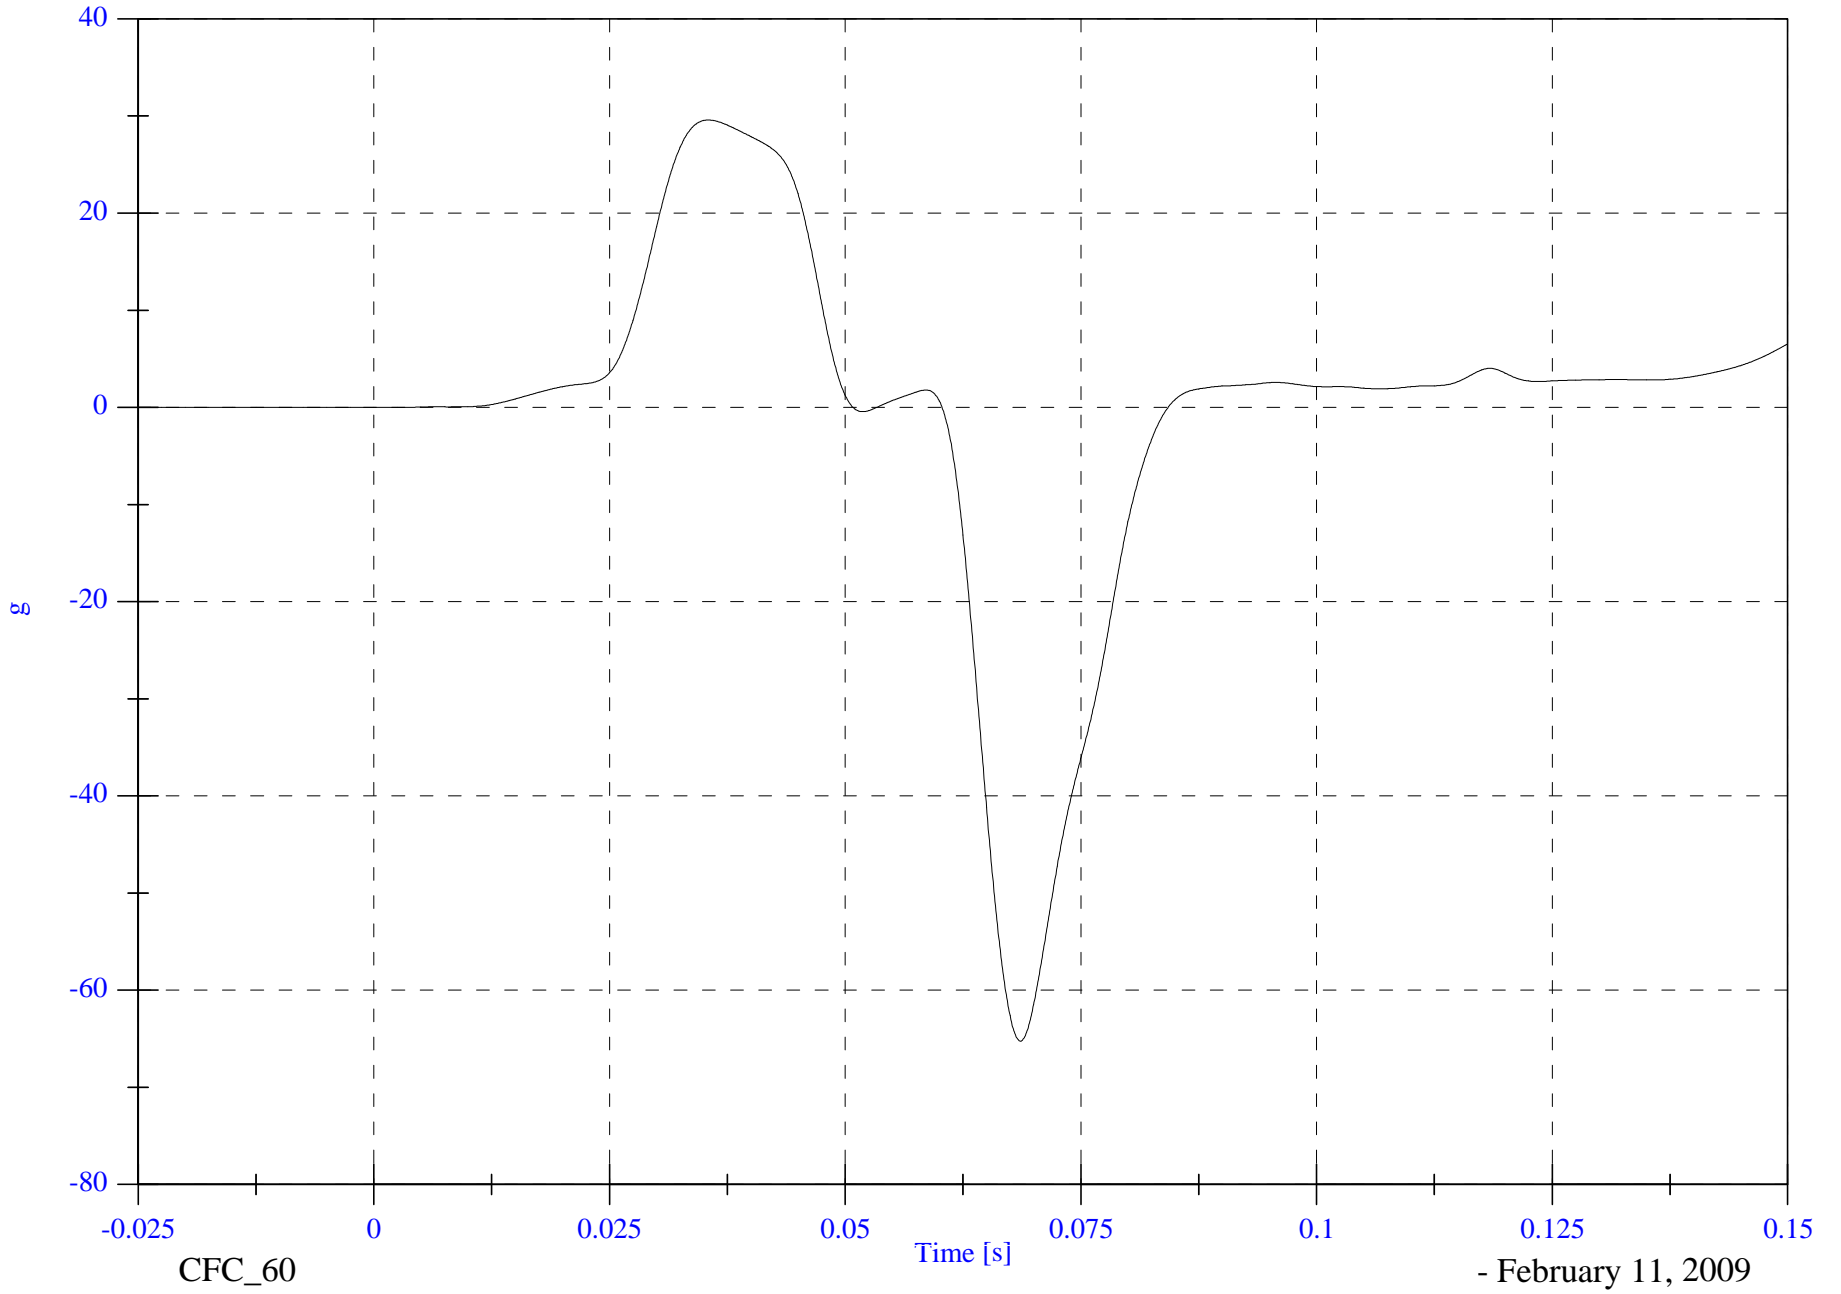
C95206 IP3 RIGHT AIRBAG COVER IMPACT PLOT #1

Max: 29.6 [g] at 0.035 [s]

Min: -65.2 [g] at 0.069 [s]

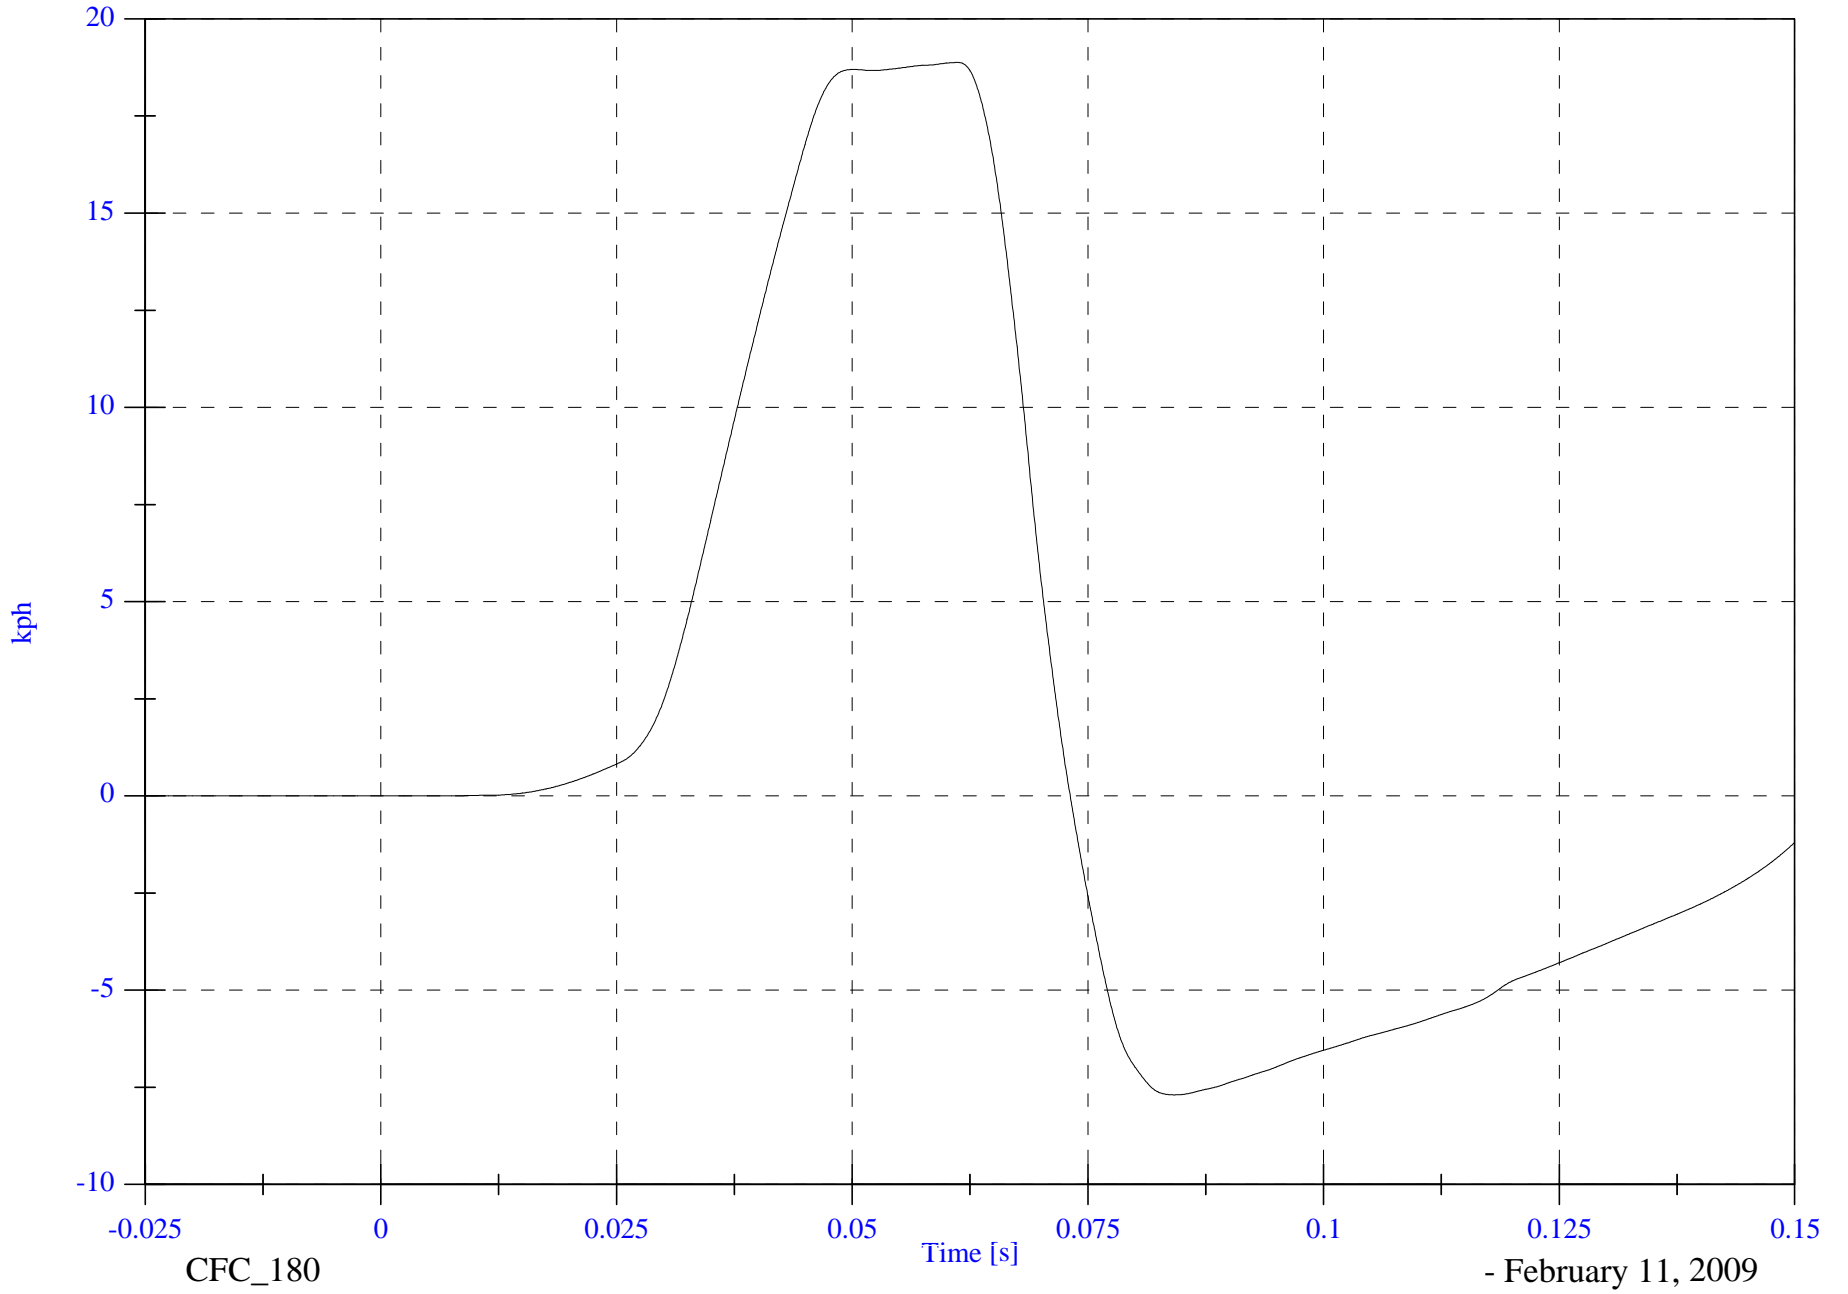
C95206 IP3 RIGHT AIRBAG COVER IMPACT PLOT #2

Max: 18.9 [kph] at 0.061 [s]

Min: -7.7 [kph] at 0.084 [s]
