REPORT NUMBER: 201-CAL-09-01

**SAFETY COMPLIANCE TESTING FOR FMVSS 201
OCCUPANT PROTECTION IN INTERIOR IMPACT**

**NISSAN MOTOR COMPANY, LTD.
2009 NISSAN SENTRA**

NHTSA NUMBER: C95206

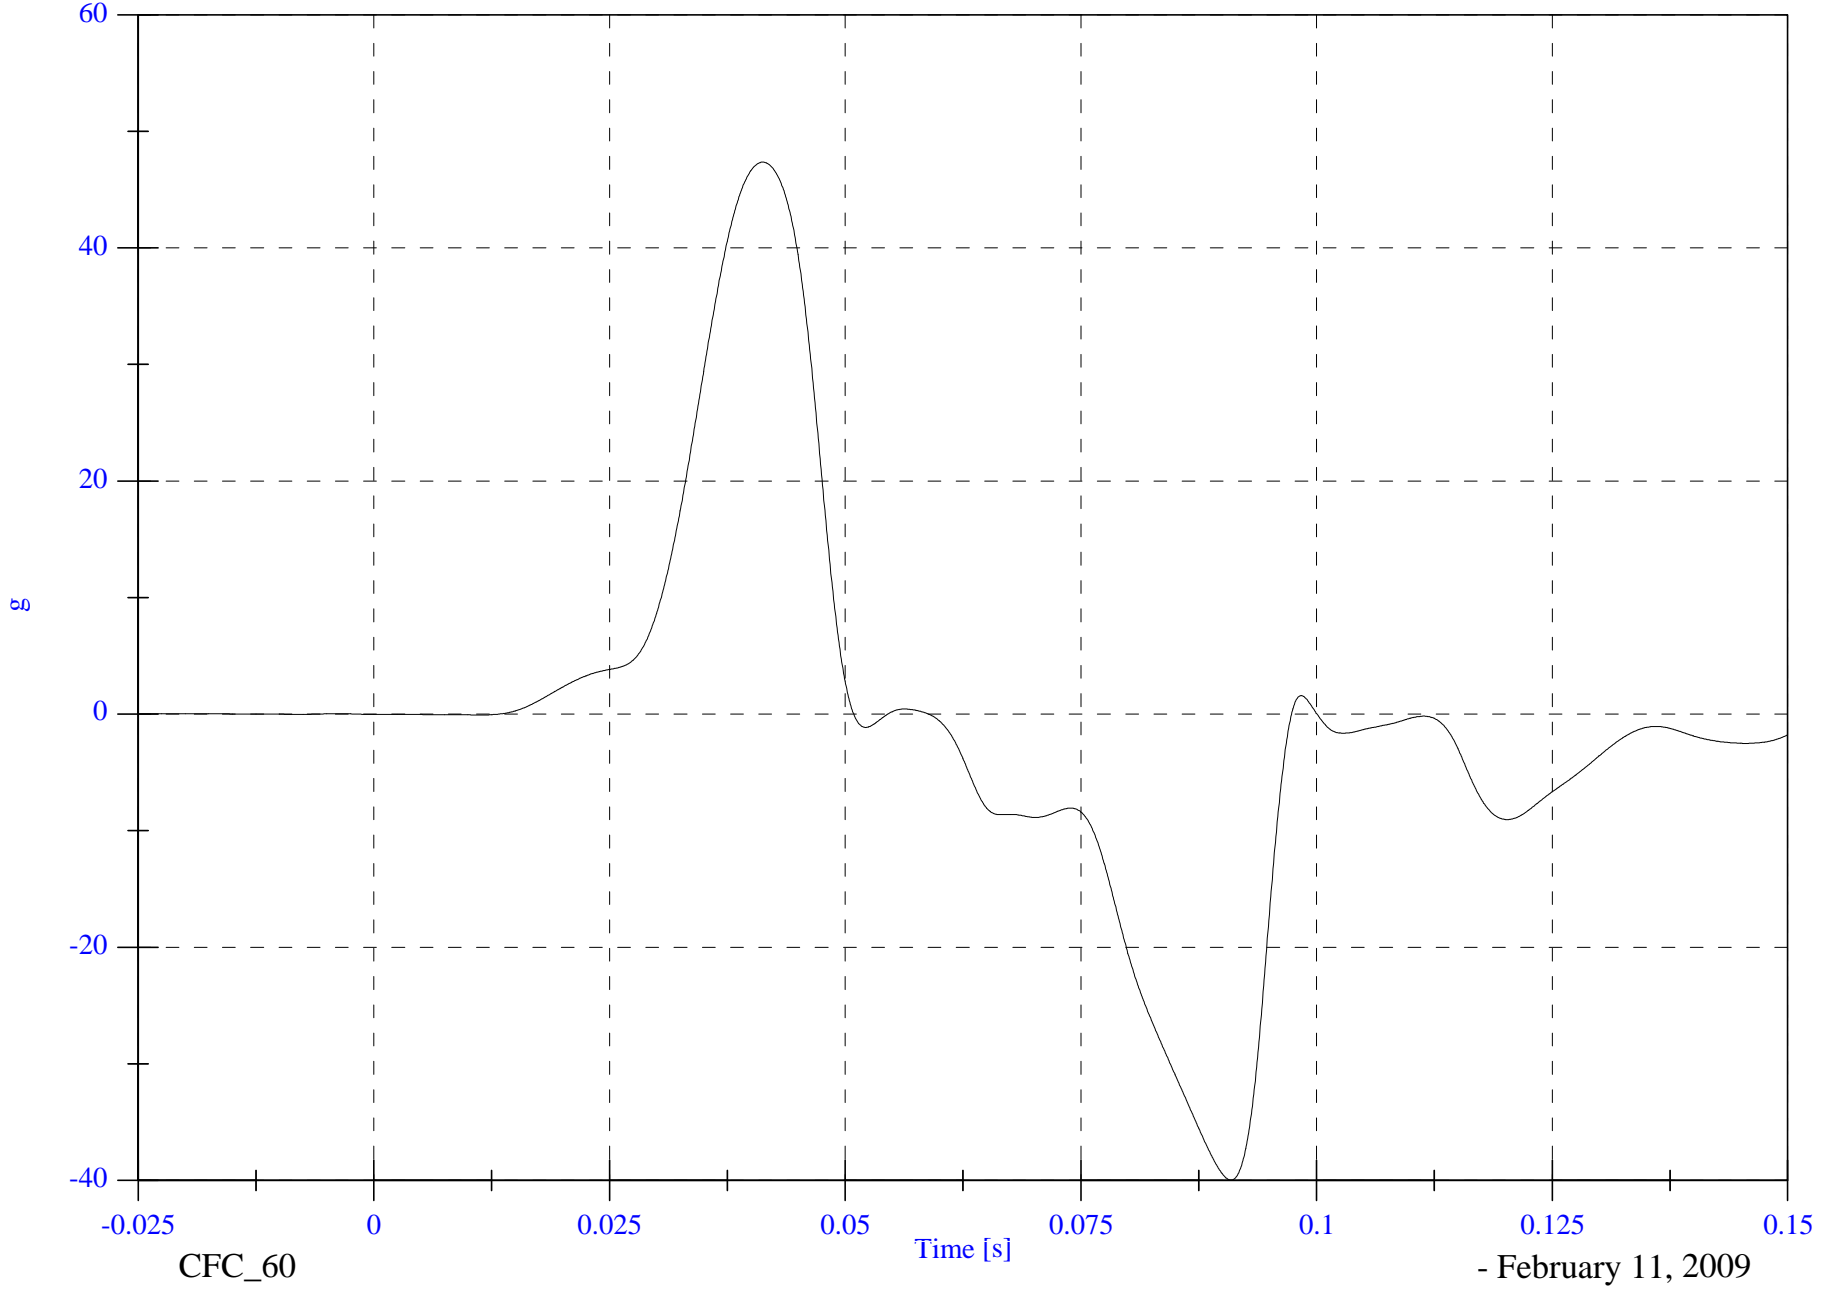
C95206 SEAT BACK HEAD RESTRAINT IMPACT PLOT #1

Max: 47.4 [g] at 0.041 [s]

Min: -40.0 [g] at 0.091 [s]

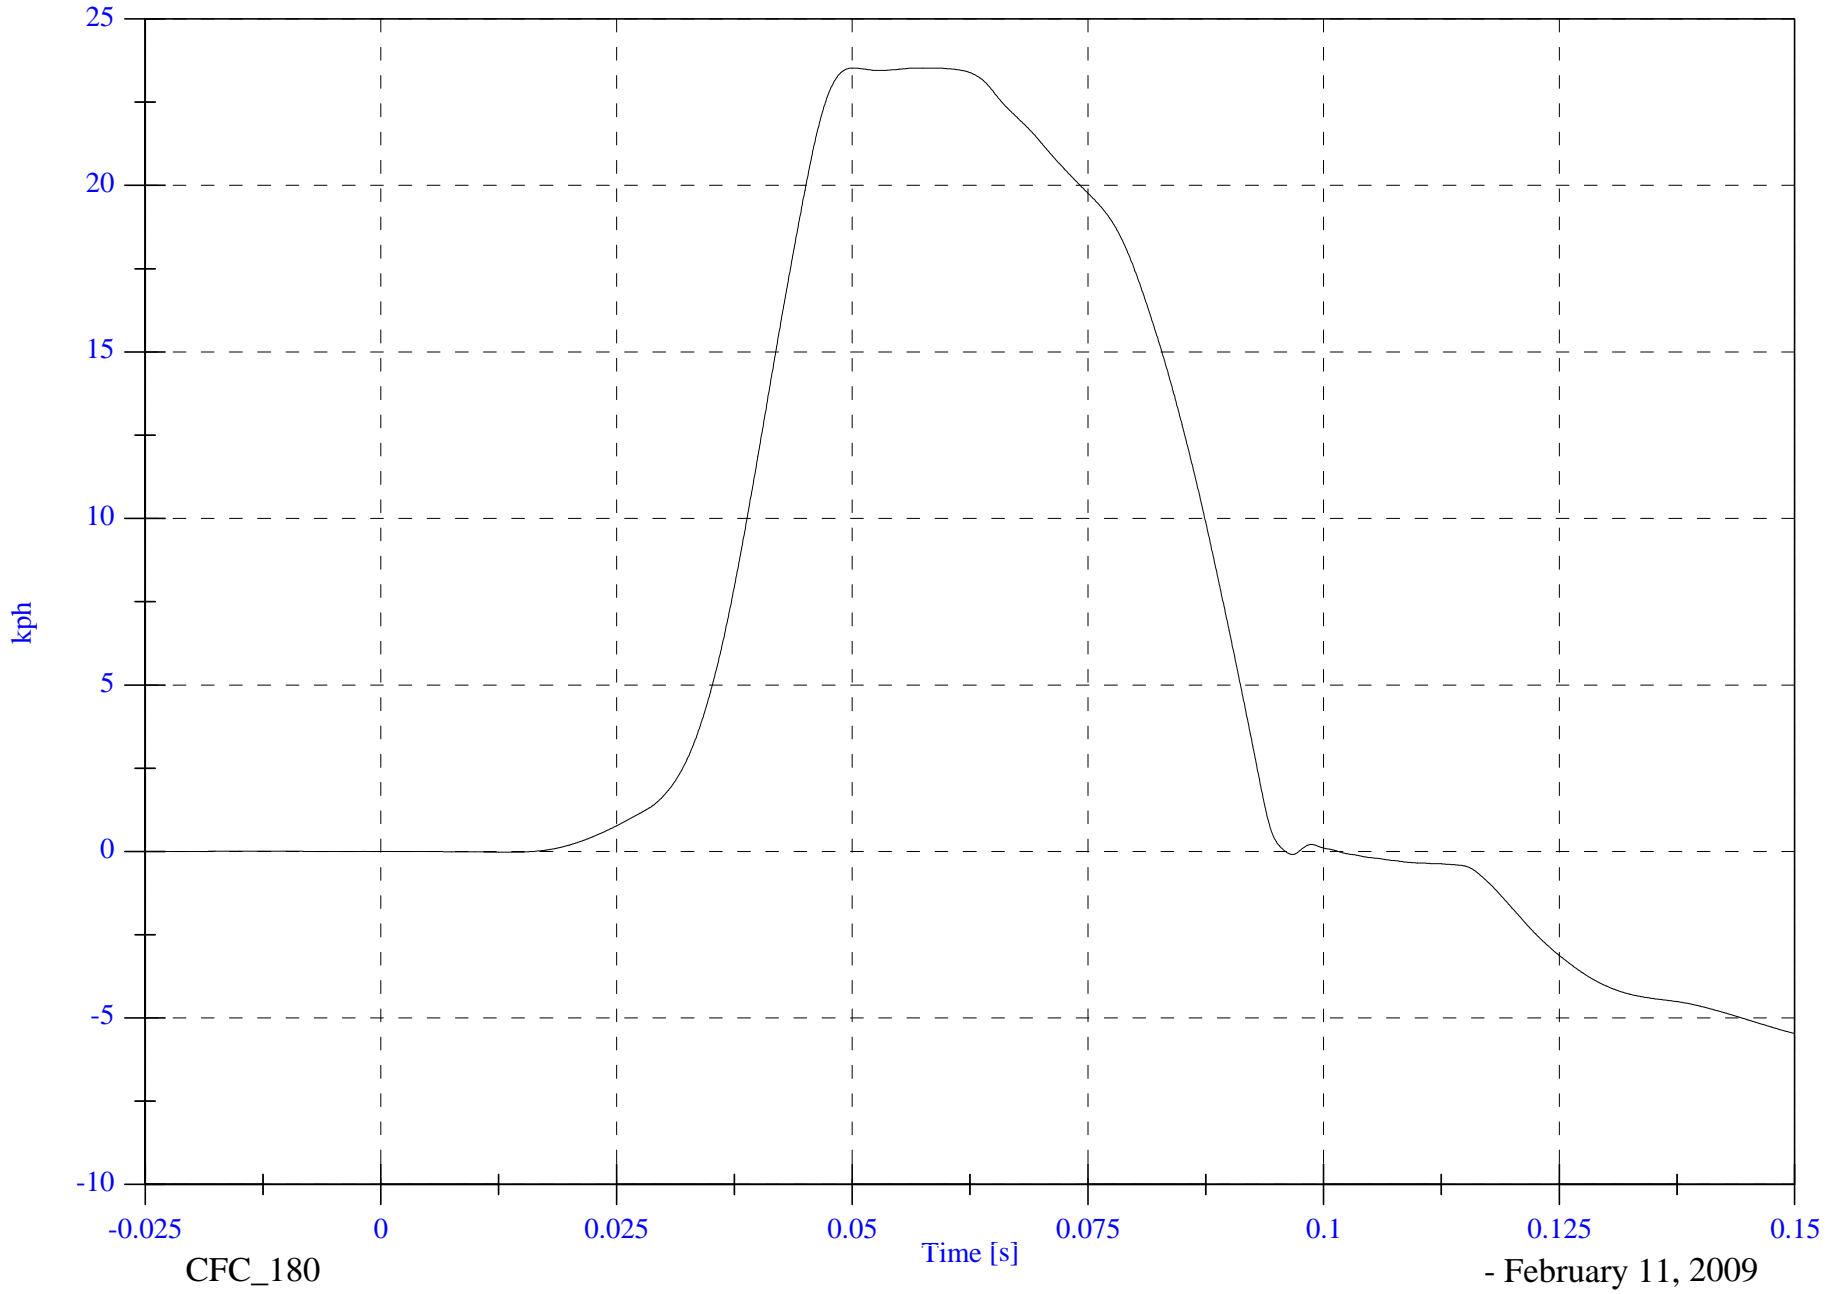
C952006 SEAT BACK HEAD RESTRAINT IMPACT PLOT #2

Max: 23.5 [kph] at 0.050 [s]

Min: -5.5 [kph] at 0.150 [s]
