DOT HS 812 549

Special Crash Investigations On-site Guardrail End Treatment Impact Investigation Vehicle: 1990 Ford Tempo Location: Missouri Crash Date: January 2017

14. Sponsoring Agency Code	
15. Supplementary Note An investigation of the X-Lite guardrail end treatment impact that resulted in injuries to the 53-year-old male driver of a 1990 Ford Tempo.

SPECIAL CRASH INVESTIGATIONS CASE NO.: CR17002
ON-SITE GUARDRAIL END TREATMENT IMPACT
INVESTIGATION VEHICLE: 1990 FORD TEMPO
LOCATION: MISSOURI
CRASH DATE: JANUARY 2017

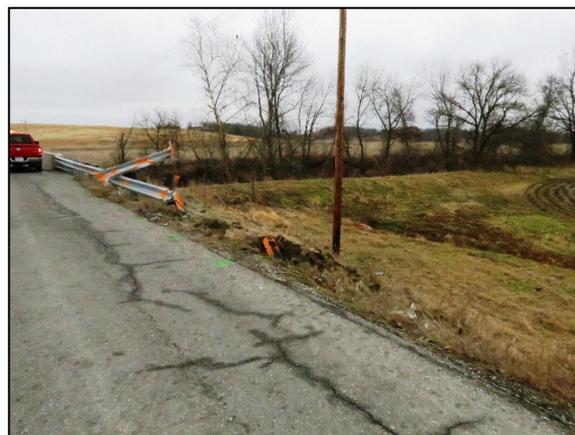
Figure 1: East-facing view of the crash site and damaged X-Lite guardrail system.

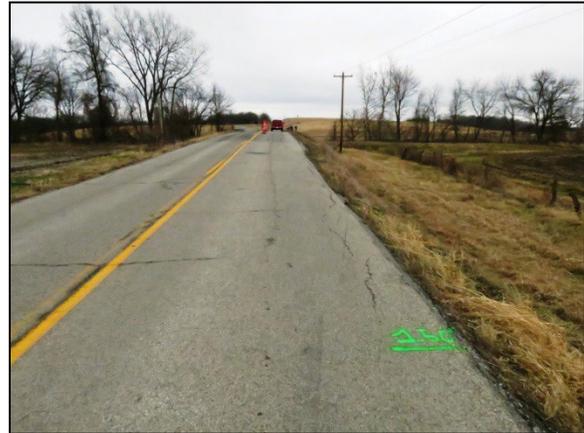
Figure 2: View of the Ford's eastbound pre-crash travel trajectory 45.7 m (150.0 ft) west of the point of impact.

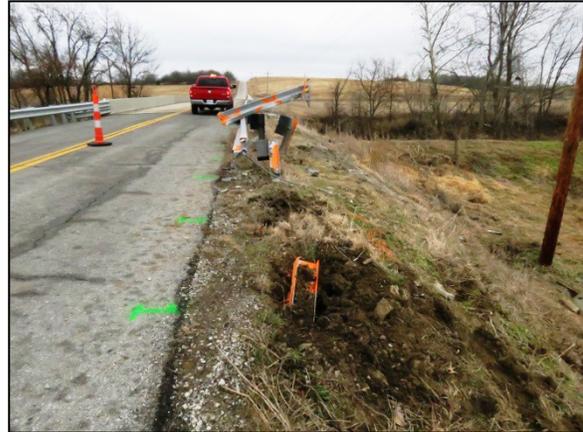
The first crash event occurred as the Ford's front plane struck the face of the X-Lite end treatment. Direct contact to the Ford's front plane was located to the left of the vehicle's centerline. As the vehicle engaged the end treatment, a counterclockwise rotation about the vehicle's vertical axis was induced. Crash forces began deforming the X-Lite end treatment as the first section was displaced downstream. The combination of the Ford's rotation and its off-center alignment and engagement with the end treatment deformed the end terminal in such a manner that the impact head of the X-Lite system deflected off the end of the second section of W-beam. This affected the ability of the system to perform as designed, and although crash forces continued to deform the end treatment, it did not collapse in a telescopic manner. **Figure 3** shows the damaged end treatment and roadside at the area of impact.

Figure 3: East-facing view of the damaged end treatment viewed from the area of initial impact.

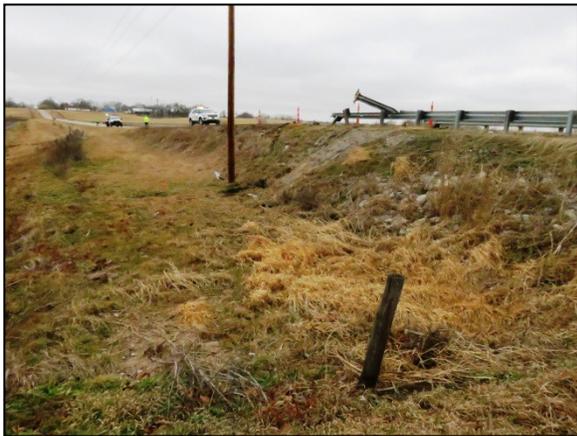
Figure 4: West-facing view of the crash site from beyond the Ford's final rest position in the roadside.

the base of the embankment. **Figure 4** shows the steep roadside and area of the Ford's final rest position, as well as the pre-crash approach of the Ford, in a west-facing view from beyond final rest.

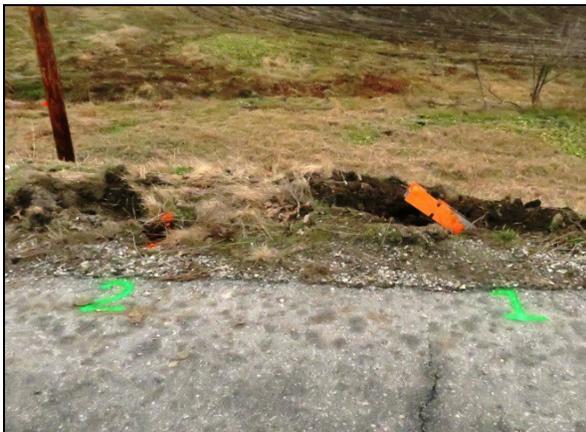
The SCI investigator inspected the damaged components and assessed the performance of the end terminal, impact head, and guardrail system. Data concerning the X-Lite system was documented on the FHWA Guardrail Forms, **Appendix A**, below. Post-1 was deformed 58 degrees to the east along the vehicle’s eastbound crash trajectory (**Figure 6**). Post-2 was deformed 25 degrees to the east and fully displaced from the ground, projected along the vehicle’s eastbound crash trajectory. The tension rods and spade remained attached to Post-2 (**Figure 7**), and the entire assembly was found at the base of the embankment. Post-3 was deformed 49 degrees to the east, and although the composite blockout remained attached, it was fractured. Post-4 was deformed approximately 20 degrees toward the south, evidentiary of engagement with the Ford as it maintained its crash trajectory through the roadside. Post-4’s blockout remained in place and was undamaged. No damage was noted to Post-5 or any of the remaining posts in the system.

Figure 6: South-facing lateral view of the damaged end treatment and the locations of Post-1 and Post-2.

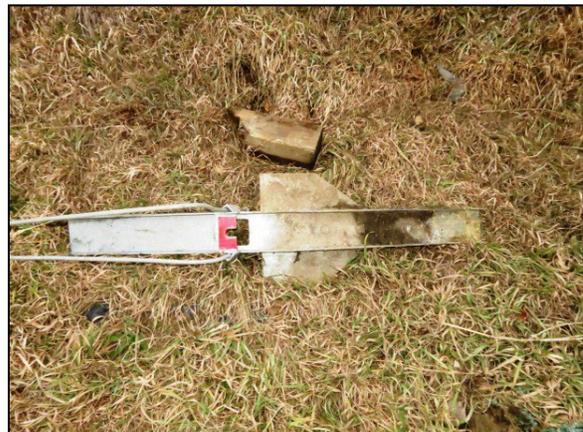
Figure 7: View of Post-2 at roadside, completely displaced from its original location.

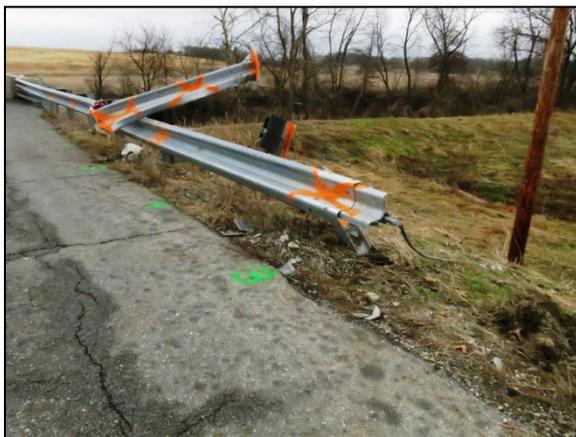
The combination of the offset impact and the lateral component of the vehicle's counterclockwise rotation in this crash resulted in misalignment of the impact head with Panel-2 as the system was deformed. Instead of engaging Panel-2, the impact head deflected up and over Panel-2 and deformed toward the field side by the rotating vehicle. No damage to Panel-2 or Panel-3 of the system was visible. As the vehicle continued eastward and maintained counterclockwise rotation, it deformed Post-3 and Post-4 as it rotated and initiated the right side-leading rollover. The impact head, still engaged with the Ford's front plane, bent nearly 90 degrees as the vehicle reached approximately 80 degrees of counterclockwise rotation and began the rollover. **Figure 8** shows an oblique view of the damaged end treatment and the exposed end of Panel-2, while **Figure 9** shows a lateral view of the displaced and deformed Panel-1.

Figure 8: Overall view of the deformed X-Lite system at the time of the SCI inspection.

representative used orange marking spray paint to highlight the damaged portion of the guardrail identified for replacement. A post-impact guardrail diagram showing the deformed system is included on **Page 14**.

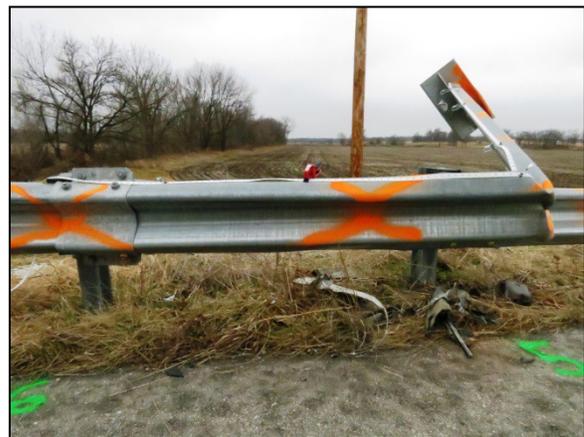
Panel-1 was displaced downstream 6.2 m (20.3 ft), measured in reference to the pre-crash location of the slider assembly at Post-3 and the post-crash location of the slider assembly engaged against the blockout of Post-6. An approximate 90-degree bend was located immediately downstream of Panel-1's center aspect, 2.1 m (7.0 ft) downstream of the impact head.

Figure 9: Lateral view of the displaced and deformed Panel-1 of the X-Lite guardrail end treatment system.

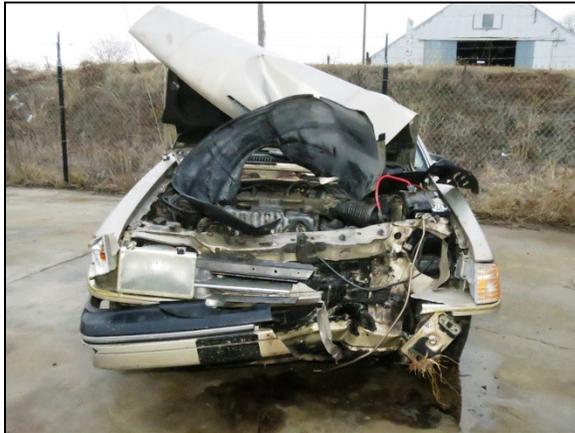
Figure 11: Front plane damage pattern to the 1990 Ford Tempo.

The direct contact damage began 9 cm (3.5 in) right of center and extended 53 cm (20.9 in) left to 44 cm (17.3 in) left of center (**Figure 11**). The left edge of the direct contact was 19 cm (7.5 in) right of the left front bumper corner. A direct and induced damage length (Field-L) of 126 cm (49.6 in) across the entire front end width of the Ford was used to document a residual crush profile. Measurements were documented by the SCI investigator using a Nikon Nivo 5.M+ total station at the original height of the front bumper, and were adjusted to account for free-space. This profile produced the following measurements: C1 = 7 cm (2.8 in), C2 = 29 cm (11.4 in), C3 = 35 cm (13.8 in), C4 = 2 cm (0.8 in), C5 and C6 = 0 cm (0 in). Maximum crush was located just to the left of the vehicle's centerline (**Figure 12**). The Collision Deformation Classification (CDC) assigned to the Ford for the X-Lite end treatment impact damage was 12FYEW2.

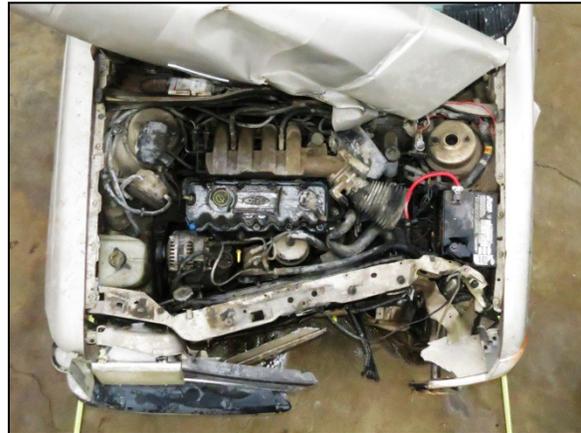
Damage associative to the multiple event crash was located on the Ford's front, right, and left planes. A distinct area of direct contact from impact with the X-Lite end terminal's impact face (Event 1) was located on the left aspect of the Ford's front plane. Within the damage pattern was longitudinal deformation to front plane components, including the hood, upper radiator support, lower radiator support, and surrounding body structure. The front bumper beam was constructed

of a polymer, and had fractured completely from the impact. The front bumper fascia and grille were also fractured, and the fractured portions of these components had separated from the Ford's front plane. Despite the loss of portions of these components, accurate documentation of the deformation and crush was made possible with reference to the lower radiator support and surrounding body structure.

Figure 12: Deformation to the 1990 Ford Tempo's front plane from an overhead perspective.

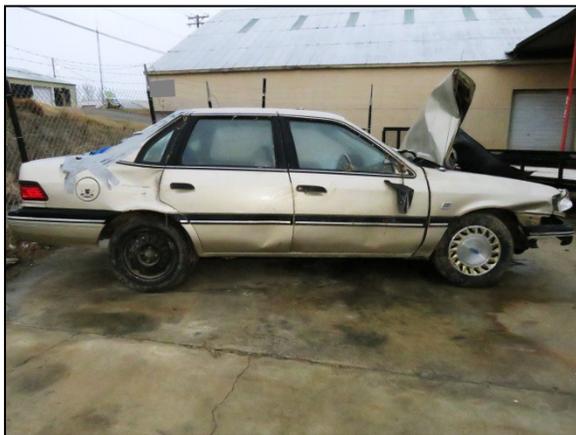
The rollover (Event 2) began as an uninterrupted right side-leading fall-over event. Damage included minor surface scratching and abrasions, with minor deformation to the side body paneling. The right side mirror was fractured from its mount and hung loosely from the side of the vehicle. All right side glazing remained intact, and all four doors were operational. Grass and soil were loosely embedded into the seams surrounding the body panels and doors of the right plane. There was no measurable residual deformation associated with the right side-leading roll.

Figure 13: Right plane damage to the Ford.

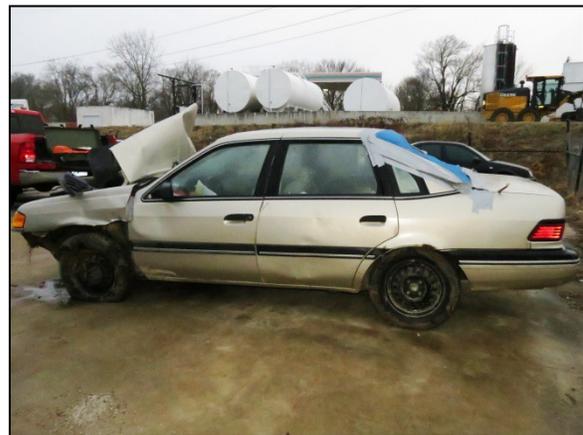
Figure 14: Left plane damage to the Ford.

There was also minimal damage visible to the Ford’s left plane relative to the final two quarter-turns of the rollover. As previously described, the dynamics of the Ford’s roll and its direction was reversed as the vehicle slid down the embankment. This caused the Ford to roll to the left, from its right plane back onto its wheels and then onto its left plane. These dynamics were evidenced by the displacement of numerous loose objects in the Ford’s interior against the interior aspect of the left side doors as observed at the time of the SCI inspection. Minor surface scratches, minor deformation to body components, and soil/vegetation in the body panel seams evidenced the vehicle’s bi-directional rollover sequence. All left plane glazing remained intact and undamaged, with both left side doors closed and operational. There was no measurable residual deformation associated with the left-directional roll. Due to the nature of the rollover dynamics and the direction of initial roll, the CDC assigned to the Ford 00RDAO2. No WinSMASH calculations could be performed for the rollover Event, because the non-horizontal nature of the forces was beyond the scope of the program’s capabilities.

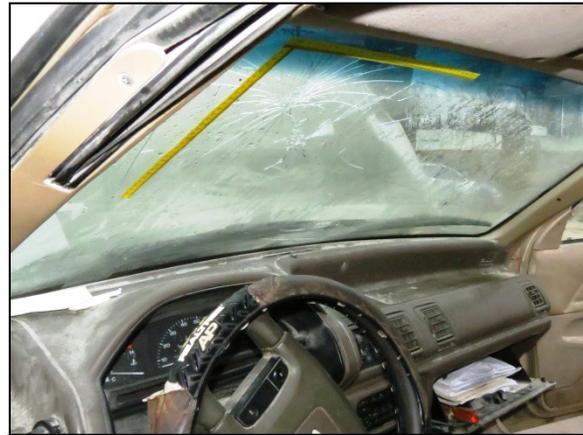
Other damage to the windshield included a circular area of fracture, located directly above the steering column. It was apparent that this fracture was resultant from contact by the driver's head during the crash sequence. **Figure 15** shows the fracture pattern to the windshield of the Ford. It likely occurred as the driver was displaced forward during the initial contact and engagement with the X-Lite end treatment during the first impact event. Other occupant contact included an area of scuffing to the left lower instrument panel/knee bolster, which also likely occurred in conjunction with the windshield fracture during Event 1. No further crash related damage or occupant contact in the Ford was discernable at the time of the SCI vehicle inspection.

Figure 15: Interior view of the Ford showing driver contact to the windshield.

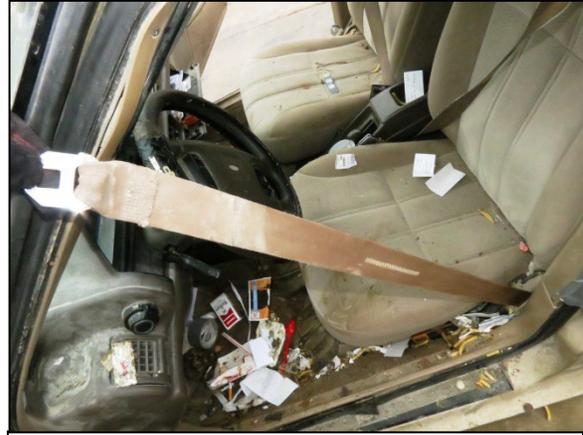
At the time of the SCI inspection, inoperability of the vehicle’s electrical system prevented operation of the automatic shoulder portion of the driver’s seat belt. It was locked in the B-pillar position, evidentiary that it was automatically in use at the time of the crash. The webbing itself was discolored, dirty, and worn, with various stains that evidenced its age. The lap belt portion of the system was found fully retracted into the retractor that was mounted on the left aspect of the driver’s seat. The SCI investigator pulled the lap webbing from the retractor, exposing a distinct area of dirt and wear near the latch plate with clean webbing extending into the retractor

Figure 16: Driver’s seat belt in the Ford at the time of the SCI vehicle inspection.

(**Figure 16**). Based on this condition and the lack of loading evidence, it was apparent that the manual lap portion of the driver’s seat belt was not in use at the time of the crash. Therefore, the SCI investigator categorized the driver as partially restrained: the automatic passive shoulder portion of the system restrained the driver, but he did not use the manual lap belt portion.
