DOT HS 812 552

**Special Crash Investigations  
On-Site Air Bag  
Non-Deployment  
Crash Investigation  
Vehicle: 2006 Toyota Scion tC  
Location: Florida  
Crash Date: May 2017**

**SPECIAL CRASH INVESTIGATIONS**  
**CASE NO: CR17015**  
**OFFICE OF DEFECTS INVESTIGATION**  
**ON-SITE ALLEGED AIR BAG NON-DEPLOYMENT CRASH INVESTIGATION**  
**VEHICLE: 2006 TOYOTA SCION tC**  
**LOCATION: FLORIDA**  
**CRASH DATE: MAY 2017**

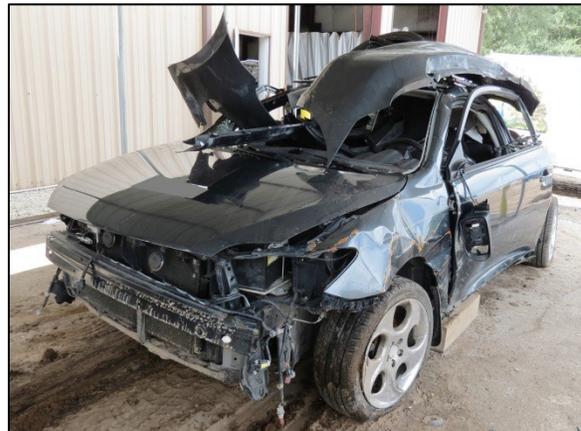
**Figure 1:** Front left oblique view of the 2006 Toyota Scion tC at the time of the SCI inspection.

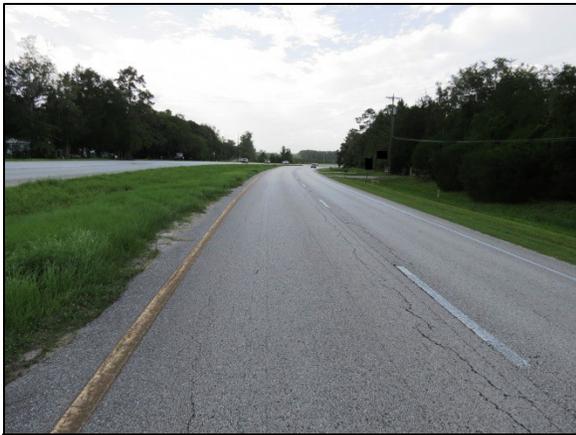
**Figure 2:** Northbound trajectory view of the Scion in the area of the crash.

lanes. For the Scion's northbound trajectory (**Figure 2**), the left lane was 3.5 m (11.5 ft) wide and the right lane was 3.8 m (12.5 ft) wide. A 1.6 m (5.2 ft) wide shoulder supported the outboard (right) travel lane, while a 0.4 m (1.2 ft) wide shoulder bordered the travel lanes on the median side. The median itself was a depressed grass swale that measured approximately 7.5 m (24.6 ft) wide and was 46 cm (18 in) deep on average. The travel lanes were delineated by a single dashed-white dividing line, single solid-yellow median line, and a single solid-white fog line. Speed was regulated by a posted limit of 97 km/h (60 mph).

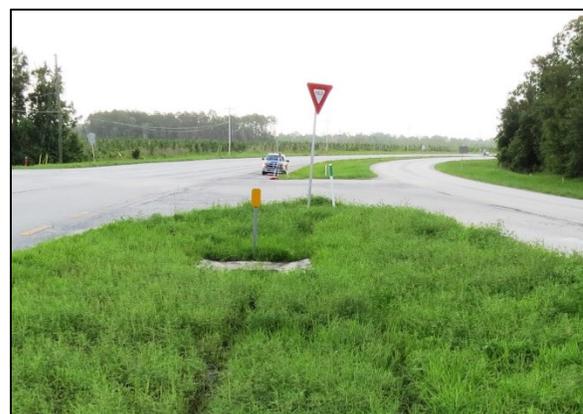
The Scion maintained a northbound trajectory through the median on approach to the intersection crossover as it began to yaw counterclockwise. The second and third crash events occurred in close proximity as the left front corner aspect of the Scion lightly struck the non-breakaway post of the yield sign (Event #2) and the non-breakaway polymer delineator post (Event #3). These impacts were of insufficient magnitude to affect or otherwise alter the Scion's trajectory. **Figure 3** depicts the Scion's tire marks and the impacted objects at the time of the SCI crash site inspection.

**Figure 3:** Location of the Scion's first, second, and third crash events along its errant northbound trajectory.

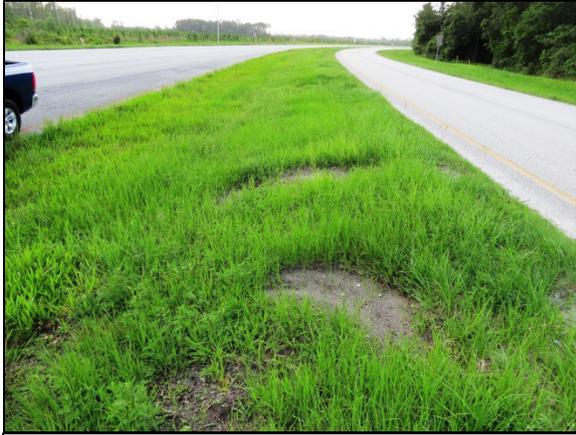
**Figure 4:** North-facing view of gouge marks within the median that evidenced the Scion's rollover trajectory.

An abrupt instability was created as the Scion's right side tires transitioned from the asphalt intersection crossover and furrowed into the soft soil/vegetation surface on the edge of the roadway. This tripped the vehicle into a rapid right side-leading rollover sequence. The Scion rolled an uninterrupted minimum of 16 quarter-turns through the median and into the southbound portion of the roadway. Gouge marks in the median (**Figure 4**) evidenced the Scion's rolling trajectory. The vehicle ultimately came to final rest facing west and on its wheels within the center of the southbound lanes, approximately 60 m (197 ft) north of the initial trip point.

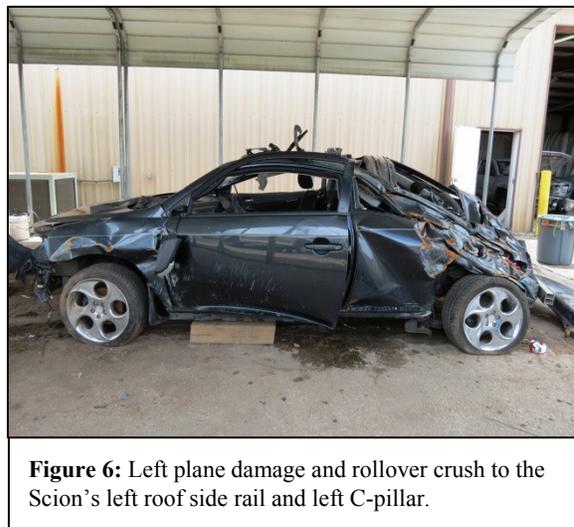
The left front fender displayed slight lateral crush, with at least two patterns of overlapping abrasions. Evidence indicated that the left front door remained closed during the crash sequence, but was forced open by the emergency response personnel to facilitate medical removal of the driver. The side mirror was fractured from its stalk and hung by its wires, but the exterior surface of the left door was largely unscathed. A pattern of abrasions was visible on its concave surface, with two distinct patterns of overlapping abrasions visible at sill level. The top of the left door frame was deflected inward. Along the left roof side rail, the SCI investigator distinguished at least three distinct patterns of abrasions. There was corresponding vertical and lateral crush to the side rail and left pillars. Severe vertical and lateral crush was apparent to the left quarter panel/fender and left C-pillar (**Figure 6**).

**Figure 6:** Left plane damage and rollover crush to the Scion's left roof side rail and left C-pillar.

Maximum vertical magnitude of the rollover crush measured 35 cm (13.8 in), located at the left C-pillar/left rear quarter panel area above the left rear axle position. This was also the location of the maximum lateral deformation, which measured 25 cm (9.8 in) in magnitude. Based on the SCI reconstruction of the crash, the Scion completed a minimum of 16 quarter-turns, uninterrupted, during the rollover sequence. The total distance of the rollover measured approximately 60 m (197 ft). The CDC assigned to the Scion for the damage associated with the rollover was 00TDDO5. No delta-V calculations could be performed for any of the impacts because their dynamics were beyond the scope of the WinSMASH program.

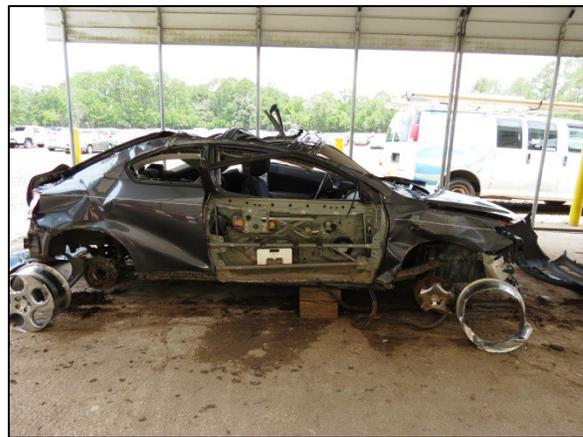
On the right plane of the Scion, both right side wheels were fractured and the tires were missing. The rear quarter panel was slightly buckled, with minor surface scratches/abrasions. The exterior panel was missing from the right door, and the upper aspect of the door frame was bent outward from the vehicle (**Figure 7**). The right side mirror was fractured from its mount and separated from the vehicle. At least four distinct patterns of abrasions were visible along the right roof side rail, with minor vertical and lateral deformation. Minor deformation was also observed to the right front fender.

**Figure 7:** Right plane damage to the Scion.

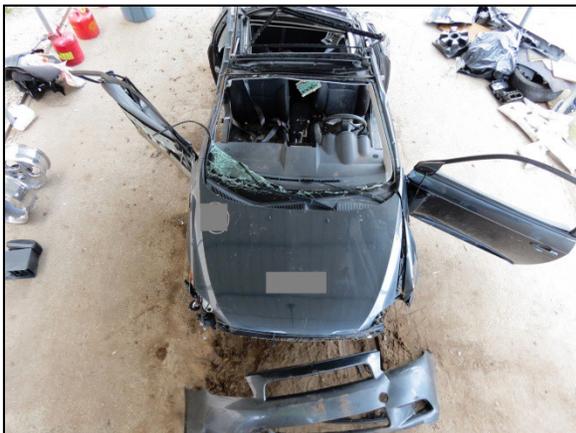
Top plane damage to the Scion consisted of vertical deflection of the windshield header and center roof support. The sunroof glazing frames were deformed and partially separated from the vehicle. Vertical rollover crush was apparent to the backlight header and left rear aspect of the roof. There was no significant damage to the top surface of the hood. **Figures 8 and 9** depict the rollover damage to the Scion from an overhead perspective.

**Figure 8:** Front overhead view of the Scion from a front perspective.

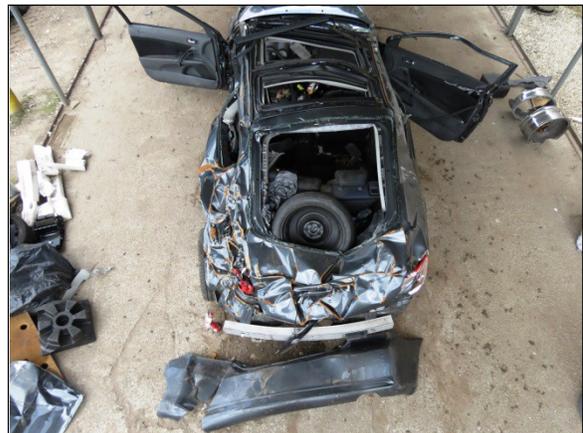
**Figure 9:** Rear view of the Scion's top plane and visible rollover damage from a rear perspective.

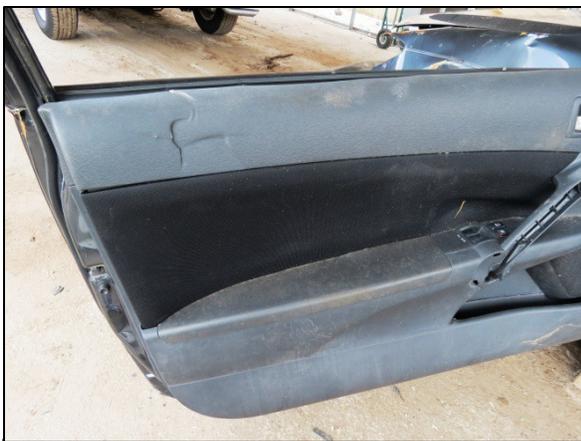
**Figure 10:** Driver loading to the Scion’s left front door.

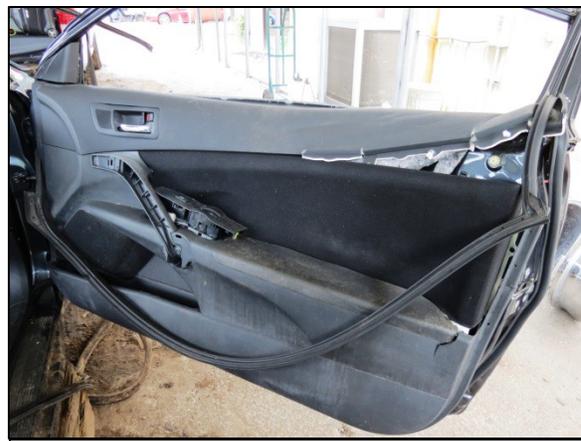
**Figure 11:** Front right occupant loading to the right door.

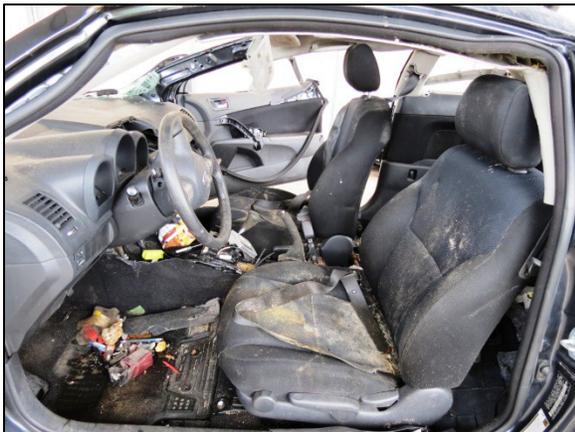
Despite the significant intrusions at the second row, occupant compartment space for the front row positions was largely unaffected by the intrusions (**Figure 12**). However, the seatback of the second row left position was deformed as the left rear roof and C-pillar structure engaged the seatback (**Figure 13**).

**Figure 12:** Crossing view of the Scion's front row at the time of the SCI vehicle inspection.

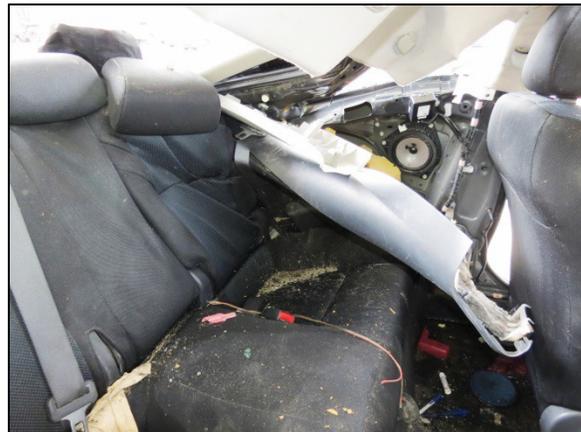
**Figure 13:** Deformed seat at the second row left position of the Scion.

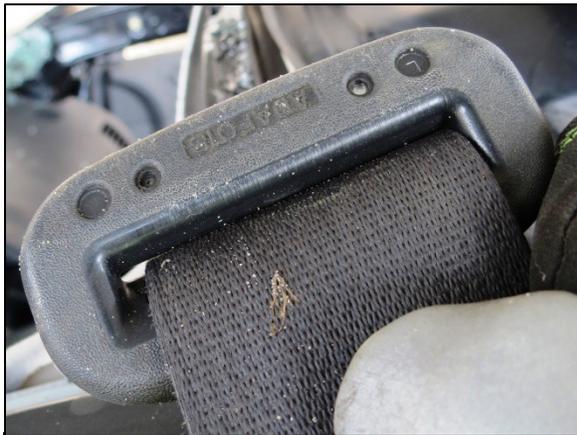
At the time of the SCI vehicle inspection, the driver's seat belt system was cut in two locations that created three separate sections. The first section remained attached to the lower anchor and measured 43 cm (16.9 in) in length. There was no visible loading evidence on the webbing of the lower anchor section. A free-floating section created by the two cut locations measured 123 cm (48.4 in) long. It contained the sliding latch plate, which had loading evidence from the webbing visible within the belt path (Figure 14). The free-floating section of the webbing was covered in dust, mold, and dirt residue, which prevented the SCI investigator from discerning specific loading patterns on the webbing (Figure 15).

**Figure 14:** Loading evidence within the belt path of the driver's latch plate in the Scion.

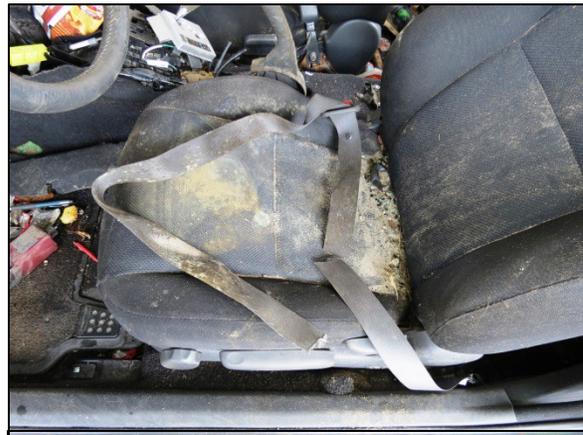
**Figure 15:** View of the cut driver's seat belt system within the Scion at the time of the SCI inspection.

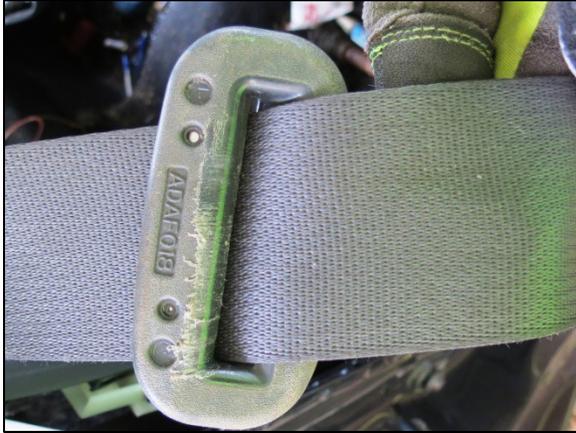
**Figure 16:** Heavy loading evidence in the belt path of the front right passenger's seat belt system within the Scion.

the B-pillar. The webbing was clean, and it spooled freely from and loosely retracted into the ELR/ALR retractor. A nearly 85 cm (33.5 in) length of the webbing was waffled ("cupped") from occupant loading, beginning 100 cm (39.4 in) above the lower anchor. There was corresponding heavy loading evidence visible within the belt path of the front right passenger's latch plate (**Figure 16**). Based on the post-crash condition of the front passenger's seat belt system at the time of the SCI inspection, it was apparent that the front row right occupant was belted at the time of the crash. This conclusion was supported by the EDR data imaged from the Scion.

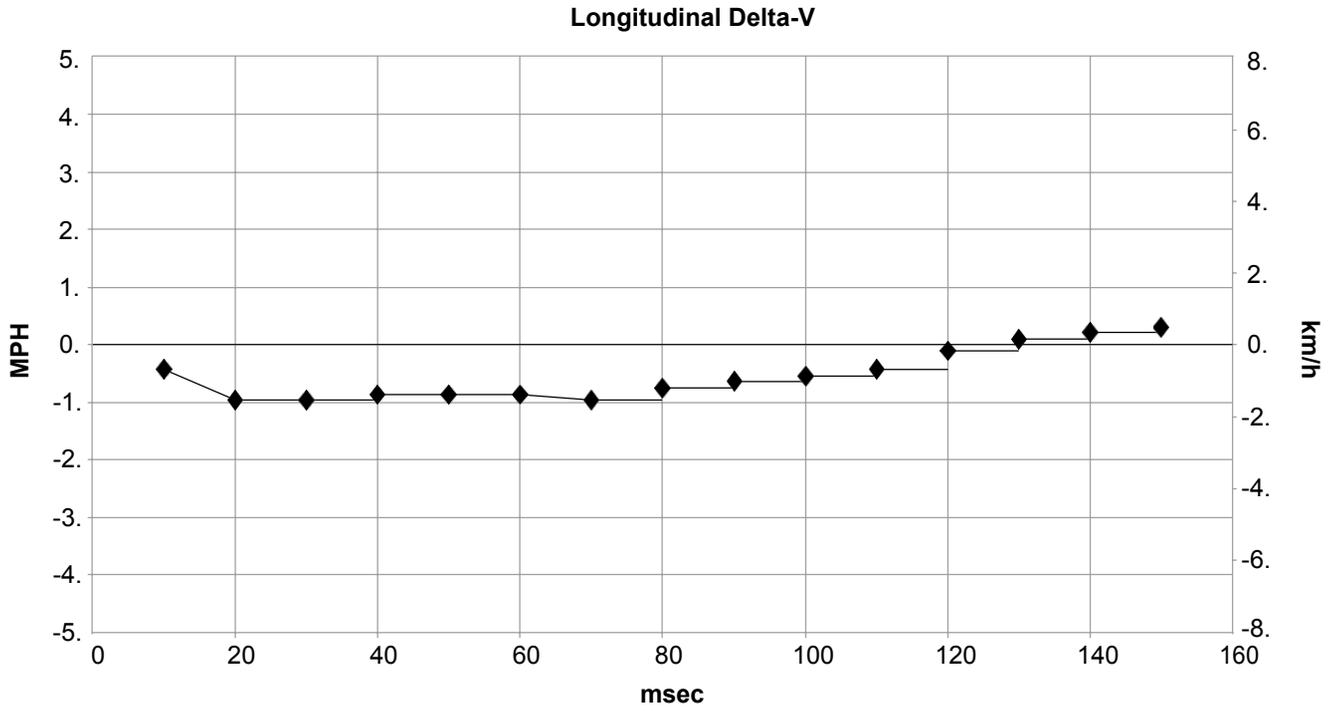
**Longitudinal Crash Pulse (Most Recent Frontal/Rear Event, TRG 13 - table 8 of 2)**

Max Longitudinal Delta-V (MPH [km/h])	-1.0 [-1.6]
---------------------------------------	-------------

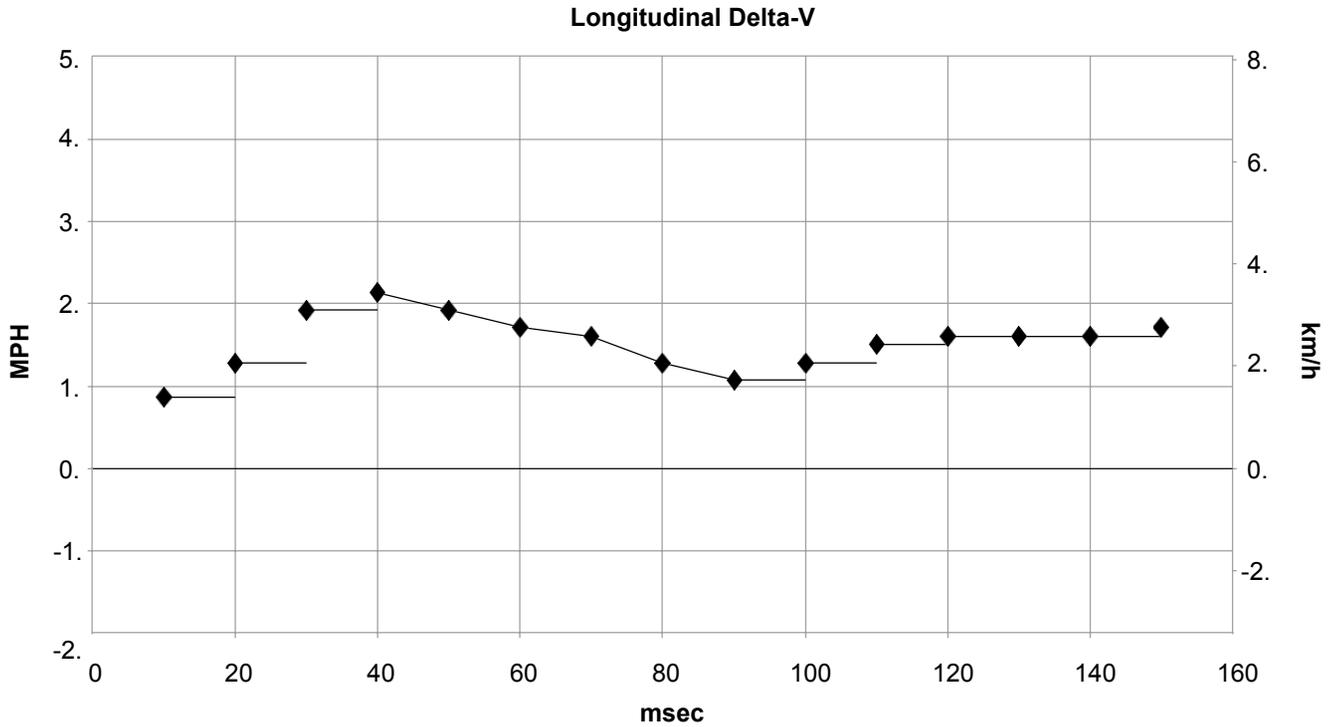
### Longitudinal Crash Pulse (1st Prior Frontal/Rear Event, TRG 12 - table 11 of

2.1 [3.4]

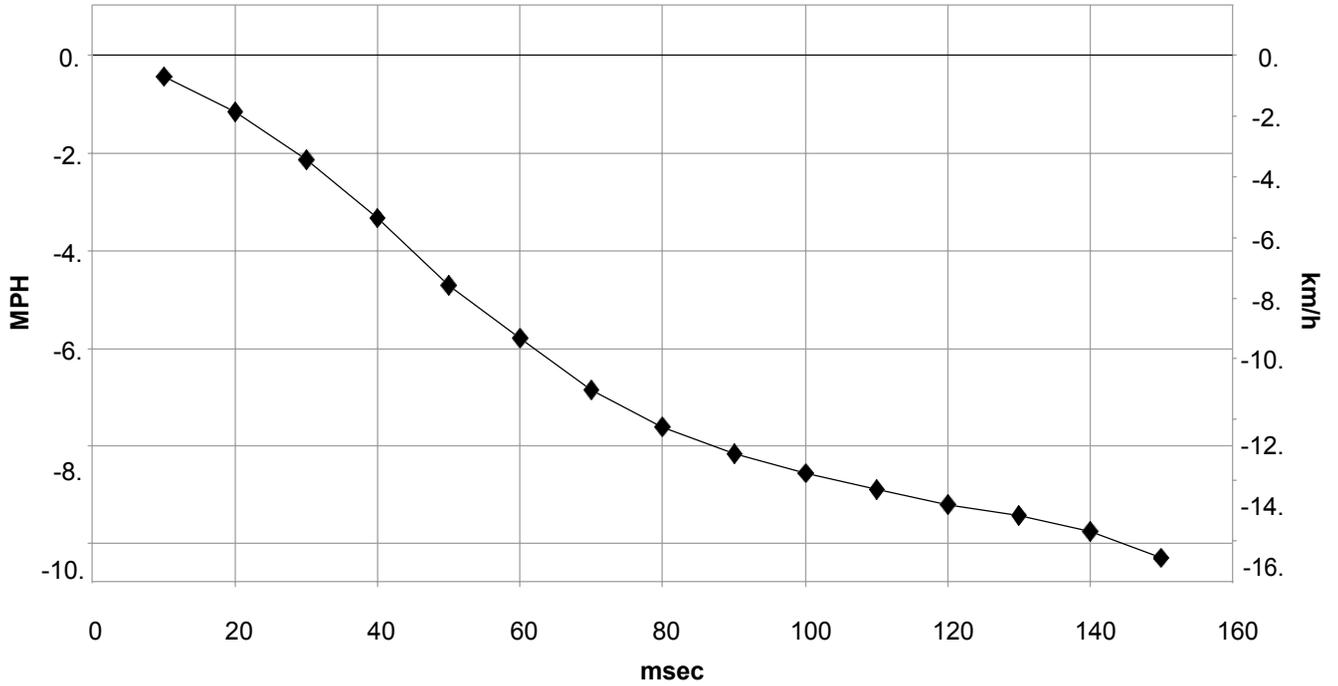
**Longitudinal Crash Pulse (Prior Frontal/Rear Event, TRG 9 - table 14 of**

The SCI investigator concluded that trigger counter number 9 most likely corresponded to SCI Event 1 of the crash (impact with the concrete drainage basin). It is likely that many, if not all, of the overwritten event triggers (1 to 7) were artifacts related to the undulation of the vehicle during its extended off-road pre-crash trajectory through the median. The SCI investigator further concluded that triggers 12 and 13, the “Most Recent” and “1st Prior” events, probably were ground contact during the multiple quarter-turn rollover event.

-10.3 [-16.5]
