DOT HS 812 609

**Special Crash Investigation
On-Site SKT Guardrail End
Terminal Crash Investigation
Vehicle: 1991 GMC Sonoma
Location: Missouri
Crash Date: April 2016**

SPECIAL CRASH INVESTIGATIONS
CASE NO.: CR16012
ON-SITE SKT GUARDRAIL END TERMINAL CRASH INVESTIGATION
LOCATION: MISSOURI
VEHICLE: 1991 GMC SONOMA
CRASH DATE: APRIL 2016

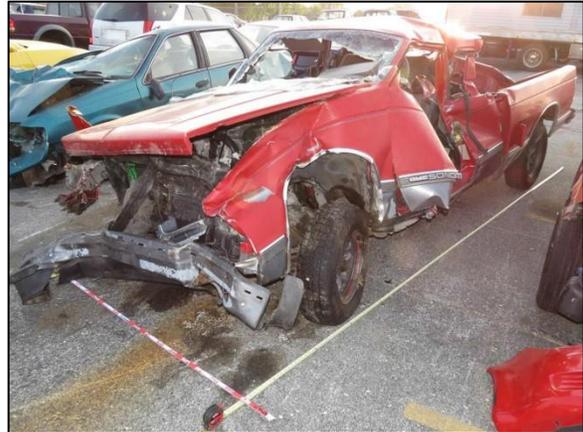
This report documents the investigation of a crash of a 1991 GMC Sonoma into an SKT guardrail end terminal (**Figure 1**). The GMC was occupied at the time of the crash by a 48-year-old belted male driver and an unbelted 48-year-old female seated in the front row right position. While the GMC traveled east on a limited-access roadway, it drifted right from its travel lane. The GMC's front plane struck the SKT impact terminal, which displaced the impact head and deformed the guardrail system. During the impact engagement, the GMC rotated clockwise and rolled one quarter-turn left-side-leading into the guardrail system. Post-crash, the driver and front row right occupant were assisted from the vehicle by emergency personnel. They were then transported by ambulances to the local hospital for police-reported incapacitating (A-level) and non-incapacitating (B-level) injuries, respectively. The crash was identified by an engineer with the Missouri Department of Transportation (MoDOT), which in turn submitted notification to the Federal Highway Administration (FHWA). The FHWA determined that the crash type and guardrail end treatment met the criteria for further research and subsequently forwarded notification to the Crash Investigation Division (CID) of the National Highway Traffic Safety Administration in April 2016. The CID assigned an on-site investigation of the crash to the Special Crash Investigations (SCI) team at Crash Research & Analysis, Inc., on the same day. The SCI team initiated contact and achieved cooperation with MoDOT to conduct an on-site investigation.

Figure 1: Left front oblique view depicting the deformation of the 1991 GMC Sonoma.

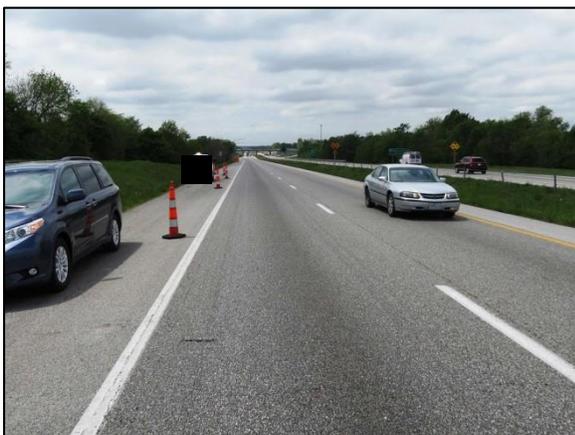
Figure 2: Westward lookback view of the GMC.

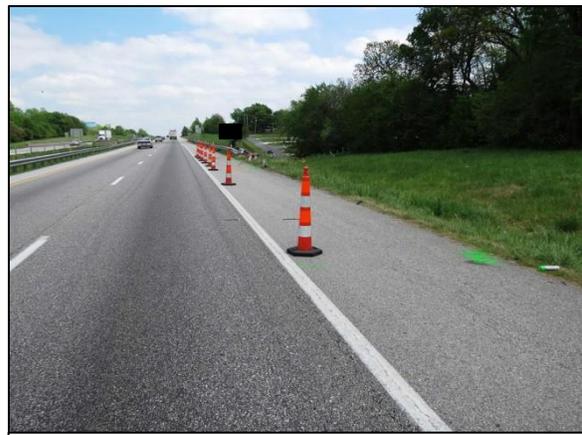
Figure 3: Eastward trajectory view of the GMC approaching the crash site.

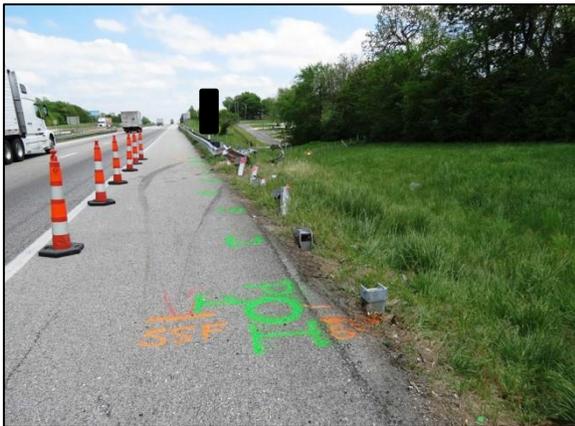
Figure 4: Trajectory view of the GMC at the point of impact with the end terminal.

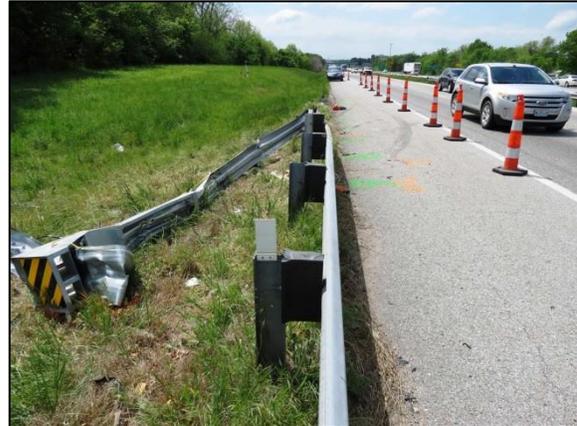
Figure 5: West lookback view beyond the final rest position of the GMC toward the point of impact.

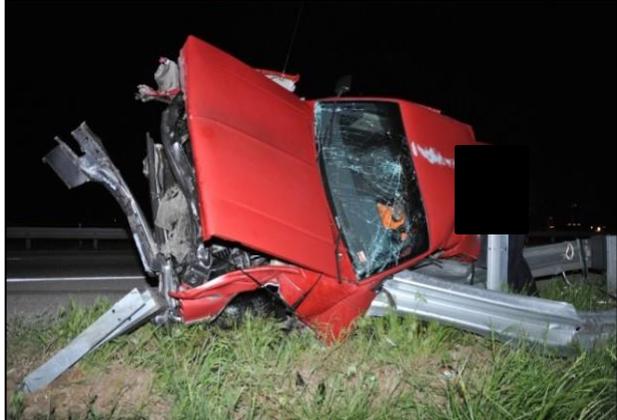
Figure 6: On-scene police image of the GMC at final rest looking toward the northeast.

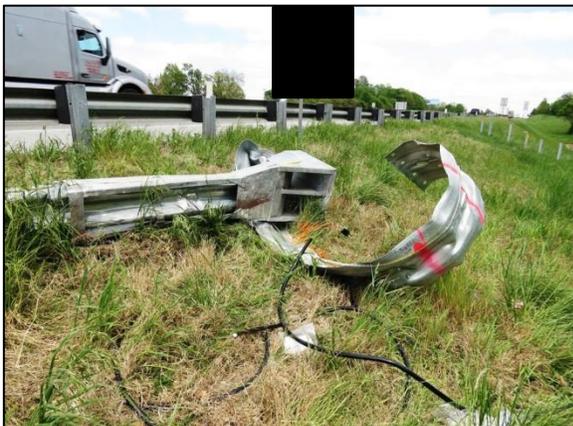
The GMC struck the impact-face of the end terminal, resulting in direct contact damage to the impact-face referenced to the lower left corner that measured 13 x 38 cm (5.0 x 15.0 in). The force of the impact displaced the end terminal to the east (Figure 8) and extruded 4.9 m (16.0 ft) of the W-beam from the impact head. The W-beam curled toward the field side, away from traffic. Post-crash, the end terminal was located 18.1 m (59.4 ft) east of Post 1. Minor deformation was noted to the feeder channel. All the welds of the end terminal remained intact. Posts 1 to 8 of the installation were deformed with 15 m (50 ft) of damage to the W-beam that extended to the splice at Post 9. The deformed guardrail was inspected and documented through measurements and photographs. A diagram depicting the deformed guardrail is included on Page 16. The FHWA Guardrail Form documenting the crash and installation is included at the end of this report as **Appendix**.

Figure 8: Final rest location of the displaced end terminal.

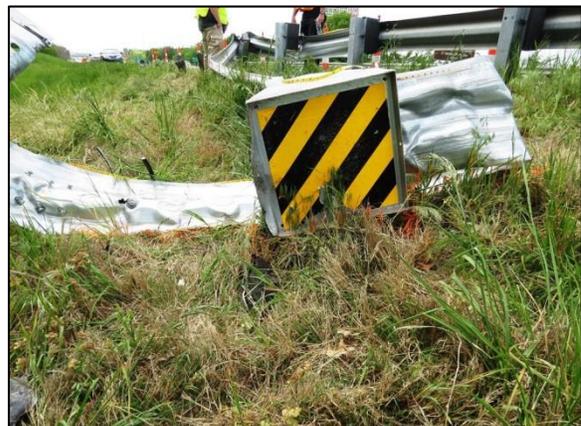
Figure 9: Image depicting the impact-face of the end terminal looking to the west.

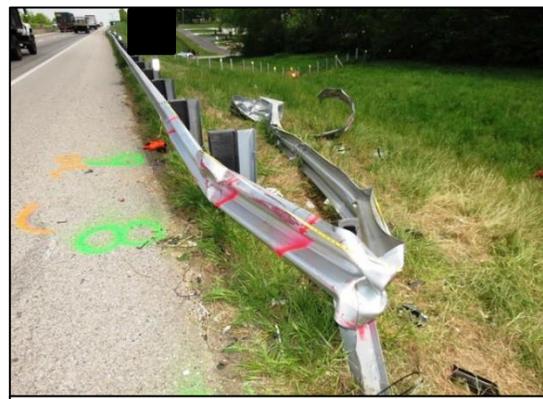
The impact head and W-beam separated from the struck posts of the end terminal and were propelled southeastward by the crash forces. This displacement deformed and wrapped the W-beam around Post 7 (**Figure 10**), which formed a knuckle. During the crash, the GMC struck this knuckle in the area of its left front door. The door buckled as the sheet metal surrounding the latch overloaded and tore, which allowed the W-beam to penetrate and pocket into the front left interior space of the vehicle in the area of the driver's foot well. Engagement of the knuckle with the GMC further deformed the guardrail, and Post 7 was deflected approximately 30 degrees to the east. This engagement exacerbated the vehicle's clockwise rotation and instability, which induced a one quarter-turn, left side-leading rollover to the GMC. The GMC's left plane

Figure 10: East-looking image of the deformed W-beam wrapped around Post 7.

struck the face of the guardrail between Post 7 and 9. Minor deformation was noted at Post 8, and the guardrail damage ended at the Post 9 splice.

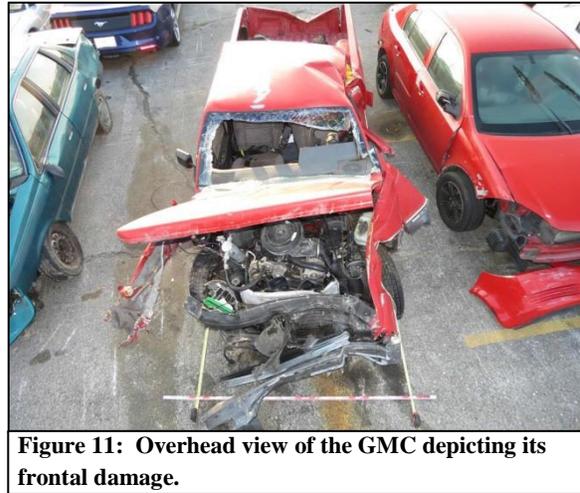
Figure 11: Overhead view of the GMC depicting its frontal damage.

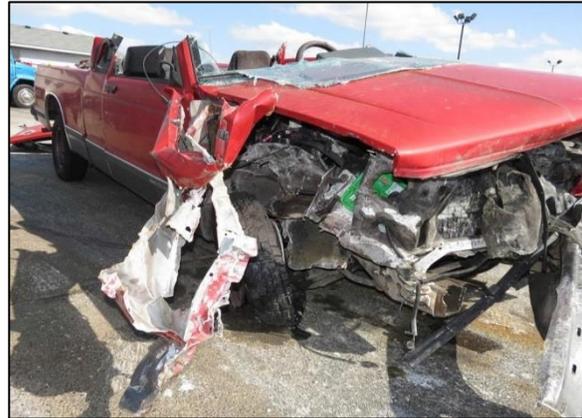
of center. The impact had crushed the right frame rail 15 cm (5.9 in), separated the right aspect of the front bumper from the frame, and deformed the right side structure of the engine compartment. The right fender was free-floating, only attached to the right A-pillar structure. Direct contact with the end terminal was also observed at the right front wheel assembly. The right front wheel rim was deformed and the tire was both flat and restricted by contact with the aft aspect of the wheel house, which reduced the wheelbase 9 cm (3.5 in). The collision deformation classification (CDC) assigned to this damage pattern was 12FREE3.

The second region of distinct front plane deformation resulted from the vehicle's clockwise rotation along the W-beam and corresponding engagement with the support posts (1-3). The crash reconstruction determined that Post 4 pocketed immediately to the left of the left frame rail (**Figure 13**). This contact was evidenced by a right angle deformation of the bumper beam that measured 8 cm (3.1 in). This pattern began 38 cm (15.0 in) left of center and extended 30 cm (11.8 in) to the left corner. There was no measurable crush to the left frame rail. The CDC representative of this damage was 10FDEW1.

Figure 12: Front right oblique view of the GMC depicting the impact damage.

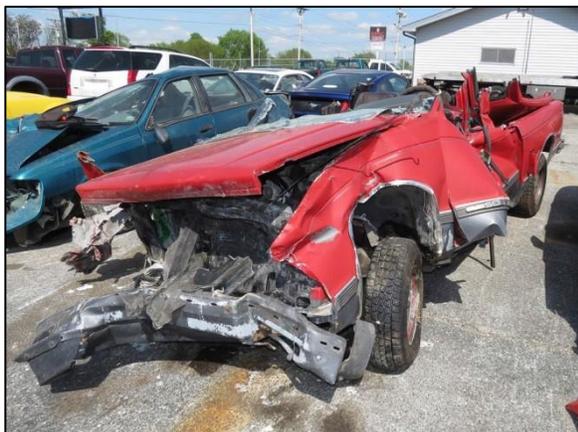
Figure 13: Left front oblique view of the GMC depicting its damage.

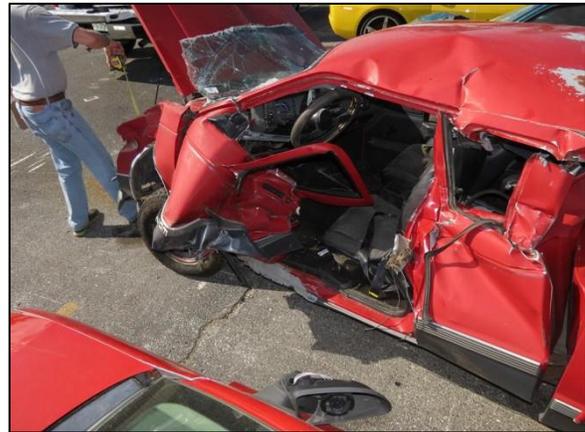
Figure 14: Left view of the GMC depicting the impact damage and intrusion at its left door.

Due to its clockwise rotation, the forward and center aspects of the left plane sustained direct contact damage from the guardrail. The direct contact damage was located from the GMC's forward left corner to the leading aspect of the pickup bed adjacent to the left C-pillar. The left door of the GMC struck the deformed/knuckled guardrail at Post 7 (**Figure 14**). Due to the clockwise rotation of the GMC, the corresponding direction of the impact force was in the vehicle's 8 o'clock sector. Crash forces overloaded and tore the sheet metal surrounding the door latch. Although the latch remained secured to the striker, the door structure buckled and separated as it intruded into the left front occupant space. The residual length of the buckled door measured 46 cm (18.1 in). For comparison purposes, the length of the undamaged right door was 114 cm (44.9 in). The CDC assigned to this contact pattern was 08LYAW4.

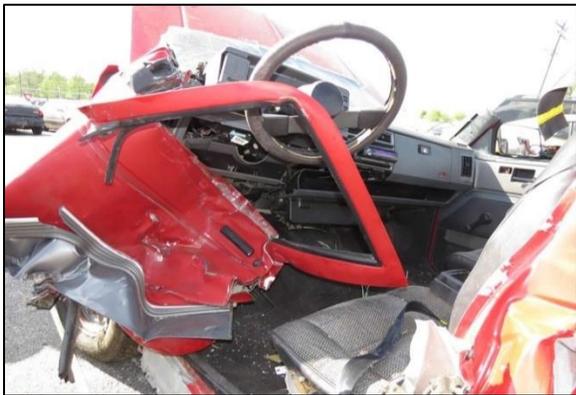
The left door was observed to be buckled and compressed forward into the driver's foot well, attributable to the crash forces associated with the engagement of the GMC and the knuckled guardrail at Post 7. Residual lateral intrusion measured 41 cm (16.1 in). The inner surface of the intruding door structure contacted, cut, and abraded the outer aspect of the driver's seat. Red paint transfers were noted on the cloth upholstery of the seat and on the seat belt webbing. The

Figure 15: Left oblique view of the GMC depicting the left door intrusion.

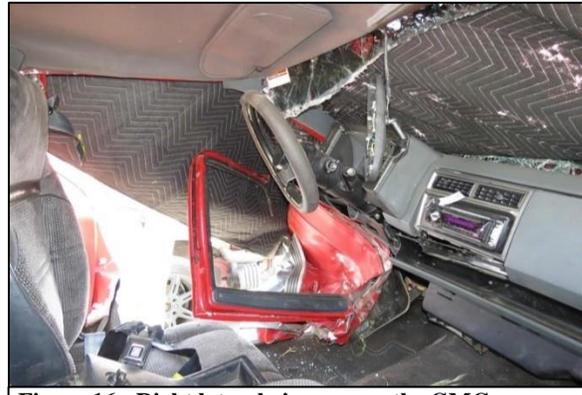
lower sector of the steering wheel rim was struck by the intruded door and deformed forward approximately 15 cm (5.9 in). The jammed position of the door hampered the inspection of its interior surface, the lower left instrument panel and foot well. Based on the on-scene police images, a gap was created in the area of the driver's foot well during the crash. The front right occupant's leg was displaced through this hole and was observed to be outside of the occupant compartment by emergency response personnel when they arrived at the crash scene.

Figure 16: Right lateral view across the GMC depicting the intrusion of the left door.
