Case 354 : Narrative

Case Vehicle (A): 1999 Honda	Vehicle (B): 2000 Chevrolet	Vehicle (C): 1993 Mercury
Type: Civic DX-V, 4-door sedan	Type: Venture Sport van	Type: Villager GS, 4 x 2, minivan
Driver: 44-year-old male	Driver: 35-year-old male	Driver: 47-year-old male
CDC: 01-RYEW-1, 12-FDEW-2	CDC: 99-0000-0	CDC: 99-0000-0

CASE NO.: 354-02

CASE VEHICLE: 1999 Honda

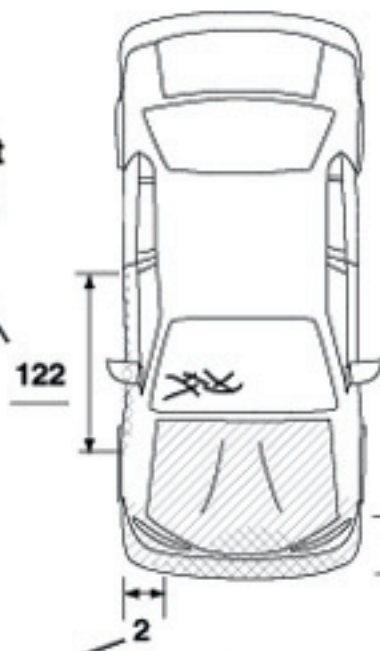
Max. crush to left front fender

Max. crush to center of front bumper

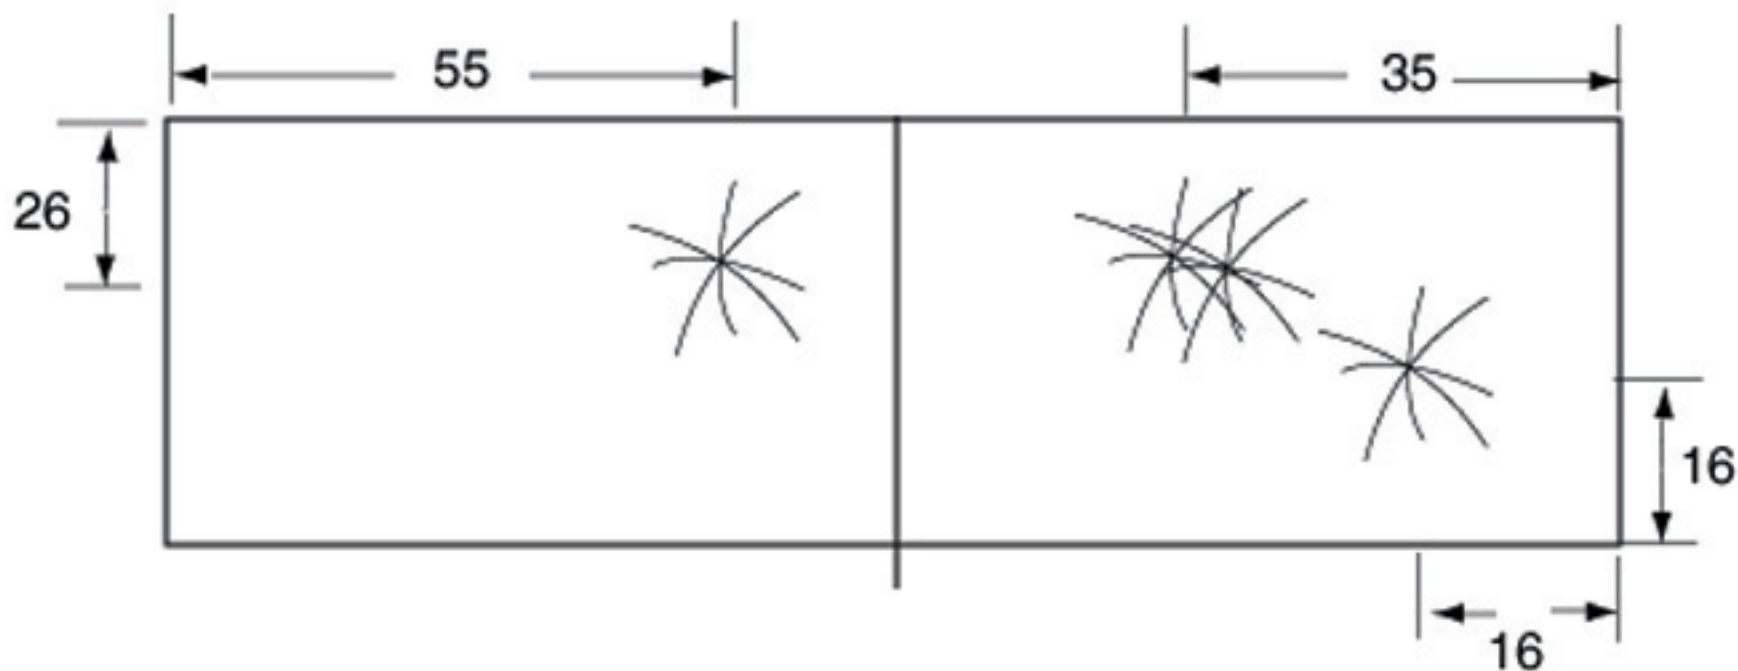
**Windshield cracked on left by rear-view mirror contact
and cracked on right by passenger airbag or
passenger airbag cover contact**

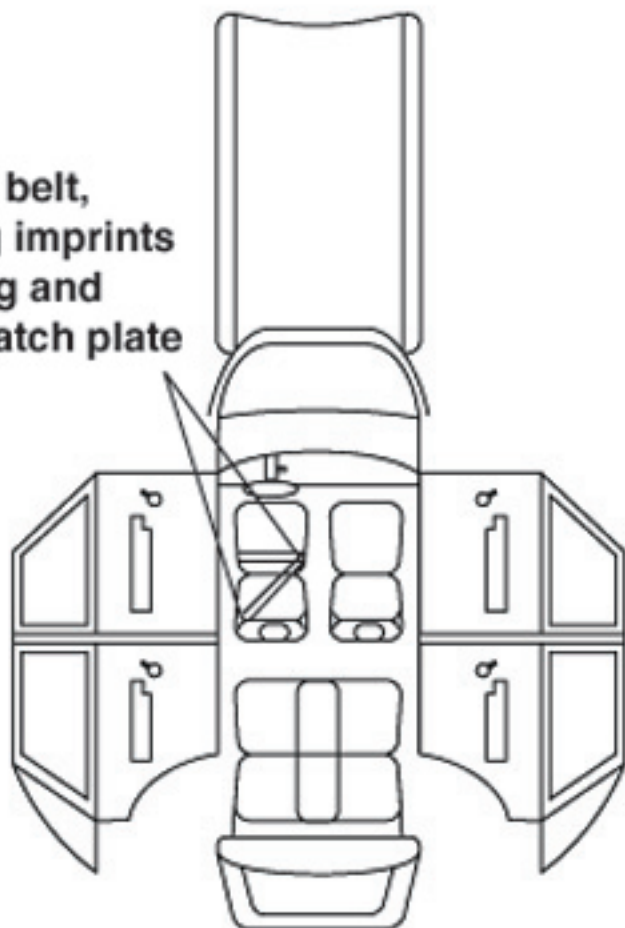
**C = seat belt,
webbing imprints
on D-ring and
sliding latch plate**

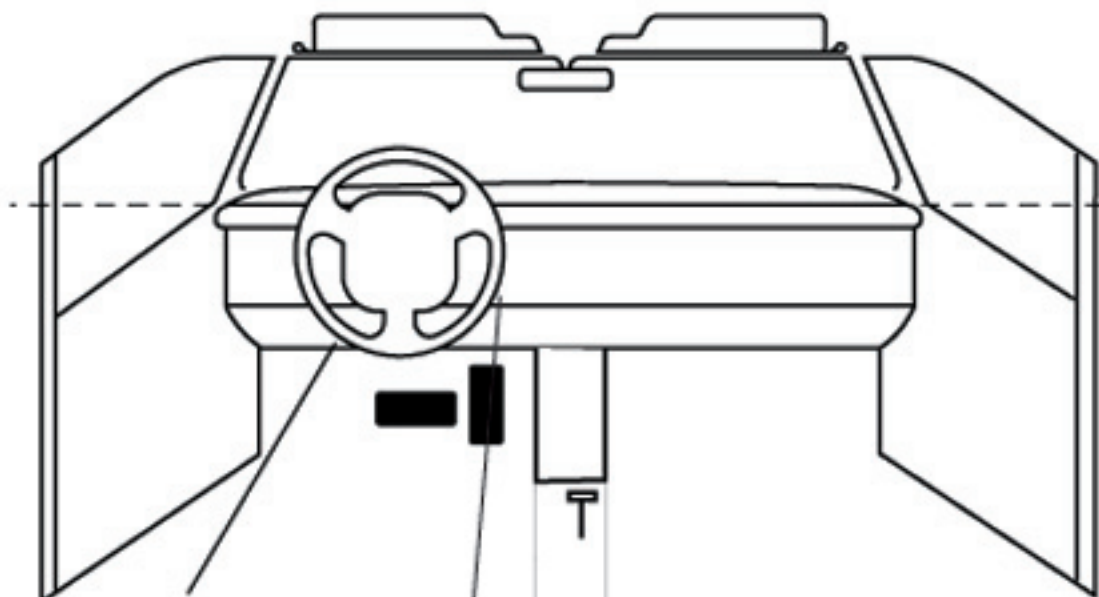
**A = knee bolster,
scuffmark**

**B = knee bolster,
scuffmark**
