SAFETY COMPLIANCE TESTING FOR FMVSS NO. 216a ROOF CRUSH RESISTANCE

MAZDA MOTOR CORPORATION
2015 MAZDA 3 | 4-DOOR SV, PASSENGER CAR
NHTSA NO. C20155401

FINAL REPORT

1. Report No. 216-GTL-15-005	2. Government Accession No. N/A	3. Recipient's Catalog No. N/A
4. Title and Subtitle Final Report of FMVSS 216a Compliance Testing of a 2015 MAZDA 3 PASSENGER CAR NHTSA No. C20155401		5. Report Date October 12, 2015

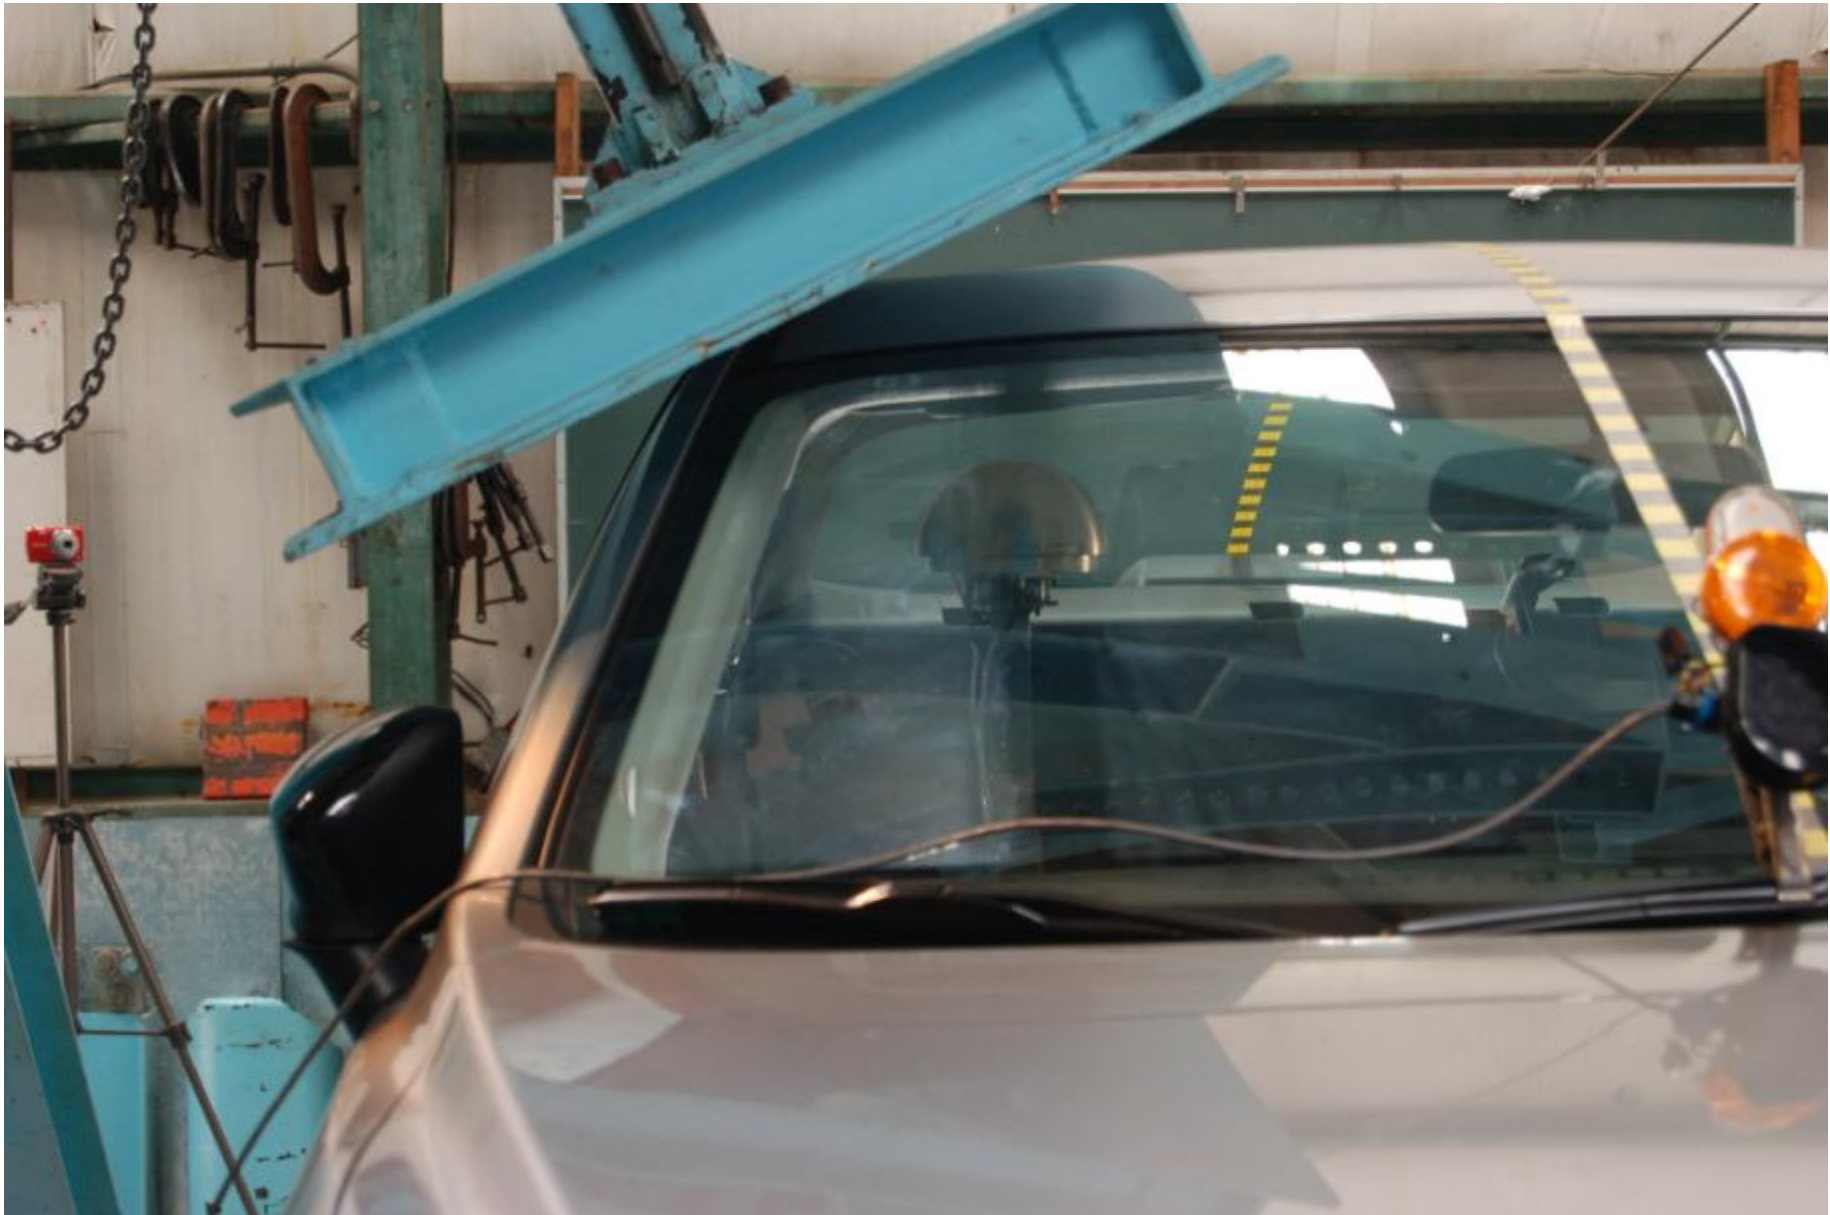
FIGURE 5.19
FRONT VIEW OF PLATEN CONTACT AT FULL LOAD – SIDE 1 TEST

Maximum load achieved = 38,264 N at 31.6 mm of displacement.

Did the maximum load achieved reach the maximum applied force (0,-250N)?
 No Fail Yes X Pass

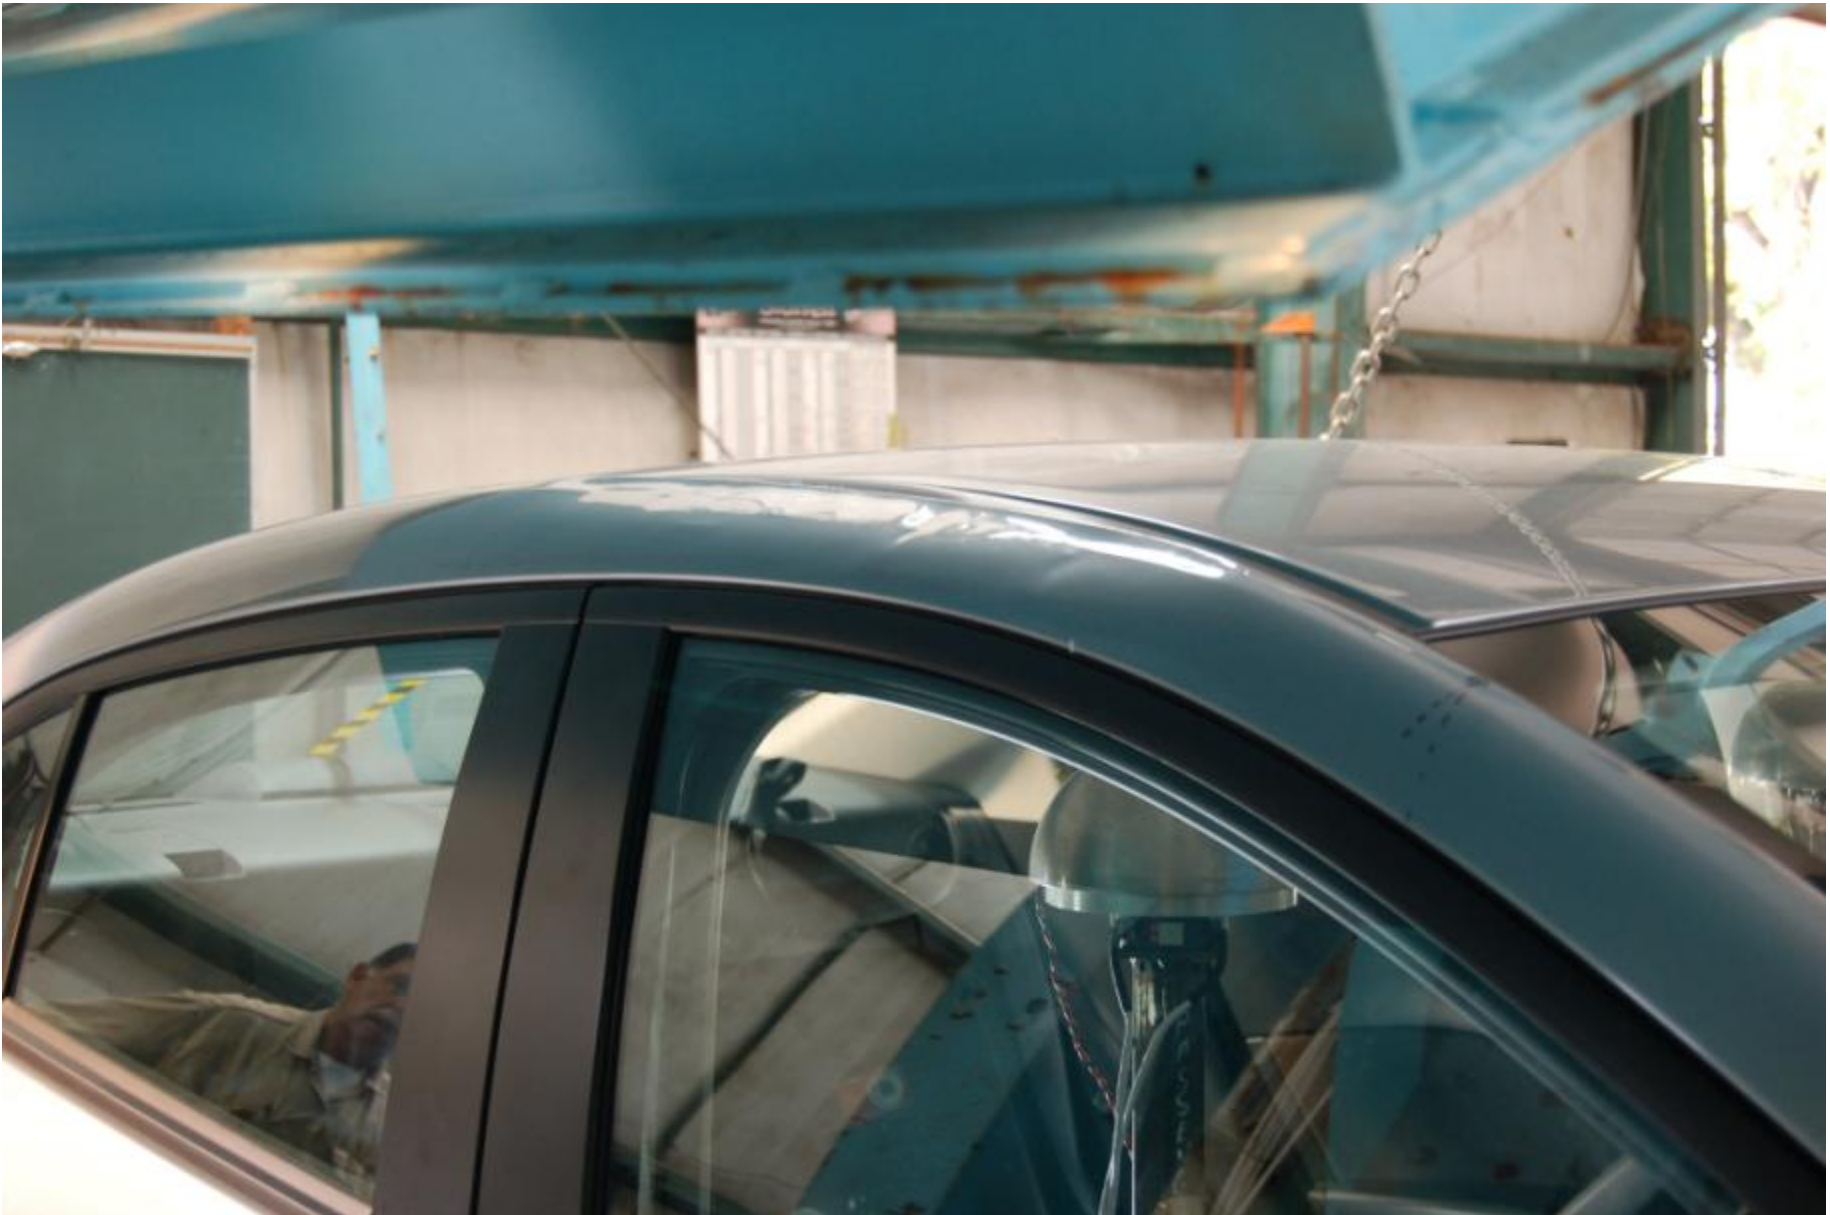
FIGURE 5.21
 $\frac{3}{4}$ FRONT VIEW OF ROOF POST TEST - SIDE 1 TEST

Flattened area above passenger's door 70 mm wide x 640 mm long. No other damage noted.

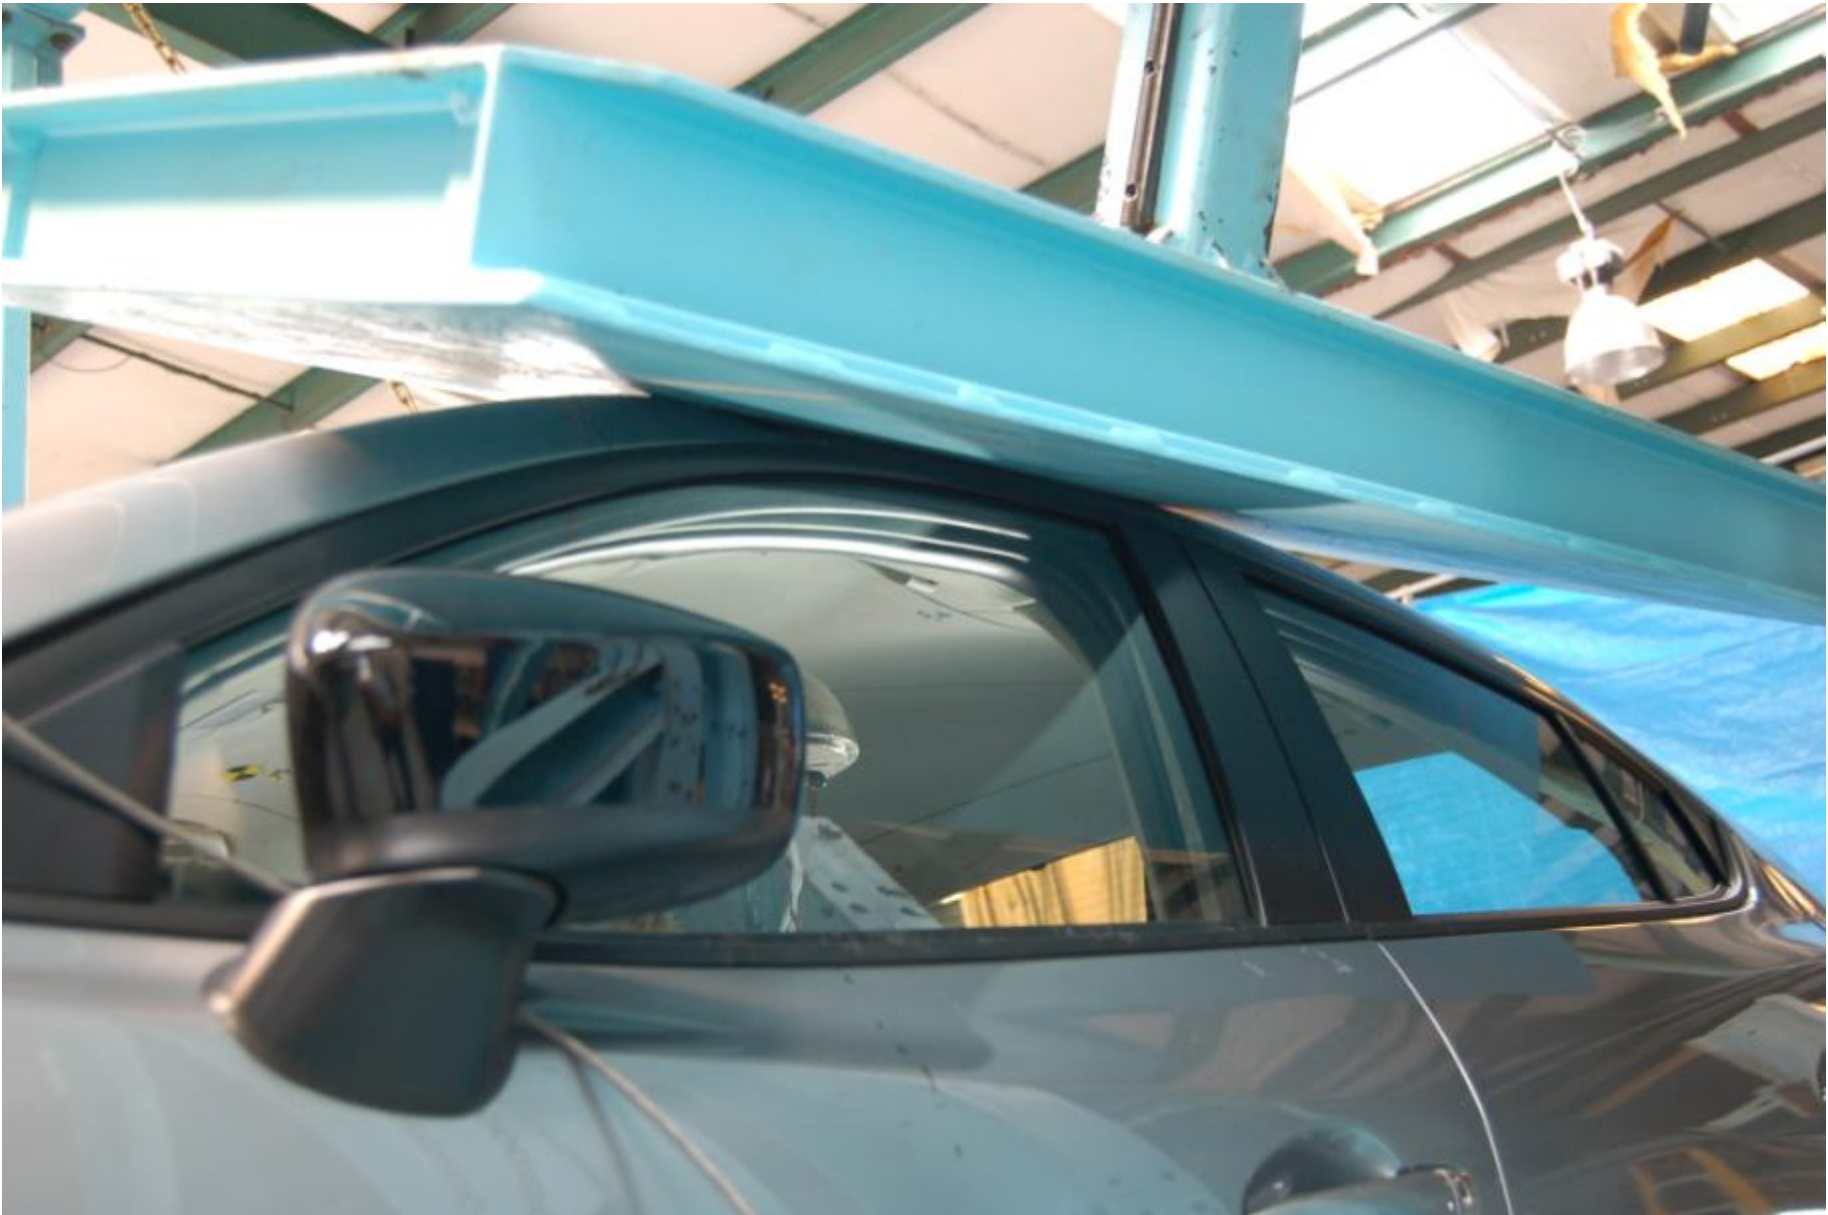
FIGURE 5.36
 $\frac{3}{4}$ FRONT VIEW OF PLATEN CONTACT AT FULL LOAD - SIDE 2 TEST

Maximum load achieved = 38,264 N at 35 mm of displacement.

Did the force reach the required load?
 No Fail Yes X Pass

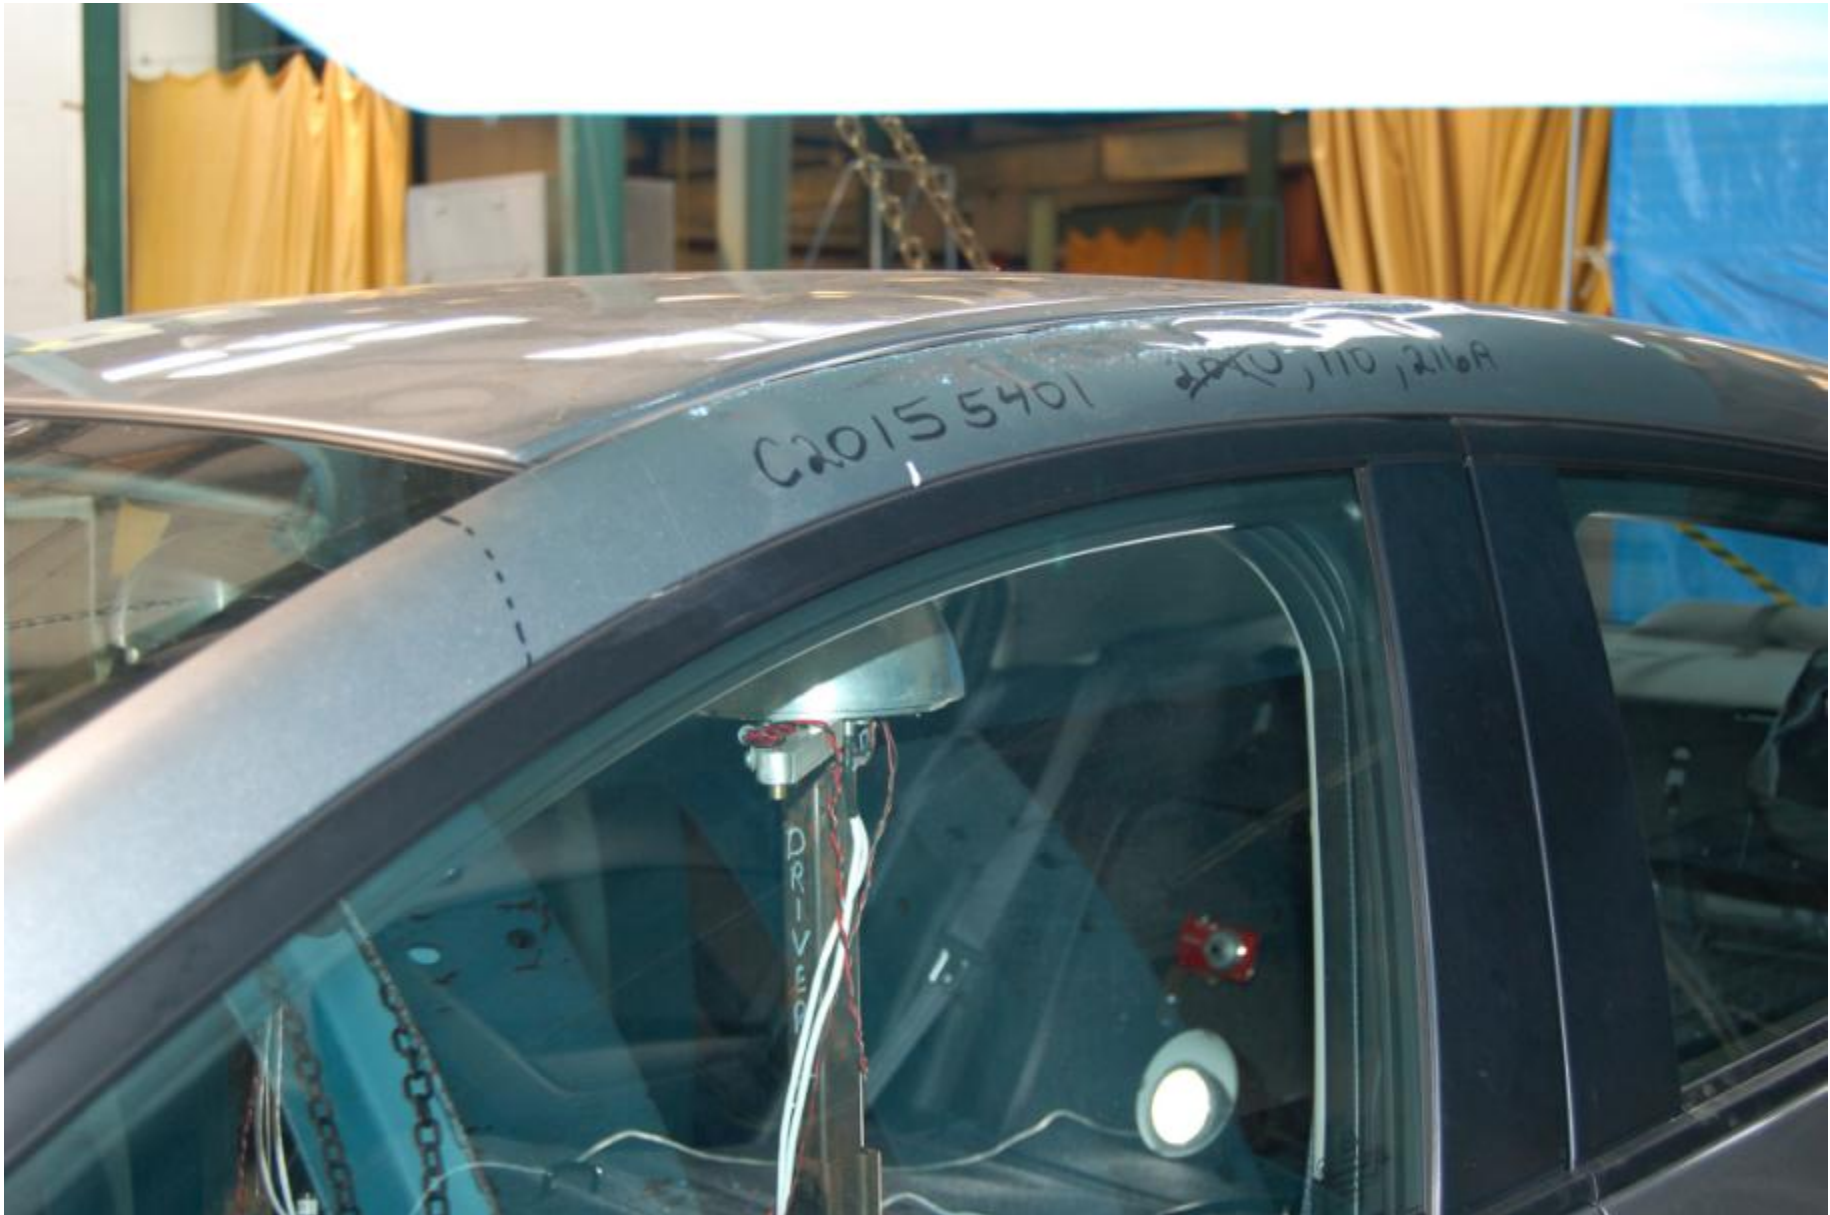
FIGURE 5.38
¾ FRONT VIEW OF ROOF POST TEST – SIDE 2 TEST

Flattened area above driver's door approximately 75 mm wide x 600 mm long.
