DOT HS 813 587

**Special Crash Investigations:  
Remote Move-Over-Law Crash  
Investigation;  
Vehicle: 1996 International 4000/  
Nonmotorist;  
Location: Washington State;  
Crash Date: April 2021**

**Special Crash Investigations**  
**Remote Move-Over-Law Investigation**  
**Case No. DS21011**  
**Vehicle: 1996 International 4000/Nonmotorist**  
**Location: Washington State**  
**Crash Date: April 2021**

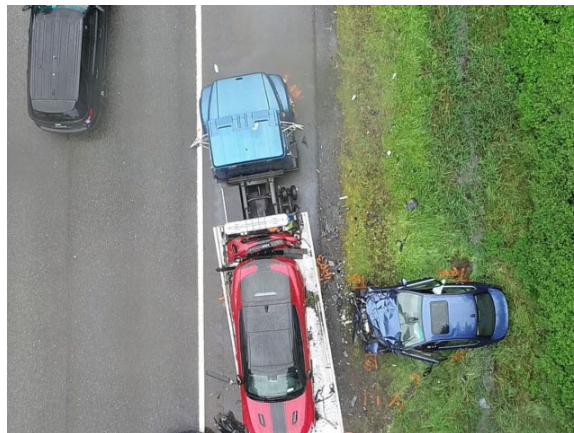
*Figure 3. Overhead view of the 1996 International 4000 and 2011 BMW 335d at final rest (police video)*

Following the impact the BMW departed the paved shoulder on the right edge, initiating a counterclockwise yaw, and deposited tire furrow marks in the ground measuring 15.3 and 20.8 m (50.2 and 68.2 ft) long before coming to rest facing west on the roadside. Impact forces from the first event pushed the Sorento forward in a counterclockwise rotation and its right plane struck the nonmotorist (Event 2) and the back plane of the International (Event 3). The Sorento's EDR captured a second deployment level event with a maximum longitudinal delta V of -12 kmh (-7.7 mph) at 300 ms and a maximum lateral delta V of -7 kmh (-4.4 mph) at 300 ms. The four triggered air bags had already deployed in the first impact. The nonmotorist was struck by the right plane of the Sorento and then struck the back plane of the International and was wedged between the two vehicles. The International and nonmotorist were pushed forward approximately 3 m (10 ft). The vehicle came to rest facing north on the right shoulder (Figure 3) and the nonmotorist came to rest on the ground. The Sorento came to rest facing north on the right shoulder and right lane.

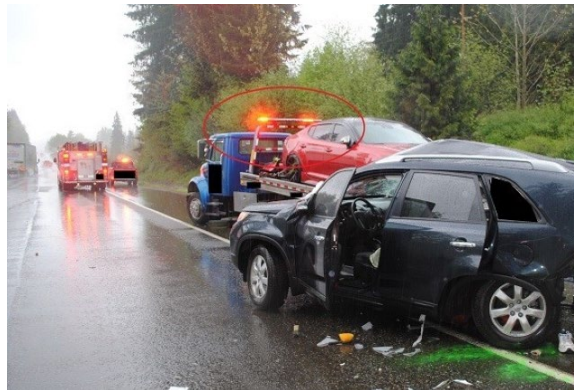
*Figure 4. 1996 International 4000 with light bar activated (police photo)*

The International was stopped facing north on the right shoulder with emergency lights activated (Figure 4). The leading end of the carrier had an LED light bar. The left and right sides of the carrier deck had red and white reflective tape extending its length. Police photos show the activated emergency lighting features included the light bar with rear-facing amber lamps, 4-way flashers with forward and rear-facing amber lamps, and red taillights. A witness to the crash told police he first observed the International's emergency lights from an estimated distance of 0.8 km (0.5 mi) south of the crash site. At the time of the crash, the International had four solid red tail lamps illuminated, and the light bar had solid red lamps and flashing amber lamps activated.

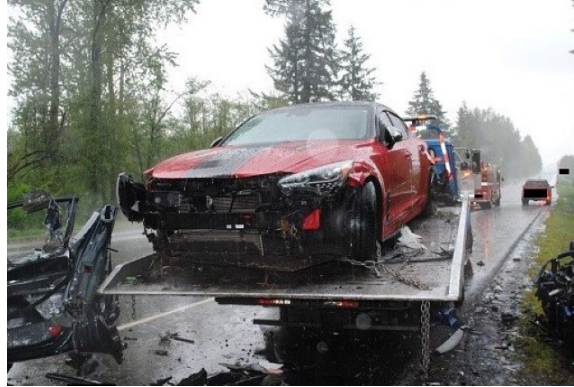
*Figure 5. Area of impact, back plane of 1996 International 4000 (police photo)*

Based on the police report and photos, the International sustained minor damage to the back and left planes of the metal carrier deck in the impact with the Sorento. The damage included scrape marks to the trailing edge, top surface, and left plane of the deck. No other damage was noted by police or visible in police photos. The estimated truck deformation classification for the International in Event 1 was 06BDFWA (Figure 5).

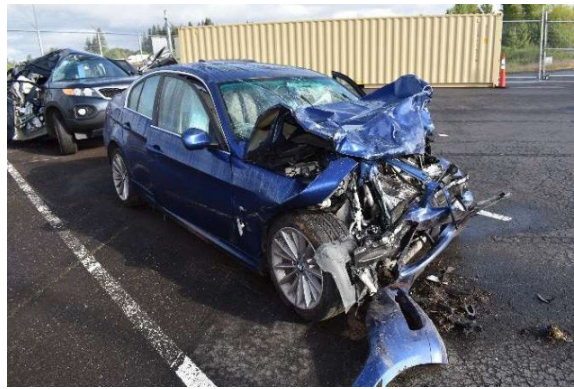
*Figure 6. Front plane damage, 2011 BMW 335d (police photo)*

Based on the police report and photos, the BMW sustained major severity damage to the front plane (Figure 6) in the Event 1 crash with the Sorento. Direct damage appeared to be distributed from bumper corner to bumper corner. The front bumper fascia was displaced, engine compartment components were displaced rearward, and the left fender, right fender, and hood were crumpled. The estimated collision deformation classification (CDC) for the BMW in Event 1 was 12FDEW3. The vehicle's ACM was not supported by the Bosch Crash Data Retrieval system so police could not image any vehicle crash data.

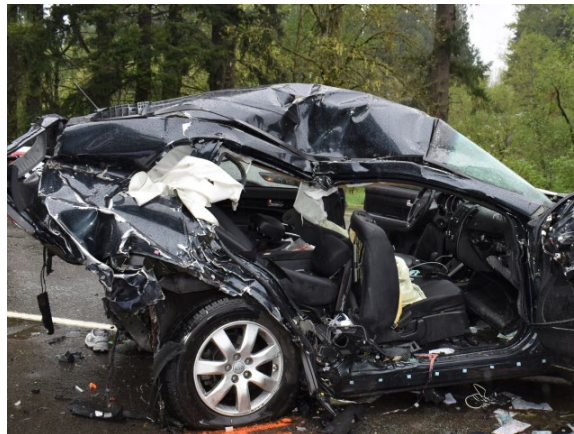
*Figure 7. Right plane damage, 2013 Kia Sorento (police photo)*

Police photos show the Sorento sustained severe crush damage to the right plane (Figure 7) in the Event 3 impact with the International. Direct damage appeared to begin at the right A-pillar and extended to the back right bumper corner where it overlapped damage from the prior event. Damage extended vertically from the frame to above the roof side rail. Maximum crush appeared to be near the junction of the right B-pillar and roof side rail. The estimated CDC for the Sorento in Event 3 was 01RDAW4.
