TRANSPORTATION RESEARCH CENTER

REMOTE AIR BAG REPORT

CASE NUMBER - IN97045 LOCATION - TEXAS VEHICLE - 1995 CROWN VICTORIA CRASH DATE - April, 1996

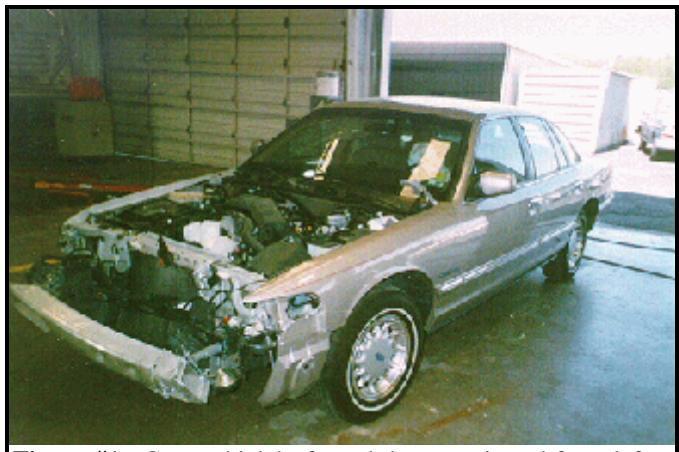
The front of the case vehicle impacted the back of vehicle #2, causing the case vehicle's driver and front right passenger supplemental restraints (air bags) to deploy (see **Figures #1-4**). The crash severity to the case vehicle was low (9-14 m.p.h.).

Figure #1: Case vehicle's frontal damage viewed from left; Note: front end being repaired

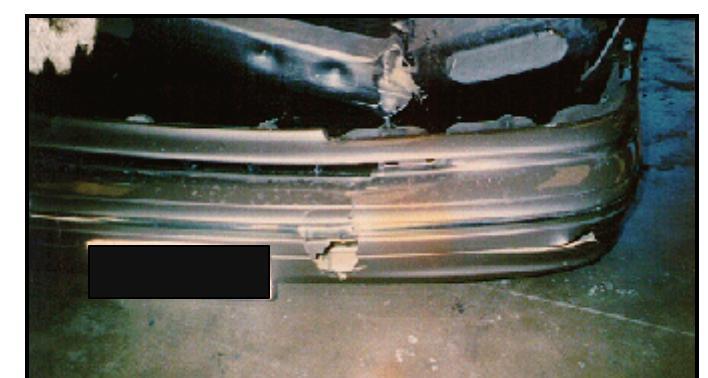
The case vehicle was a rear wheel drive 1995 Ford Crown Victoria LX, four-door sedan (VIN: 2FALP74W55X-----), and was equipped with anti-lock brakes. The case vehicle was towed due to damage. The case vehicle was almost totally disassembled for repair, but the damaged components were photographed (see Figures #2-4). The damage to the case vehicle was primarily above the bumper (underride type) indicating the case vehicle's air bag sensor, located in the center radiator support, was directly contacted resulting in not only the air bags deployment but an elongated delta T. The bumper fascia does show some direct contact (see Figure #2). Based on the one interior photo, there was no passenger compartment integrity loss, nor any intrusion. All the doors remained closed and operational. Based on the available photographs of the case vehicle, the CDC was determined to be: 12-FDEW-1 [maximum crush was estimated at 7 centimeters (2.75 inches)]. No reconstruction program was used on this crash because the NASS, CDS, WinSmash protocol requires that actual vehicular crush measurements be obtained; however, this contractor's visually estimated Delta V is between 13 km.p.h. (8 m.p.h.) and 19 km.p.h. (12 m.p.h.).

Figure #2: Direct damage to case vehicle's bumper fascia

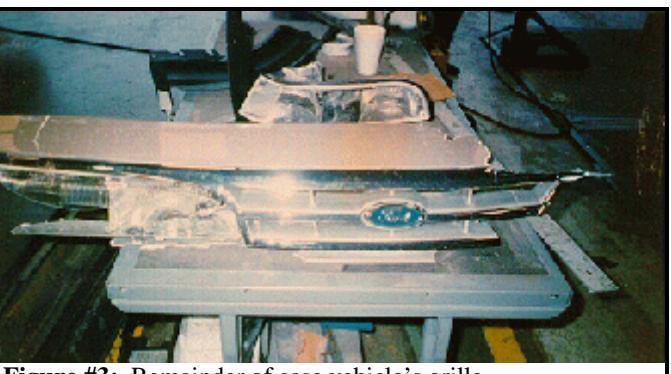
Figure #3: Remainder of case vehicle's grille

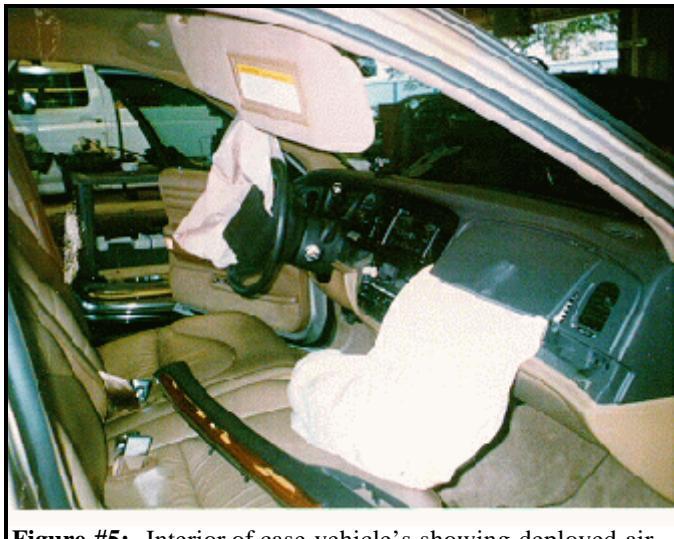
back seat was equipped with a nonadjustable bench seat. The front and rear outboard seats were equipped with active, three-point lap and shoulder belts with a two-point manual lap belt in the front and rear center seat positions. The vehicle was equipped with driver and front right passenger supplemental restraints (air bags). The driver's air bag was located in the steering wheel hub with the front right passenger air bag located in the front of the right dash. The driver's cover flap configuration is unknown while the front right air bag module's cover flap was a single flap configuration hinged at the top/forward part of the module. Based on the one interior photograph (see **Figure 5**), it is unknown whether either bag was vented or tethered or if either cover flap was contacted; although, there does appear to be something on the front right air bag module's cover flap (possibly air bag exhaust).

Figure #5: Interior of case vehicle's showing deployed air bags; Note: broken piece of dash trim on seat and unknown mark on front right air bag module's cover flap.

but thrust the right front passenger forward. Due to the passenger's close proximity to the deploying air bag (seat track at the full forward position), her head absorbed a large portion of the air bags deployment forces. The passenger's use of her three-point lap and shoulder belt had little affect on her forward movement due to her close proximity to deploying air bag. The deploying air bag thrust the passenger upwards toward the roof and backwards into her seat back. At some point during this passenger's backwards thrust her left wrist, which was previously broken and outfitted with a fixator splint, was thrown to the left and back into the driver's right shoulder leaving two puncture wounds. The passenger rebounded back forward but was held back by her three-point seat belt. At final rest the right front passenger may have attempted to assist the driver. As a result she had her head turned downward and to the left, and subsequently, she was closer to the air bag module prior to impact. This scenario would explain why the right front passenger did not observe the back of the motor home and warn the driver.
