SCHOOL BUS CRASH

VERIDIAN CASE NO. CA98-040

1994 INTERNATIONAL AMTRAN SCHOOL BUS 1995 INTERNATIONAL AMTRAN SCHOOL BUS

CRASH DATE - JULY 1998

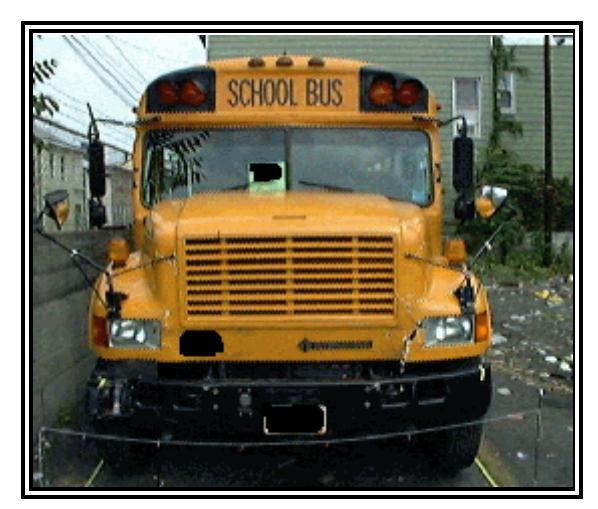
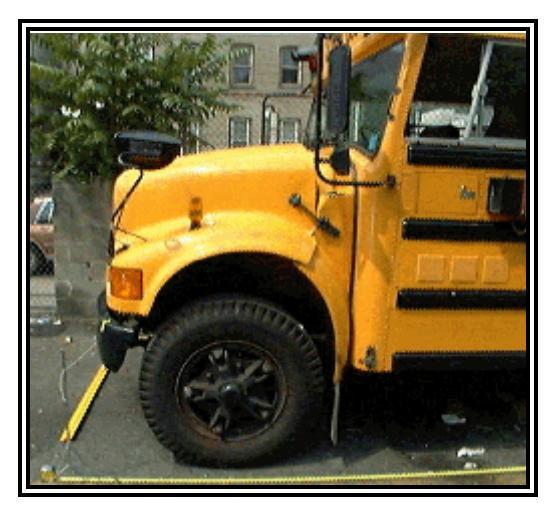
The front of Vehicle #1 (refer to **Figures 1-2**) struck the rear of Vehicle #2 (resulting in an estimated delta V of 16-24 km/h (10-15 mph). Contact on Vehicle #1 extended across the entire front of the vehicle and was assigned an equivalent Truck Deformation Classification (TDC) of 12-FDEW-1 (school buses are not classifiable under current SAE deformation guidelines). The maximum crush on the front bumper measured 9.5 cm (3.75") which was located at the right front bumper corner. The vehicle sustained damage to the radiator which resulted in the vehicle being towed from the scene.

Figure 1 Frontal view of Vehicle #1

Figure 2 View of the left side illustrating the damage.

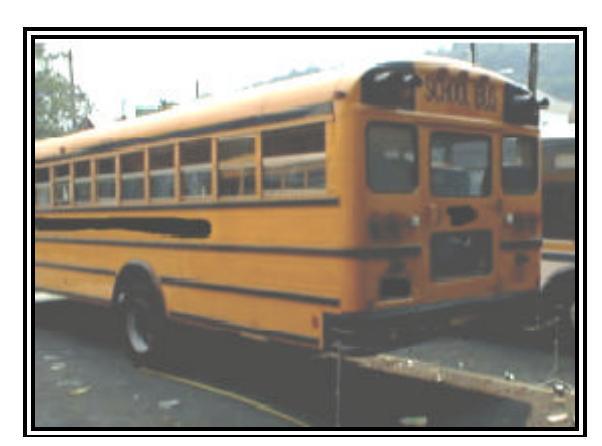
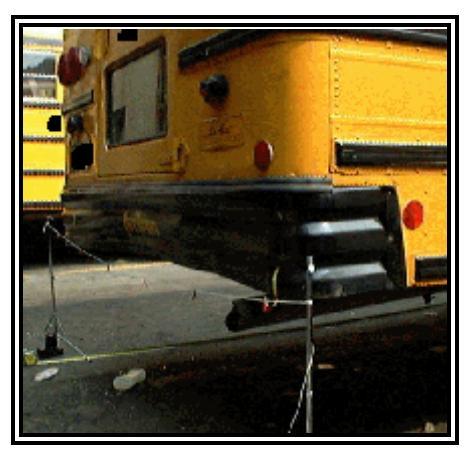
Vehicle #2 sustained contact damage across the entire rear plane with the maximum crush of 11.4 cm (4.5") which was located 88.9 cm (35.0") right of the left bumper corner. An equivalent Collision

Deformation Classification (CDC) of 06-BDEW-1 was assigned. This vehicle was driven from the scene to the bus company's parking lot (refer to **Figures 3-4**).

Figure 3 View of the left rear corner of Vehicle #2, struck school bus

Figure 4 Close-up view of the damage to the rear plane of Vehicle #2

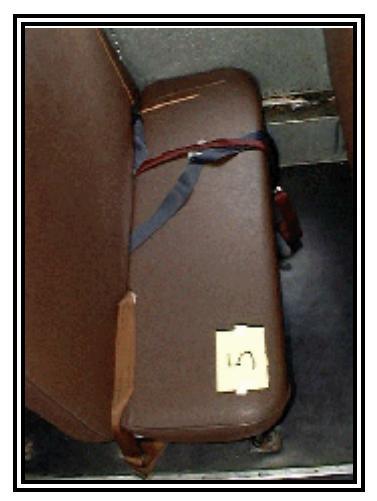
Inspection of the lap belt systems in both buses indicated that several lap belts (particularly in Vehicle #1) were either not available (i.e., a portion of the belt was buried under the seat) or the latch plate was extended to the outer limit of the belt thereby rendering the belt ineffective if worn **Figures 9 and 10** are typical views of the condition of the seat belts. **Figures 11 and 12** are schematics of the respective buses documenting the inspected condition of the seat belts. Many of the children injured in Vehicle #1 were located in the rear seat rows where many belts were either not accessible or not worn.

Figure 9 View of row 5 left side in Vehicle #1 showing inboard and outboard lap belt buckles were not visible

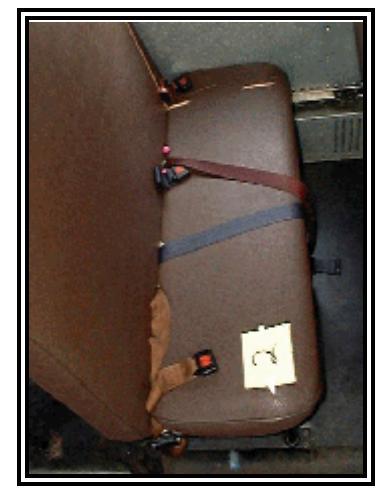
Figure 10 View of row 2 in Vehicle #1 showing the outboard and center lap belts adjusted to the maximum length

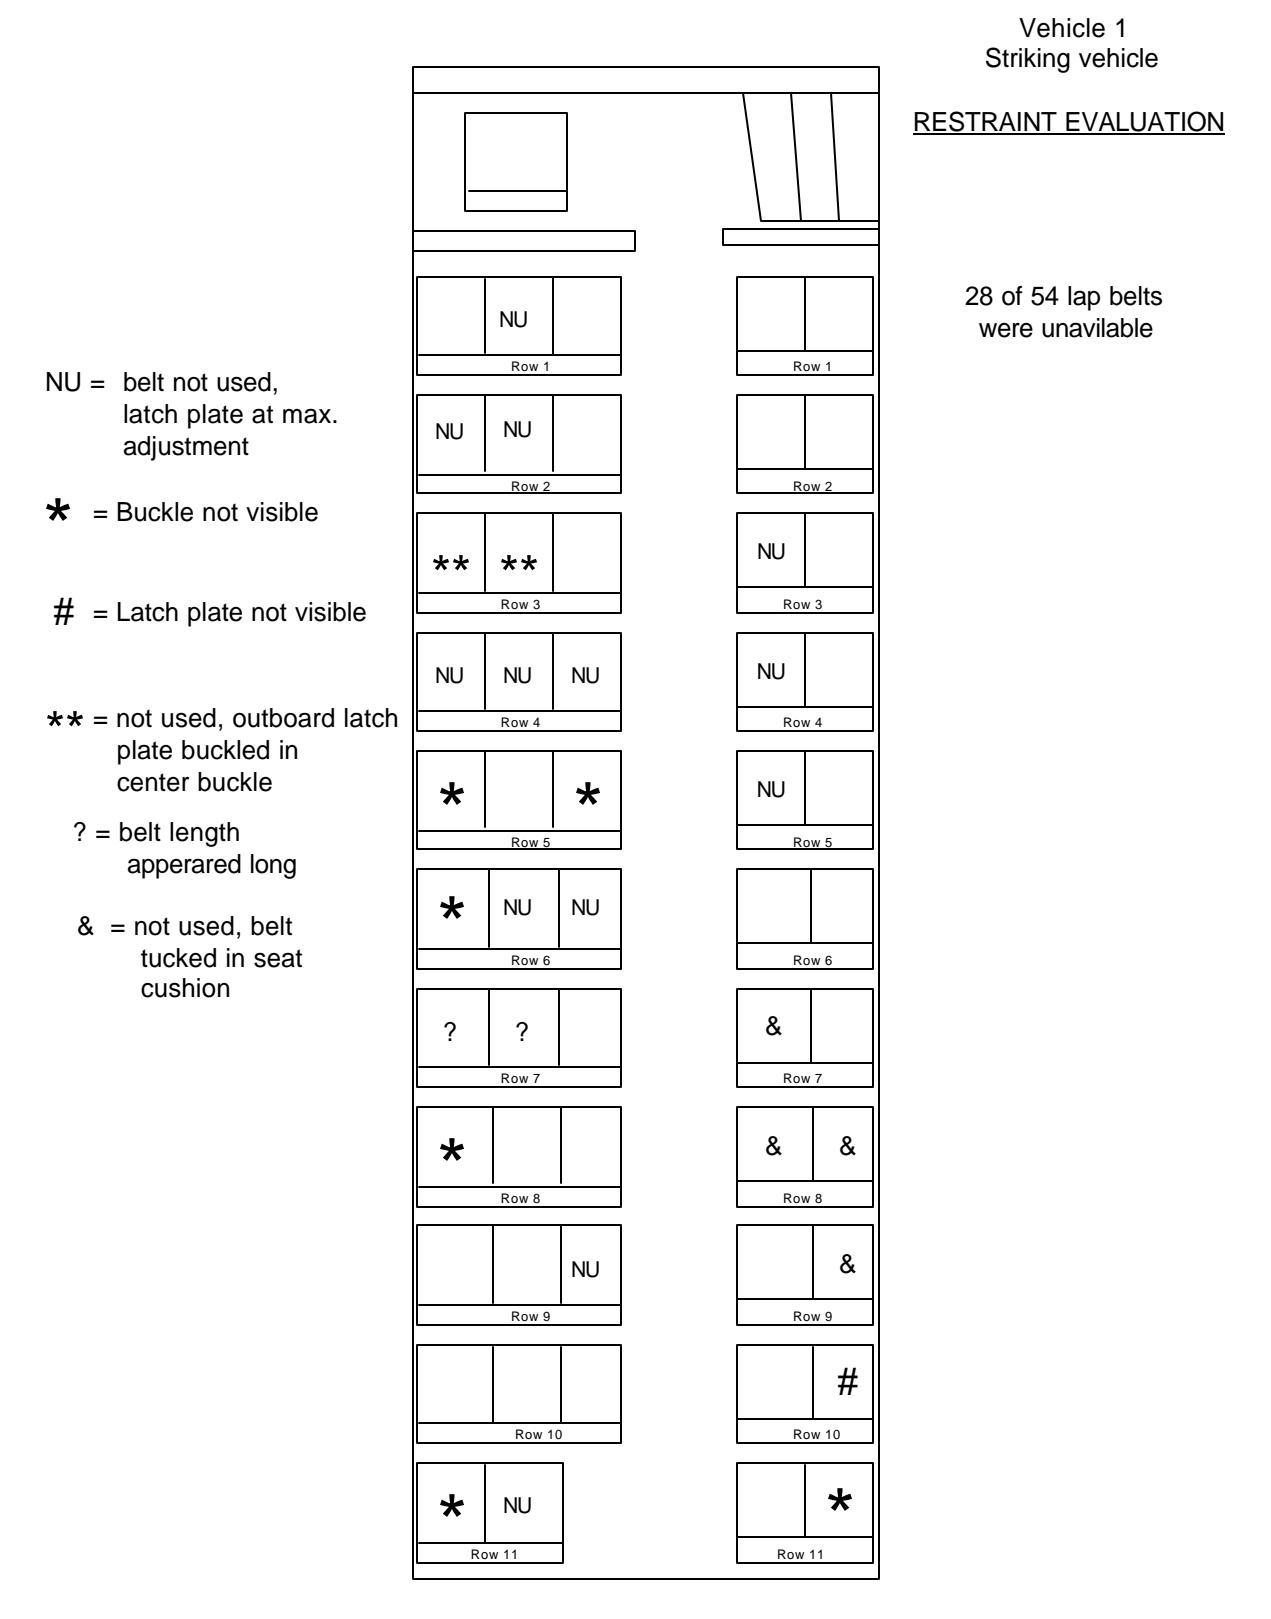
Figure 11 LAP BELT RESTRAINT EVALUATION

- C Row 3, left side, center seat, 10 year old male, may not be restrained (portion of outboard red belt was latched into center blue belt, laceration of the lip,
- C Row 8, left side, outboard seat, 10 year old boy, not restrained due to belt being adjusted to maximum length, injured left eye injury
- C Row 9, left side, center seat, 11 year old female, not restrained (per interview), injured head
- C Row 6-10, unknown seat location, 2 females, unknown if restrained, restraint belt tucked into seat in row 7 right side inboard, restraint belt tucked into seat in row 8 both right side seats, restraint belt tucked into seat in row 9 left side outboard, row 10 right side outboard

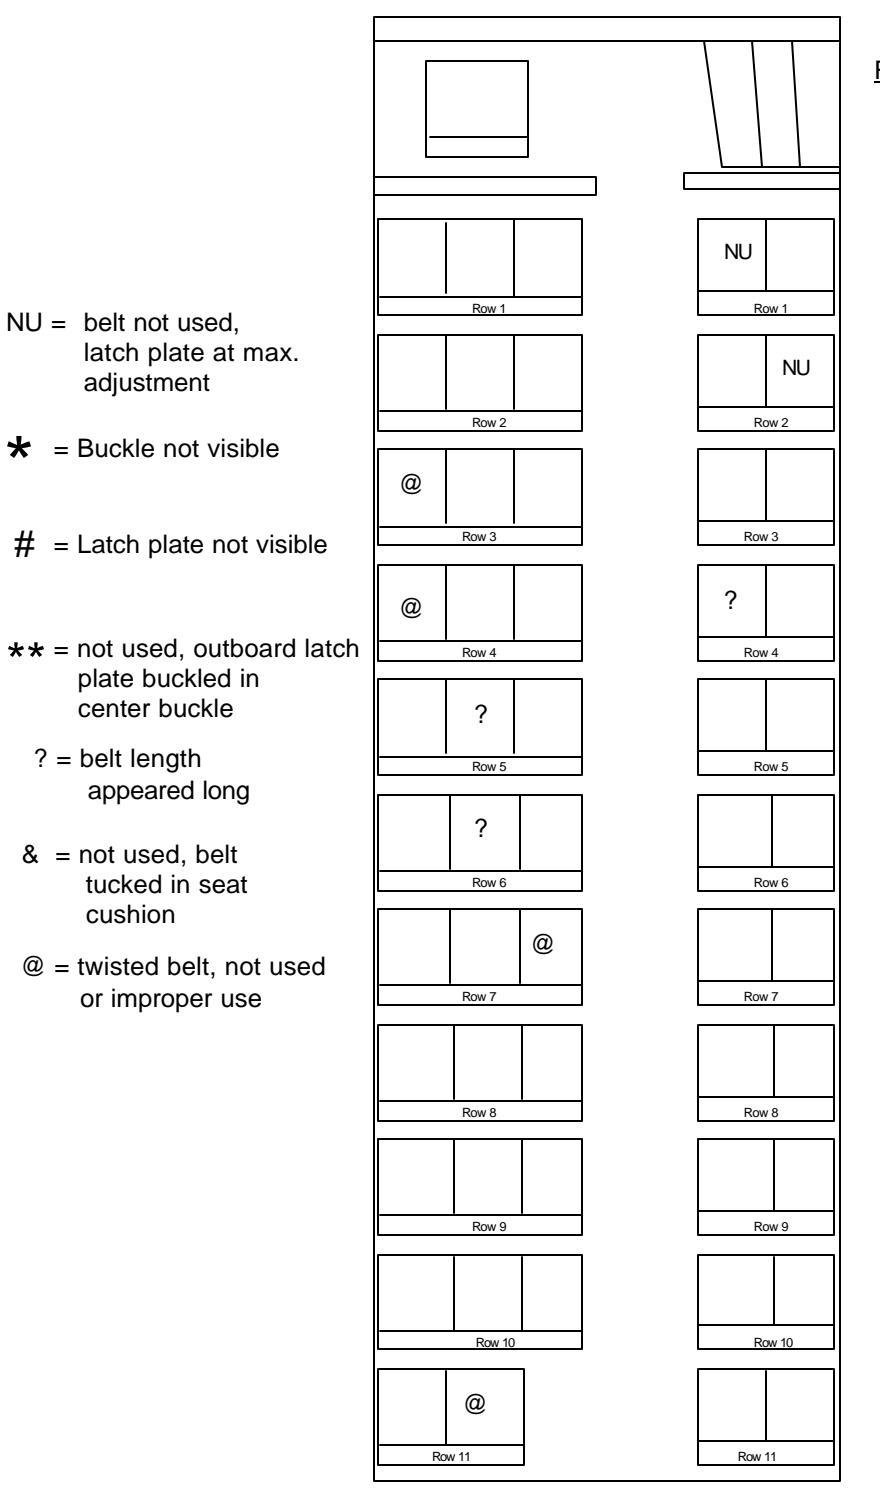
Figure 12 SEAT BELT EVALUATION VEHICLE #2

9 of 54 lap belts were unavailable
