On-scene Investigation / Vehicle to Vehicle Dynamic Science, Inc. / Case Number: DS00015 1999 Porsche Boxster California May 2000 This document is disseminated under the sponsorship of the Department of Transportation in the interest of information exchange. The United States Government assumes no responsibility for the contents or use thereof.

Dynamic Science, Inc. Accident Investigation Case Number: DS00015

Crash Location: Crash Date: Notification Date: Field Work Completed: California May, 2000 August 25, 2000 NA

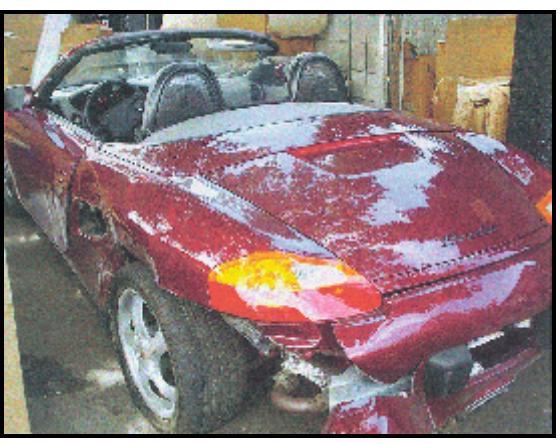
Figure 1. Left rear corner, case vehicle

The driver appears to have lost control in the curve, over-corrected to the left, and departed the roadway. The vehicle first struck the ditch–causing minor undercarriage damage. The driver corrected to the right and as the vehicle rotated it struck the retaining wall with the left side (10LZEW1). The case vehicle sustained a longitudinal delta v of -6.0 km/h and a lateral delta v of 10.5 km/h. The driver's door mounted side air bag deployed at this time. According to the driver, the deploying side air bag struck and fractured his left

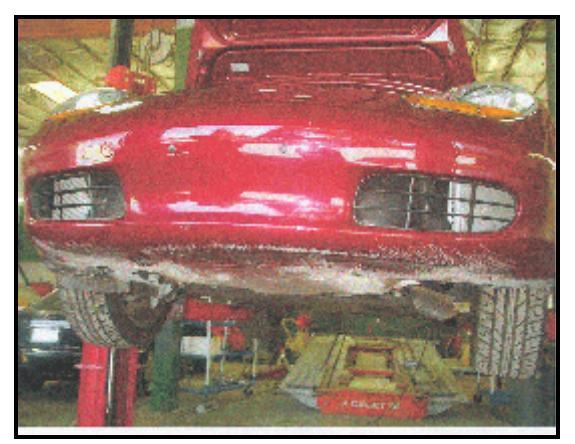
Figure 2. Undercarriage damage

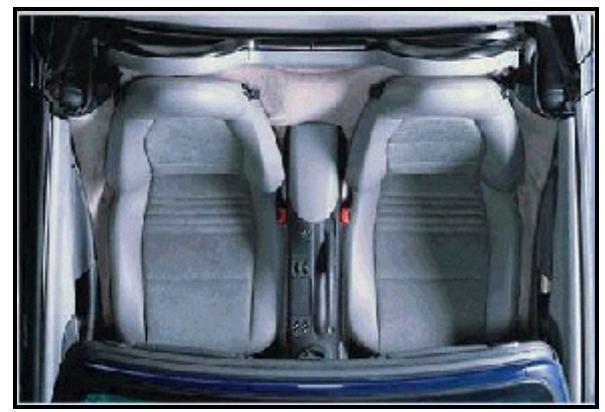
Figure 4. Down view showing position of side air bag relative to driver's seated position

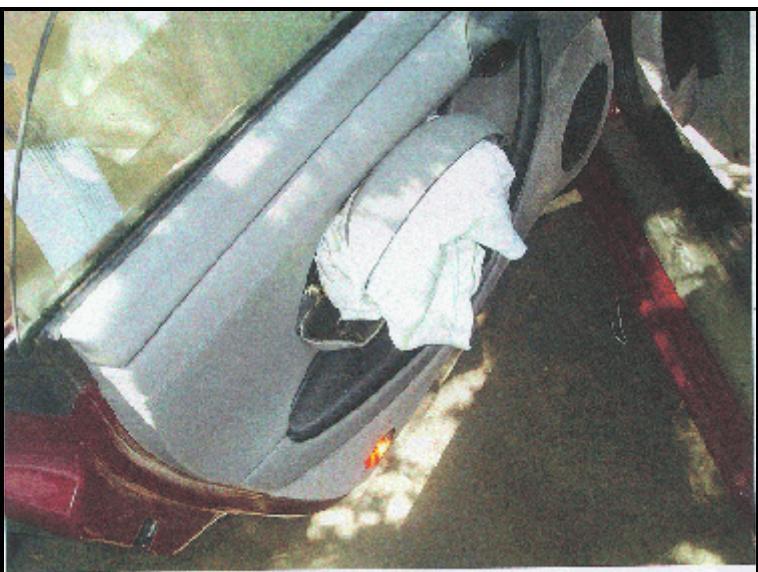
Figure 5. Driver's door mounted side air bag

he was attempting to turn to the right. It is likely that the right hand was above the left–moving the left elbow into a position very close to the side air bag. At impact with the wall, the driver's door mounted side air bag deployed and came into contact with the driver's left elbow–causing the lateral epicondyle fracture. The side air bag also struck the left side of the driver's chest–causing a minor contusion.

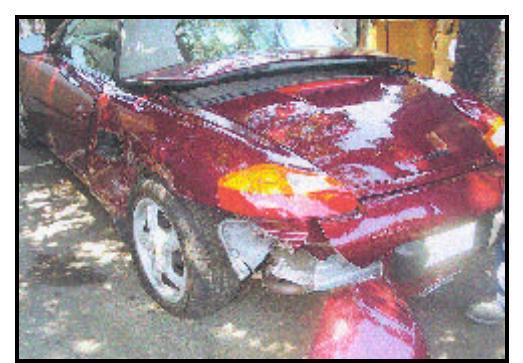
Case vehicle				
Description:	1999 Porsche Boxster	1999 Porsche Boxster convertible		
VIN:	Unknown	Unknown		
Odometer:	Unknown	Unknown		
Engine:	3.2 L 6 cylinder	3.2 L 6 cylinder		
Reported Defects:	None noted	None noted		
Cargo:	None	None		
Damage Description:	Light scuffing to front left door extending to Portion of plastic body	Light scuffing to front spoiler. Moderate crush to left door extending to left rear bumper corner. Portion of plastic body shell broken away.		
CDC:	Impact 1: 12FDLW1 Impact 2: 10LZEW1			
Delta V (Impact 2) ¹ :	Total	12.1 km/h (7.5 mph)		
	Longitudinal	-6.0 km/h (-3.8 mph)		
	Latitudinal	10.5 km/h (6.5 mph)		
	Energy	17,992 joules (13,273 ft-lbs)

Figure 7. Left rear corner, case vehicle

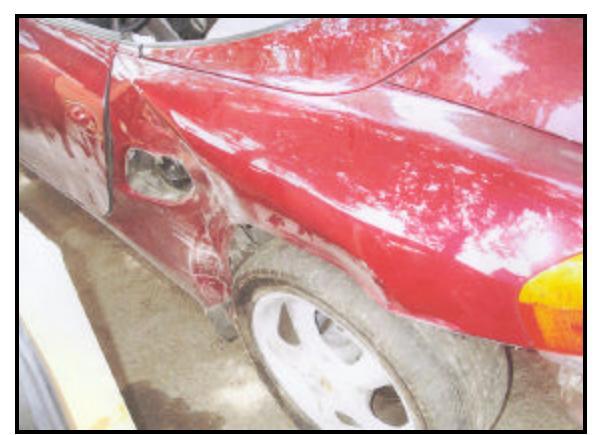
Figure 8. Close up of damage

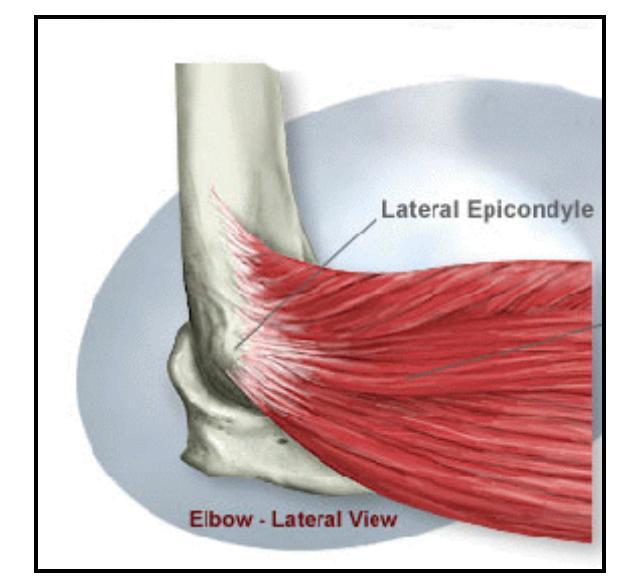
Figure 10. Lateral epicondyle fracture
