## REMOTE CHILD SAFETY SEAT CRASH INVESTIGATION SCI TECHNICAL SUMMARY REPORT

#### NASS/SCI COMBO CASE NO. 01-13-149K

## **VEHICLE – 1997 PLYMOUTH VOYAGER**

## **CRASH DATE – OCTOBER 2001**

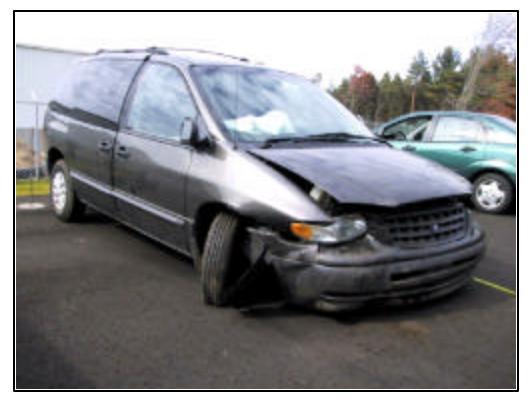
Figure 1. Damaged Plymouth Voyager

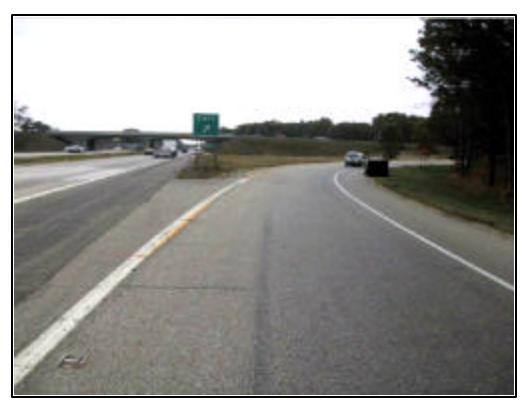
Figure 2. Southbound approach for the Plymouth Voyager

The 29-year-old male driver of the 1997 Plymouth Voyager was operating the vehicle in a southbound direction (**Figure 2**) on the divided highway during nighttime hours. The driver reportedly fell asleep and relinquished control of the vehicle at an interchange with a right side exit ramp. It was unknown if the driver's intent was to exit the highway at the interchange. The vehicle departed the roadway onto the grassy gore area between the southbound travel lanes and the exit ramp in a tracking mode.

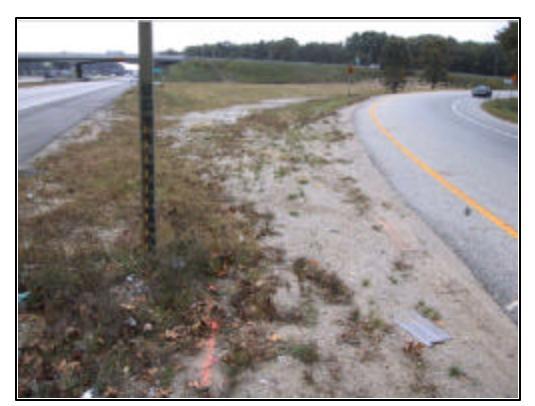
The 1997 Plymouth Voyager struck a non-breakaway sign post (Figure 3) with the left side aspect as it departed the roadway. The direction of force was in the 12 o'clock sector. The sideswipe impact resulted in minor damage to the Voyager and did not significantly alter its forward trajectory. The Voyager continued an additional 50 m (164') in a forward tracking mode along the level gore and impacted the sloped grassy embankment with the front aspect (Figure 4). The principal direction of force was in the 12 o'clock sector. The frontal impact was sufficient to deploy the frontal air bag system in the vehicle. The damage algorithm of the WinSMASH program computed a total delta-V of 31.0 km/h (19.3 mph) based on the frontal crush profile.

Figure 3. View of sign post from the sideswipe impact

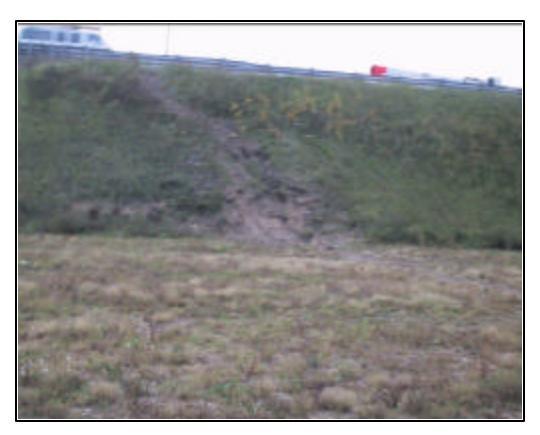
Figure 4. View of embankment

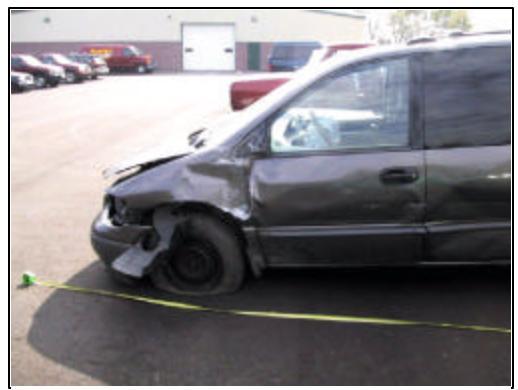
The 1997 Plymouth Voyager sustained minor damage as a result of the sideswipe impact with the sign post (**Figure 5**). The direct damage began 296.0 cm (116.5") forward of the left rear axle and extended 264.0 cm (103.9") rearward along the left side plane. The left side mirror was separated from the vehicle. The left front rim exhibited deformation and abrasions and the left front tire was deflated. Longitudinal abrasions began approximately 53.0 cm (20.9") forward of the leading edge of the left front fender to the center trim strip. The abrasions continued in a rearward direction along the left front door and along

Figure 5. Left front side view of sideswipe damage

the left side plane and terminated at the left rear wheel. Lateral crush was present on the left front

fender and left side panel aft of the left front door. The maximum lateral crush was located at the rear aspect of the left front fender and measured 10.0 cm (3.9"). The Collision Deformation Classification (CDC) for the sideswipe event was 12-LDAS-2.

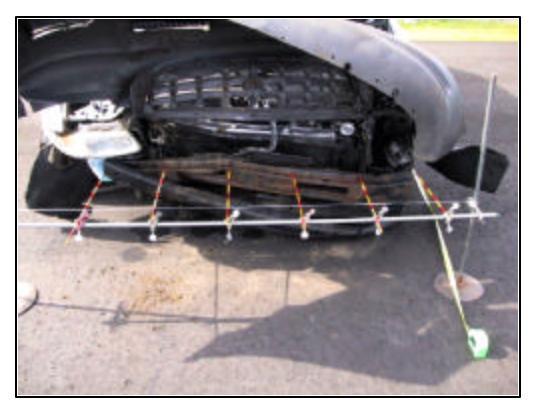
The Plymouth Voyager sustained moderate damage as a result of the frontal impact with the embankment. The direct contact damage involved the entire frontal width of the Voyager. The combined direct and induced damage involved the entire bumper beam and measured 134.0 cm (52.8"). The center and right lower aspect of the front bumper fascia were abraded with dirt deposits. The entire bumper fascia was displaced left and partially separated from the vehicle. The bumper beam was displaced rearward and the bottom right aspect of the beam was deformed upward (Figure 6). The left aspect of the Styrofoam filler was separated. The grille was displaced and the left head lamp assembly was separated. The left front fender was displaced slightly left from induced damage. The right head lamp assembly was displaced and the front aspect of the right front fender was displaced to the left. The right front tire was deflated. The hood was displaced upward. Six crush measurements were taken along the bumper beam and were as follows: C1 = 19.0 cm (7.5"), C2 =17.0 cm (6.7"), C3 = 21.0 cm (8.3"), C4 = 26.0 cm (10.2"), C5 = 28.0 cm (11.0"), C6 = 28.0 cm (11.0").The CDC for the frontal impact with the embankment was 12-FDEW-2.

Figure 6. View of crushed bumper beam

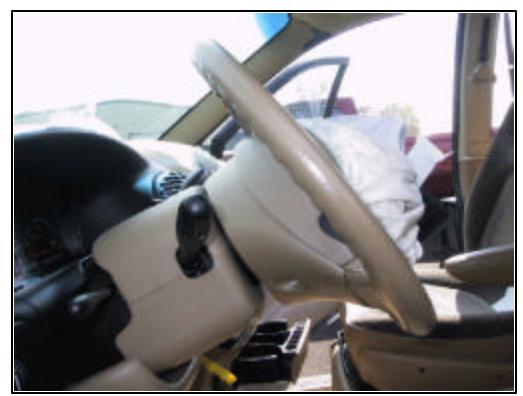
Interior damage to the 1997 Plymouth Voyager was minor and attributed to occupant contact. There was no glazing damage, integrity loss, or intrusion. The rearview mirror was displaced forward on the left side, most likely a result of the driver's air bag expansion. The top half of the steering wheel rim was deformed forward 4.0 cm (1.6") from occupant loading (Figure 7). The knee bolster was scuffed from contact with the driver's left knee, and the center console area was

Figure 7. View of deformed steering wheel rim

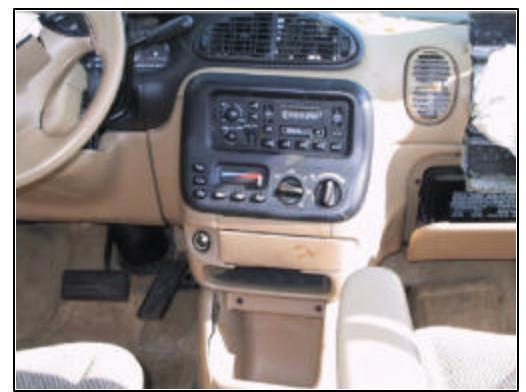
fractured from contact with the driver's right knee and Figure 8. View of fractured center console lower leg (Figure 8). A scuff was located on the upper

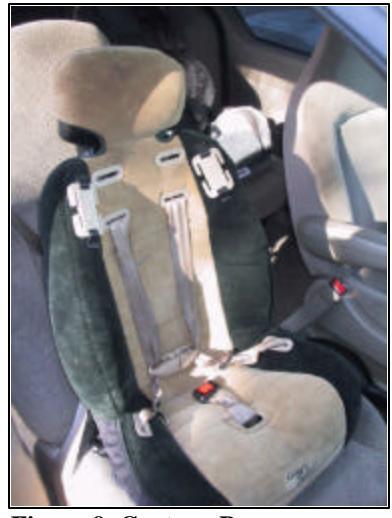
A Century Breverra Classic forward-facing booster seat was installed on the front right bucket seat of the Plymouth Voyager (Figure 9). The model number was 4865MAL01 and the manufacture date was February 16, 2000. There were no recalls associated with this CSS. The history of the CSS was not known. The CSS was configured with a five-point harness system for use with children who weighed between 13.6–18.0 kg (30-40 lb) and were between 89-127 cm (35-50") in height. The CSS could also be used as a belt-positioning-booster without the harness system for children who weighed between 13.6-36.3 kg (30-80 lb) and were between 89-127 cm (35-50") in height. The CSS was configured with a tether. The CSS was occupied by a 3-yearold male child who weighed 17 kg (37 lb) and measured 91 cm (36") in height. The child was within the manufacturer's recommended height and weight limits that were specified for this CSS.

Figure 9. Century Breverra Classic Booster Seat

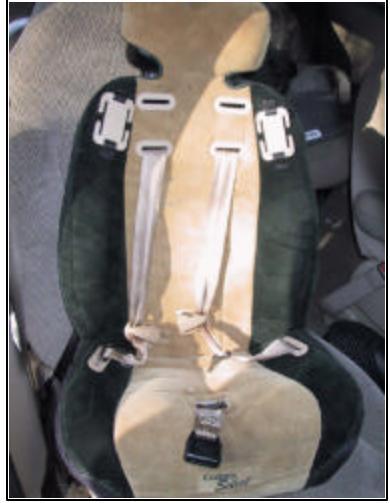
As shown in **Figure 10**, at the time of the CSS inspection, both harness straps were routed through the bottom set of harness

Figure 10. Frontal view of the Century CSS showing the harness system

slots. The webbing of both harness straps exhibited longitudinal creases. The CSS was

configured with a split harness retainer clip and both harness straps were gathered in the outboard aspects of the respective retainer clip aspects. The pre-crash position of the harness retainer clip was not reported, and the retainer clip was located approximately  $25 \text{ cm} (10^{\circ})$  below the bottom harness slots at the time of the inspection. Loading evidence to the harness straps could not be determined from the available photographs.

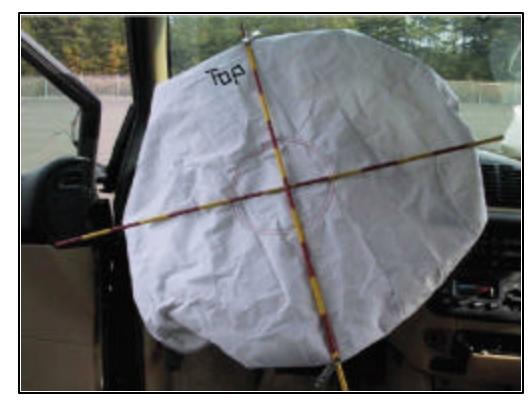
(19.7") in diameter in its deflated state (Figure 11), was tethered by two internal straps, and was vented internally through the instrument panel. The NASS researcher documented minor striations on the left aspect of the air bag adjacent to the seam, but the source was not specified. There was no occupant contact evidence documented on the surface of the air bag.

Figure 11. Driver's air bag

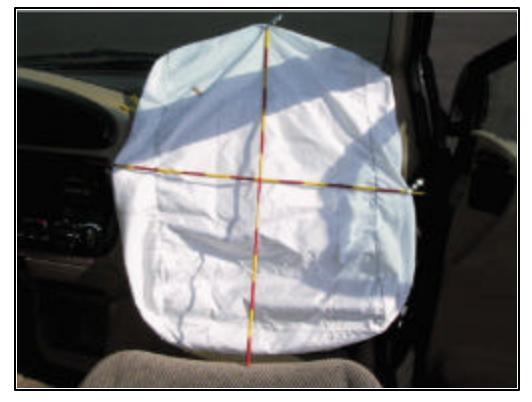
(2.8") in height and 29.0 cm (11.4") in width. The Figure 12. Front right passenger's air bag upper flap exhibited a lateral fracture on the right aspect, but the cause was unknown. The front right passenger's air bag measured 70.0 cm (27.6") in height and 50.0 cm (19.7") in width in its deflated state (Figure 12). The air bag was not tethered and was vented internally through the instrument panel. There was no occupant contact evidence documented on the surface of the bag.

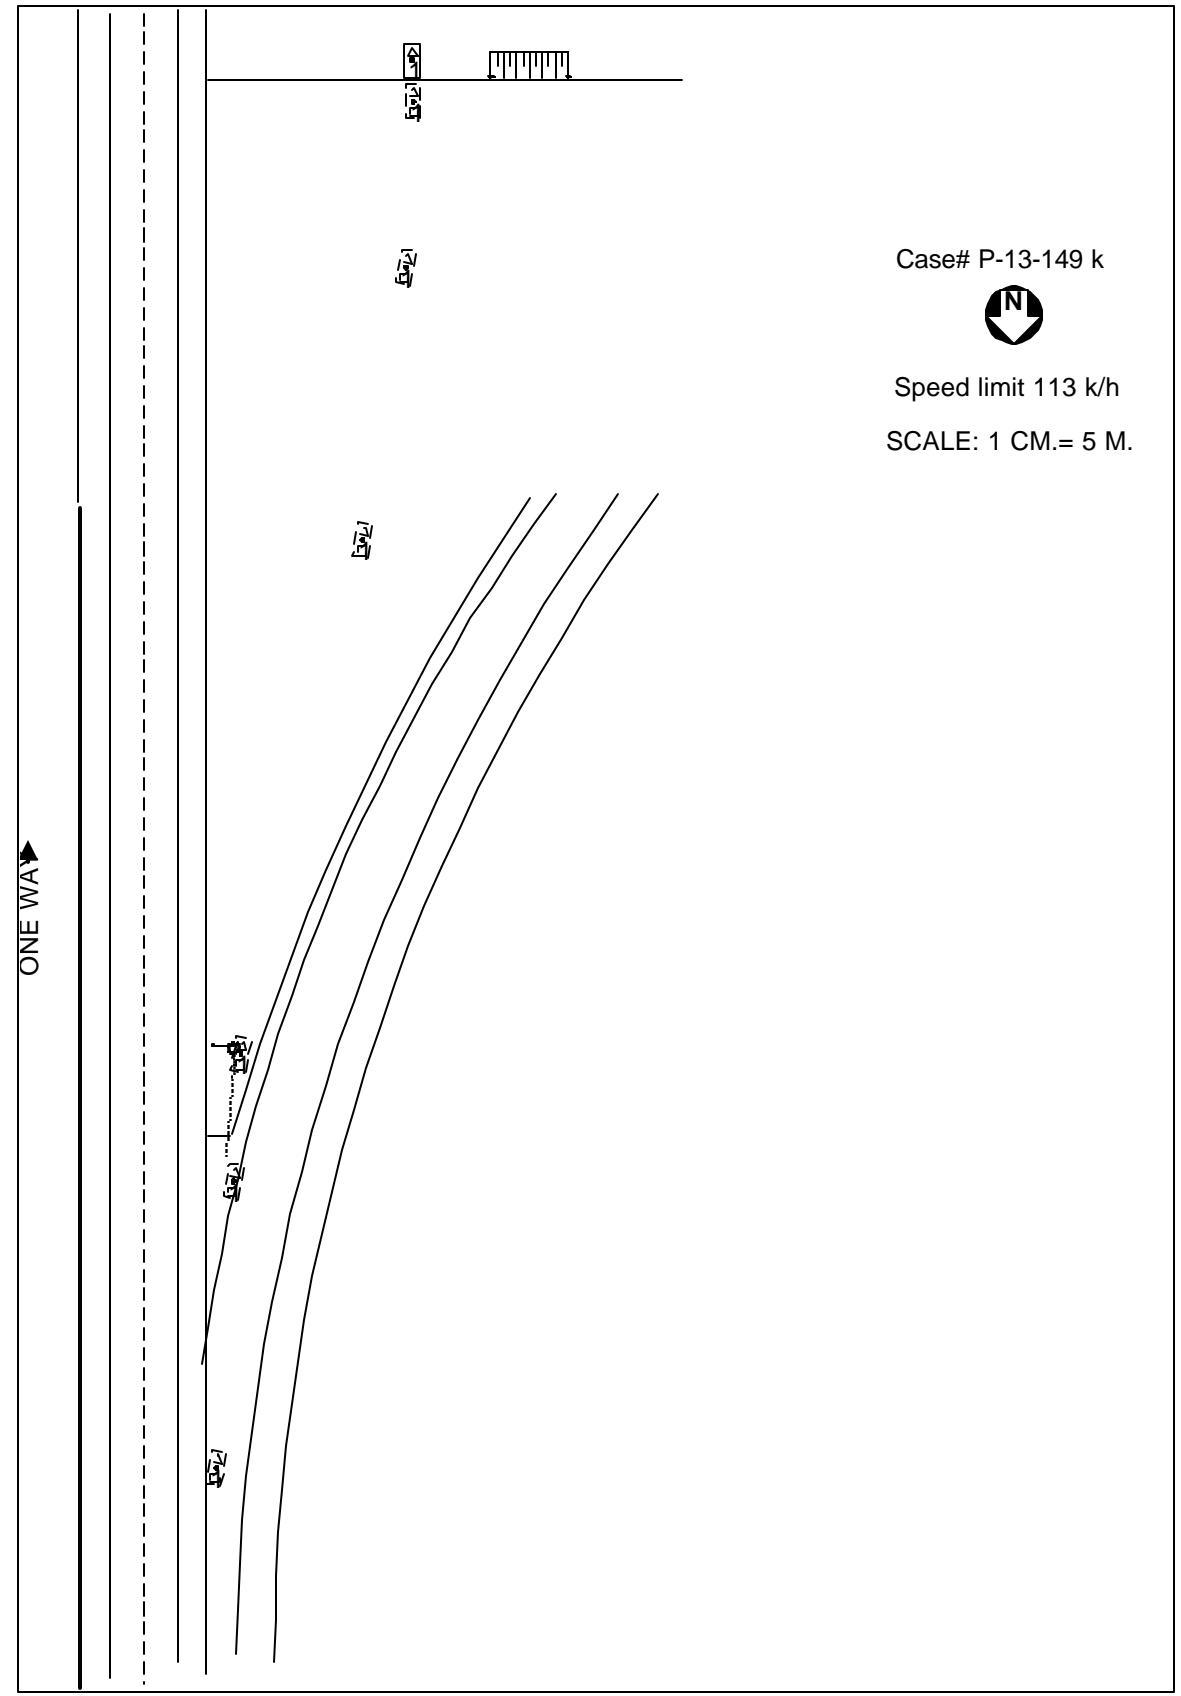
Figure 13. NASS scene schematic

The travel lanes were straight and level. An exit ramp with a right curve was present at the crash site, and a level grassy gore area separated the right side exit ramp from the southbound travel lanes. A sign marked "Exit" was present on the north aspect of the gore. The gore measured 130 m (427') in length and ended at a steep embankment with a positive slope adjacent to a roadway and bridge which crossed the highway. There were no traffic controls present at the scene. The posted speed limit for the divided highway was 113 km/h (70 mph). The NASS scene schematic is included as **Figure 13** at the end of this report.
