Remote Investigation / Vehicle to Vehicle Dynamic Science, Inc. / Case Number: DS98013 1994 Toyota Corolla 4-door Texas June 1997 This document is disseminated under the sponsorship of the Department of Transportation in the interest of information exchange. The United States Government assumes no responsibility for the contents or use thereof.

## Dynamic Science, Inc. Accident Investigation Case Number: DS98013

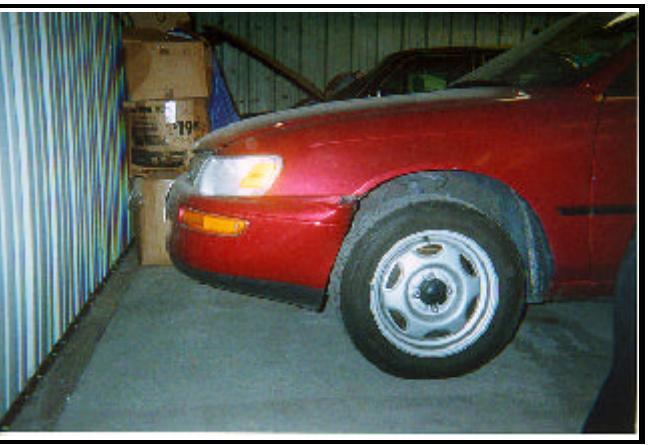
The photographs provided of the front end damage to Vehicle 1 indicate minor damage (see Figure 1).

The damage was assigned a CDC of 12FDLW1 (PDOF =0 degrees).Vehicle 1 sustained a total delta V of 21.6 km/h (13.4 mph), a longitudinal delta V of -21.6 km/h (-13.4 mph)<sup>2</sup>. This is a borderline reconstruction but the results appear reasonable. Vehicle 1 was towed from the scene, but not due to damage. Vehicles 2 was driven from the scene.

Figure 1. Exterior damage to left-front.

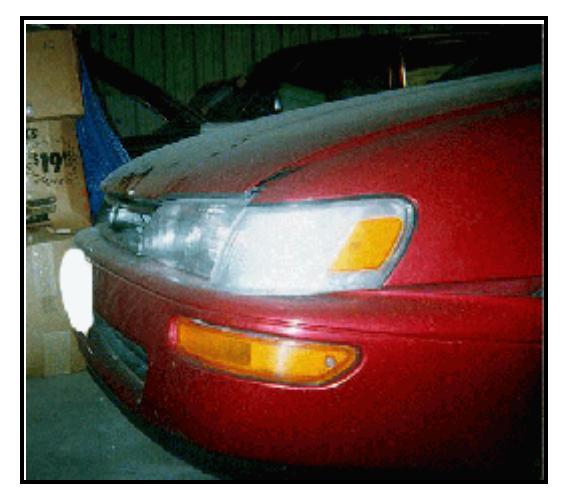
Figure 3. Exterior damage Vehicle 1.

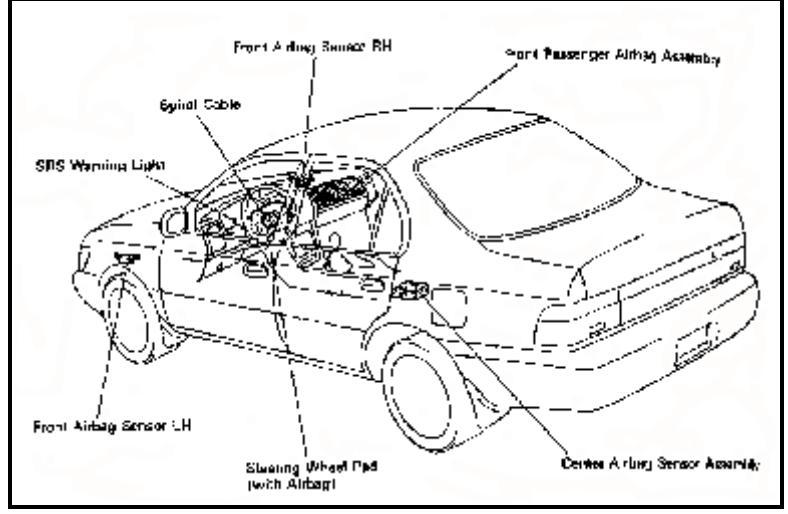
The front right passenger's air bag is rectangular in shape and its dimensions, number of tethers and vent ports are unknown. The single module cover is rectangular in shape and do not appear damaged.

Figure 4. Air bag components.

Blood was splattered about the

driver's air bag, and about the lower front quadrant of the passenger's air bag.

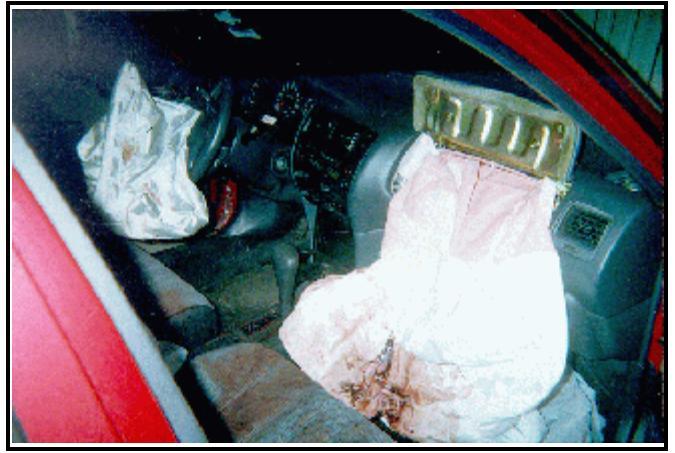
Figure 5. Interior of vehicle.

engaging the deploying air bag with the anterior part of her neck and upper body. There were abrasions and contusions to the anterior area of her neck indicating that the air bag was engaged at some point. As the air bag continued its unfolding pattern, the driver's head was rapidly accelerated rearward causing the laceration and fracture of the cervical spine. There were also critical injuries to her thorax region which are also attributed to the air bag. She also sustained skull fractures, but it is not clear what caused them. After impact with Vehicle 2, Vehicle 1 veered to the right and continued moving forward and struck a concrete curb. It came to final rest on a driveway embankment facing northwest. It appears that the driver came to rest on the front right seat and in contact with the front right seat (see Figure 5).
