Remote, Redesigned Air Bag Special Study <u>FOR NHTSA'S INTERNAL USE ONLY</u> Dynamic Science, Inc., Case Number (1999-074-077C)

1999 Nissan Sentra Nebraska June/1999

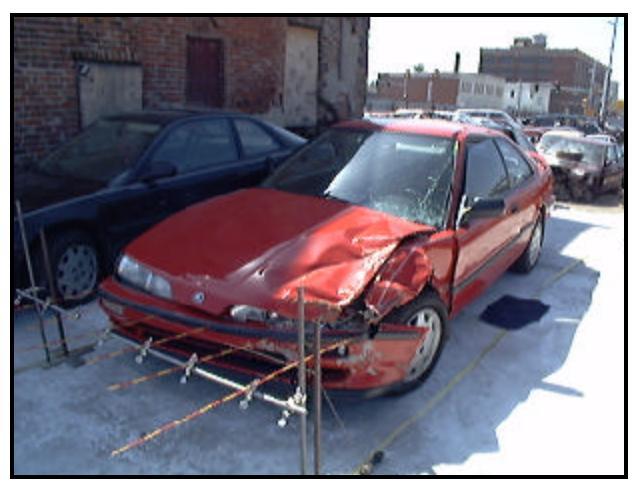
Figure 1. Exterior, Vehicle 1 (1991 Acura Integra)

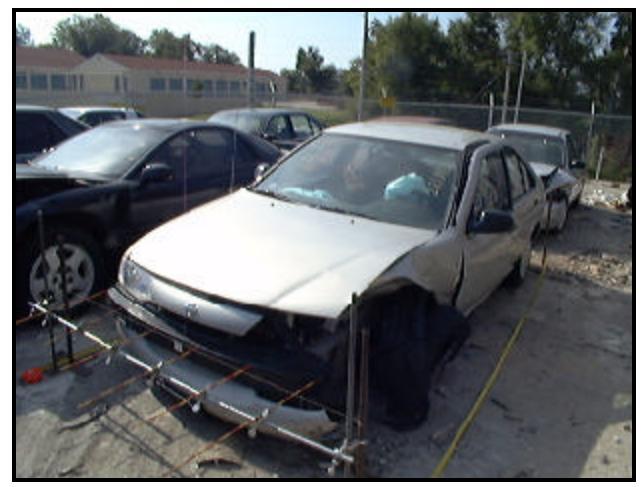
Figure 2. Exterior, Vehicle 3 (1999 Nissan Sentra)

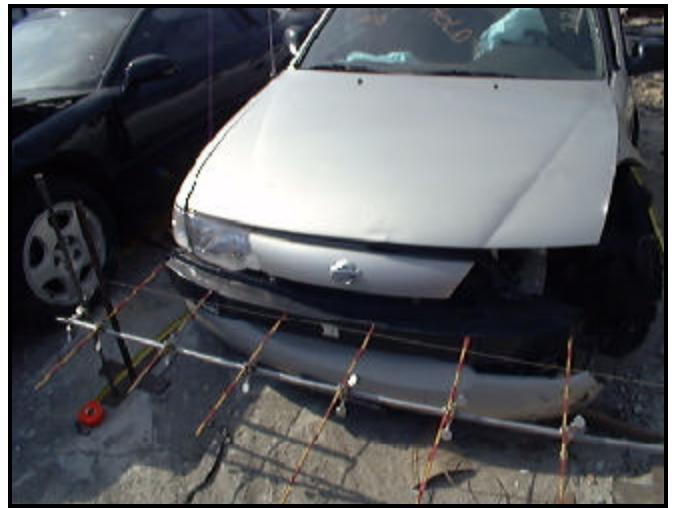
Figure 3. Exterior, Vehicle 3 (1999 Nissan Sentra)

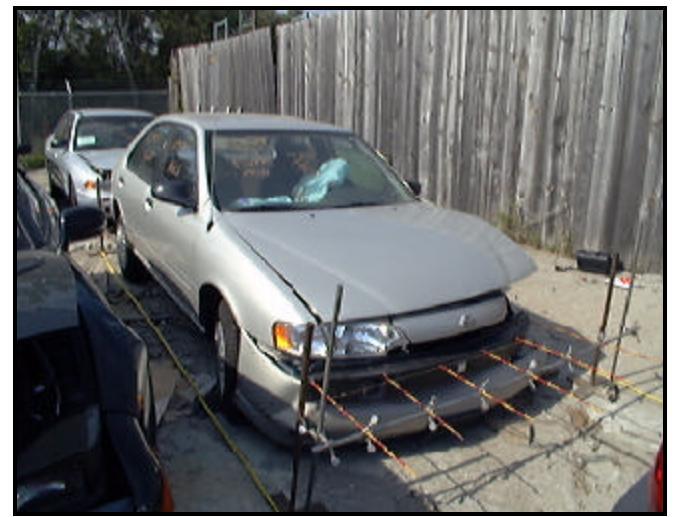
Figure 4. Exterior, Vehicle 3 (1999 Nissan Sentra)

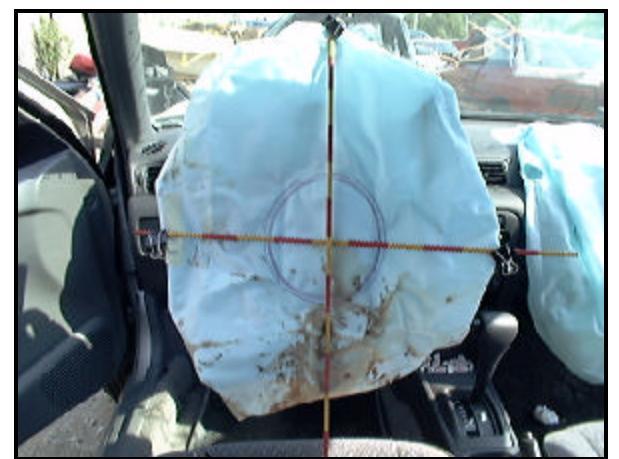
The front left air bag was housed in the steering wheel hub and was concealed by asymmetrical H-configuration cover flaps which were not damage in the crash. The circular air bag was equipped with two vent ports and no tether straps. Contact evidence consisting of blood was found on the lower half of the front of the air bag. The bag was not damaged.

Figure 5. Interior, case vehicle. Driver's frontal air bag.

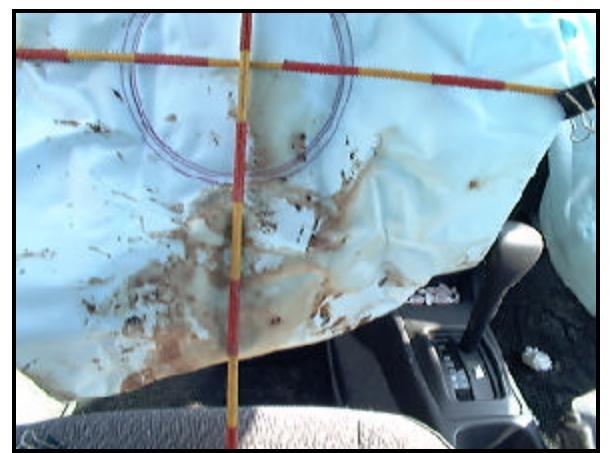
Figure 6. Occupant contact, driver's frontal air bag.

movement of the driver was prevented. Impact with the locked shoulder belt webbing caused the left upper extremity skin contusion. The case occupant also engaged the deploying driver's frontal air bag-causing the nose fracture and multiple facial skin contusions. A significant amount of blood was found on the lower half of the front of the bag (see Figure 6). The case occupant was transported by land to a trauma center where she was treated and released.
