Recall Bulletin 150708ARG

CLASS A:
Fleetwood Flair,
Fleetwood
Storm, Fleetwood
Fleetwood Terra
SE,
Holiday Rambler
Admiral,
Monaco Trek

CLASS C:
Fleetwood
Jamboree Sport,
Fleetwood
Tioga Ranger,
Fleetwood Tioga
Montara

SUBJECT:
Inspection/
Correction of
Propane Tank
Regulator

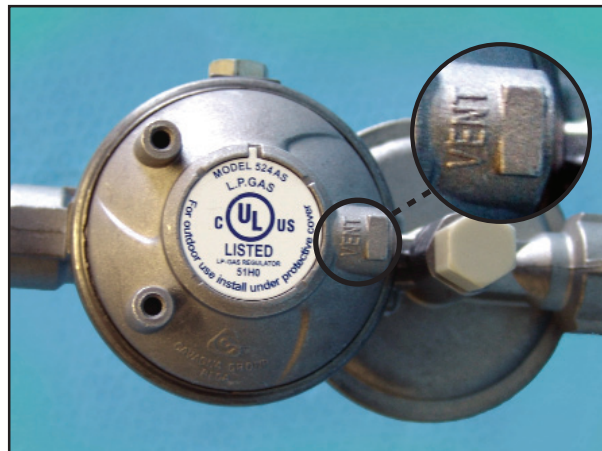
On motor homes affected by this recall, a propane (“LP”) gas tank regulator designed for vertical use may have been installed instead of the specified horizontal-style regulator. An incorrect regulator has vent openings that face horizontally when installed on the subject vehicles, potentially allowing moisture to accumulate inside of the regulator. Under certain conditions temperature conditions this moisture could freeze which may result in improper operation of the regulator. If the regulator fails to operate properly, excessive pressure may build up inside of it, potentially resulting in a propane leak and posing the risk of fire in the presence of an ignition source, resulting in property damage, personal injury, and/or death.

b) An incorrect regulator has vents located parallel with the regulator's inlet and outlet. When installed in the subject vehicles, the vents face horizontal, allowing moisture to accumulate. See Figure 2.

Figure 2
If the regulator's vents face horizontally in the installed position, the regulator is incorrect and must be replaced.

If the regulator is determined to be incorrect, it will need to be replaced; proceed to Correction, below.

4. Shut off the propane at the propane tank. **Ensure the propane gas valve is completely closed before beginning work.**
5. From inside the motorhome, light one burner on the cooktop to purge the propane from the supply lines. After the flame goes out, turn off the burner.
6. Disconnect the supply end of the propane hose from the brass connector.
7. Disconnect the regulator from the propane supply by loosening the POL fitting.
8. While holding the propane regulator stationary, disconnect the brass fitting connected to its outlet port. Remove old thread sealant from the brass fitting. Discard the original regulator.

9. Connect the new regulator to the brass outlet fitting, while holding the regulator stationary with a back-up wrench. Thread locking sealant, such as Locktite 242, must be applied to the threads before assembly. Tighten to 25 - 30 ft.-lbs.
10. Connect the new regulator's POL fitting to the propane supply. Tighten to "snug" plus 1/6 turn. Ensure that the new regulator's vents are pointing down within 45 degrees of vertical after installation.
11. Reconnect the propane supply hose, using pipe thread sealant, such as Rectorseal T-2-PLUS, on the hose fitting.
12. Verify all connections are securely tightened, and then turn on the propane at the tank. Check all reassembled connections for leaks using approved leak detector solution ("bubble spray").
