On-scene Investigation / Vehicle to Vehicle
Dynamic Science, Inc. / Case Number:DS00004
2000 Ford Taurus
Washington
February 2000

1. Report No. DS00004		2. Government Accession No.		3. Recipient Catalog No.	
4. Title and Subtitle In-Depth Accident Investigation				5. Report Date January 18, 2001

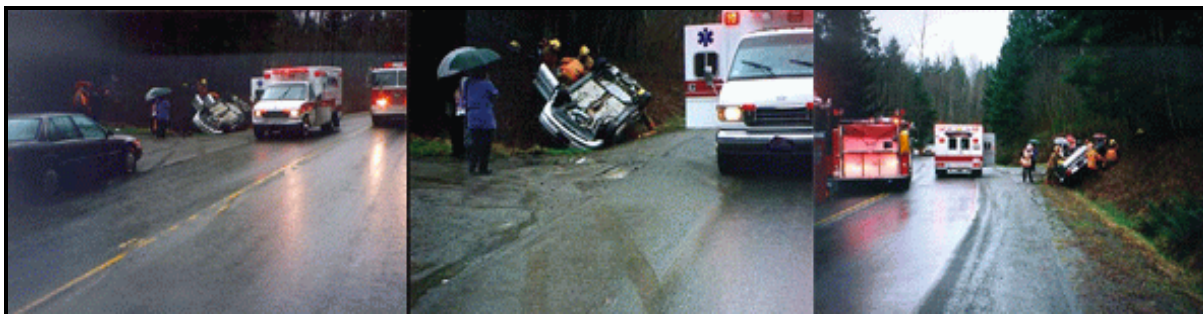
Figure 1. Overview of crash location and final rest (police photos)

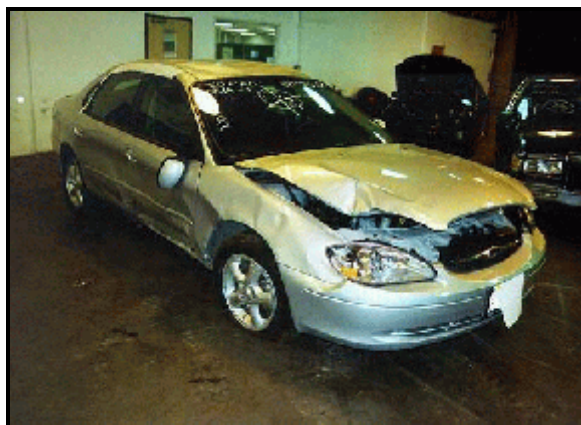
Figure 2. Exterior, 2000 Ford Taurus

Description:	2000 Ford Taurus
VIN:	1FAFP53U4YGxxxxxx
Odometer:	4,970 km (3,088 miles)
Engine:	3.0 L 6 cylinder
Reported Defects:	None
Cargo:	None
Damage Description:	Minor damage to front right fender, front right door, and the roof rail. Both right doors were jammed shut. There was intrusion on the right side (B pillar) and through the roof.
CDC:	00RDA02
Delta V:	Unknown

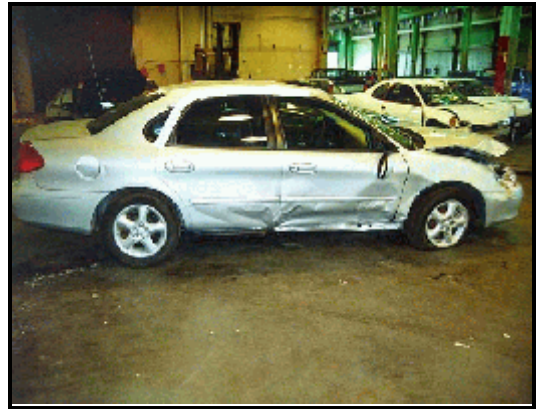
As the case vehicle entered the curve, the driver lost control and the vehicle went into a counterclockwise rotation. The case vehicle rotated approximately 180 degrees while crossing through the westbound lanes. The case vehicle departed the roadway with its right side leading. As the case vehicle departed the roadway the vehicle tripped as it went into a shallow ditch, and rolled onto its right side (00RDAO2) and its roof. The right front passenger's side air bag deployed at this time. The vehicle came to rest at a 45 degree angle on its roof and right side. The Ford Taurus sustained minor damage to the front right fender, the front right door, and the roof rail. Both right side doors were jammed shut.

Figure 3. Exterior, case vehicle

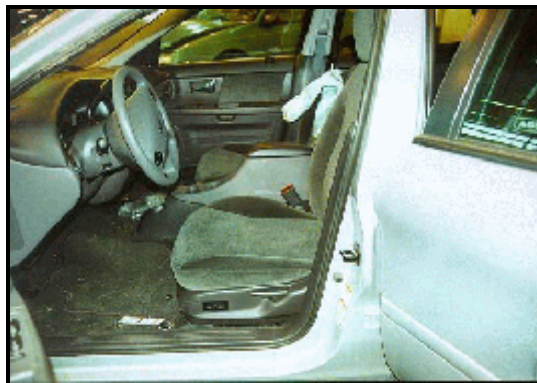
Figure 4. Driver's seating area

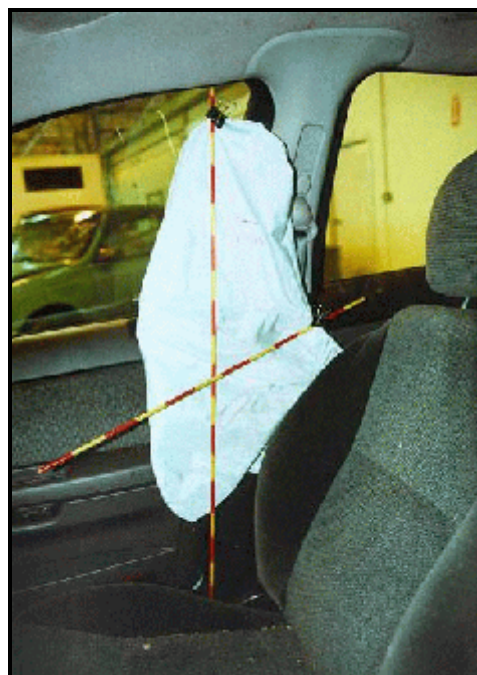
The front right seat position was equipped with a seat-mounted side air bag. The air bag was equipped with a single tether and no vent ports. The bag is vaguely rectangular and measures 64 cm (25 in.) high by 29 cm (11.4 in.) wide at its base. There was no indication of a contact to the air bag nor any damage.

Figure 5. Deployed right front passenger's side air bag

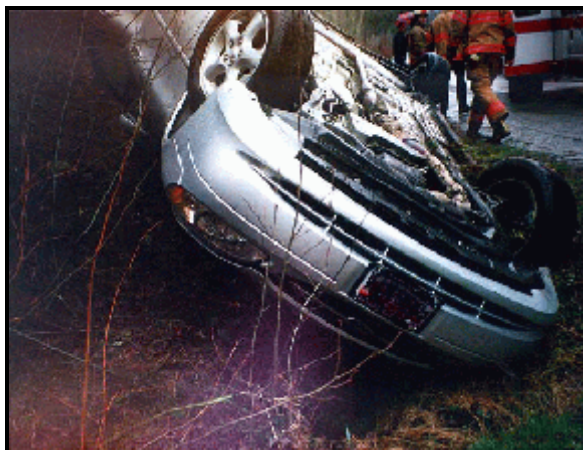
Figure 7. Case vehicle final rest configuration

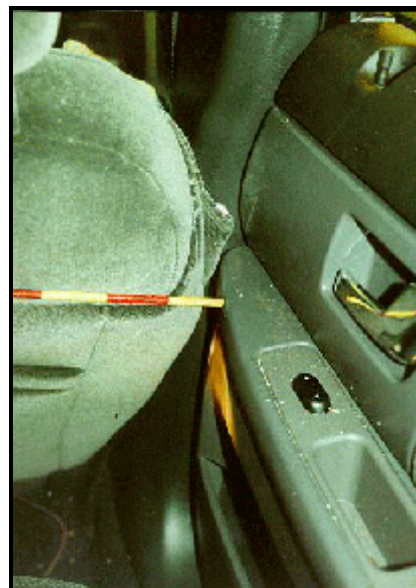
Figure 8. Right side B pillar intrusion

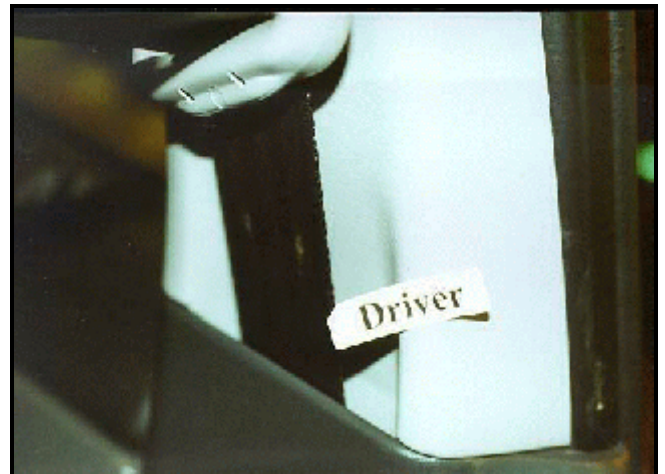
The 30-year-old female driver of the case vehicle was seated in a normal, upright fashion. She was wearing the available lap and shoulder belts. The belt anchorage was in the full down position and the tilt steering wheel was in the middle position. The seat track was in the rear most position and the seat back was set a 4 degrees from vertical. As the case vehicle went into the curve, the driver lost control and the vehicle went into a counterclockwise rotation. This movement would have caused the driver to move to the right. The vehicle continued this motion until tripping onto its right side. As the vehicle went over, the driver engaged the torso belt in a mostly vertical fashion—causing the contusion to the breast area. The tripping motion and rollover impact would have caused the driver to further load the seat belts to the right. Witnesses opened the vehicle and released the driver from the seat belts.

Figure 9. Load marks to driver's seat belt
