On-scene Investigation / Vehicle to Vehicle
Dynamic Science, Inc. / Case Number: DS00007
2000 Ford Taurus
Missouri
April 2000

1. Report No. DS00007		2. Government Accession No.		3. Recipient Catalog No.	
4. Title and Subtitle In-Depth Accident Investigation				5. Report Date December 7, 2000

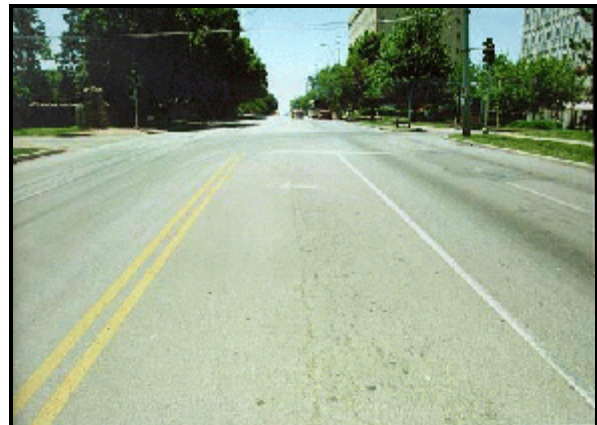
Figure 1. Path of other vehicle to area of impact (south)

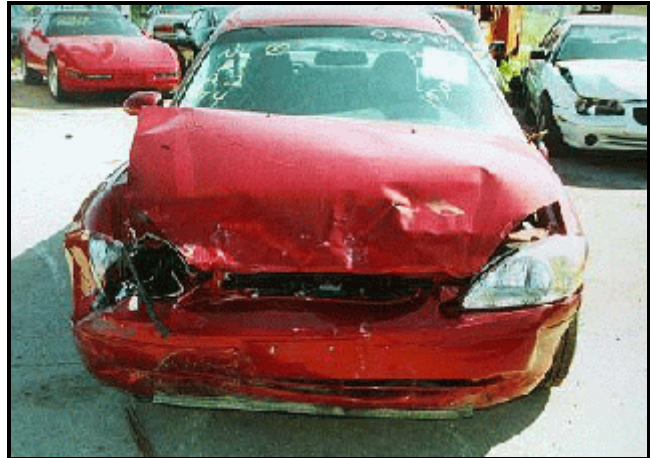
As the vehicles reached the intersection, the Plymouth Acclaim began a left hand turn. The front of the case vehicle (11FDEW2) struck the right front of the Plymouth Acclaim.

Figure 2. Front view, Ford Taurus

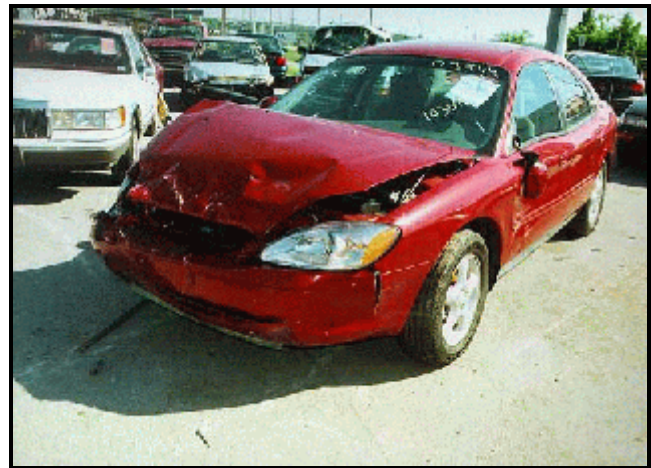
The case vehicle rotated in a clockwise direction after the initial impact and the other vehicle was pushed in a counterclockwise direction. There was a second, "side-slap" type impact on the driver's door.

Figure 3. Left front quarter view, Ford Taurus. Shows second impact

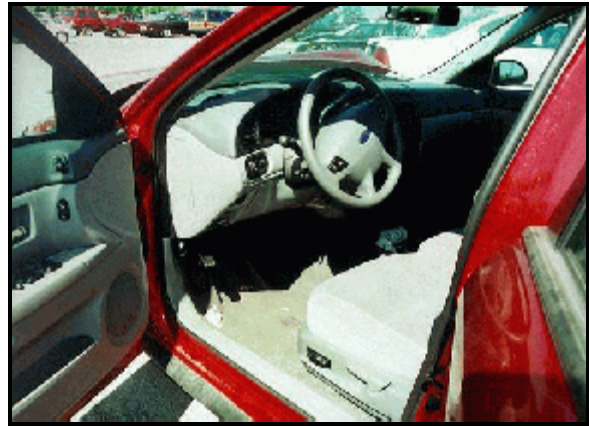
The driver's air bag and the front right passenger's air bag did not deploy. The driver's side seat belt pretensioner did however fire at this time. The pretensioner tube measurement on the driver's side was 3 cm (1.2 in.). There was no movement of the steering column shear capsules.

Figure 4. Left front seating position

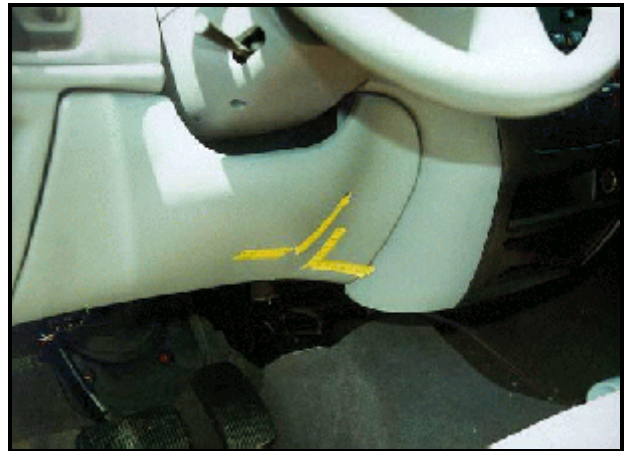
Figure 7. Knee contact to lower instrument panel

The 44-year-old male driver of the case vehicle was seated in a normal upright fashion in the cloth covered front left bucket seat. The seat was adjusted to between the middle and rear most track positions. He was wearing the available lap and shoulder belt—the shoulder belt upper anchorage was adjusted to the full down position. The driver of the case vehicle saw the other vehicle prior to impact and began braking with his right foot. At impact, the driver pitched forward and to the left before being cinched down by the seat belt pretensioner. The driver did not recall contacting any interior surfaces of the vehicle; however, there was an indication of a right knee contact to the lower instrument panel (see Figure 7). There was a second, side-slap impact with the other vehicle. This would have caused this occupant to move the left, but there were no indications of any contact.

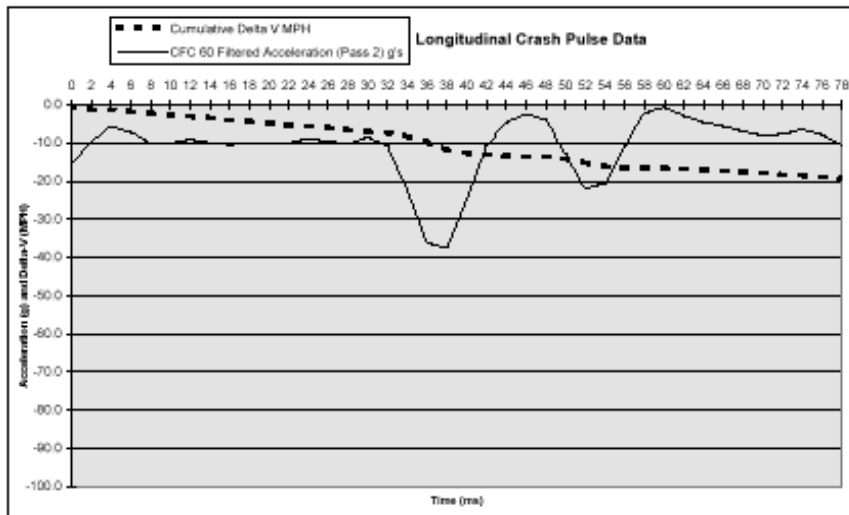
Longitudinal Cumulative Delta-V

Time (ms)	0	10	20	30	40	50	60	70	78
Delta-V (MPH)	-0.7	-2.7	-4.8	-6.9	-12.6	-14.1	-16.6	-17.9	-19.3

The case vehicle sustained a longitudinal delta v of -37.5 km/h (-23.3 mph)¹ as computed by WinSmash. The downloaded Electronic Data Recorder (EDR) data indicates a cumulative longitudinal delta v of -31 km/h (-19.3 mph) at the 78 ms mark. The data indicates that the driver's seat belt was engaged and that the pretensioner on the driver's side fired. The EDR report is included as an attachment to this report.

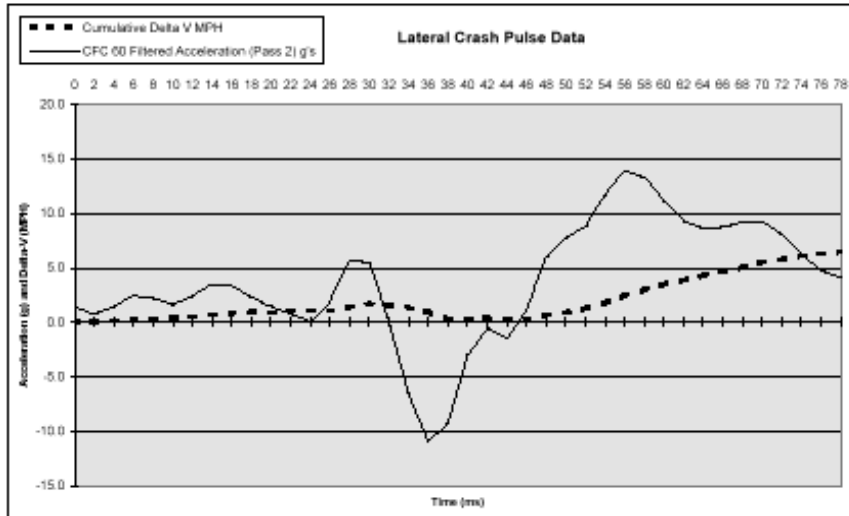
Lateral Cumulative Delta-V

Time (ms)	0	10	20	30	40	50	60	70	78
Delta-V (MPH)	0.1	0.4	1.0	1.7	0.4	0.9	1.5	5.5	6.5
