On-scene Investigation / Vehicle to Vehicle
Dynamic Science, Inc. / Case Number: DS00016
2000 Ford Taurus
Arkansas
June, 2000

1. Report No. DS00016		2. Government Accession No.		3. Recipient Catalog No.	
4. Title and Subtitle In-Depth Accident Investigation				5. Report Date February 5, 2001

Dynamic Science, Inc.
Accident Investigation
Case Number: DS00016

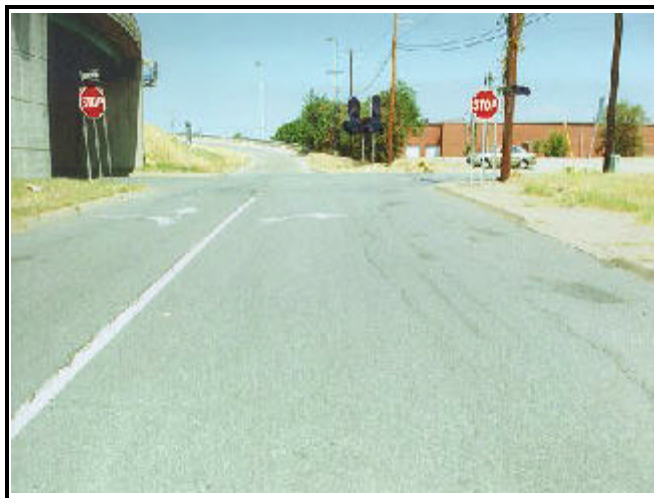
Figure 1. Case vehicle's approach to area of impact (north).

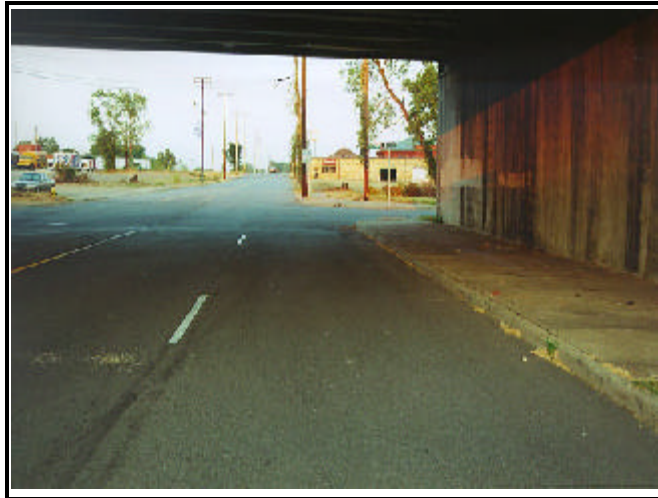
Figure 2. Other vehicle's approach to the area of impact (east).

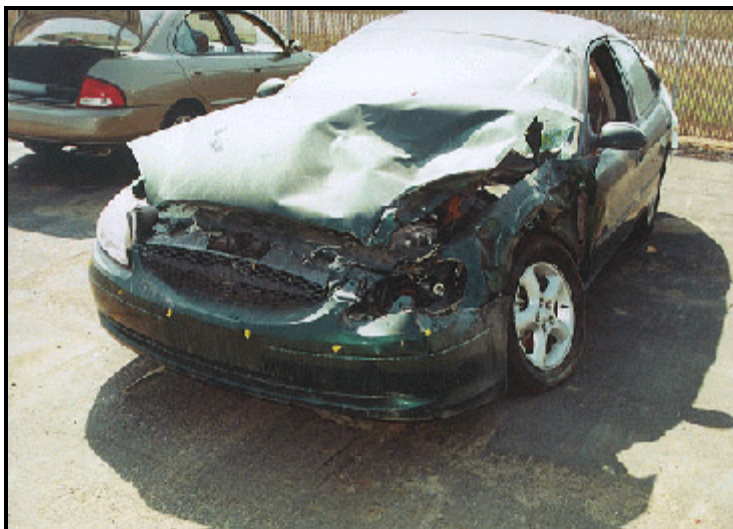
Figure 3. Front left view of case vehicle

Description:	2000 Ford Taurus SE 4-door	
VIN:	1FAFP53U4YAxxxxxx	
Odometer:	13,945 km (8,665 miles)	
Engine:	3.0 L	
Reported Defects:	None	
Cargo:	None	
Damage Description:	Moderate side damage to left front fender from the initial impact. The left axle was deformed. There was damage to the C-pillar and the left rear from the side-slap impact.	
CDC:	Impact 1: 10LYEW2 Impact 2: 09LYGW2	
Delta V (Impact 1) ² :	Total	15.3 km/h (9.5 mph)
	Longitudinal	-5.2 km/h (-3.3 mph)
	Latitudinal	14.4 km/h (9.0 mph)
	Energy	26,081 joules (19,242 ft-lbs)

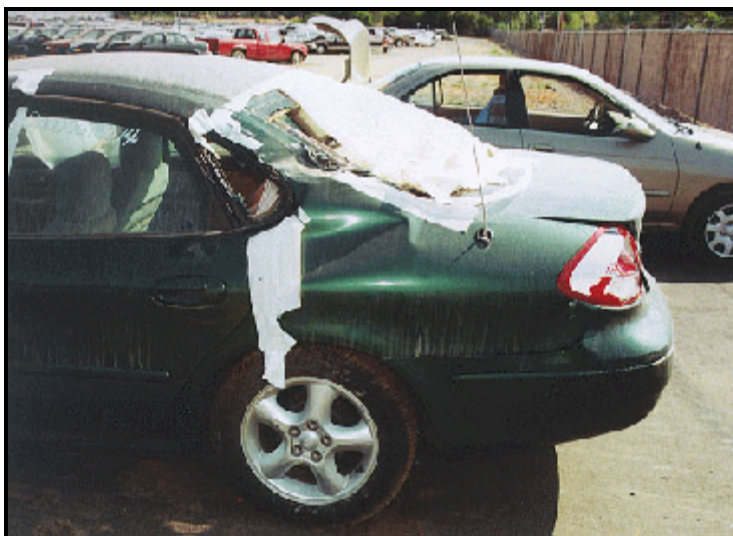
Figure 4. Case vehicle, left side, second impact

After impact, the case vehicle rotated clockwise and there was a second impact between the case vehicle and the other vehicle; the left rear C-pillar and backlight area of the case vehicle side-slapped the right side of the other vehicle.

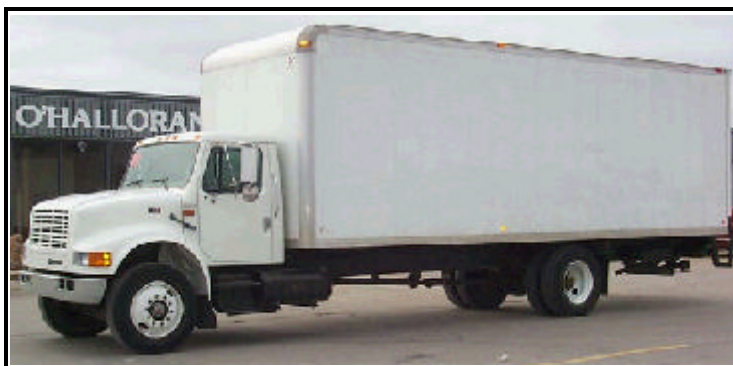
Figure 5. Exemplary 1 1998 International 4700 4x2 80 in steel cab

Description: 1998 International 4700 4x2 van body heavy truck, 25,500 GVW

Length	701 cm (276 in.)
Width	244 cm (96 in.)
Height	373 cm (147 in.)

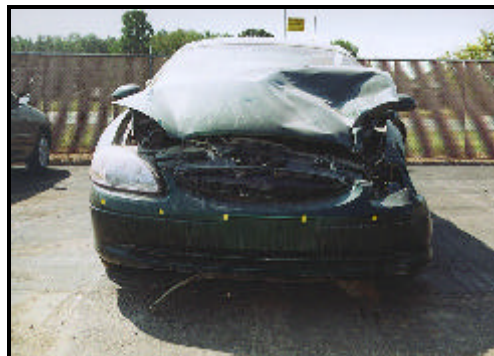
Figure 8. Front, case vehicle

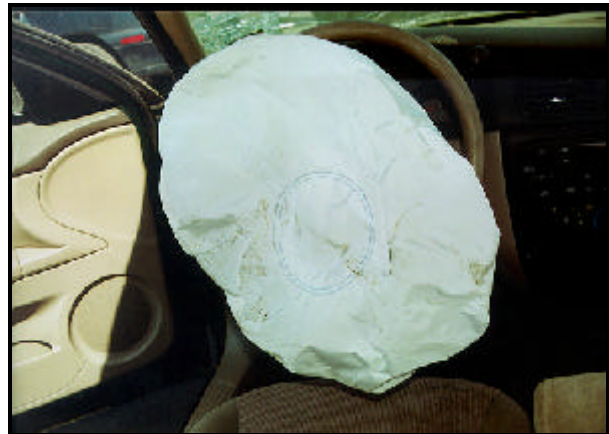
Figure 9. Driver's air bag

The driver’s air bag was circular and measured 44 cm (17.3 in.) in diameter. It was equipped with two tethers and two vent holes. There was grease/dirt on the face and back of the air bag. It appears that this was not due to occupant contact. The module cover opened in an “H” configuration. There were no indications of any damage to the cover or air bag.

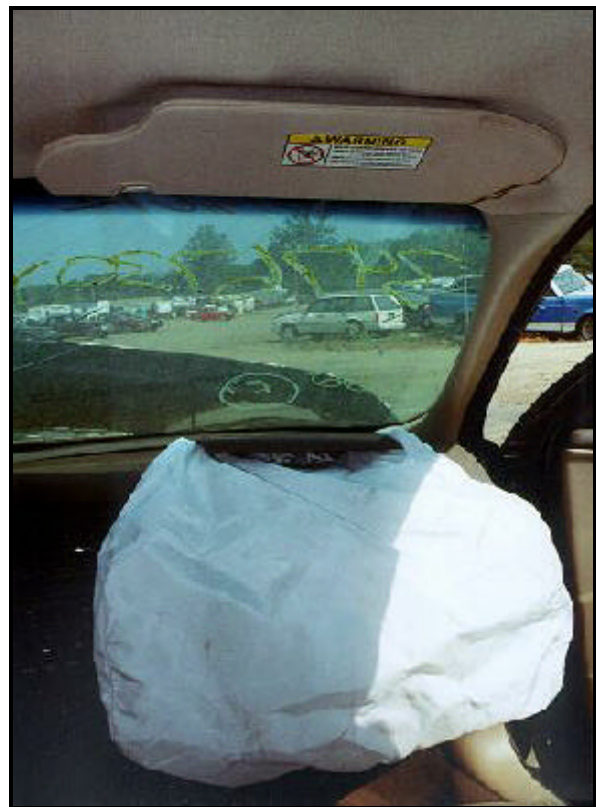
Figure 10. Front right passenger air bag

The front right passenger’s air bag was rectangular and measured 44 cm (17.3 in) by 55 cm (21.7 in). It was equipped with two vent ports and did not have any tethers. On the face and back of the passenger’s air bag there was black smudging that was due to contact with the module cover. The single flap module cover opened properly. There were no indications of damage to the front right passenger’s air bag or module cover.

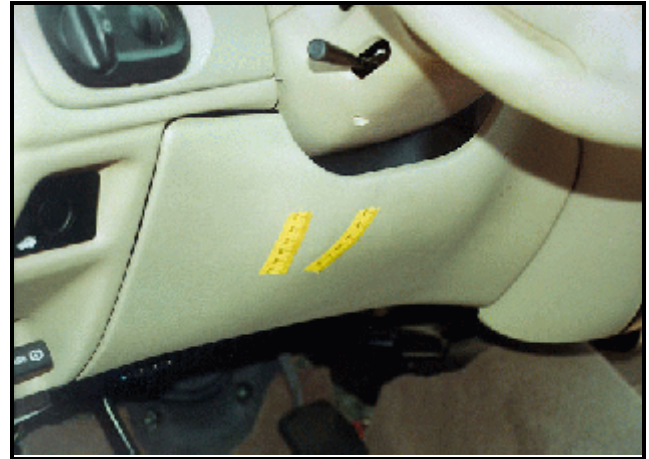
Figure 11. Driver position, possible knee contact

The driver of Vehicle 1 was seated in a normal, upright position. He was wearing the available lap and shoulder belt. As the case vehicle was broadsided by the other vehicle, the driver of the case vehicle responded to the 290E direction of principal force by moving to the left and forward—striking the door panel which caused the left shoulder contusion and engaging the deploying air bag with the left side of his chest which caused a minor contusion. As the case vehicle rotated clockwise and side-slapped the right side of the other vehicle with its rear left side, the driver responded to 270E direction of principal force by moving to the left. There was no evidence of loading on the steering column, there was no indication of shear capsule movement.

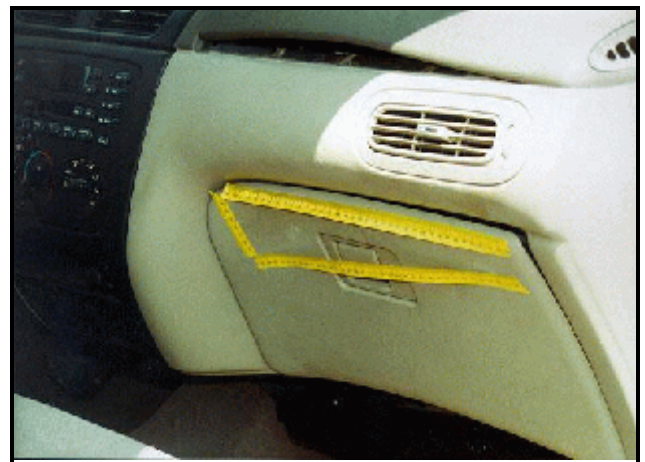
Figure 12. Front right occupant, knee contacts

The front right occupant was seated in a normal, upright position. She was using the available lap and shoulder belt. During the first impact—broadside of the case vehicle's left front—the front right occupant responded to the 290E direction of principal force by moving laterally to the left and forward—loading her torso belt and causing the chest contusion and then striking the lower instrument panel causing the bilateral knee contusions. The front right passenger's air bag deployed and this occupant likely contacted it to some degree, though there was no evidence of any specific contact. As the case vehicle rotated clockwise and side-slapped the right side of the other vehicle with its rear left side, the front right occupant responded to 270E direction of principal force by moving to the left.

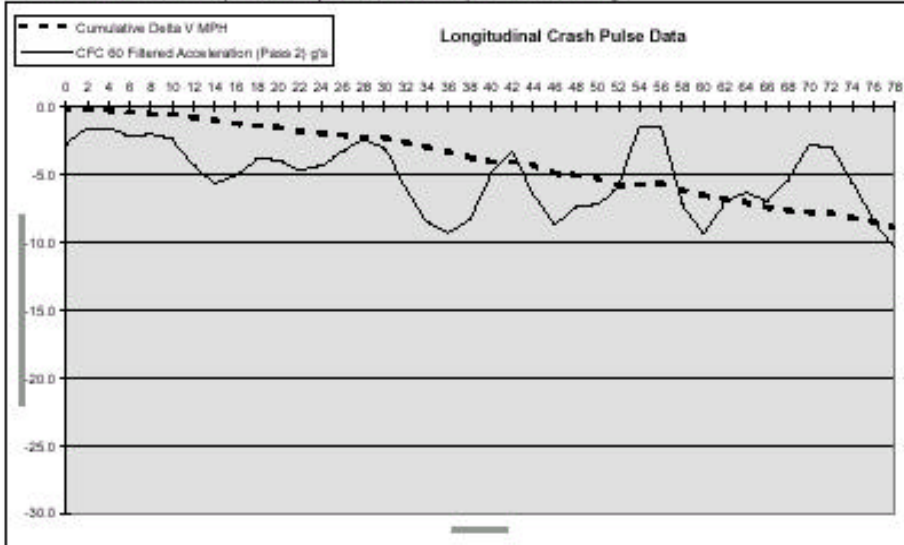
Longitudinal Cumulative Delta-V

Time (ms)	0	10	20	30	40	50	60	70	78
Delta-V (MPH)	-0.2	-0.5	-1.5	-2.2	-4.0	-5.2	-6.5	-7.7	-8.9

The case vehicle sustained a total Δv of 15.3 km/in (9.5 mph), a longitudinal Δv of -5.2 km/in (-3.3 mph) and a latitudinal Δv of 14.4 km/in (9.0 mph) as computed by WinSmash. This is a borderline reconstruction and the results appear low. The EDR report shows a longitudinal cumulative Δv of 14.3 km/h (-8.9 mph) at the 78 ms mark and a lateral cumulative Δv of 21.7 km/h (13.5 mph) at the 78 ms mark. The EDR report is included as an attachment to this report.

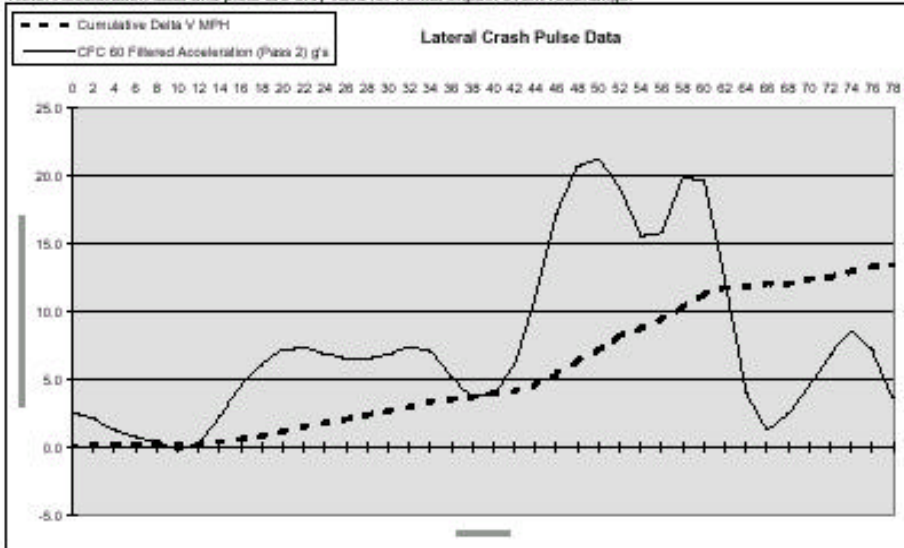
Lateral Cumulative Delta-V

Time (ms)	0	10	20	30	40	50	60	70	78
Delta-V (MPH)	0.1	0.3	1.4	3.7	8.0	12.2	13.3	12.4	13.5
