**VERIDIAN ON-SITE ADVANCED OCCUPANT PROTECTION SYSTEM
INVESTIGATION
VERIDIAN CASE NO. CA00-021
VEHICLE: 2000 FORD TAURUS SE
LOCATION: TENNESSEE
CRASH DATE: MAY 2000**

1. <i>Report No.</i> CA00-021	2. <i>Government Accession No.</i>	3. <i>Recipient's Catalog No.</i>	
4. <i>Title and Subtitle</i> Veridian On-Site Advanced Occupant Protection System Investigation Vehicle: 2000 Ford Taurus SE Location: Tennessee		5. <i>Report Date:</i> March, 2001

14. <i>Sponsoring Agency Code</i>	
15. <i>Supplementary Notes</i> On-site investigation of a 2000 Ford Taurus that was equipped with an Advanced Occupant Protection System.

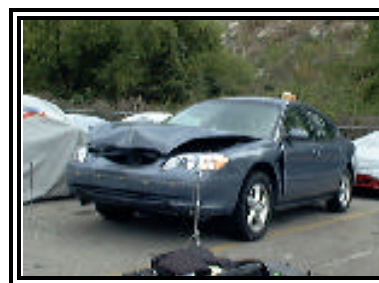
Figure 1. Front left three-quarter view of the 2000 Ford Taurus.

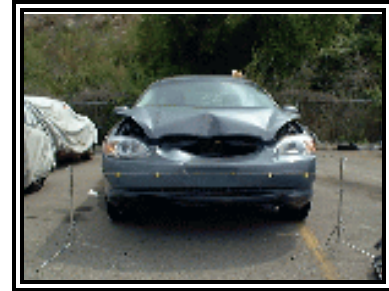
The center frontal area of the Ford Taurus impacted the wooden utility pole. The 12 o'clock direction of force impact crushed the front bumper system, the hood face, and the radiator support panel (**Figure 2**). Maximum crush was 19.3 cm (7.6") located on the bumper beam 9.5 cm (3.75") right of the vehicle's centerline. The damage algorithm of the WinSMASH program computed a total velocity change of 18.5 km/h (11.5 mph) with a matching longitudinal component. The velocity change was below the threshold required for the frontal air bag first stage deployment. Additionally, the driver's seat belt buckle pretensioner did not fire. The EDR output data identified the restraint system as engaged.

Figure 2. Center frontal damage to the Taurus.

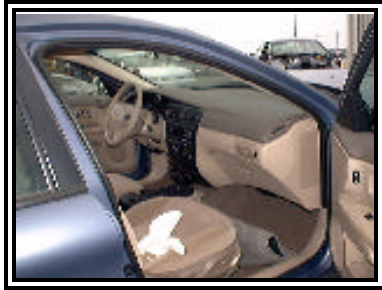
The Taurus was equipped with the Advanced Occupant Protection System (AOPS) that included a center front mounted crash sensor, dual stage inflators for the frontal air bags (**Figure 3**), a driver's seat positioning sensor, front seat belt buckle pre-tensioners (**Figure 4**), load force limiters in the front seat belt retractors, and a center tunnel mounted Restraints Control Module that had sensing and Event Data Recording capabilities. Although the Taurus sustained a center frontal impact, the external crash sensor was not damaged. The Taurus was not equipped with the adjustable pedal option or side impact air bags.

Figure 3. Interior view of the non-deployed frontal air bag modules.

This longitudinal component did not meet the threshold to fire the driver’s seat belt buckle pre-tensioner or the frontal air bag system. Therefore, the algorithm times recorded from wake-up to pretensioner and air bag deployment are 0 ms.

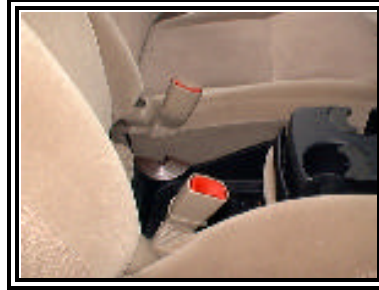
Figure 4. Non-fired front seat belt buckle pretensioners.

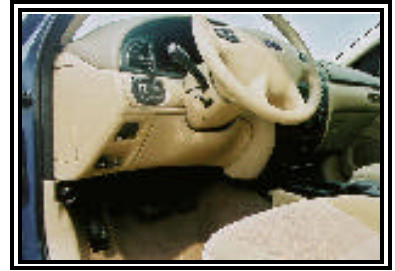
The 20 year old male driver of the 2000 Ford Taurus was presumed to be in an upright driving posture and properly restrained by the manual belt system. At impact, he responded to the 12 o'clock direction of force by initiating a forward trajectory and loading the manual belt system. The belt system provided adequate crash protection and prevented the driver from contact with interior components (**Figure 7**). He was not injured and refused medical treatment at the scene.

Figure 7. Steering wheel rim and knee bolster lacking contact evidence.

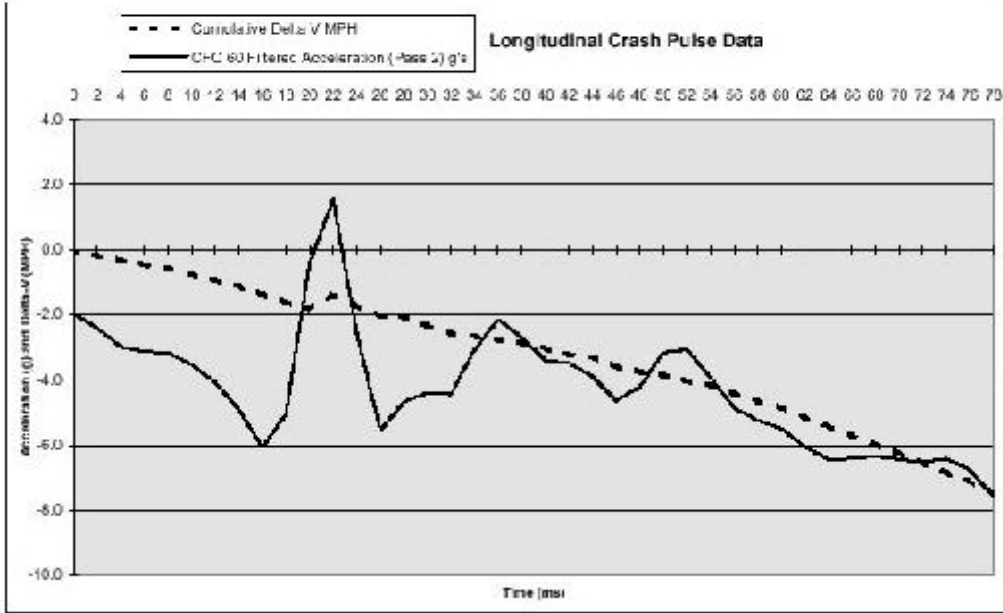
Longitudinal Cumulative Delta-V

Time (ms)	0	10	20	30	40	50	60	70	78
Delta-V (MPH)	-0.1	-3.7	-1.8	-2.3	-2.8	-3.3	-4.8	-6.3	-7.8

The EDR recorded the status of the driver belt system as buckled and the status of the front right passenger belt system as unbuckled. This was consistent with the police report identifying the driver as the sole occupant of the vehicle at the time of the crash. The EDR recorded a longitudinal delta V of -12.1 km/h (-7.5 mph) that occurred at 78 ms (end of recording time) with a lateral delta V of -1.9 km/h (-1.2mph). The longitudinal crush pulse was increasing at the 78 ms termination point of the EDR, therefore, the WinSMASH generated delta V of -18.5 km/h (-11.5 mph) may be a more realistic estimate of the total pulse experienced by the Taurus.
