REMOTE CHILD AIR BAG-RELATED FATALITY INVESTIGATION

CASE NUMBER - IN-03-035
LOCATION - Illinois
VEHICLE - 1997 Ford Taurus
CRASH DATE - August 2003

14. Sponsoring Agency Code		
15. Supplementary Notes Remote investigation of an air bag deployment crash involving a 1997 Ford Taurus that impacted a legally parked lowboy trailer.

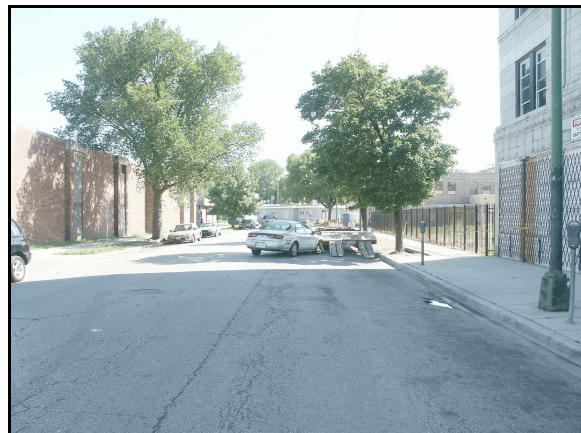
Figure 1: Case vehicle's southbound approach toward impact, showing case vehicle and parked trailer at final rest (case photo #01)

The case vehicle's front right corner impacted the trailer's back left corner, causing the case vehicle's driver and front right passenger air bags to deploy. The case vehicle pushed the trailer forward approximately 0.6 meters [2 feet] (as evidenced by scraping on the pavement by the case vehicle's front right wheel), rotated clockwise a few degrees and came to rest.

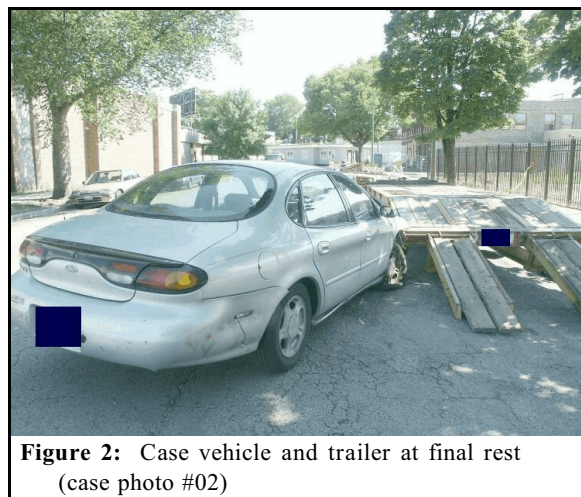
Figure 2: Case vehicle and trailer at final rest (case photo #02)

The case vehicle impacted a legally parked, disconnected and unattended 2000 Dynaweld lowboy trailer (VIN: 4U161AEX0Y1-----) that was used to haul heavy construction equipment (**Figures 2, 3 and 4**). The trailer's length, curb weight, number of axles and manner of attachment to a power unit are not known. The back end of the trailer's deck sloped down and had folding ramps to enable the loading and unloading of heavy machinery, and the ramps were folded down at the time of the crash. There is no evidence visible in the available photographs that the trailer sustained any damage as a result of the crash.

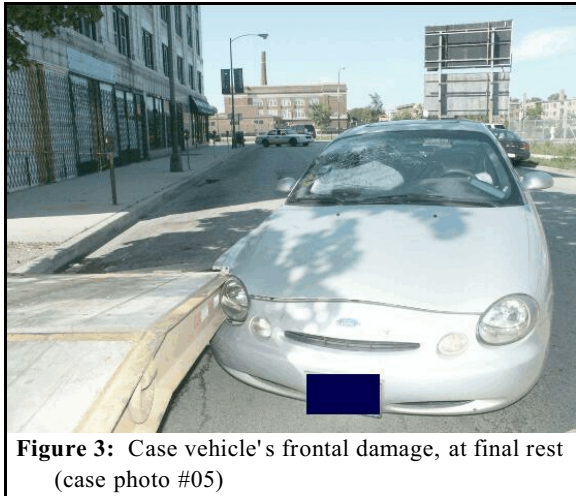
Figure 3: Case vehicle's frontal damage, at final rest (case photo #05)

The case vehicle sustained a very narrow impact at its extreme front right corner, outboard of the right headlamp assembly, above the bumper and below the engine hood (**Figure 3**). The trailer's steel frame penetrated into the case vehicle's wheel well and impacted the tire, displacing the wheel and tire rearward and damaging the right front suspension (**Figure 4**). The right headlamp and the front portion of the vinyl bumper cover were not damaged. The trailer's penetrating steel frame member sliced through the bumper cover on the side and caused slight direct contact damage and substantial induced damage to the right fender, with the fender crushed and pushed rearward such that it was jammed against the right front door. The engine hood was forced slightly upward. The right front wheel/tire assembly was pushed rearward, against the trailing edge of the wheel well. The right front tire's outboard sidewall was torn and punctured and the tire was deflated, with no damage to any other wheel or tire. The right side of the windshield was heavily cracked and there was no other glazing damage. The case vehicle had various dents and scrapes on several different portions of its body, but these were judged to be pre-existing damage.

The CDC for the case vehicle's single impact was estimated from the available photographs as **12-FRME-2 (0 degrees)**. This impact is out of scope for the WinSMASH reconstruction program. This contractor estimates that this was a crash of low severity (14-23 km.p.h. [9-14 m.p.h.]) for the case vehicle.

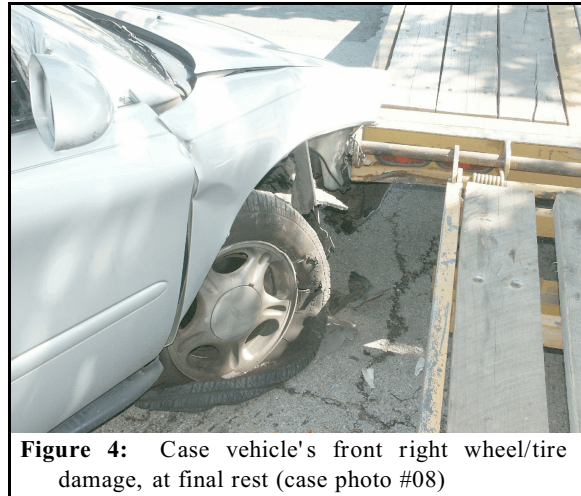
Figure 4: Case vehicle's front right wheel/tire damage, at final rest (case photo #08)

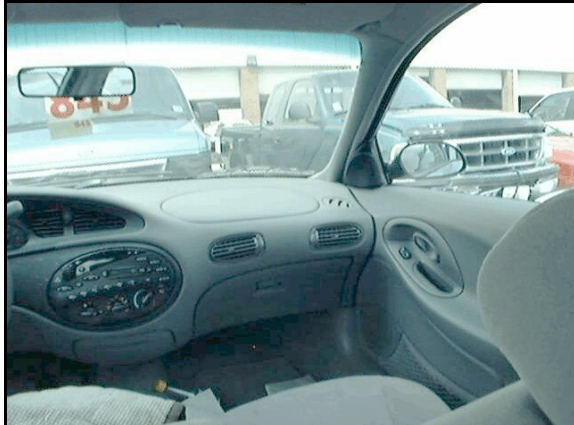
Figure 5: EXEMPLAR vehicle, showing non-deployed front right passenger's air bag module NOT THE CASE VEHICLE (case photo #13)

The front right passenger's air bag module was mounted in the top of the instrument panel on the right side. The cover flap is not visible in any of the available photographs. Photographs of exemplar 1997 Ford Taurus vehicles were obtained to illustrate the manner in which the front right passenger air bag was installed (**Figures 5 and 6**). The cover flap is oval (**Figure 5**) and is not hinged, such that, upon deployment, the entire cover flap is forced upward by the expanding air bag. The cover flap is attached to the module by fabric tether straps (**Figure 6**).

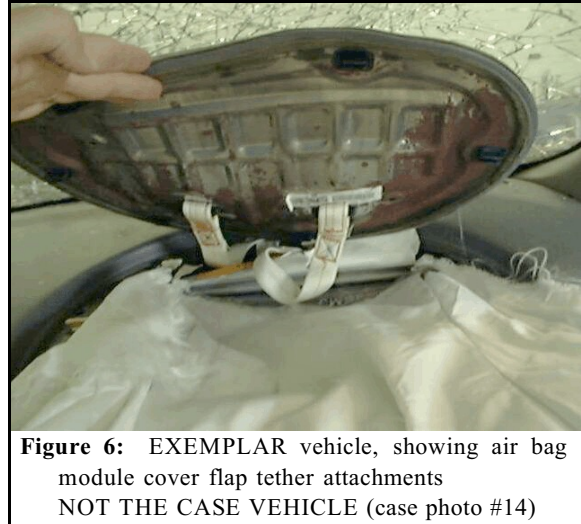
Figure 6: EXEMPLAR vehicle, showing air bag module cover flap tether attachments NOT THE CASE VEHICLE (case photo #14)

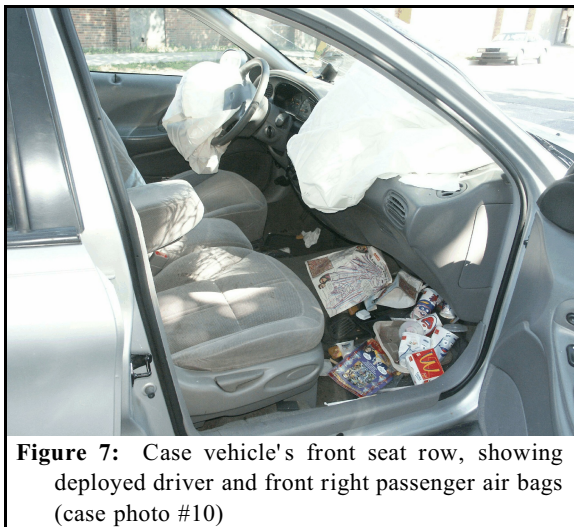
The case vehicle was equipped with driver and front right passenger first generation air bags. Both air bags deployed as a result of the single frontal impact (**Figure 7**).

Figure 7: Case vehicle's front seat row, showing deployed driver and front right passenger air bags (case photo #10)

The driver's air bag was mounted in the steering wheel hub. The size and shape of the driver's air bag are not known. The available photographs do not show any obvious evidence of occupant contact or damage to the air bag (**Figure 7**).

The case vehicle's front right passenger air bag module cover flap struck the case vehicle's windshield, causing extensive cracking in the lower and center areas. The size and shape of the air bag are not known. There is no obvious evidence of occupant contact or damage to the air bag visible in the available photographs (**Figures 7 and 8**).

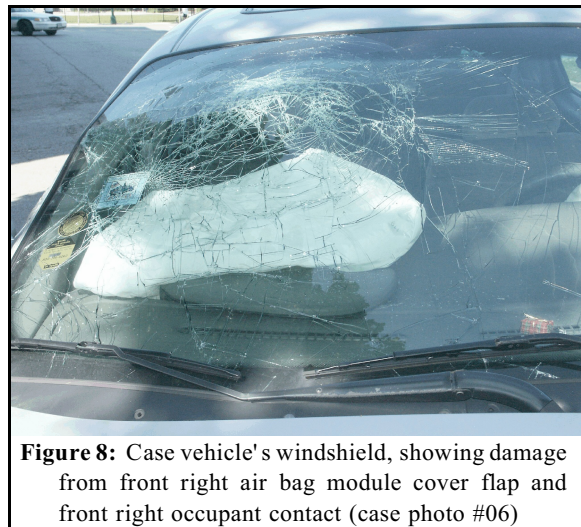
Figure 8: Case vehicle's windshield, showing damage from front right air bag module cover flap and front right occupant contact (case photo #06)
