## REMOTE NOT IN TRAFFIC SURVEILLANCE HYPERThERMIa INVESTIGATION

CASE NUMBER - IN09031  
LOCATION - FLORIDA  
VEHICLE - 2006 DODGE CHARGER R/T  
INCIDENT DATE - June 2009

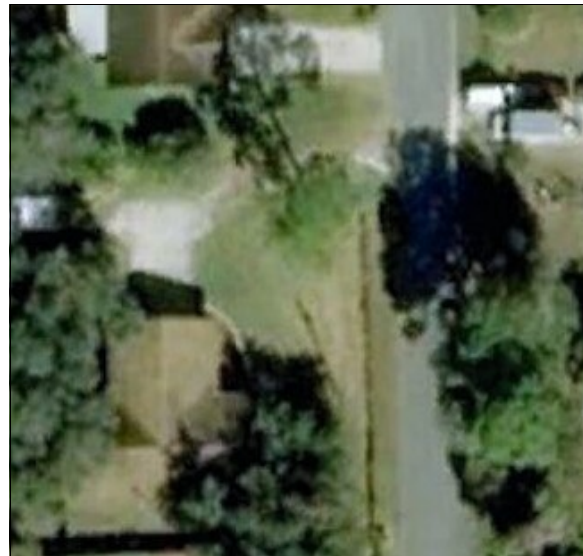
**Figure 1:** Overhead view of driveway in which incident occurred

**Incident Environment:** The incident occurred in a residential driveway which arced in a generally northeast-southwest direction (**Figures 1 and 2**). The driveway intersected a 2-lane, undivided, urban residential street, traversing in a north-south direction. The Dodge had been parked in the driveway, heading west-southwest (**Figure 3**), with its engine running and air conditioning on. During the daytime incident it was partly cloudy and the driveway pavement was dry. The **INCIDENT DIAGRAM** is on page 4.

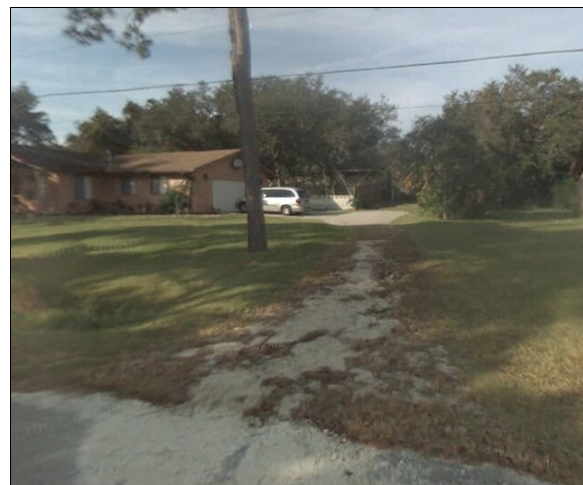
**Figure 2:** Home where child occupant was found dead inside Dodge

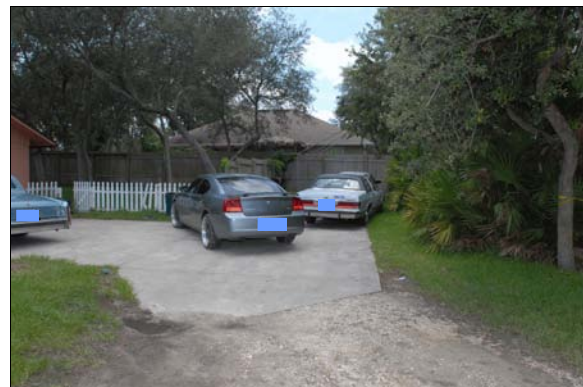
**Figure 3:** On scene view of Dodge parked in driveway heading west-southwest

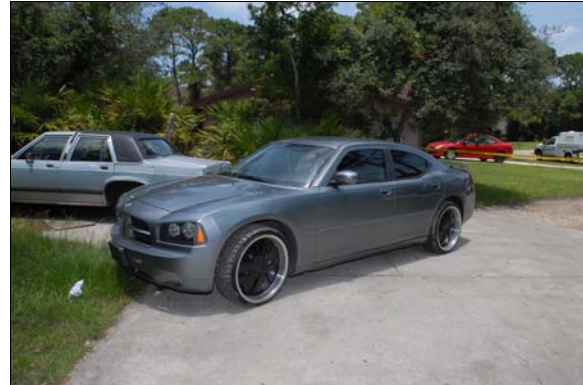
**Figure 4:** Position of Dodge in driveway viewed from garage

The 2006 Dodge Charger R/T (**Figure 4**) was a rear wheel drive, 5-passenger, 4-door sedan (VIN: 2B3KA53H96H-----) equipped with a 5.7-liter, 5-speed shifttable automatic transmission, and this vehicle’s frontal air bags are certified by the manufacturer to be compliant to the

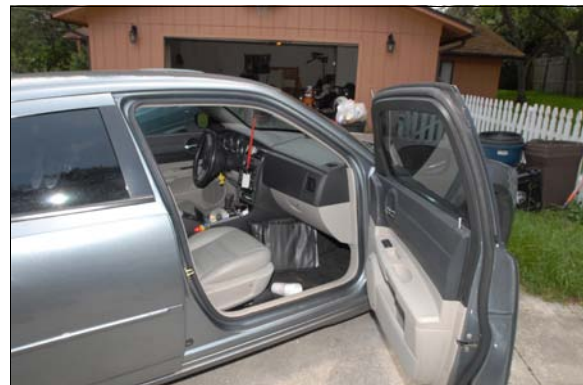
**Figure 5:** On-scene view of interior of Dodge showing tint of right side window glazings

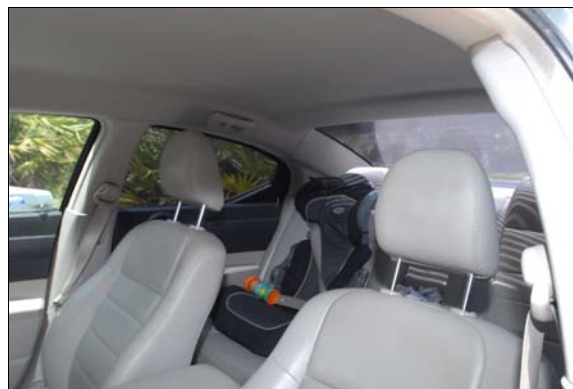
**Figure 6:** On-scene view of child booster seat in second row right position of Dodge

The second row right passenger of the Dodge (23-month-old, female) was seated in a BSS (**Figure 6**). The child was not restrained by the vehicle's lap-and-shoulder, safety belt system.
