**REDESIGNED AIR BAG SPECIAL STUDY (RABSS)
SCI TECHNICAL SUMMARY REPORT**

NASS RABSS CASE NO. 1998-12-805G

RABSS VEHICLE - 1998 FORD TAURUS SE

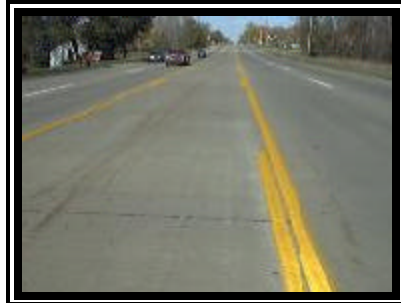
Figure 1. Northbound approach for the 1990 Oldsmobile Cutlass Ciera.

The 73 year old female driver of the 1990 Oldsmobile Cutlass Ciera was operating the vehicle northbound (**Figure 1**) on the inboard lane of the five lane roadway when she entered the center turn lane and proceeded to turn left (west) into a private driveway. The 17 year old female driver of the 1998 Ford Taurus was operating the vehicle southbound (**Figure 2**) in the outboard lane when she observed the Oldsmobile cross her path of travel. Upon recognition of the impending harmful event, the Ford driver steered right in avoidance remaining in the outboard southbound lane prior to the collision.

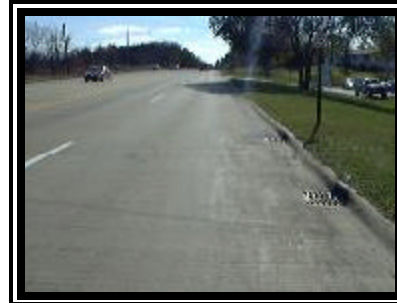
Figure 2. Southbound approach for the 1998 Ford Taurus SE.

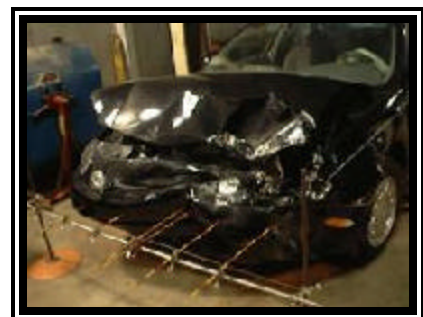
The 1998 Ford Taurus SE sustained moderate frontal damage as a result of the impact with the Oldsmobile Cutlass Ciera (**Figure 3**). The direct contact damage began at the front left bumper corner and extended 85.0 cm (33.5 in) inboard. The impact deformed the full frontal width resulting in a combined direct and induced damage length (Field L) of 132.0 cm (52.0 in). Six crush measurements were documented at the level of the bumper: C1= 17.0 cm (6.7 in), C2= 21.0 cm (8.3 in), C3= 26.0 cm (10.2 in), C4= 11.0 cm (4.3

Figure 3. Frontal damage to the 1998 Ford Taurus SE.

in), C5= 1.0 cm (0.4 in), C6= 0 cm. The Collision Deformation Classification (CDC) for this impact to the Ford was 12-FYEW-2 with a principal direction of force of (-)10 degrees. An indentation was documented to the center portion of the bumper attributed to the front right bumper corner of the Oldsmobile. The hood was displaced up and rearward from engagement against the side surface of the Oldsmobile. Induced damage was noted to the fenders which were deformed slightly rearward. No reduction in the vehicle's wheelbase was sustained. The windshield was fractured from (exterior) impact forces and the (interior) front right air bag module cover flap. All tempered glazing remained undamaged.

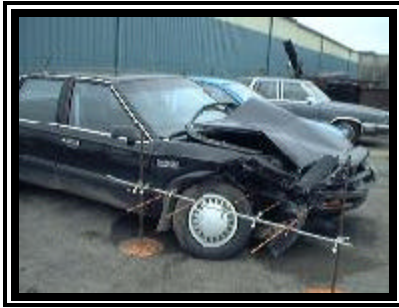
Figure 4. Front right damage to the 1990 Oldsmobile Cutlass Ciera.

The 1990 Oldsmobile Cutlass Ciera 4-door sedan sustained moderate frontal damage as a result of the impact with the Ford Taurus (**Figure 4**). The direct contact damage began at the front right bumper corner and extended 64.0 cm (25.2 in) rearward. The impact resulted in a combined direct and induced damage length (Field L) of 113.0 cm (44.5 in). The CDC for this impact to the Oldsmobile was 02-RFEW-3 with a principal direction of force of (+)60 degrees. The right fender was deformed laterally to the left which restricted the right front wheel/tire (not deflated). End structure shifting to the left measured approximately 18.0 cm (7.1 in). The hood was deformed up and to the left from the

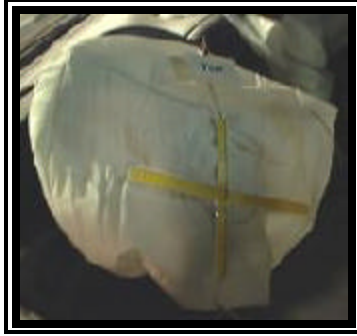
The 1998 Ford Taurus SE was equipped with redesigned frontal air bags for the driver and front right passenger positions. The air bags had deployed as a result of the crash. The driver air bag was housed in the center of the steering wheel with a horizontally oriented flap tear seam (H-configuration). No contact evidence was identified on the air bag or exterior surface of the module cover flaps. The flaps were nearly symmetrical in shape as the upper flap measured 15.0 cm (5.9 in) in width and 8.0 cm (3.1 in) in height while the lower flap measured 15.0 cm (5.9 in) in width and 6.0 cm (2.4 in) in height. Multiple black vinyl transfers were noted across the face of the air bag from expansion within the module. The NASS researcher measured the diameter of the driver air bag at 56.0 cm (22.0 in) in its deflated state (**Figure 5**). The bag was tethered by two internal straps and vented by two ports located at the 11 o'clock and 1 o'clock sectors on the rear aspect of the air bag.

Figure 5. 1998 Ford Taurus SE redesigned driver air bag.

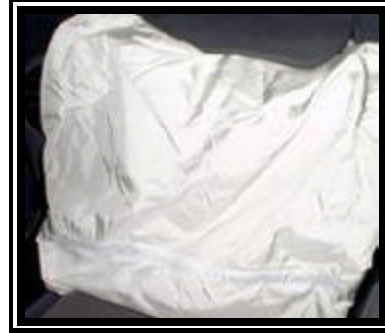
The front right passenger air bag deployed from the right top instrument panel area with a single cover flap design hinged at the forward aspect (*right mid-windshield area fractured by the module cover flap*). No contact evidence was identified on the air bag or exterior surface of the module cover flap. The cover flap was rectangular in shape and measured 40.0 cm (15.7 in) in width and 25.0 cm (9.8 in) in height. The NASS researcher measured the passenger air bag at 62.0 cm (24.4 in) in width and 56.0 cm (22.0 in) in height in its deflated state (**Figure 6**). No internal tether straps or vent ports were present. No cutoff switch was found for the front right air bag.

Figure 6. 1998 Ford Taurus SE redesigned passenger air bag.
