On-scene Investigation / Vehicle to Vehicle
Dynamic Science, Inc. / Case Number: DS99020
1997 Ford Taurus
Arizona
July 1999

1. Report No. DS99020		2. Government Accession No.		3. Recipient Catalog No.	
4. Title and Subtitle In-Depth Accident Investigation				5. Report Date June 1, 2000

14. Sponsoring Agency Code	
15. Supplemental Notes					
16. Abstract This case was initiated in response to a report of an air bag deployment related passenger fatality. This low speed crash took place in the state of Arizona in June, 1999. Vehicle 1, a 1997 Ford Taurus GL four-door (green) driven by a 28-year-old male, was traveling eastbound on a two-lane undivided roadway. The front right bucket seat was occupied by a 3-year-old female (104 cm/41 in., 21.8 kg/48 lbs.) seated in a forward-facing, overhead shield-equipped Cosco Touriva (Model # 02-014) child safety seat ¹ . The seat had been placed in the forward facing toddler position with the shoulder harness threaded through the upper slots—though the harness on the right was twisted. According to post-crash witnesses, the child seat was attached to the vehicle using the lap and shoulder belts. This seating position is equipped with a switchab

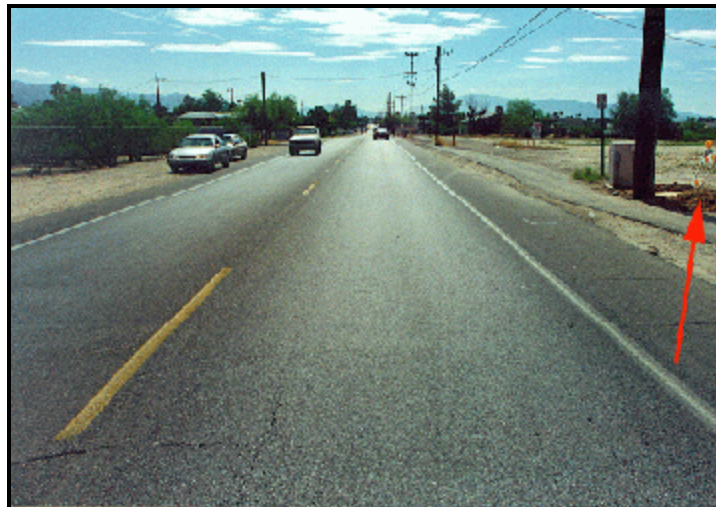
Figure 1. Travel path for Vehicle 1. Arrow shows path Vehicle 2 used to initially exit roadway.

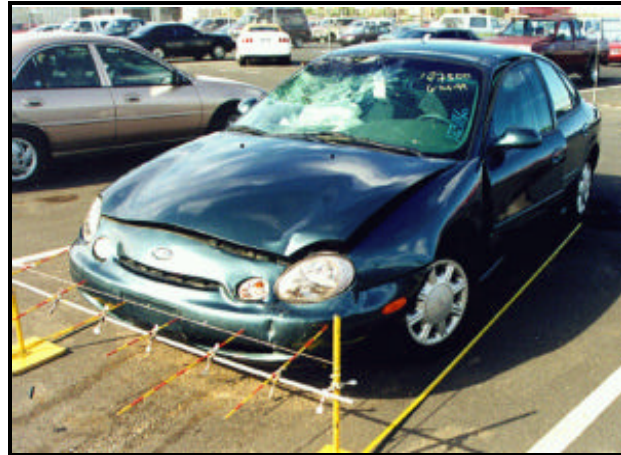
Figure 3. Exterior, Vehicle 1

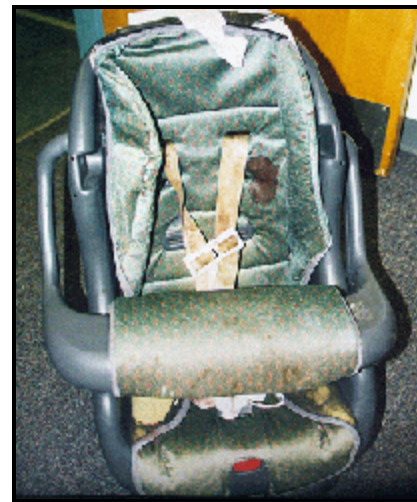
Figure 2. Child safety seat, front view

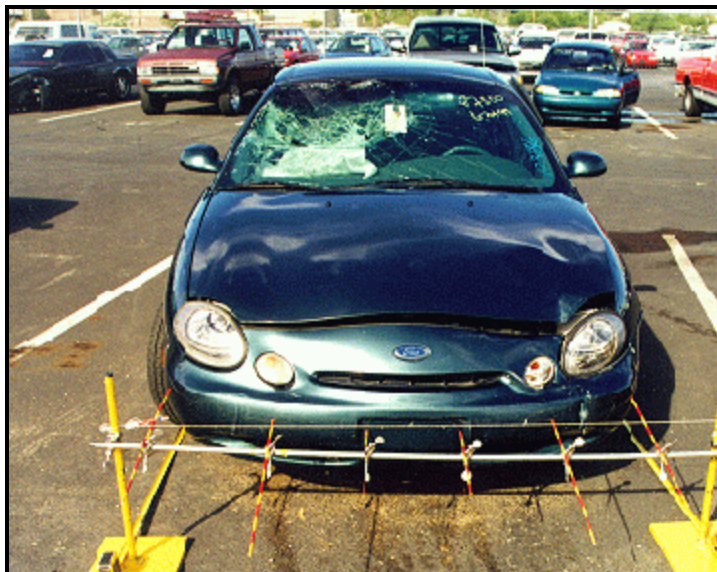
Description:	1997 Ford Taurus GL four-door sedan (green)	
VIN:	1FALP52U3VGXXXXXX	
Odometer:	Unknown	
Engine:	3.0L EFI V6	
Reported Defects:	None	
Cargo:	None	
Damage Description:	Minor rearward crush to front bumper, hood displaced, fractures to passenger side of windshield.	
CDC:	12FDEW1	
Delta V:	Total	13.5 km/h (8.4 mph)
	Longitudinal	-13.4 km/h (-8.3 mph)
	Latitudinal	-1.2 km/h (-0.7 mph)
	Energy	8,117 joules (5,988 ft-lbs.)

Figure 5. Exterior, Vehicle 1

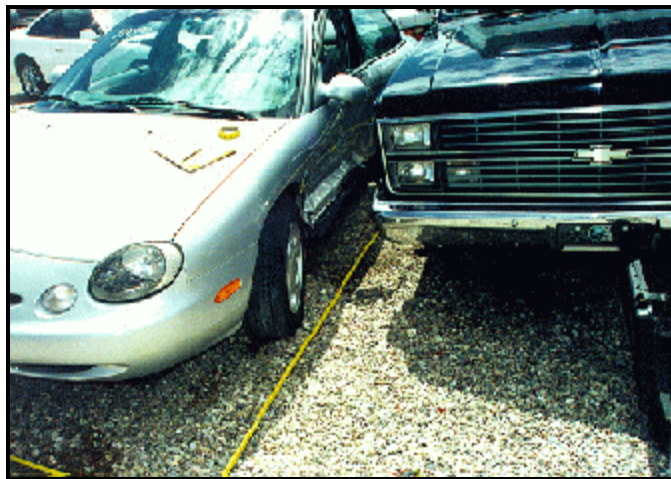
Damage Description: Moderate lateral crush to left front door area and left rear door area. Minor intrusion on left side.

Figure 8. Exterior, Vehicle 2

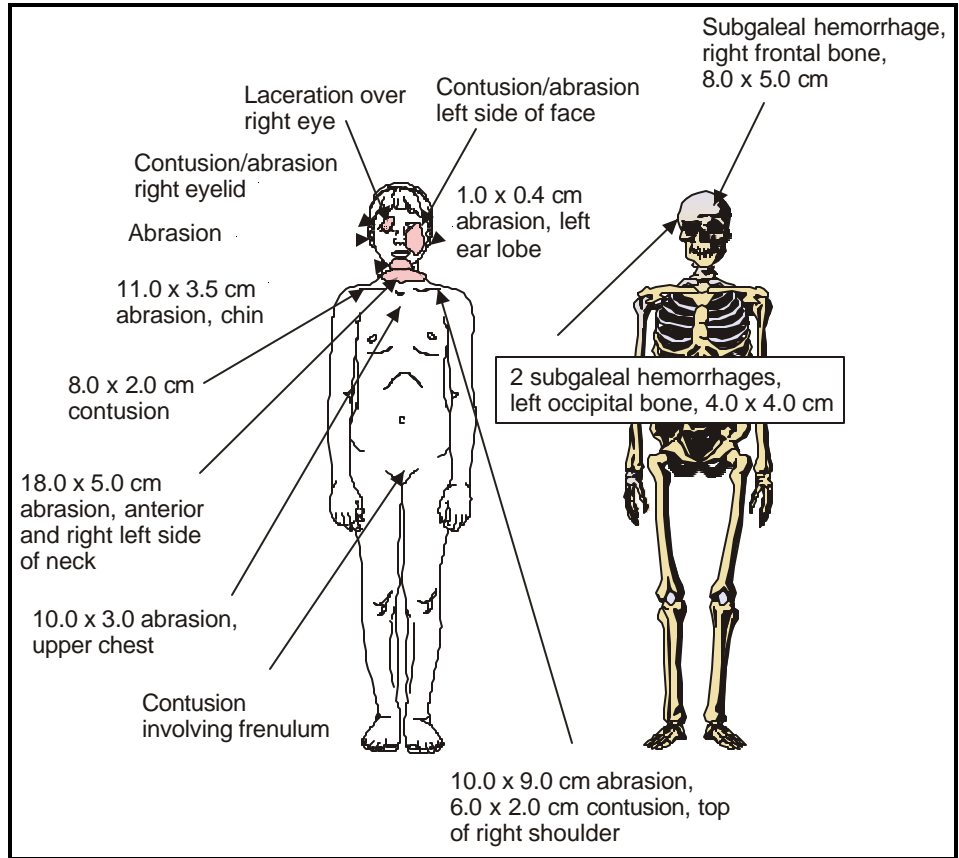
Abrasion, anterior/right/left neck, 18.0 x 5.0 cm	390202.1,0	910.0	Air bag
	Abrasions (2), upper chest, 10.0 x 3.0 cm	490202.1,9	911.0 911.0	Child seat tray
	Contusion/abrasion, left side of face	290202.1,2 290402.1,2	910.0 920.0	Air bag
	Abrasion, left ear lobe, 1.0 x 0.4 cm	290202.1,2	910.0	Air bag
	Abrasion, top of right shoulder, 10.0 x 9.0 cm	790202.1,1	912.0	Child seat harness
	Contusion, top of right shoulder, 6.0 x 2.0 cm	790402.1,1	923.00	Child seat harness
	Contusion, frenulum/crotch	545410.1,8	922.4	Child seat harness, crotch belt

Figure 9. External Injuries

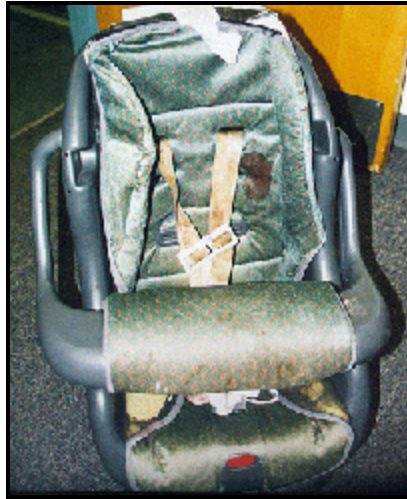
The front right bucket seat was occupied by a 3-year-old female (104 cm/41 in., 21.8 kg/48 lbs.) seated in a forward-facing, overhead shield-equipped Cosco Touriva (Model # 02-014) child safety seat. The case occupant exceeded the seat weight limit of 19.5 kg (43 lbs.) by 2.2 kg (5 lbs.). The child seat had been placed in the forward facing toddler position with the shoulder harness threaded through the upper slots—though the harness on the right was twisted. The front right fabric-covered bucket seat was adjusted between the middle and rear most track position. According to post-crash

Figure 11. Child safety seat, front view

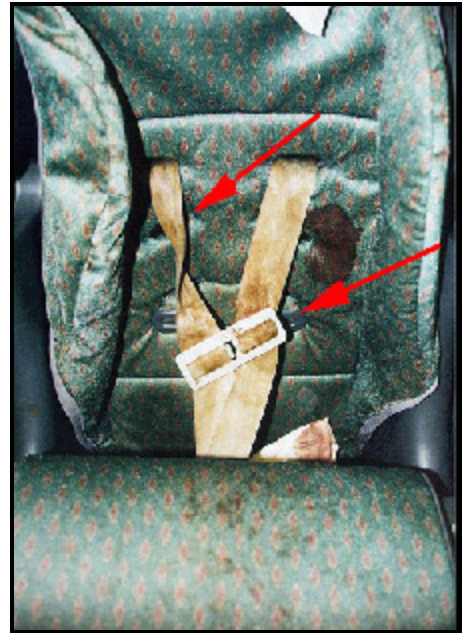
Figure 12. Child safety seat—chest clip and twisted harness

There are no indications that the retractor had been switched, which would cause the child seat to not be firmly held in place. The chest clip was being used, but appears to have been used in a position which would have been too low on the child.

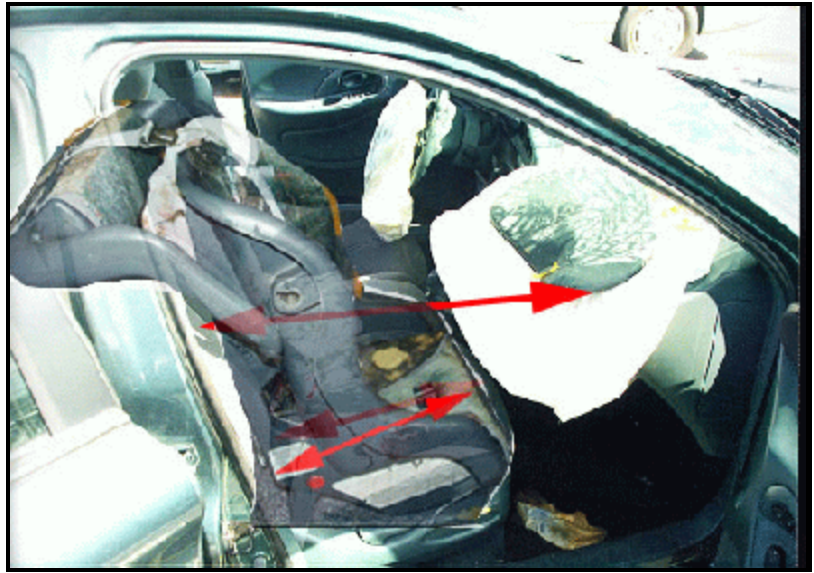
It appears that as the driver of Vehicle 1 saw Vehicle 2, he applied the brakes and began steering to the left. As a result of the braking, the child seat slid forward taking up any slack in the lap and shoulder belt. One of the child's feet likely contacted the face of the instrument panel (see Figure 15). The child seat is 44 cm (17 in.) long from the back to the front. The post-deployment excursion of the air bag is 53 cm (20.8 in.). The distance from the seat back to the base of the air bag was 78 cm (30.7 in.). Even if the child seat had been properly installed, there still would have been an overlap between the seat and the deploying air bag of approximately 19 cm (7.5 in.).

Figure 14. Front right seat with scaled image of child seat superimposed onto seat image.

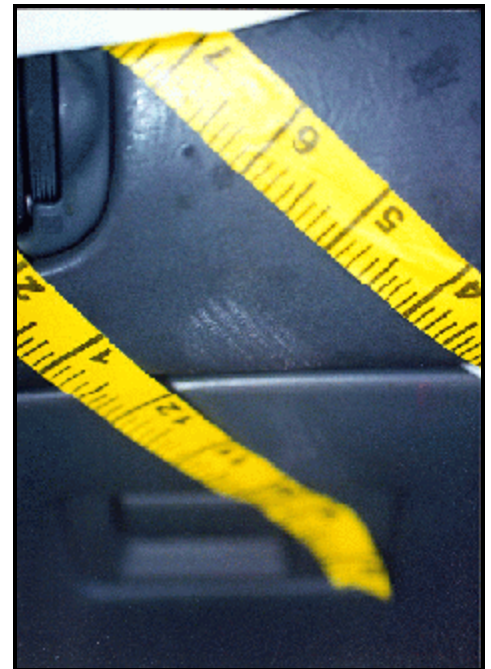
Figure 15. Contact to face of right instrument panel

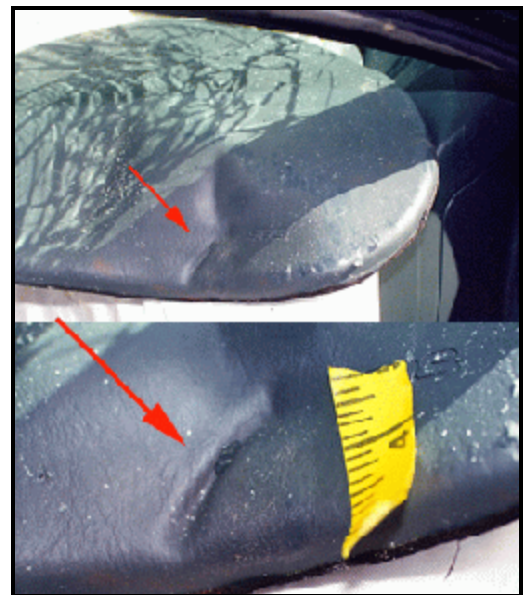
Figure 17. Fiber transfers, passenger side module cover

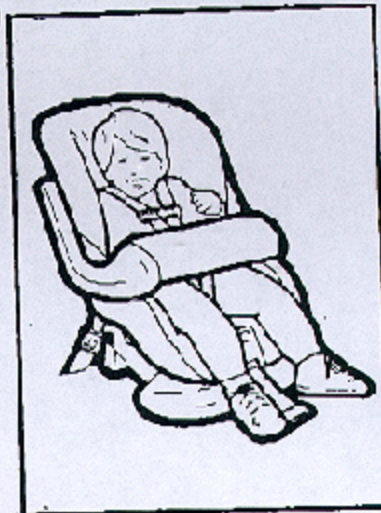
Editor's Notes Touriva Overhead shield: One piece shell with no tubular frame on back or sides of seat; red push button adjusts recline stand from reclined to upright position; red button to release shield says "Press"; seat belt for rear-facing position threads under pad of seat beneath child's legs.
