REPORT NUMBER: 111-MGA-03-001

**SAFETY COMPLIANCE TESTING FOR  
FMVSS NO. 111  
SCHOOL BUS REARVIEW MIRRORS**

American Transportation Corporation  
2003 ATC IC3S530 School Bus  
NHTSA No.: C30902

**FINAL REPORT**

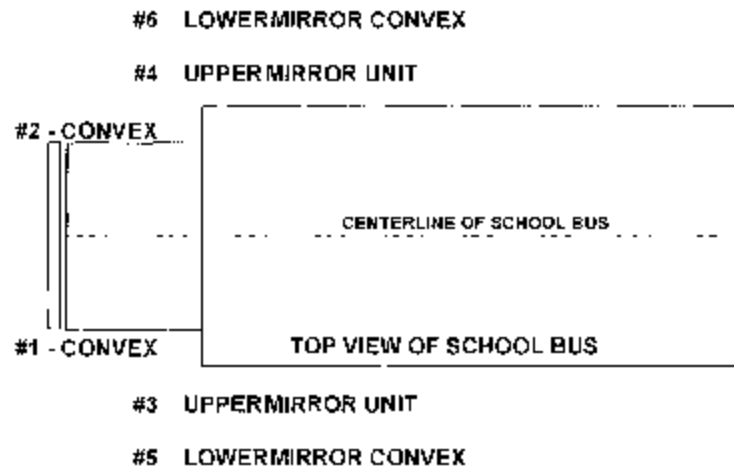
**MIRROR DIAGRAM**

MIRROR NO.	TYPE	MIRROR SYSTEM	CYLINDERS VIEWED (entire top surface)
1	CROSS VIEW/CONVEX	B	B,C,E,F,G,H,I,J,L,M
2	CROSS VIEW/CONVEX	B	A,B,D,E,F,G,H,I,K,N,O,P
3	UNIT MAGNIFICATION	A	61 Meter INDICATOR
4	UNIT MAGNIFICATION	A	61 Meter INDICATOR
5	CONVEX	A	L,M
6	CONVEX	A	N,O,P

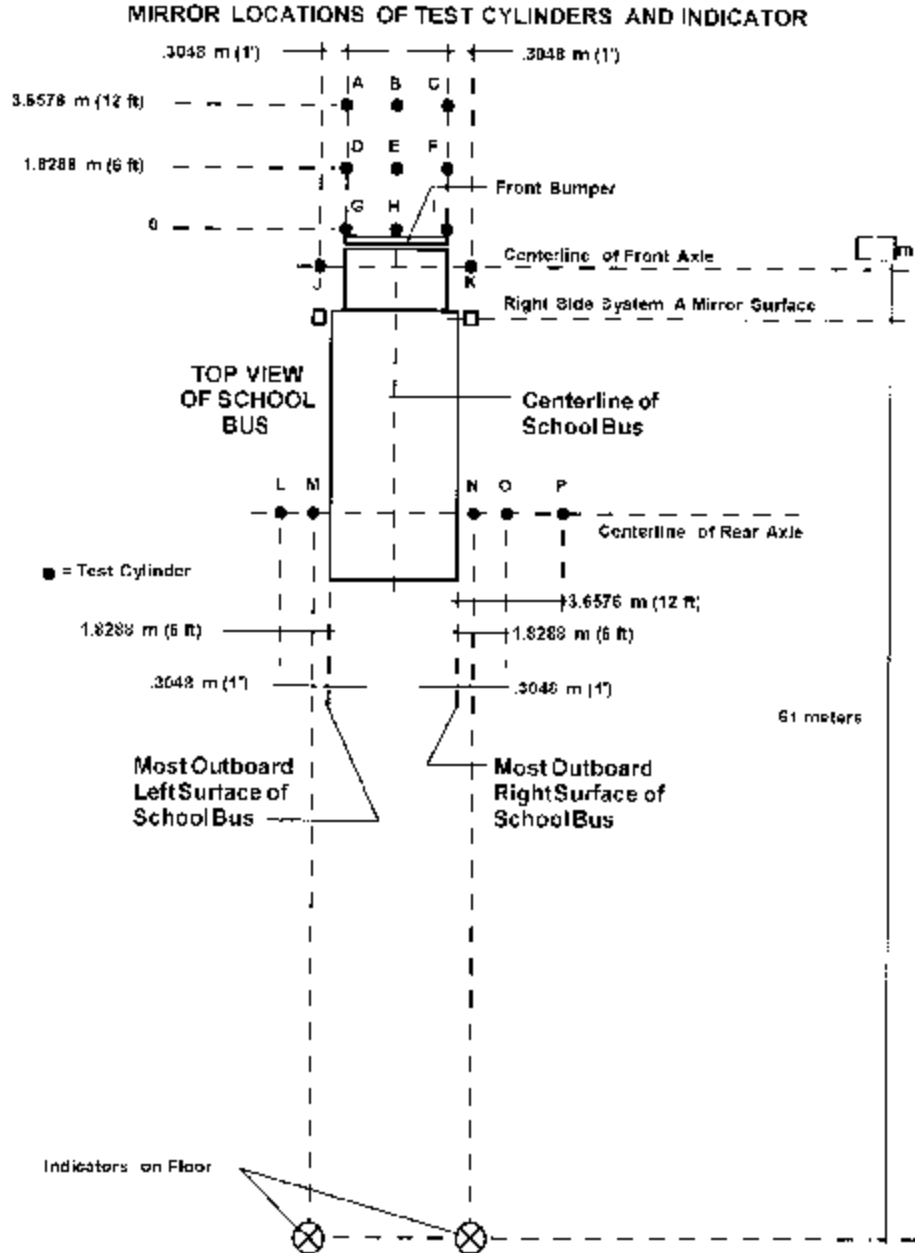
- NOTES:**
1. The cylinders shall be a color which provides a high contrast with the surface on which the bus is parked (S13.1).
  2. The cylinders are 0.3048 m high and 0.3048 m in diameter, except for cylinder P which is 0.9144 m high and 0.3048 m in diameter.

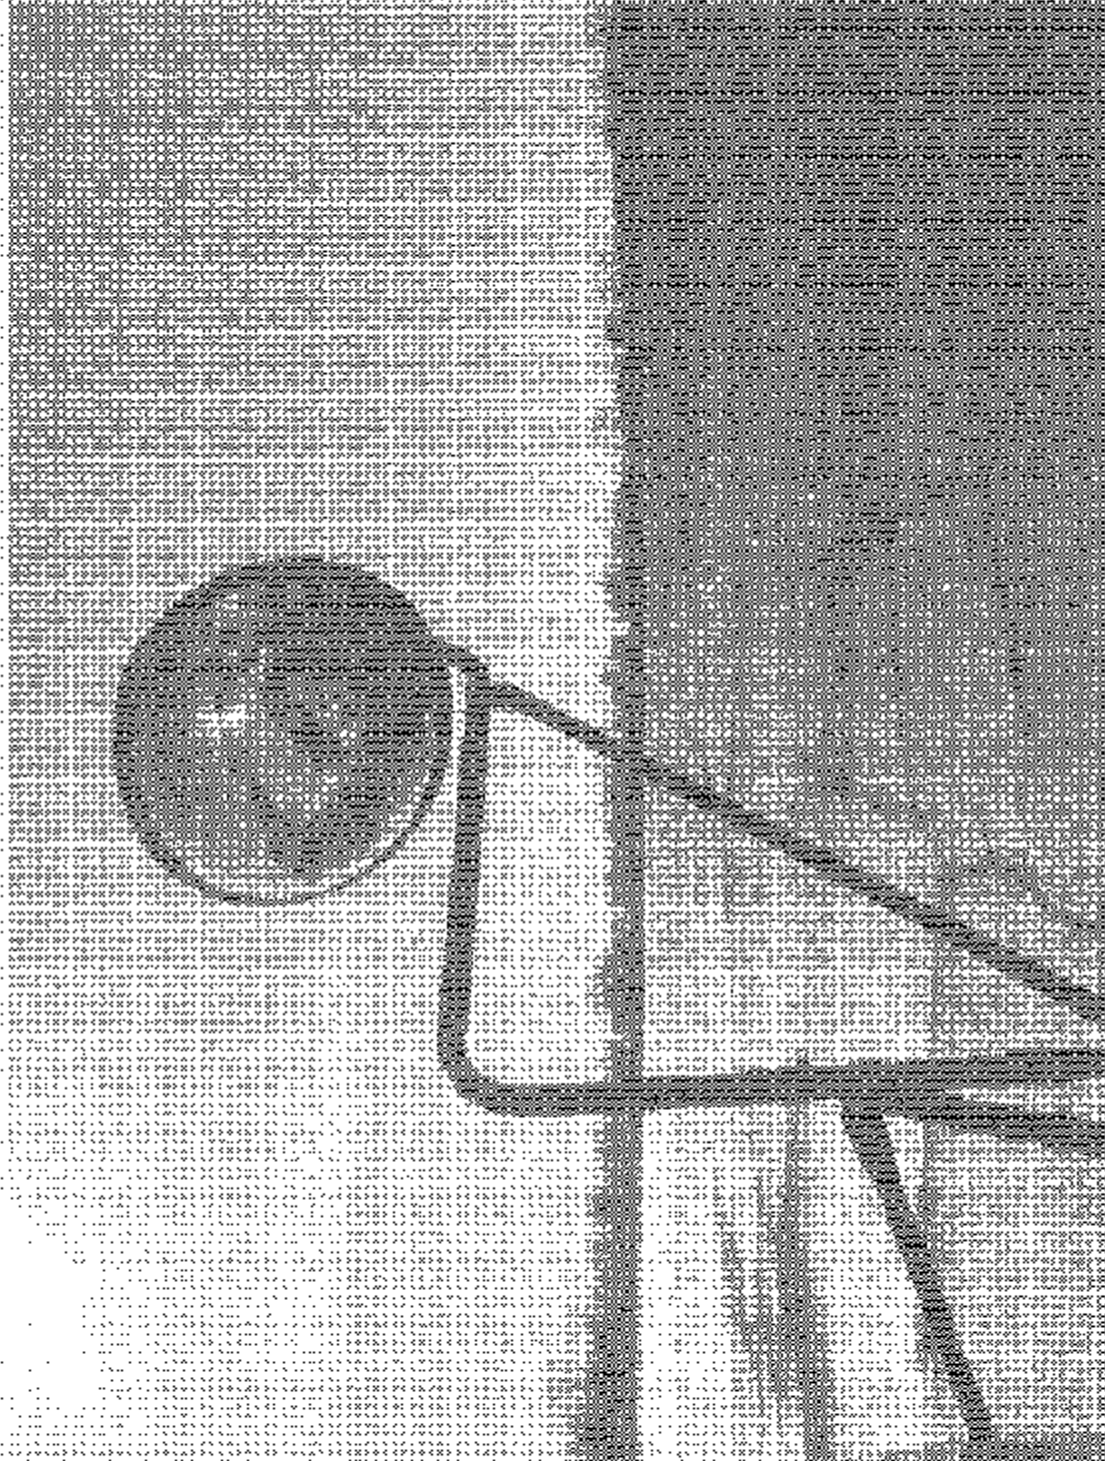
Test Vehicle : 2002 American Transportation Corp. (C36610) : Photograph 4  
Procedure : FAYSB 111 : Right Front Cross View (Left of Direction)  
NHTSA No. : CE0502

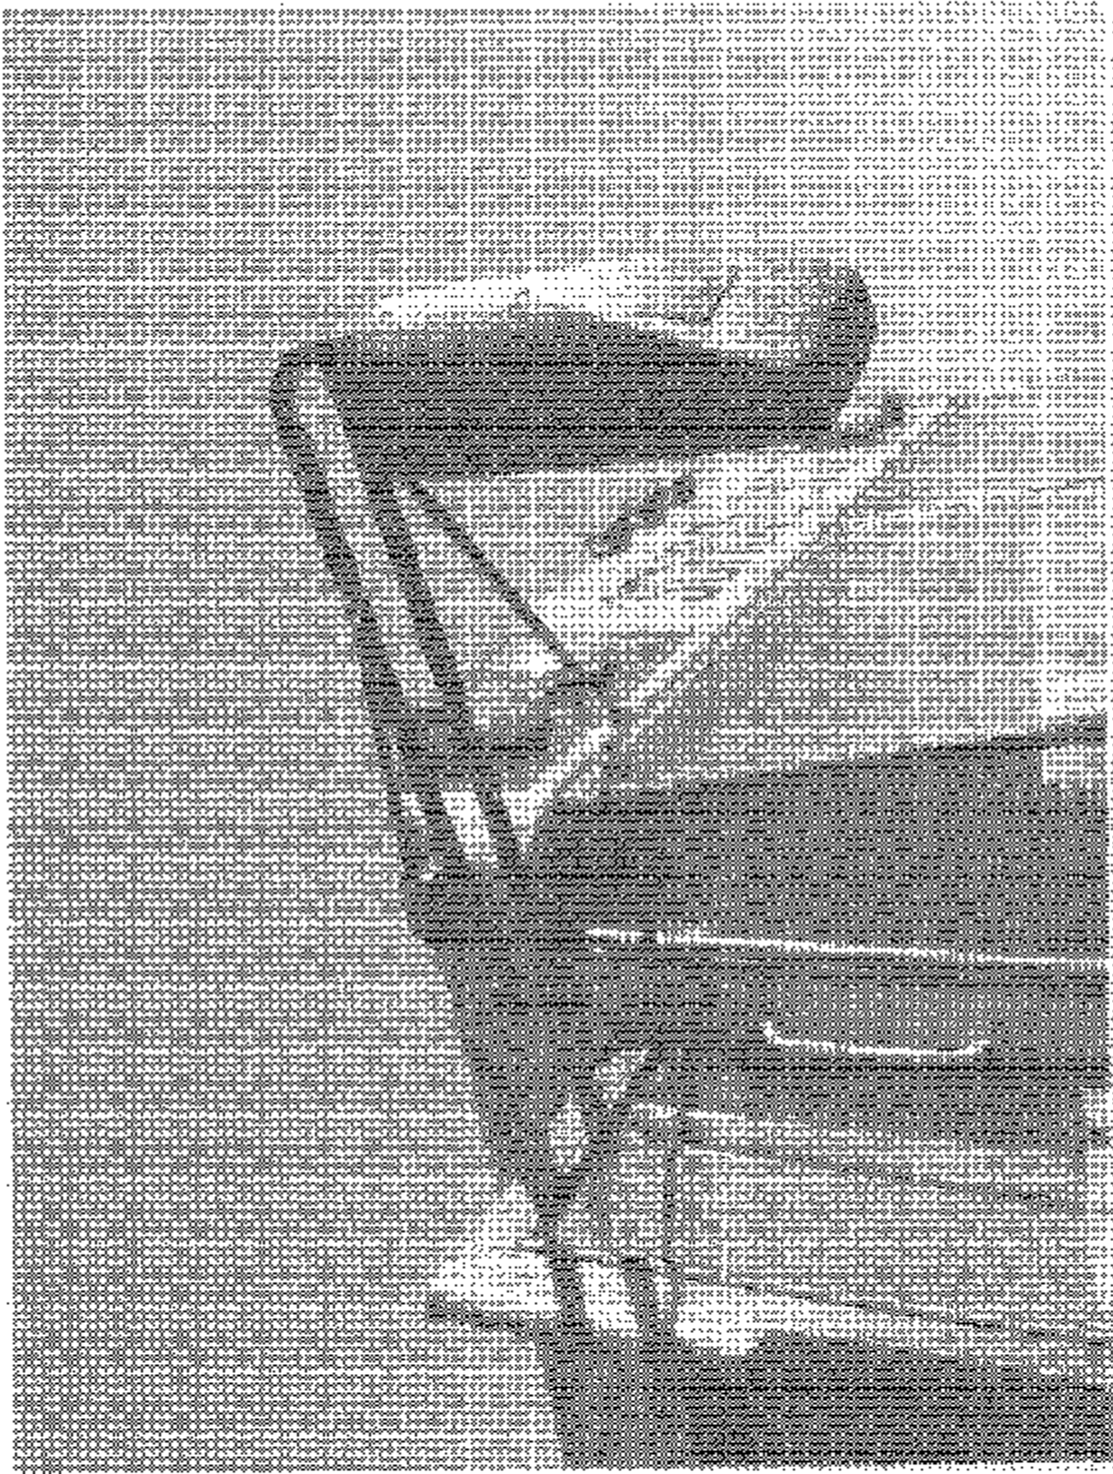
Photograph 5

Passenger Side Rearview Mirror and Mounting

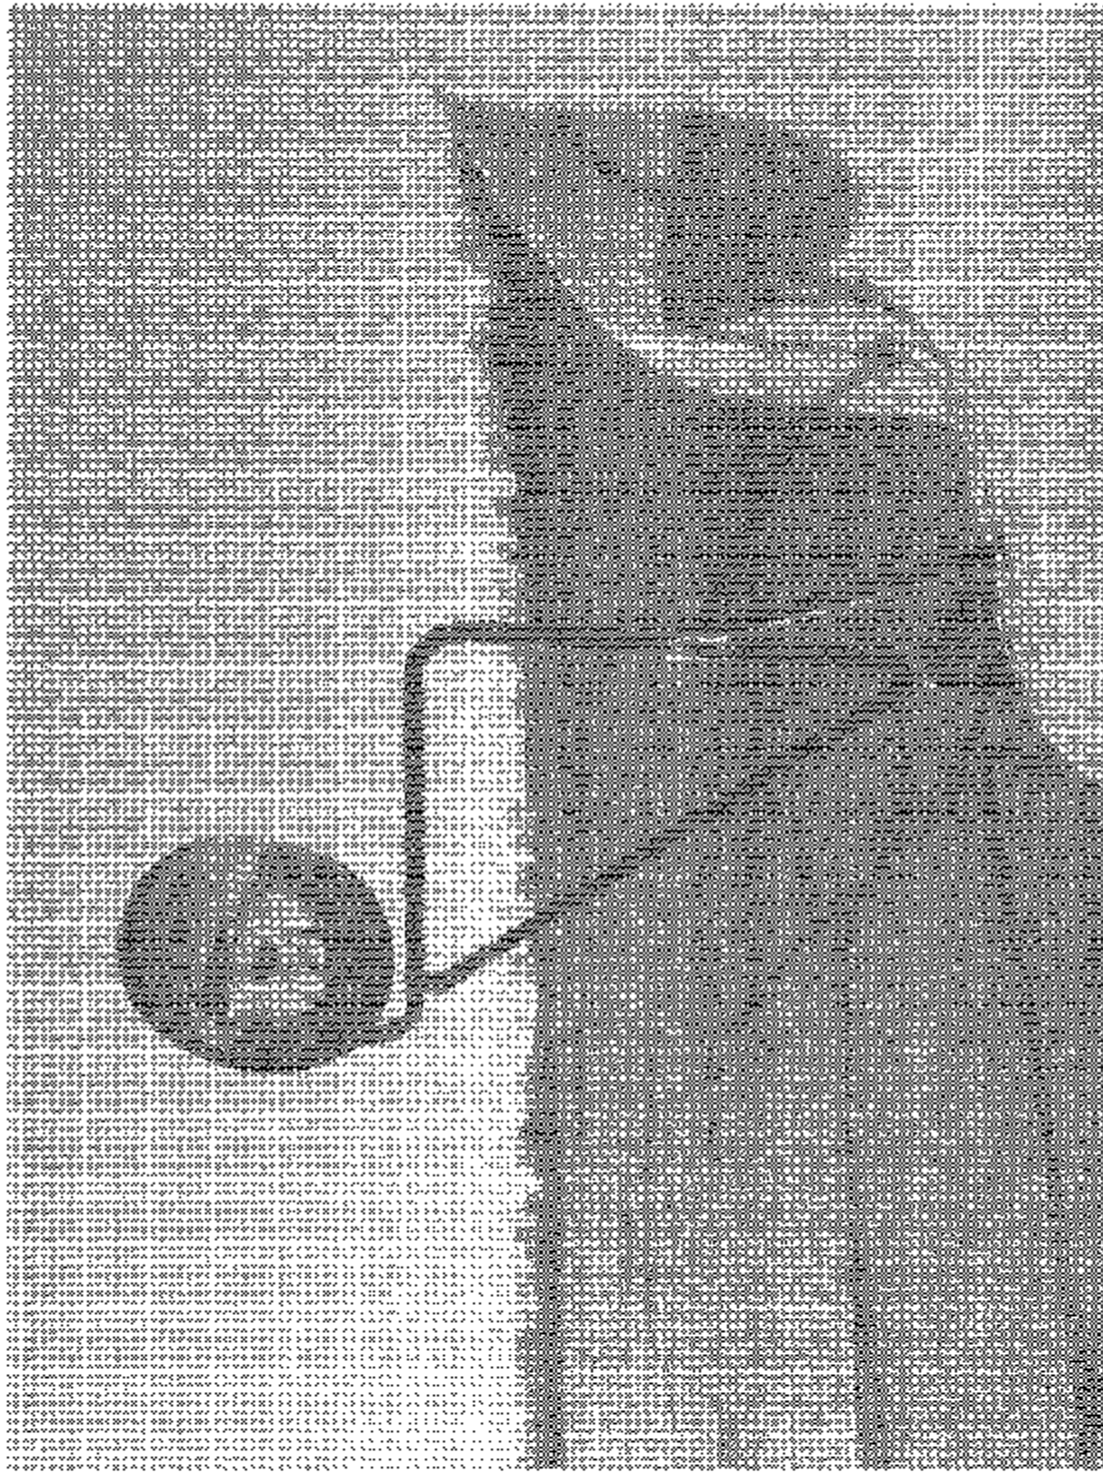
Photograph 7.

Left Front Cross View Mirror and Mounting

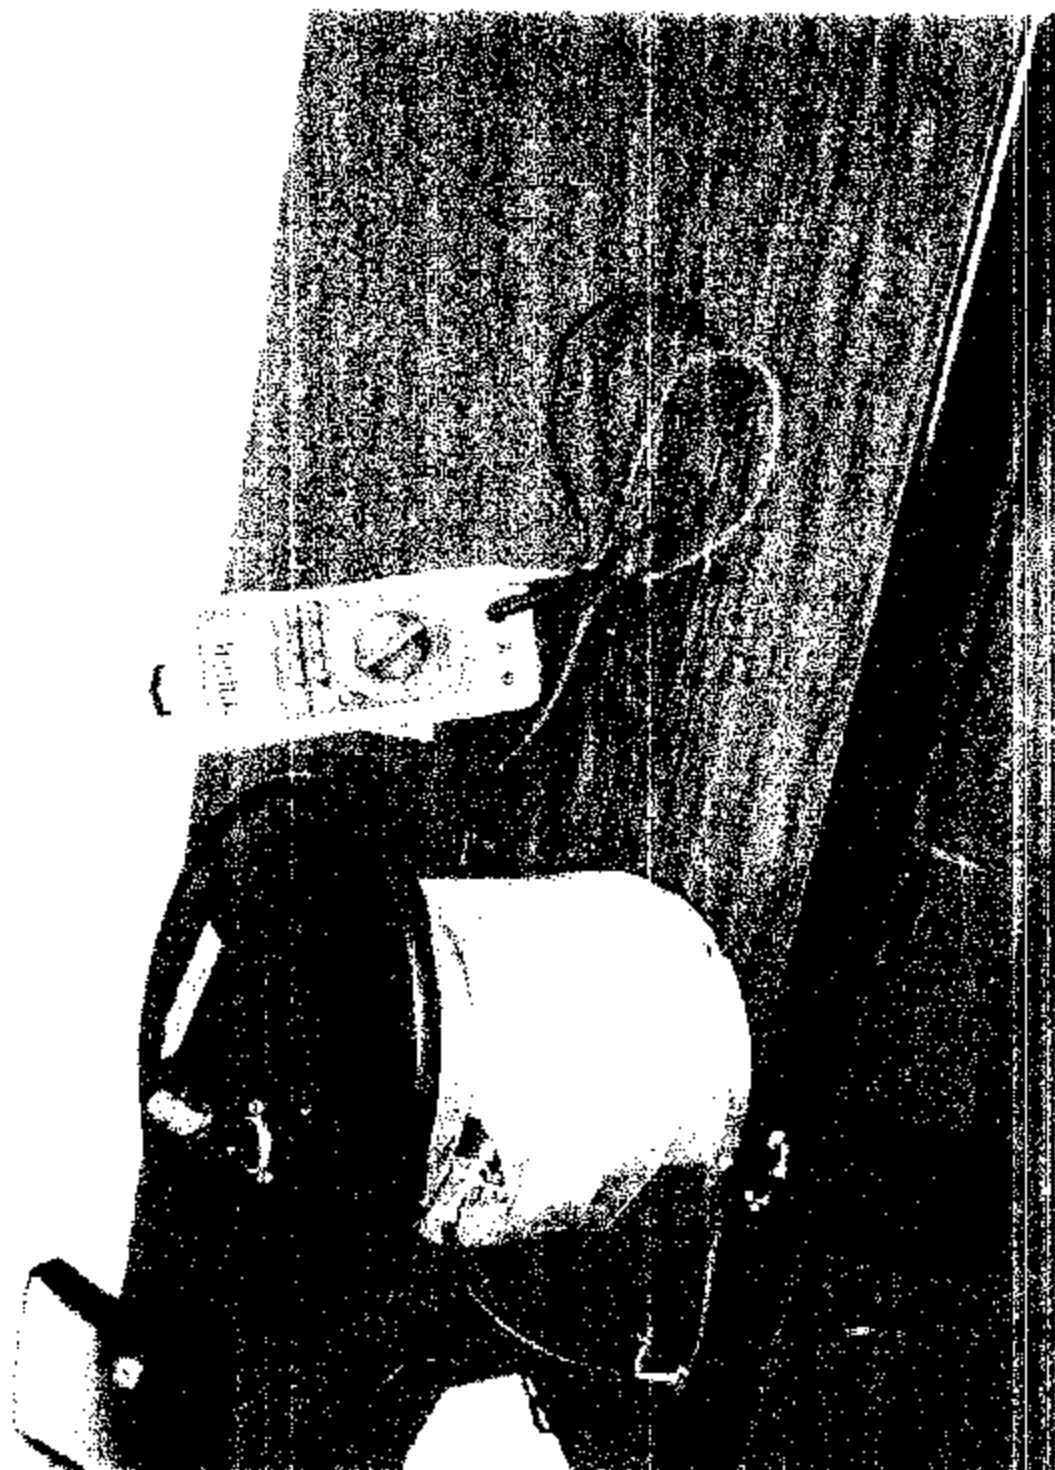
**ATTENTION DRIVER!**  
USE CROSS-VIEW MIRRORS TO VIEW  
PEDESTRIANS WHILE BUS IS STOPPED.  
DO NOT USE THESE MIRRORS TO VIEW  
TRAFFIC WHILE BUS IS MOVING. IMAGES  
IN SUCH MIRRORS DO NOT ACCURATELY  
SHOW ANOTHER VEHICLE'S LOCATION.  
THE FAWCETT™ CROSS-VIEW MIRROR SYSTEM BY  
RESCO INC. JAMAICA, NY 11409 TEL: 718-264-2461

Test Vehicle: 2003 American Transportation Corp. IC3S530      Photograph 18:  
Procedure: FMVSS 111      Label for Cross View Mirror Warning  
NHTSA No.: C30902
