REPORT NUMBER 216-GTL-03-001

**SAFETY COMPLIANCE TESTING FOR  
FMVSS NO. 216  
ROOF CRUSH RESISTANCE**

**BAYERISCHE MOTOREN WERKE AG  
2003 MINI COOPER, PASSENGER CAR  
NHTSA NO. C30506**

**GENERAL TESTING LABORATORIES, INC.  
1623 LEEDSTOWN ROAD  
COLONIAL BEACH, VIRGINIA 22443**

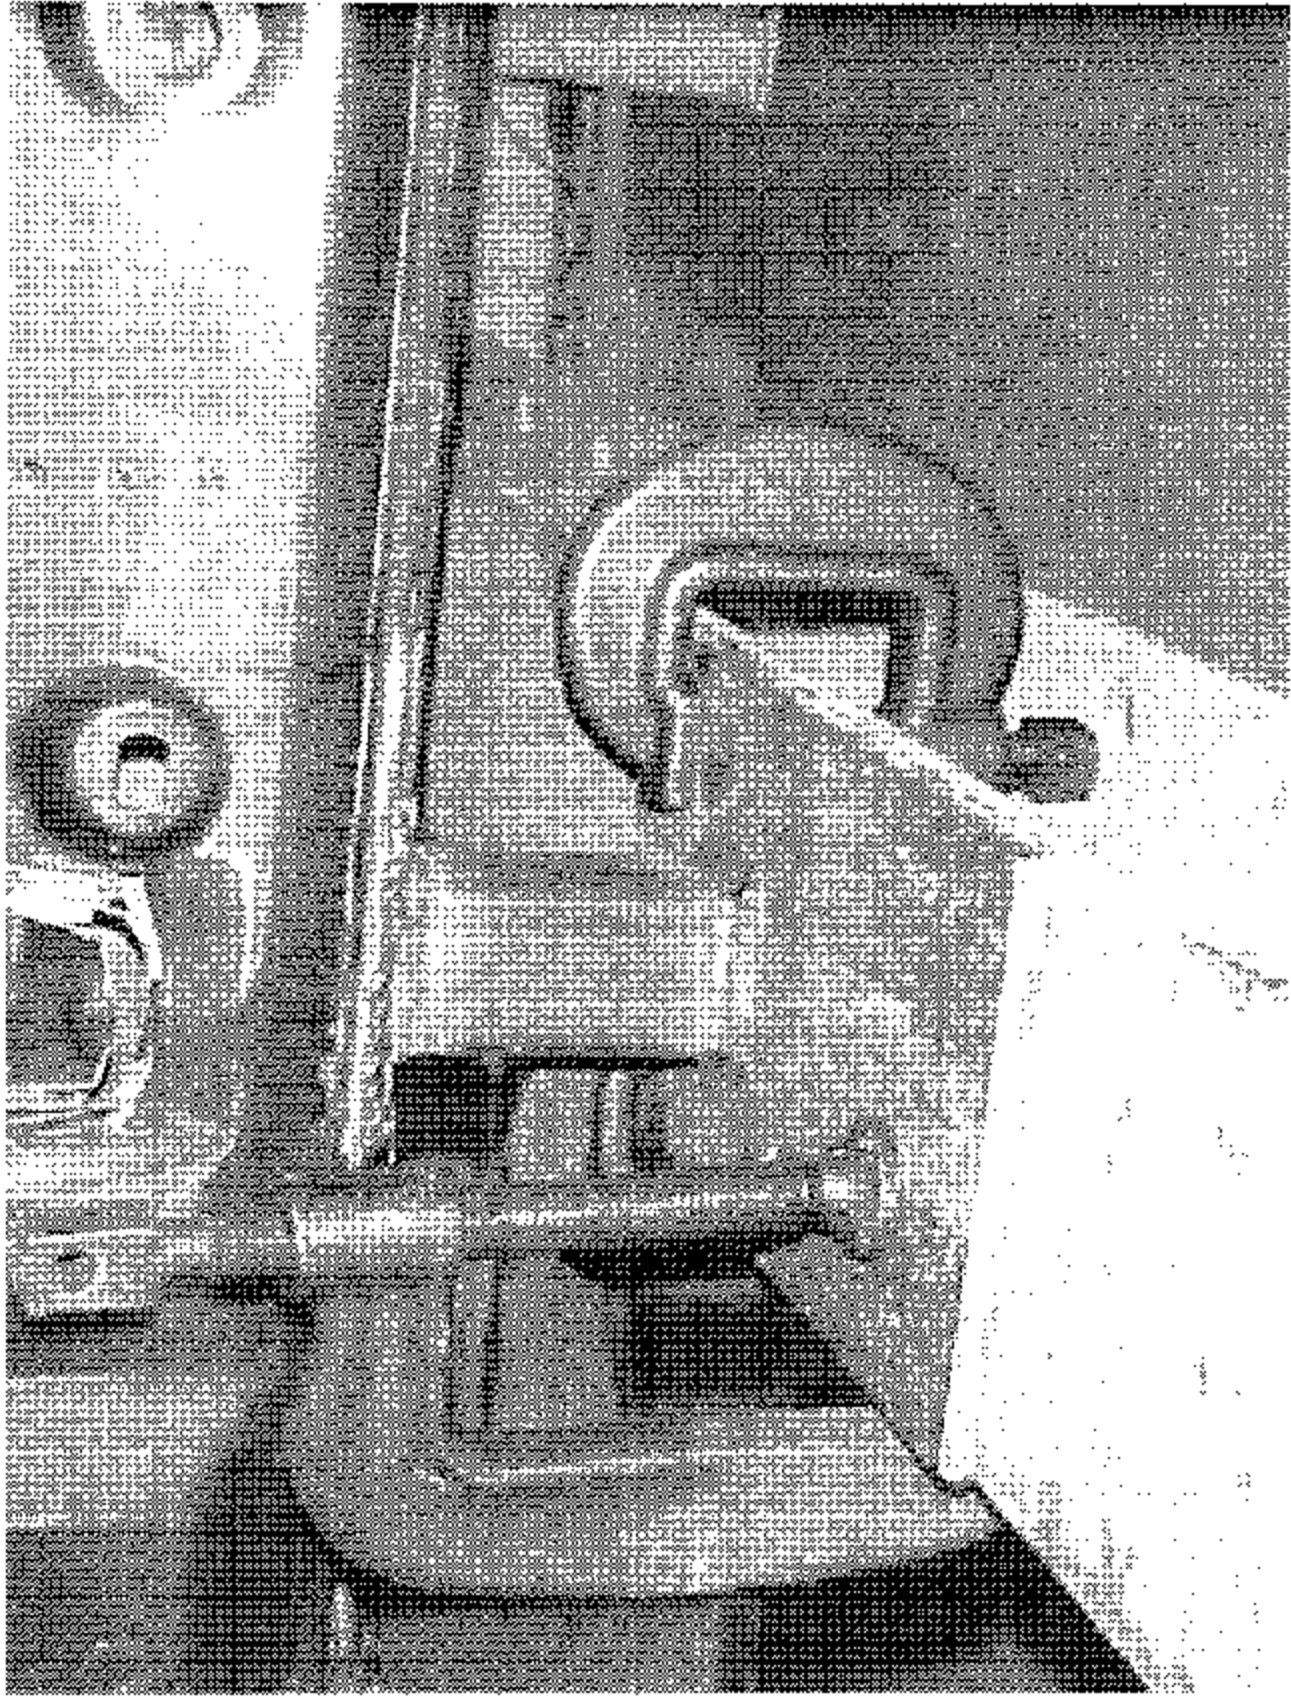
FIGURE 5.4  
LEFT FRONT VEHICLE TIE DOWN

- 1) The vehicle was rigidly mounted in the test fixture by welding vertical supports to the vehicle jack points to prevent any vehicle movement. Chains were not used in an effort to reduce and/or eliminate "pre-stressing" of the vehicle due to the tightening of chains.
- 2) Dial gauges were placed at the vehicle corners and at the passenger door to track overall vehicle motion and the ability of the alternate tie-down procedure to restrict motion of the vehicle.
- 3) String potentiometers were placed at the driver's designated seat position and attached to the interior surface of the roof above a normally positioned 50<sup>th</sup> percentile Hybrid III ATD head. The string potentiometers tracked the interior motion of the roof.
- 4) Performed the roof crush test to a loading ram displacement of 127 mm or 4536 KG force, whichever comes first.

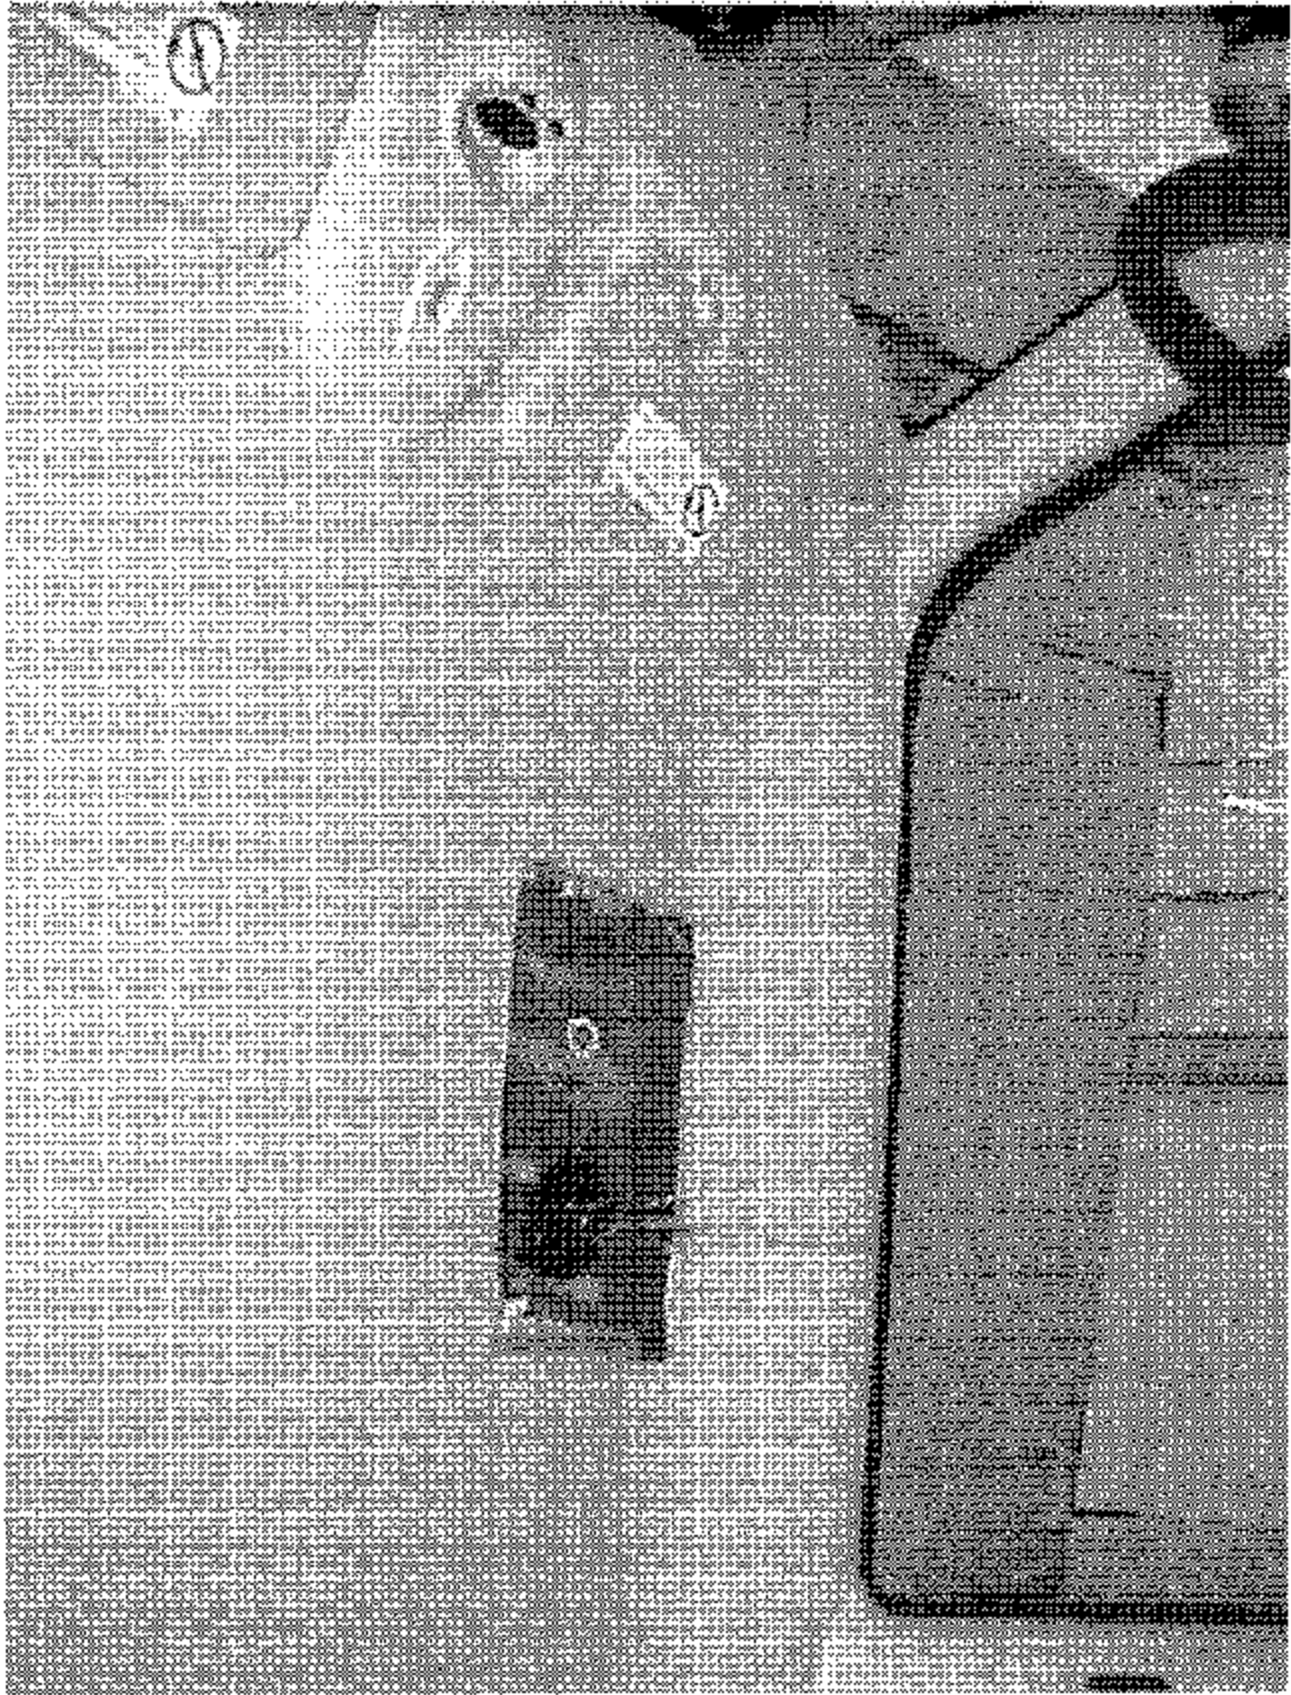
FIGURE 5.8  
LVDI DISPLACEMENT MOUNTING TO  
ROOF

#1 LVDT (R.F.) Length: 927 mm

#2 LVDT (R.R.) Length: 895 mm

#3 LVDT (L.R.) Length: 895 mm

Distance from LVDT #1 (R.F.) to LVDT #2 (R.R.) = 270 mm

Distance from LVDT #2 (R.R.) to LVDT #3 (L.R.) = 250 mm

Distance from LVDT #1 (R.F.) to LVDT #3 (L.R.) = 370 mm

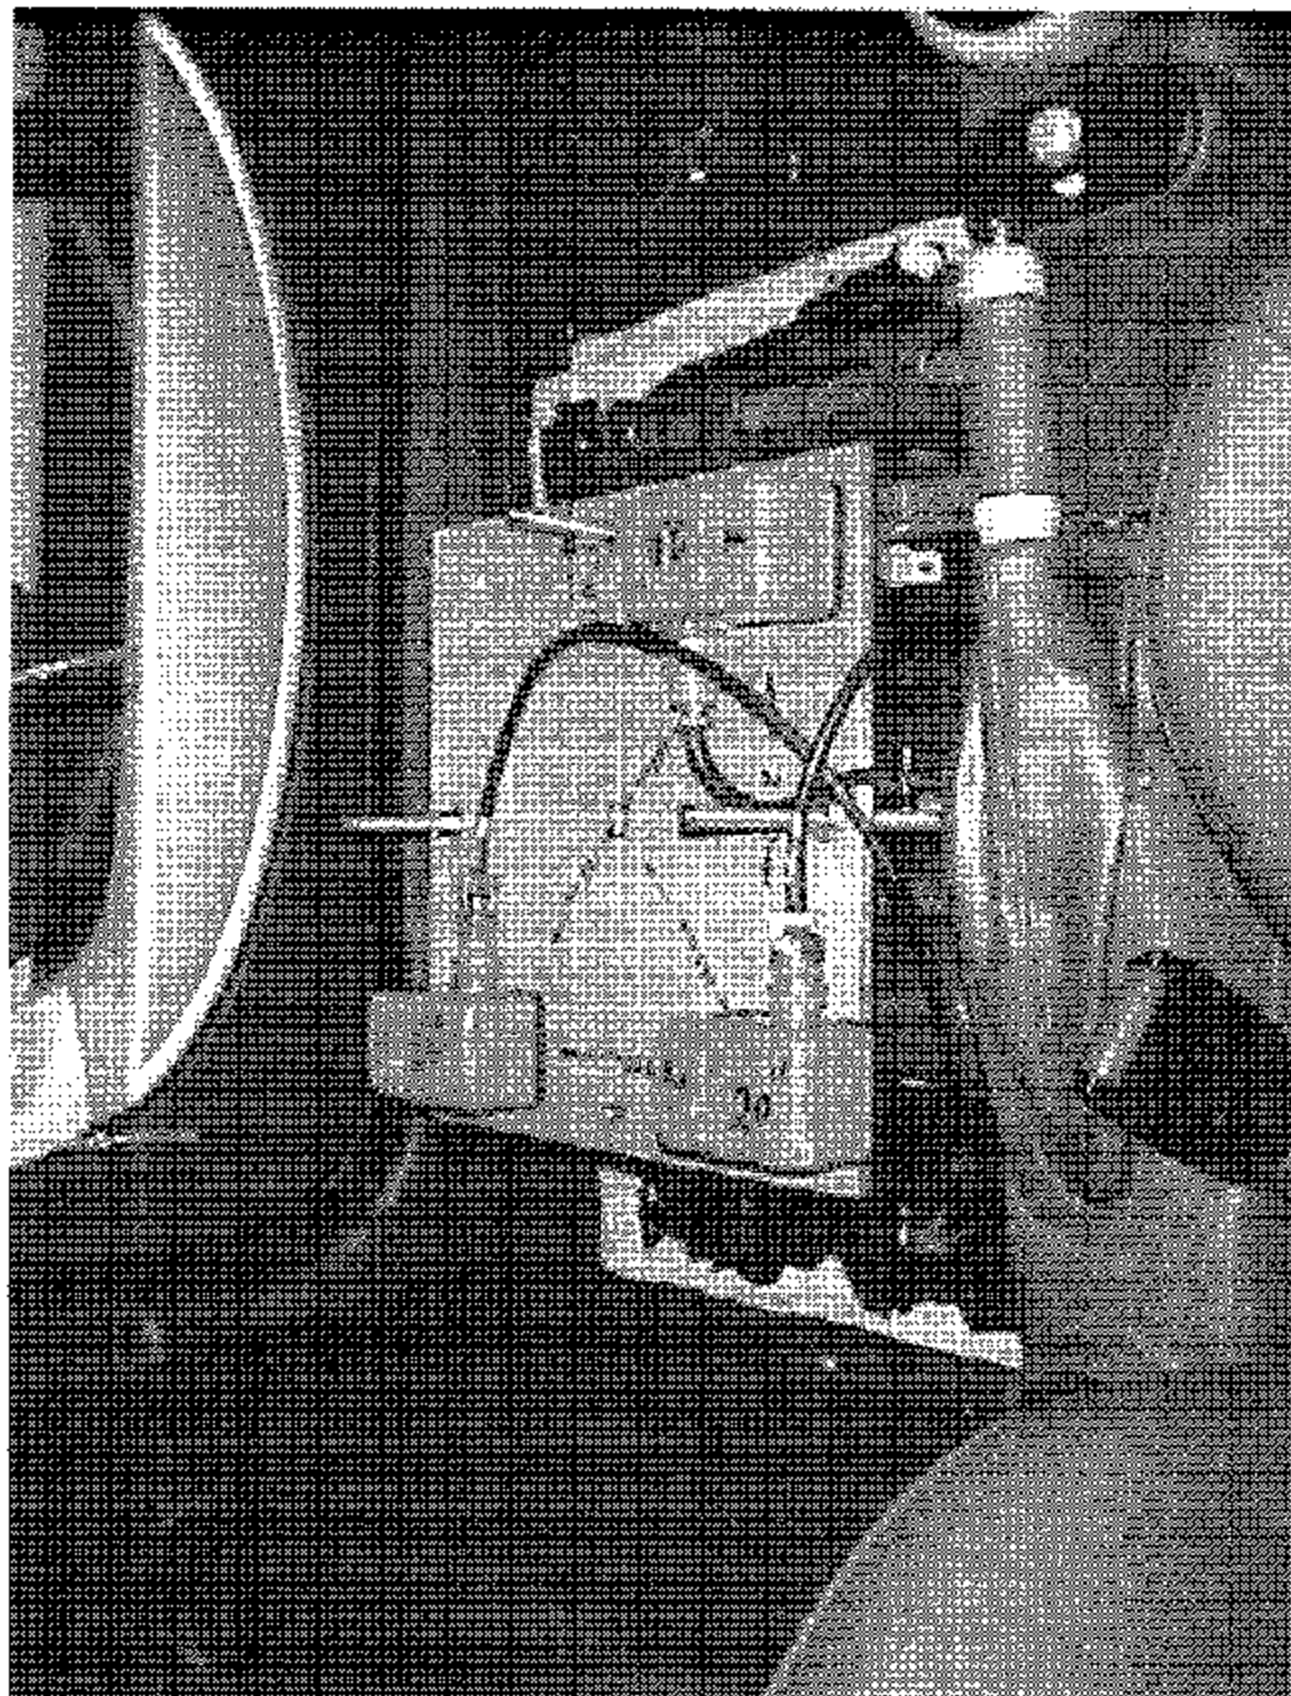
FIGURE 5.9  
LVDT TRANSDUCER MOUNTING AT  
"H" POINT

Driver Seat "H" Point Location at Mid Travel:

X= 250 mm aft of front outboard seat mounting bolt center line

Y= 204 mm inboard of front outboard seat mounting bolt center line

Z= 250 mm up from front outboard seat mounting bolt center line

All LVDT's are located 185 mm from a vertical line passing through the seat "H" point.

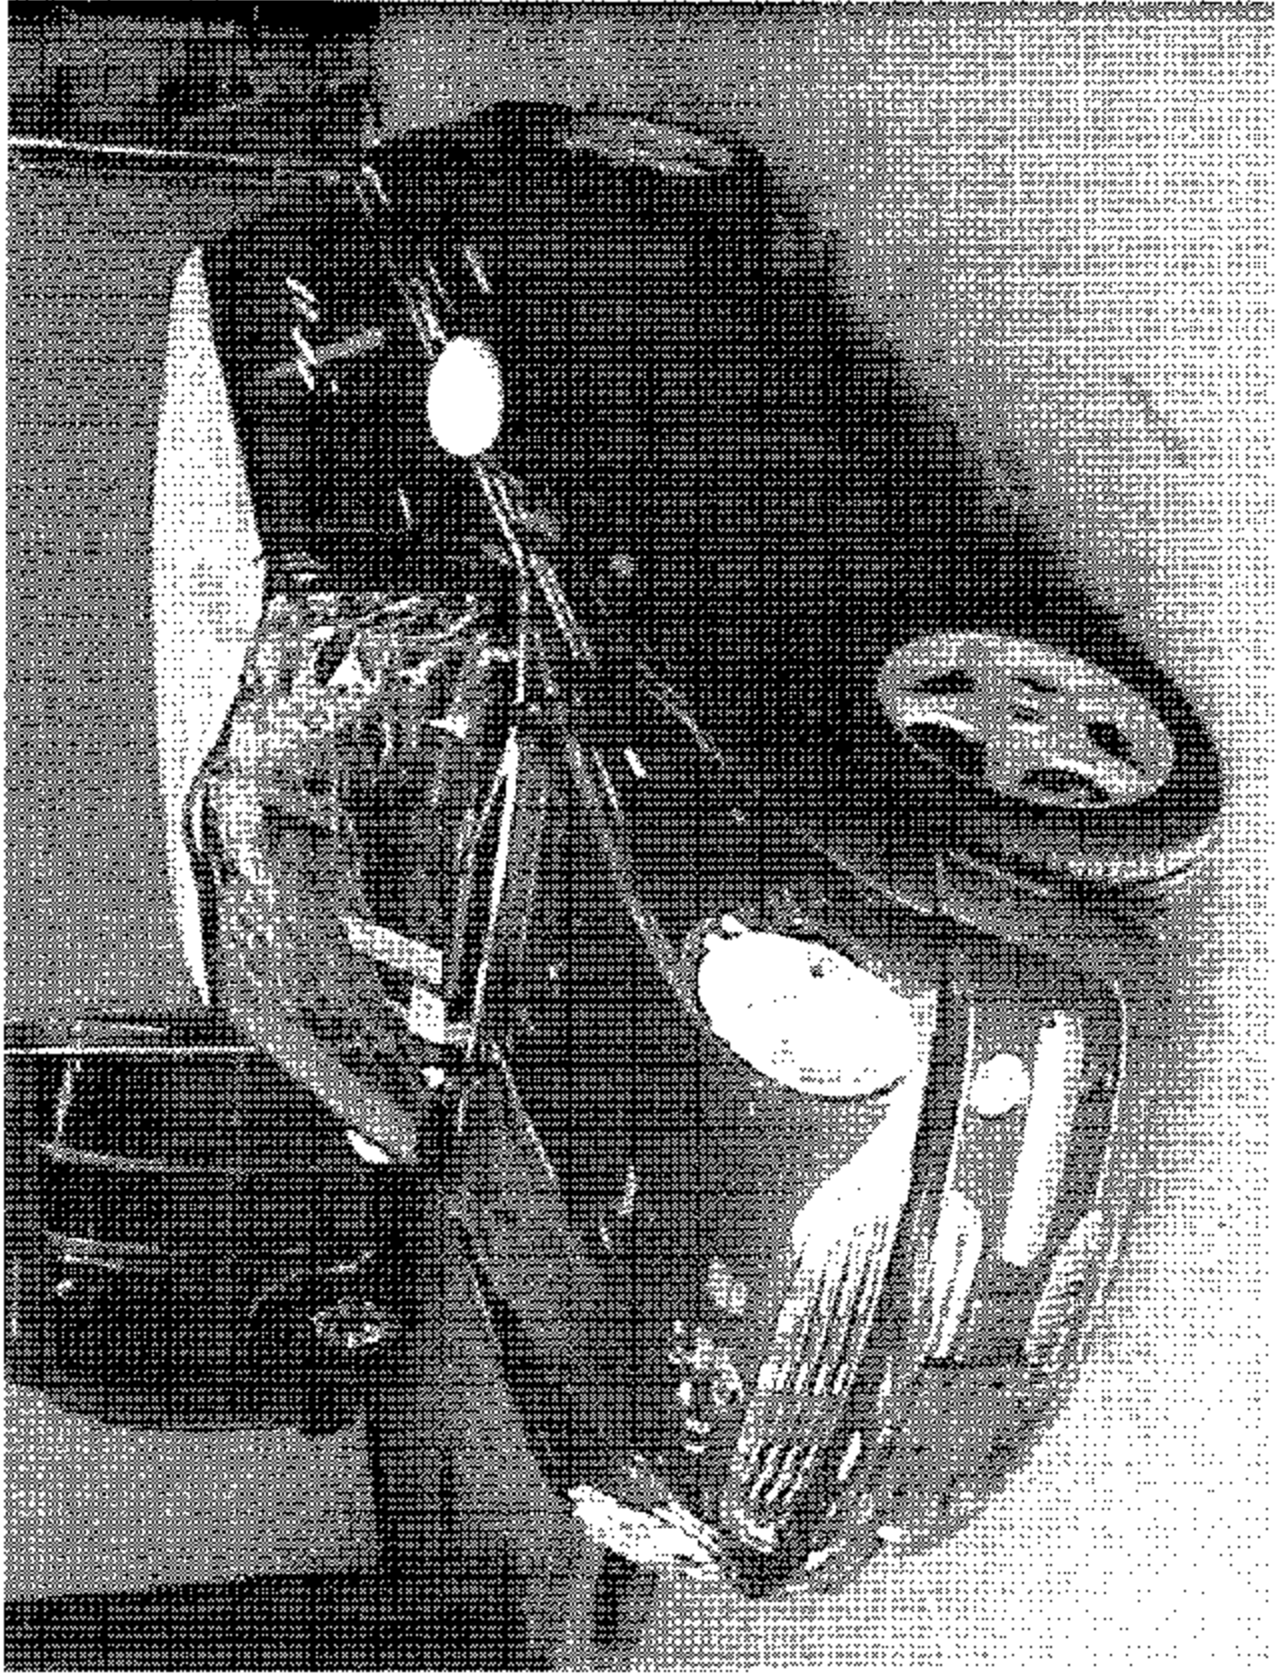
FIGURE 5.14  
3/4 FRONT LEFT SIDE VIEW OF VEHICLE ON  
TESTED SIDE AFTER TESTING

RESULTS: 500 mm wide x 1200 mm long flattened area above driver. Center of roof between driver and passenger pushed up approximately 30 mm. Driver "A" pillar pushed toward passenger side approximately 80 mm. Windshield shattered.

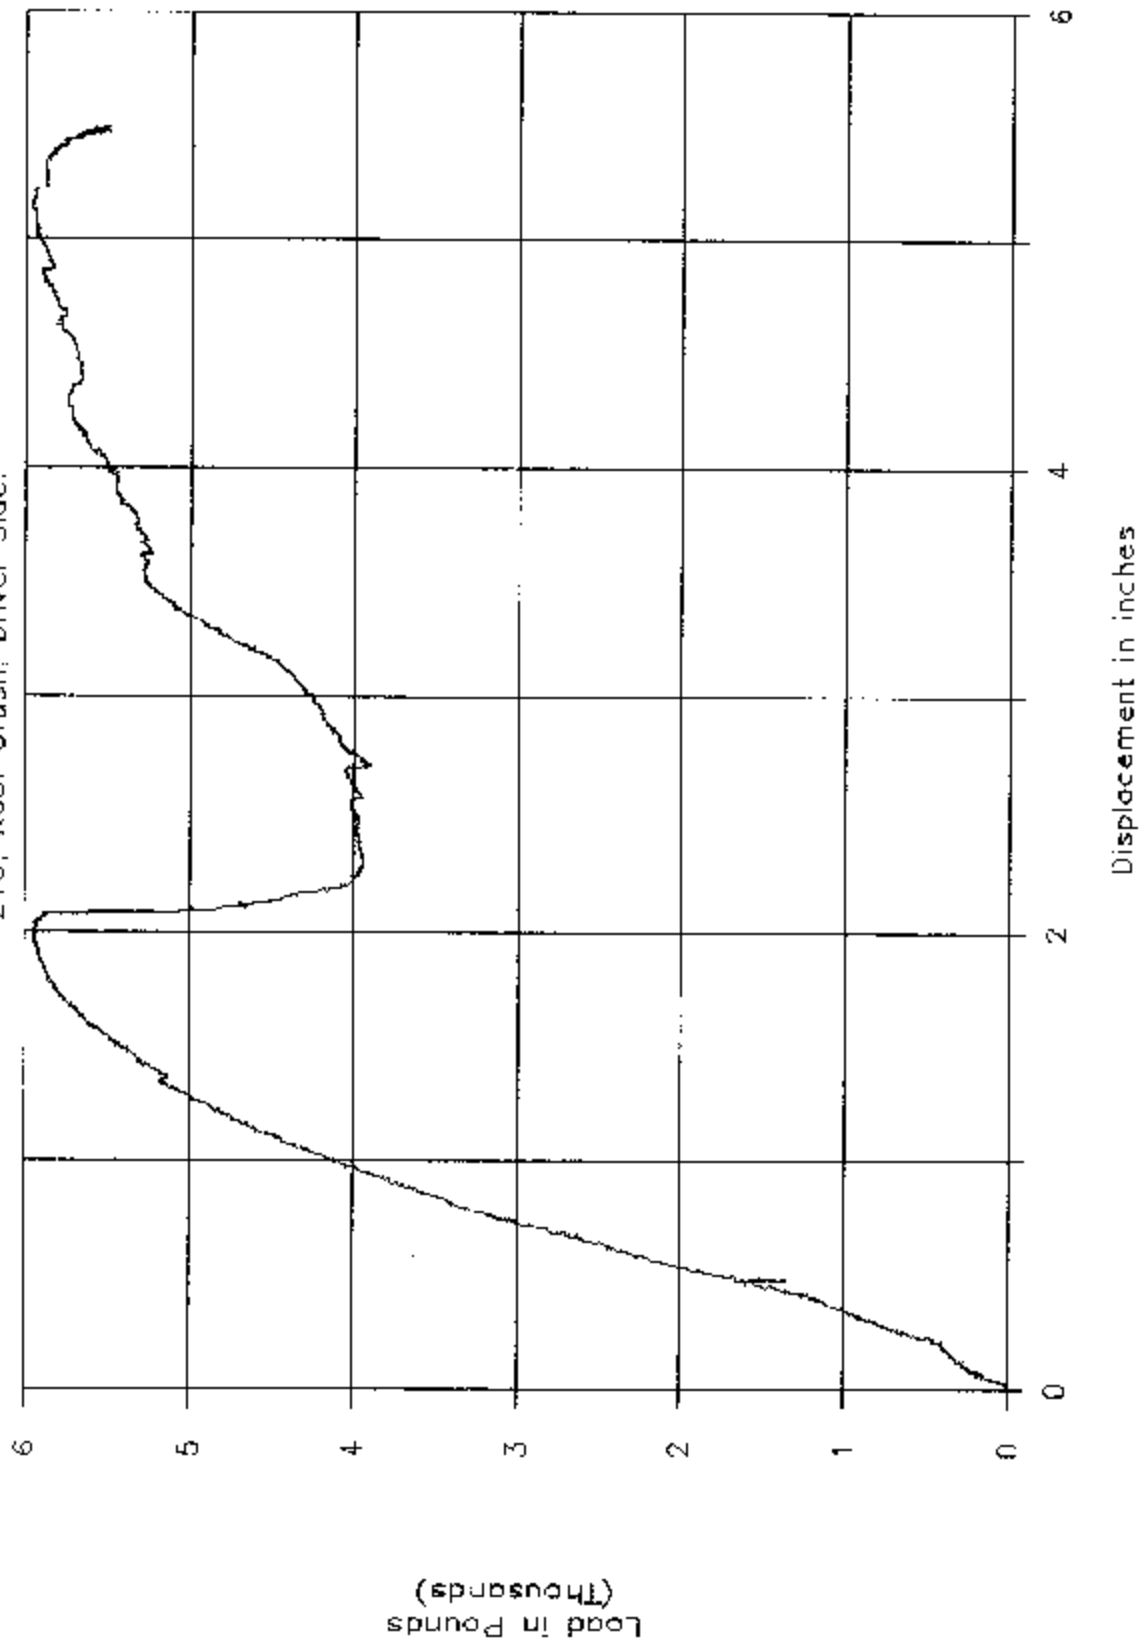
216, Roof Crush, Driver Side.

- (1) The maximum roof crush resistance was 26,550 N at 130.9 mm
- (2) The rate of loading was 5.08 mm/sec (.2 in/sec)
- (3) The required roof crush resistance of 17,125 N was at 23.6 mm

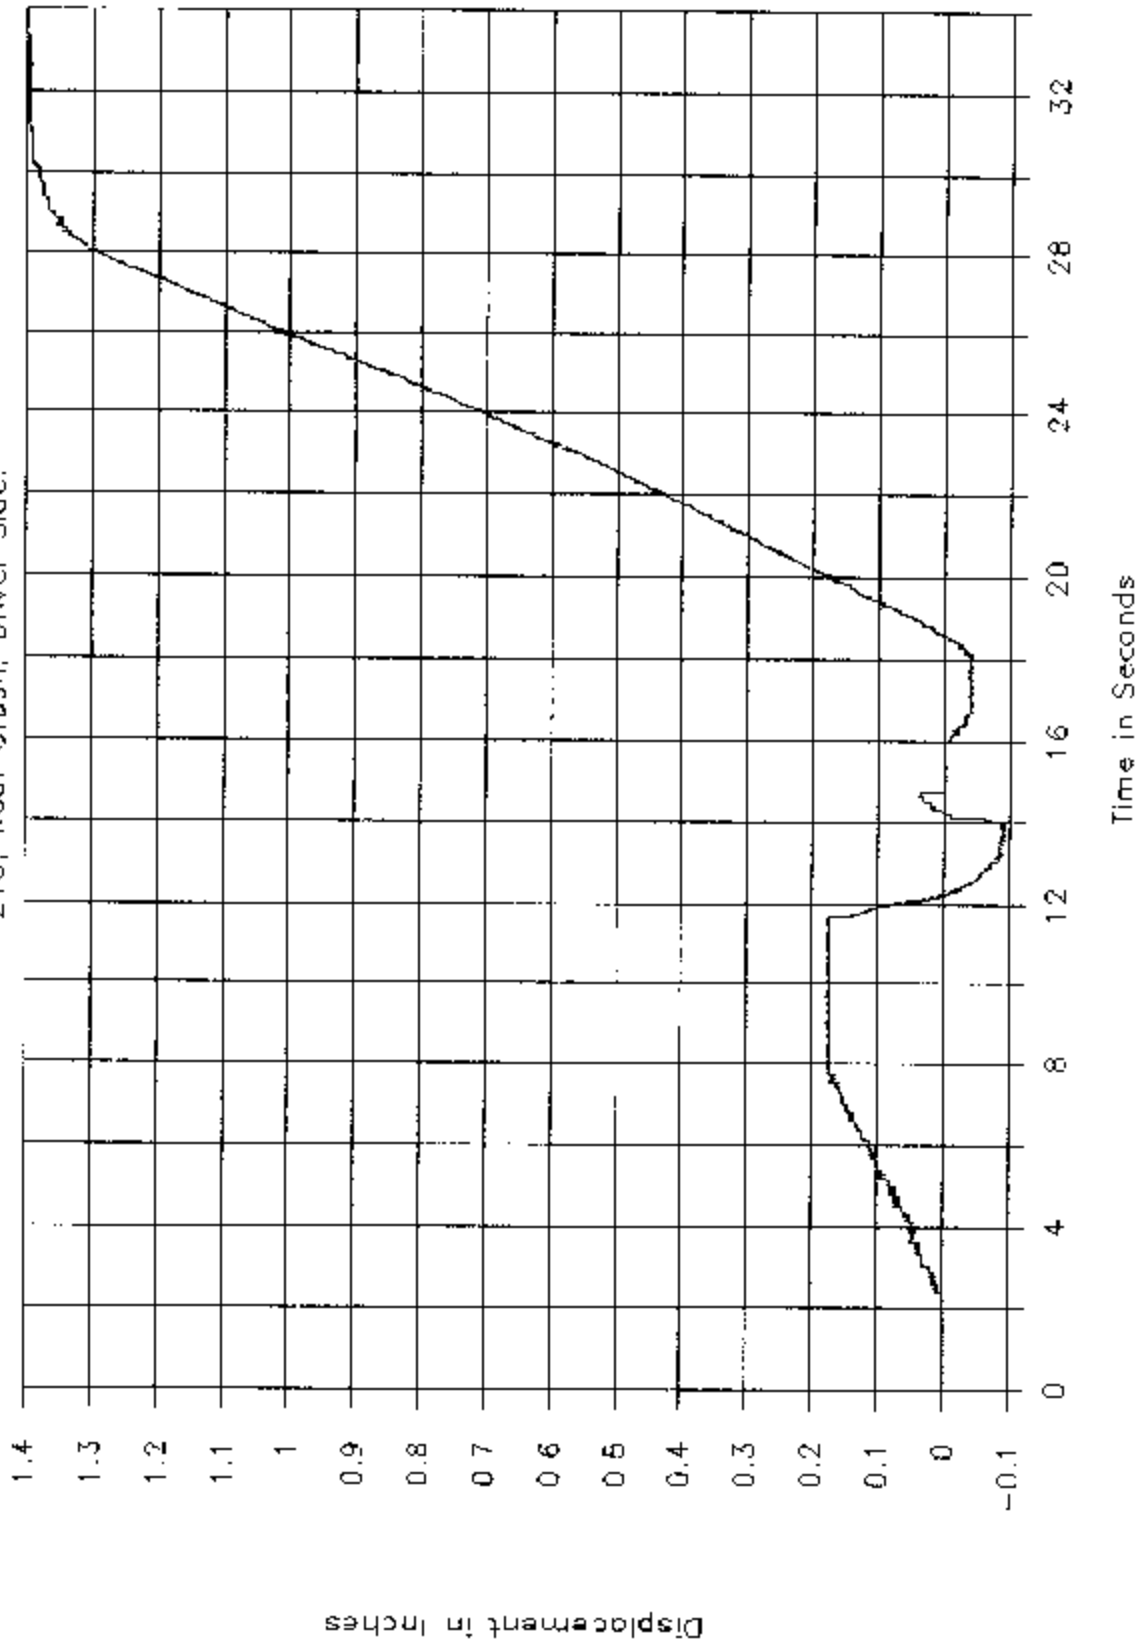
# GTL 5017, LVDT #1,R.F.

216, Roof Crush, Driver Side.

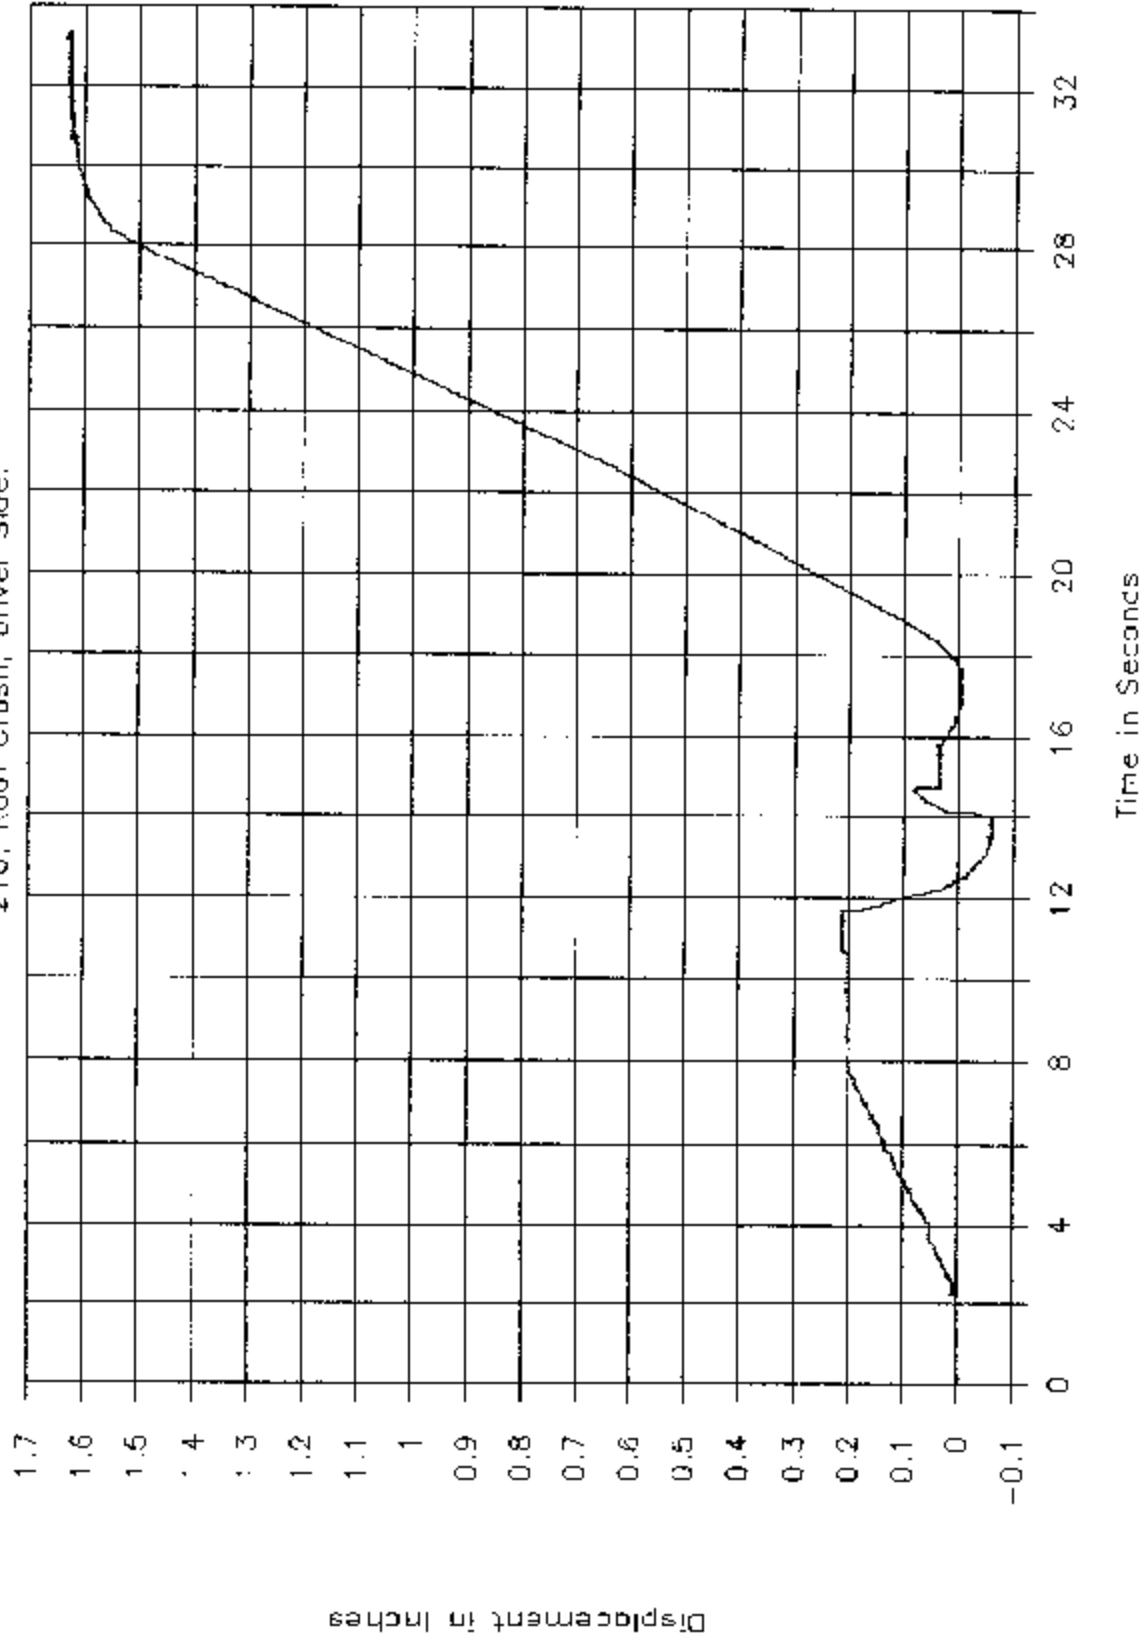
GT- 5017, LVDT #2, R.R.

216, Roof Crush, Driver Side.

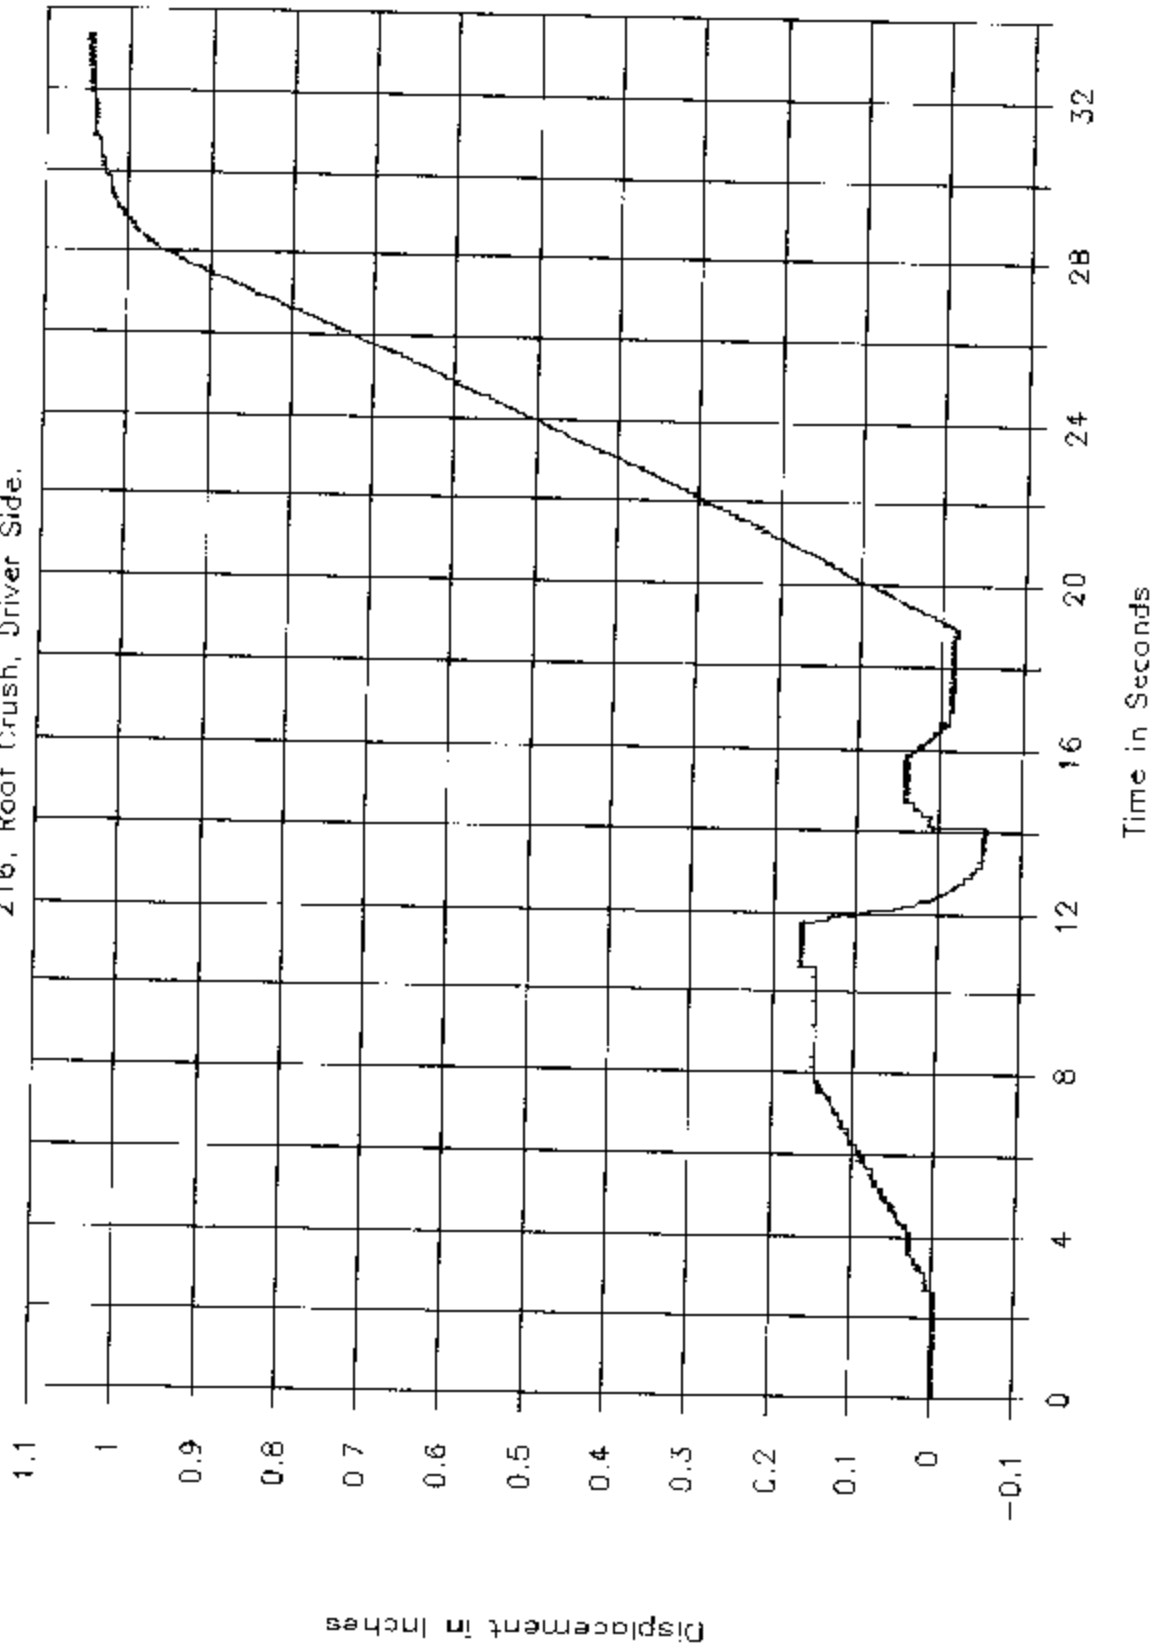
# GTL 5017, LVDT #3, L.R.

216, Roof Crush, Driver Side.
