REPORT NUMBER: 217-MGA-03-004

**SAFETY COMPLIANCE TESTING FOR
FMVSS NO. 217
SCHOOL BUS EMERGENCY EXITS AND WINDOW
RETENTION AND RELEASE**

2003 Liberty Bus
Freedom School Bus
NHTSA No.: C30901

PREPARED BY:
MGA RESEARCH CORPORATION
5000 WARREN ROAD
BURLINGTON, WI 53105

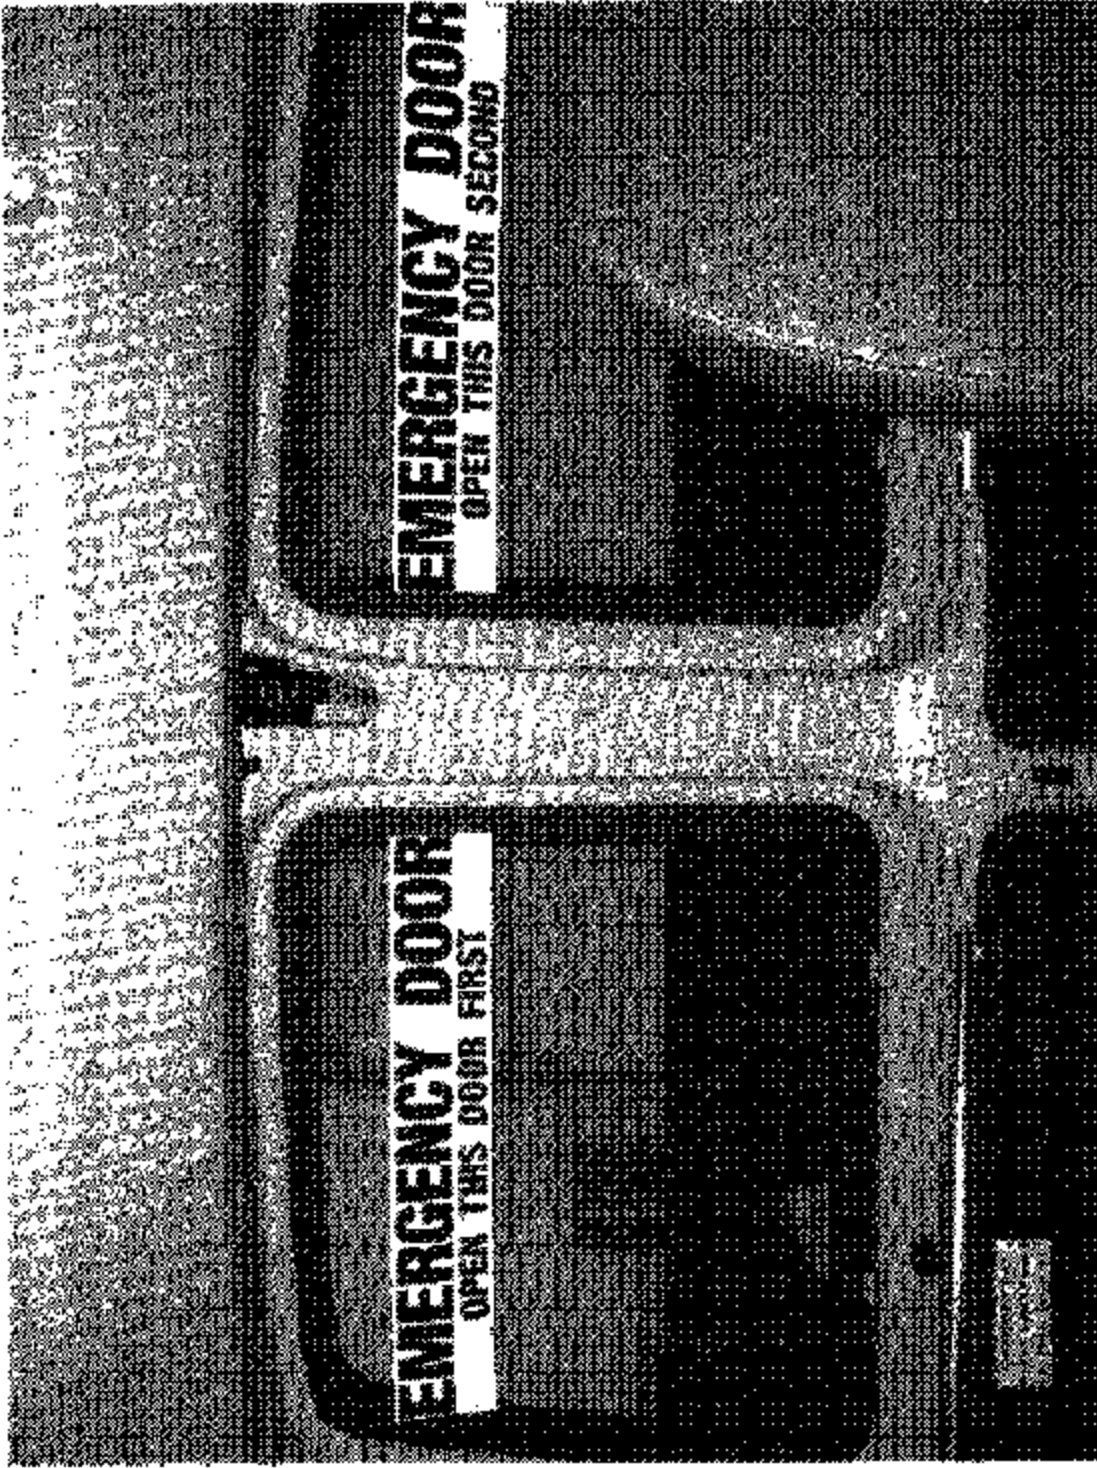
Photograph 6:
Rear Exit Door Identification (Inside View)

EMERGENCY EXIT LABELING - INTERIOR

Exit Location	Rear Left Door	Rear Right Door
Exit Description	Emergency Door	Emergency Door
Letter Height (cm)	5.0	5.0
Background Color	White	White
Location Inside	Top of Door	Top of Door
Pass/Fail	PASS	PASS

OPERATING INSTRUCTIONS - INTERIOR

Exit Location	Rear Left Door	Rear Right Door
Instructions	Move Handle To Open: Push out	Move Handle To Open: Push out
Letter Height (cm)	0.9	0.9
Letter Color	Black	Black
Background Color	White	White
Distance From Release (cm)	4	15
Reflective Tape Color	N/A	N/A
Reflective Tape Width	N/A	N/A
Pass/Fail	FAIL	FAIL

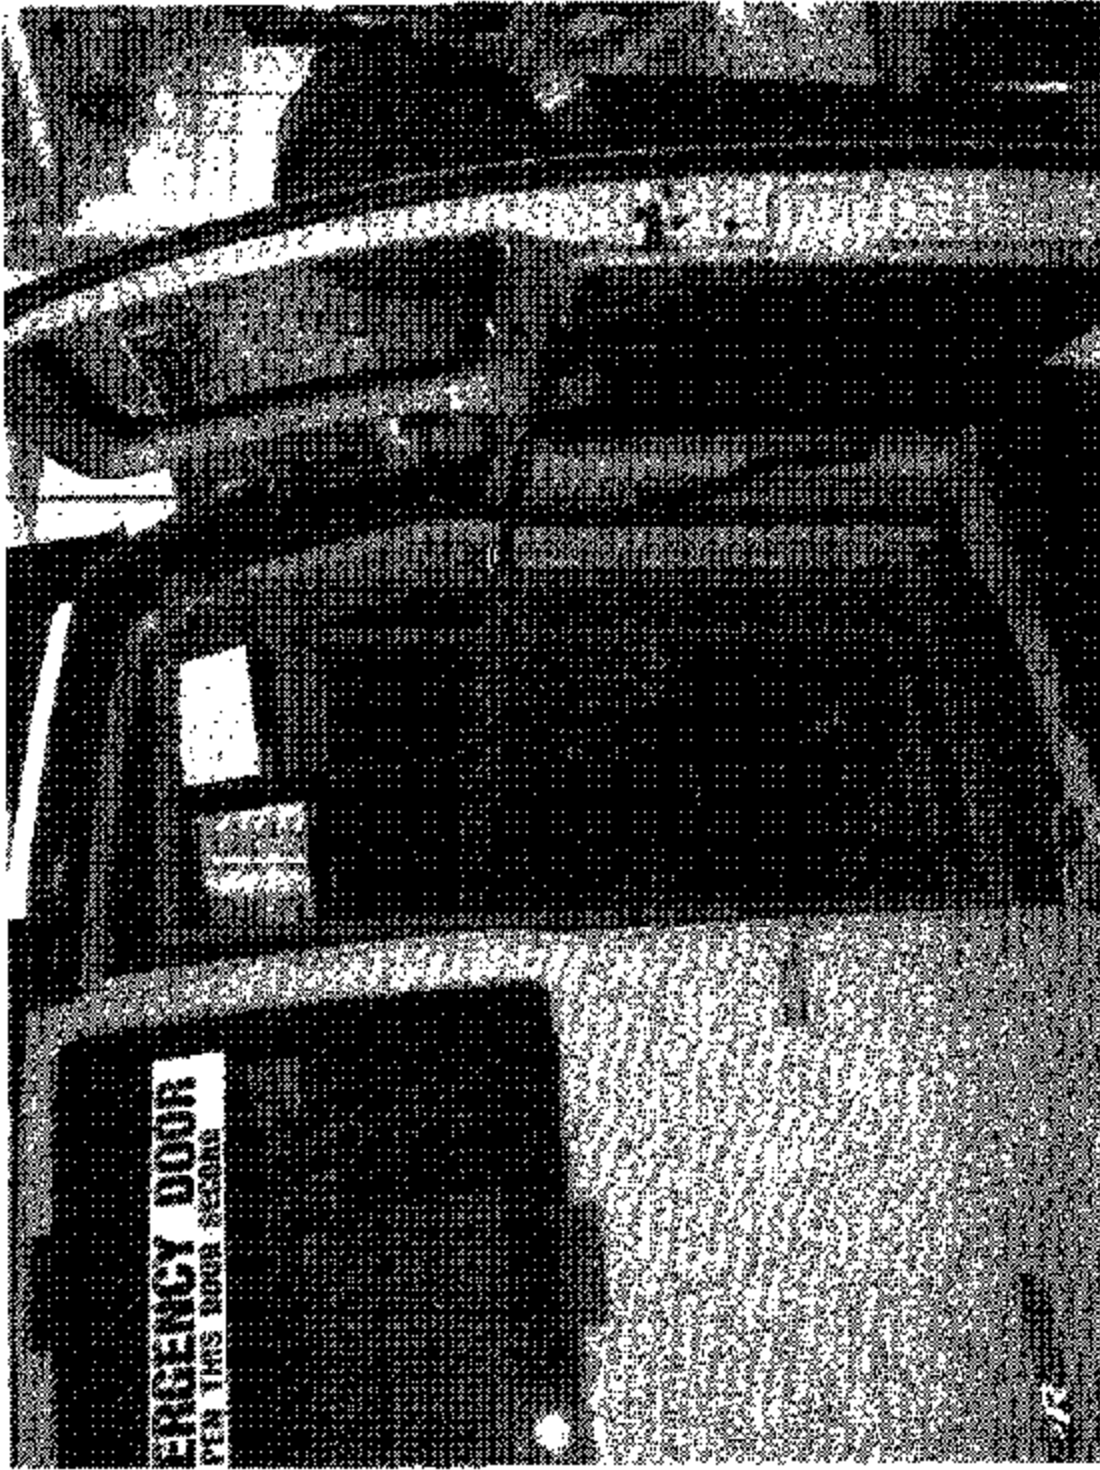
Photograph 7:
Rear Door Emergency Exit Parallelepiped Clearance

Exit Location	Exit Description	High/Low Force Area	Maximum Force Requirement Newtons	Actual Force Measured (N)	Motion(s) required to Open Exit	Actual Motion(s) to Open Exit	Passage of Ellipsoid or Parallelepiped	PASS/FAIL
Rear Left Door	Door Exit	High	178	1. 20.5	Straight and Perpendicular to the undisturbed exit surface	Straight Outward Push	114x55x15 Parallelepiped	PASS
				2. 21.0				
				3. 18.0				
				Average: 19.8				
Rear Right Door	Door Exit	High	178	1. 16.0	Straight and Perpendicular to the undisturbed exit surface	Straight Outward Push	114x55x15 Parallelepiped	PASS
				2. 17.0				
				3. 13.5				
				Average: 15.5

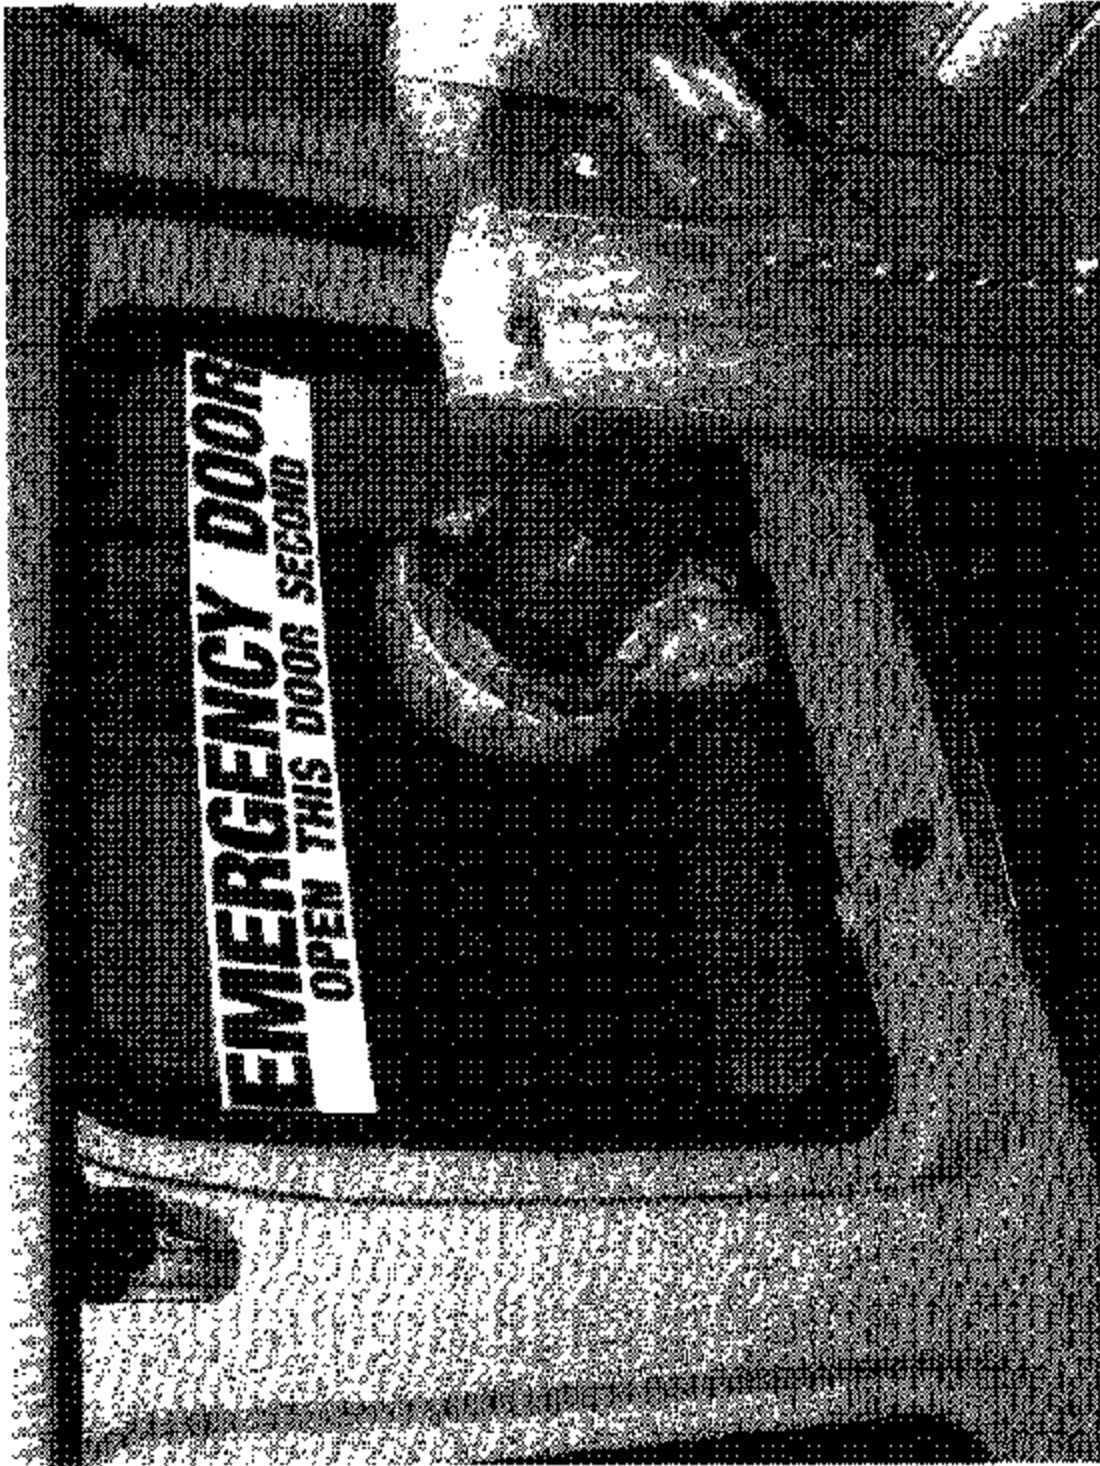
Photograph 10:
Retention Test of Left Rear Window (Pre-Test)

1	Test Window Identification:	Left Rear Emergency Door Window
2	Provide a detailed description of the window such as fixed, push out, single or double glazed, horizontal or vertical sliding, etc.	Fixed Window - Push Out Door Operation
3	Provide the horizontal and vertical glazing dimensions for each panel.	536 mm x 596 mm
4	Did the window pass the retention requirements? Describe how the window structure and glazing withstood the force per the PASS/FAIL criteria:	Glazing shattered at 489 kg - PASS
5	Did the window pass the force tests to unlatch and open the exit after the completion of the retention test?	PASS 53.0 N to Unlatch 21.2 N to Open

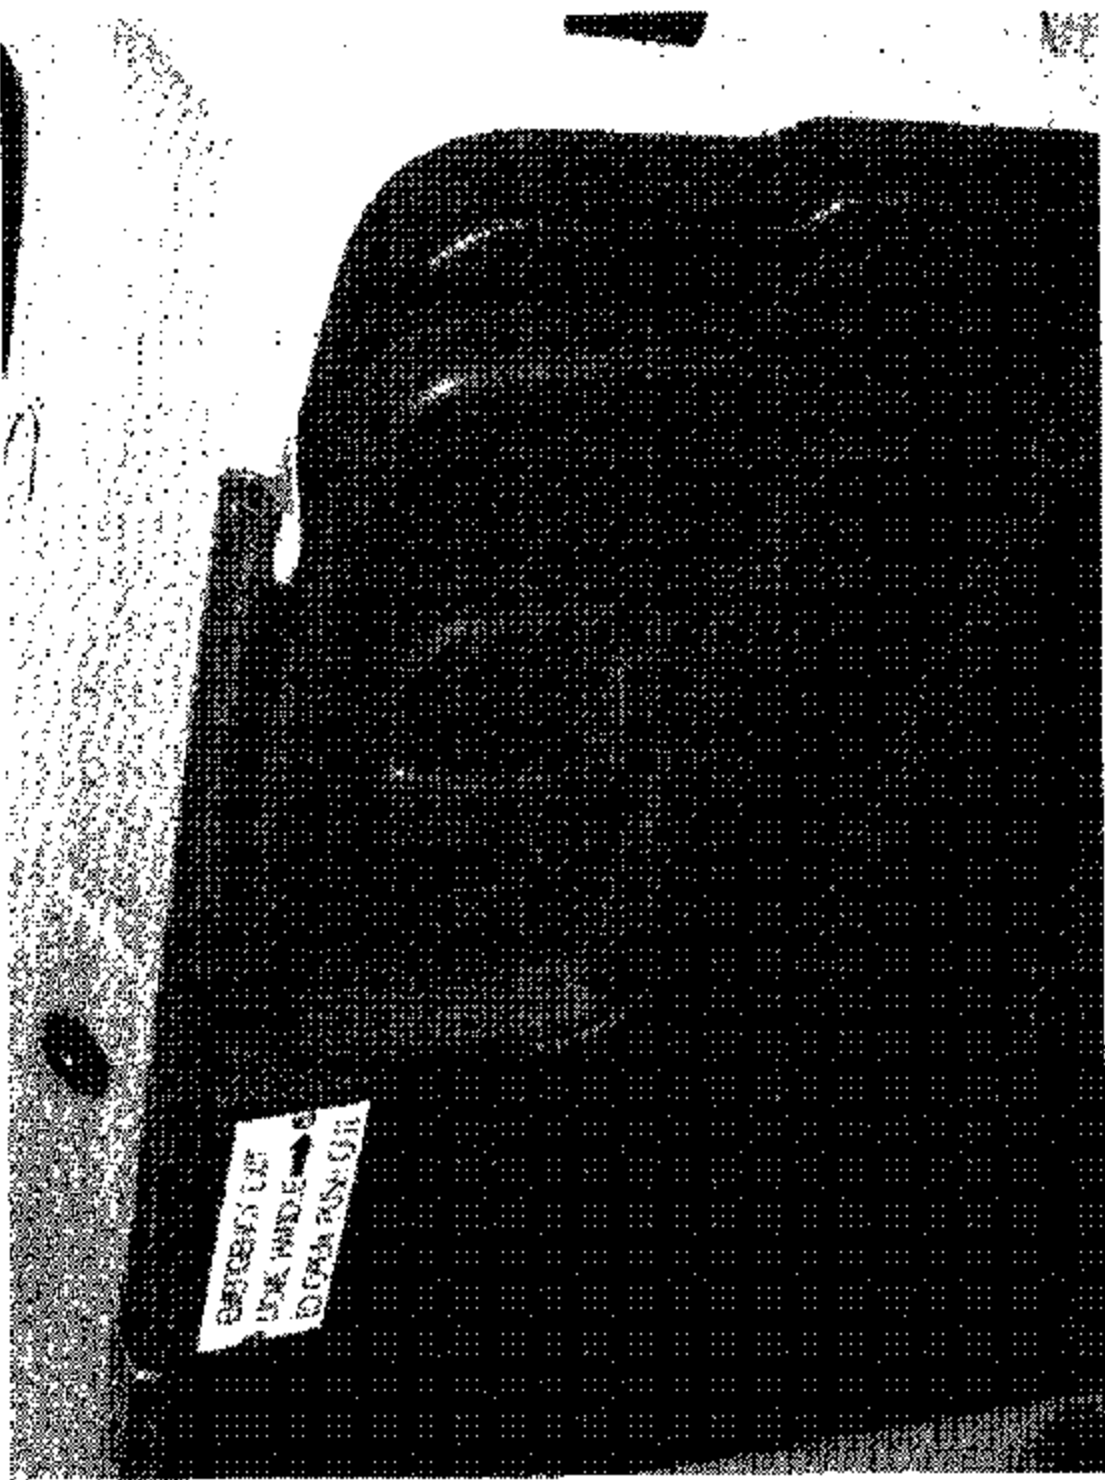
Photograph 16:
Door Handle Failure

⁽²⁾ The release mechanism uses a pull type motion and is required to be recessed such that the mechanism does not protrude beyond the rim of the recessed receptacle (49 CFR 571.217 Paragraph S.5.3.3.1(b)). The release mechanism is not recessed below the rim of the receptacle.

Due to its pull type motion, FMVSS 217 requires the handle to unlatch the right rear emergency door from the interior of the bus be recessed so that it does not protrude beyond the rim of the recessed receptacle. The handle does protrude beyond the rim of the recessed receptacle.

Paragraph S.5.3.1(b): "... The pull type motion shall be used only when the release mechanism is recessed in such a manner that the handle, ..., does not protrude beyond the rim of the recessed receptacle.
