REPORT NUMBER: 301F-MGA-03-004

**SAFETY COMPLIANCE TESTING FOR
FMVSS NO. 301F
FUEL SYSTEM INTEGRITY**

2003 Liberty Freedom
School Bus
NHTSA No.: C30901

PREPARED BY:
MGA RESEARCH CORPORATION
5000 WARREN ROAD
BURLINGTON, WI 53105

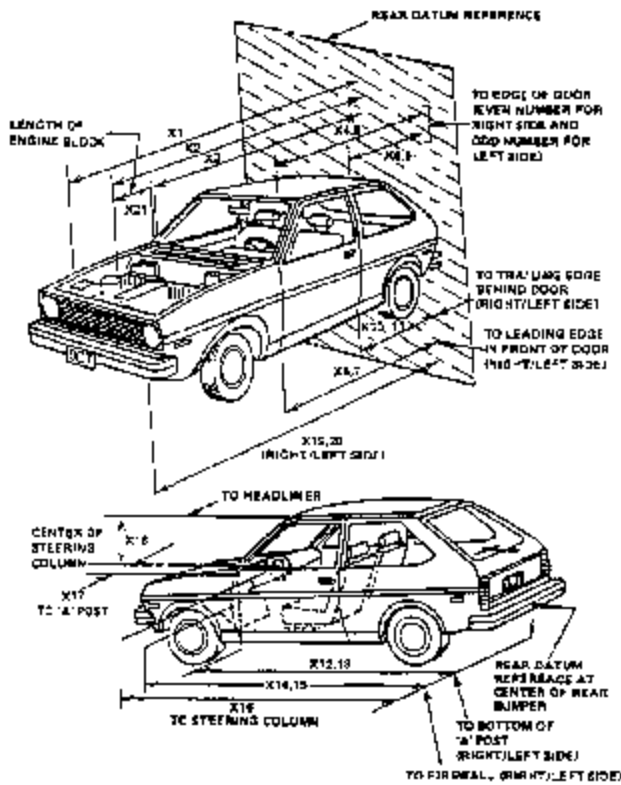
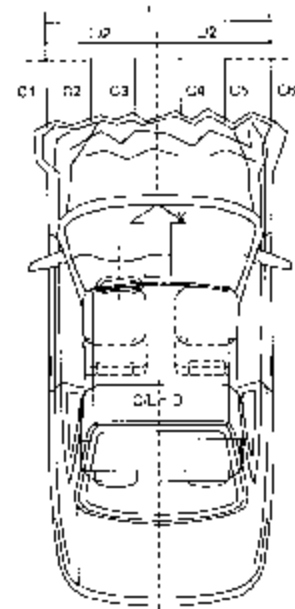
No.	Measurement Description	Units	Pre-Test	Post-Test	Difference
X1	Total length of vehicle at centerline	mm	6173	5616	557
C1	See Diagram	mm	5955	5321	634
C2	See Diagram	mm	6110	5611	499
C3	See Diagram	mm	6164	5625	540
C4	See Diagram	mm	6165	5630	535
C5	See Diagram	mm	6111	5620	491
C6	See Diagram	mm	5959	5456	503
L	See Diagram	mm	1800	1830	-30

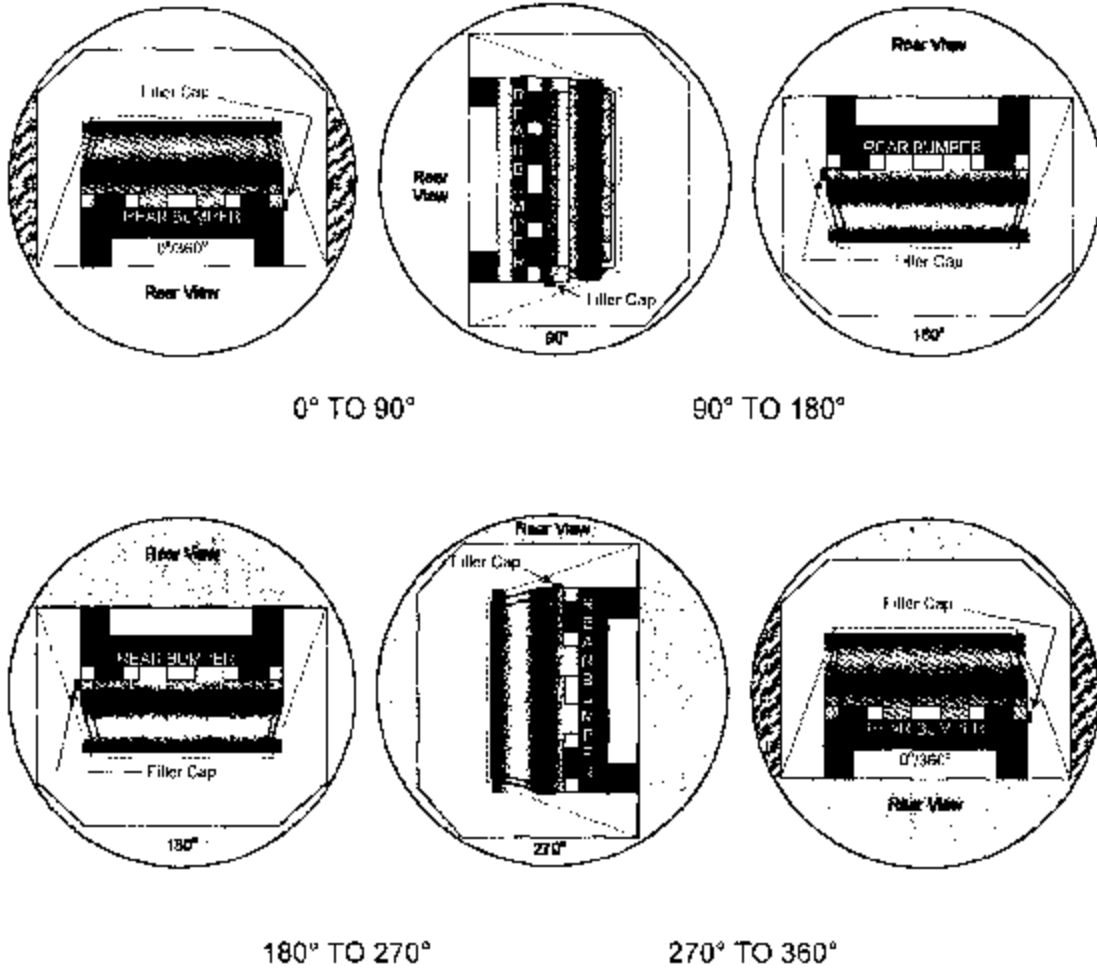
**DATA SHEET 3
FMVSS 301 STATIC ROLLOVER DATA**

1. The specified fixture rollover rate for each 90° of rotation is 60 to 180 seconds.
2. The position hold time at each position is 300 seconds (minimum).
3. Details of Stoddard Solvent spillage locations:

Test Phase	Rotation Time (sec)	Hold Time (sec)	Spillage (oz)
0° TO 90°	165	300	0
90° TO 180°	152	300	0
180° TO 270°	141	300	0
270° TO 360°	157	300	0

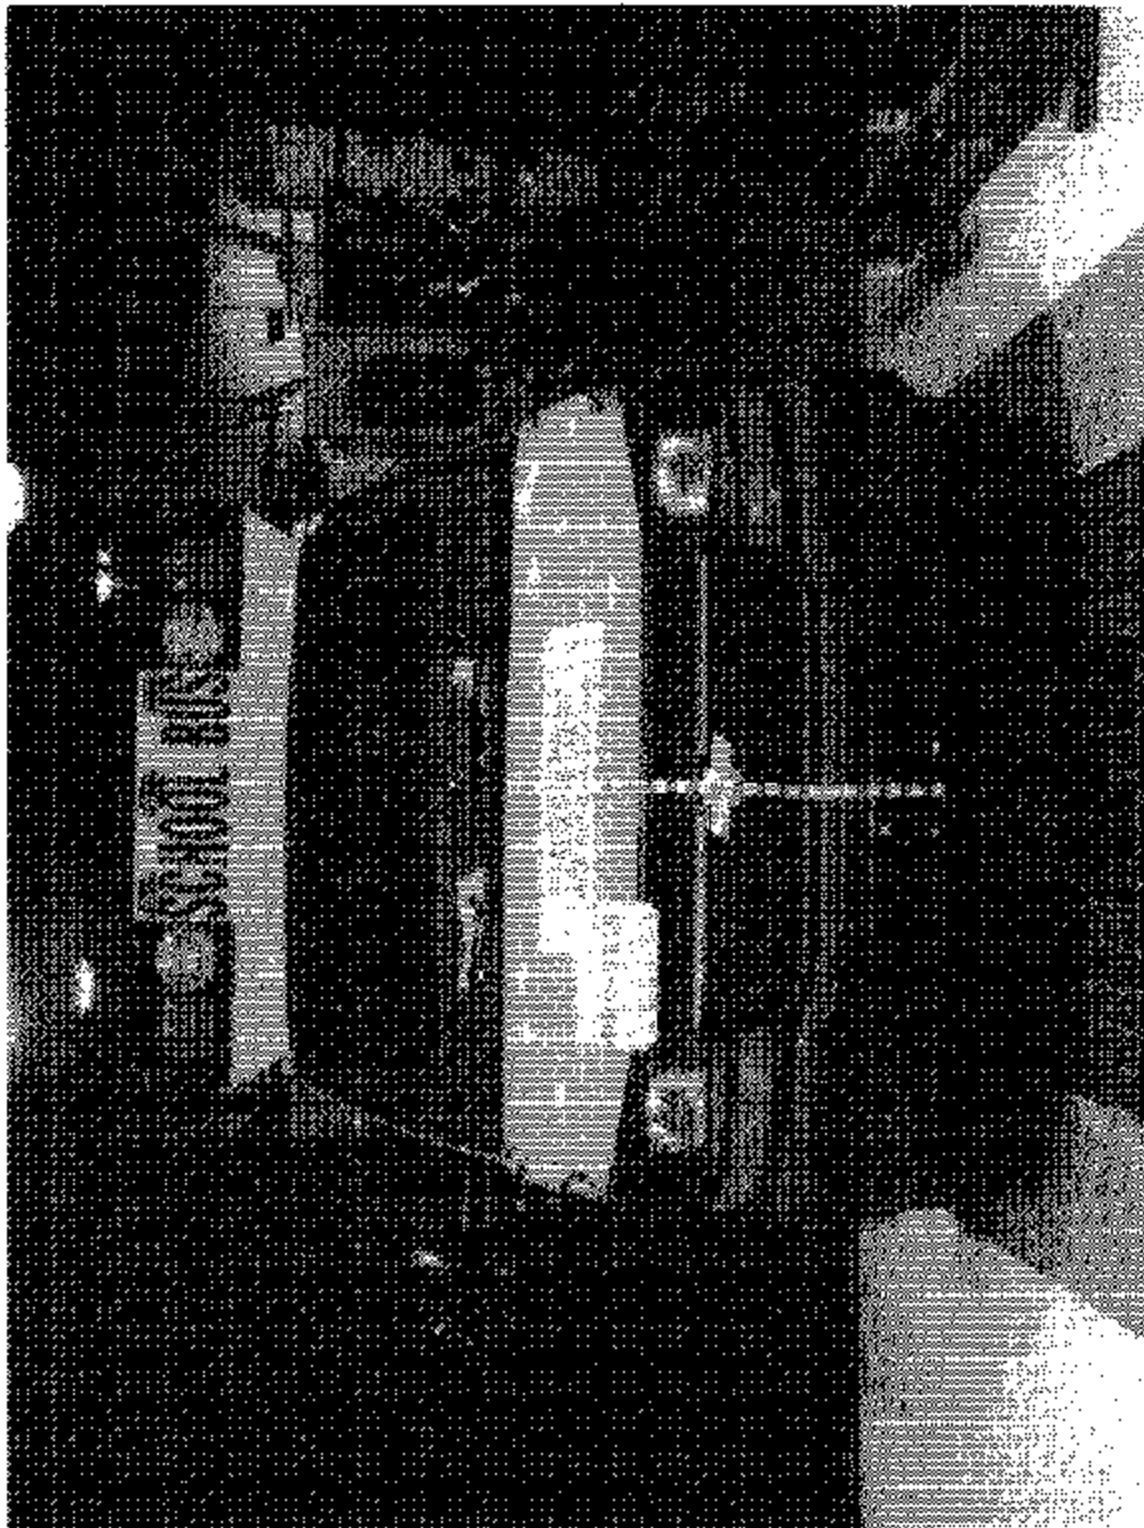
Pre-Test Front View of School Bus

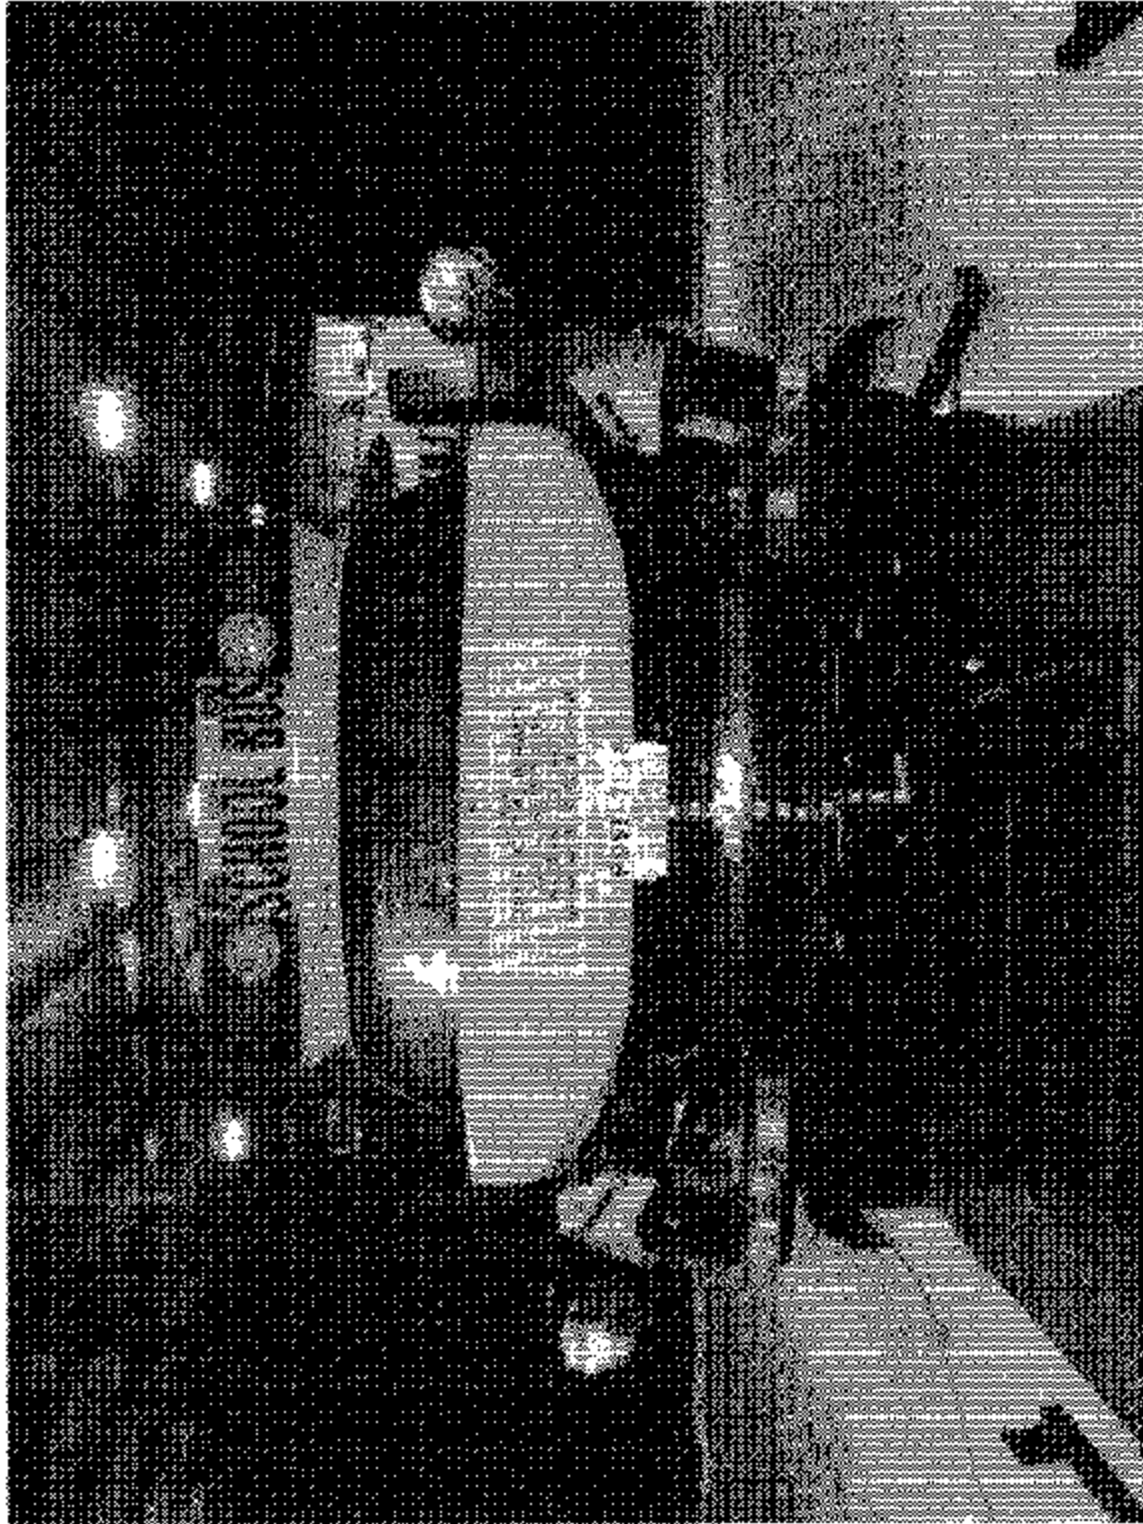
Post-Test Front View of School Bus

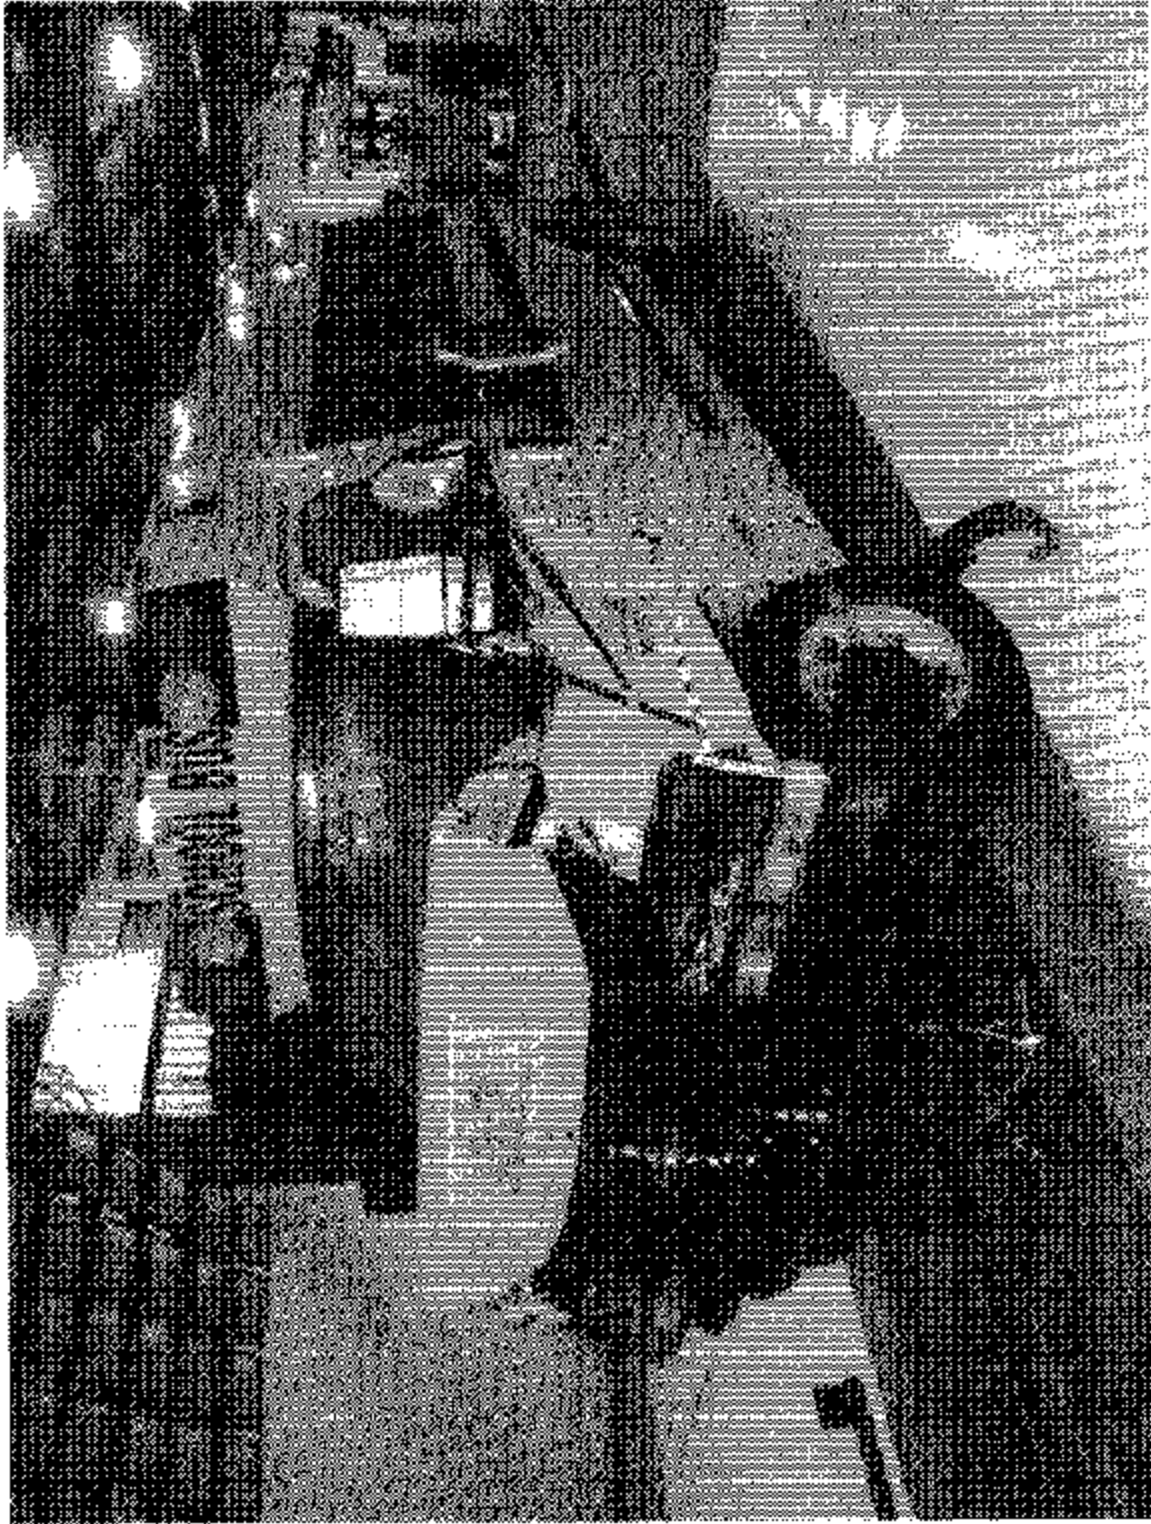
Post-Test Left Front 3/4 View of School Bus

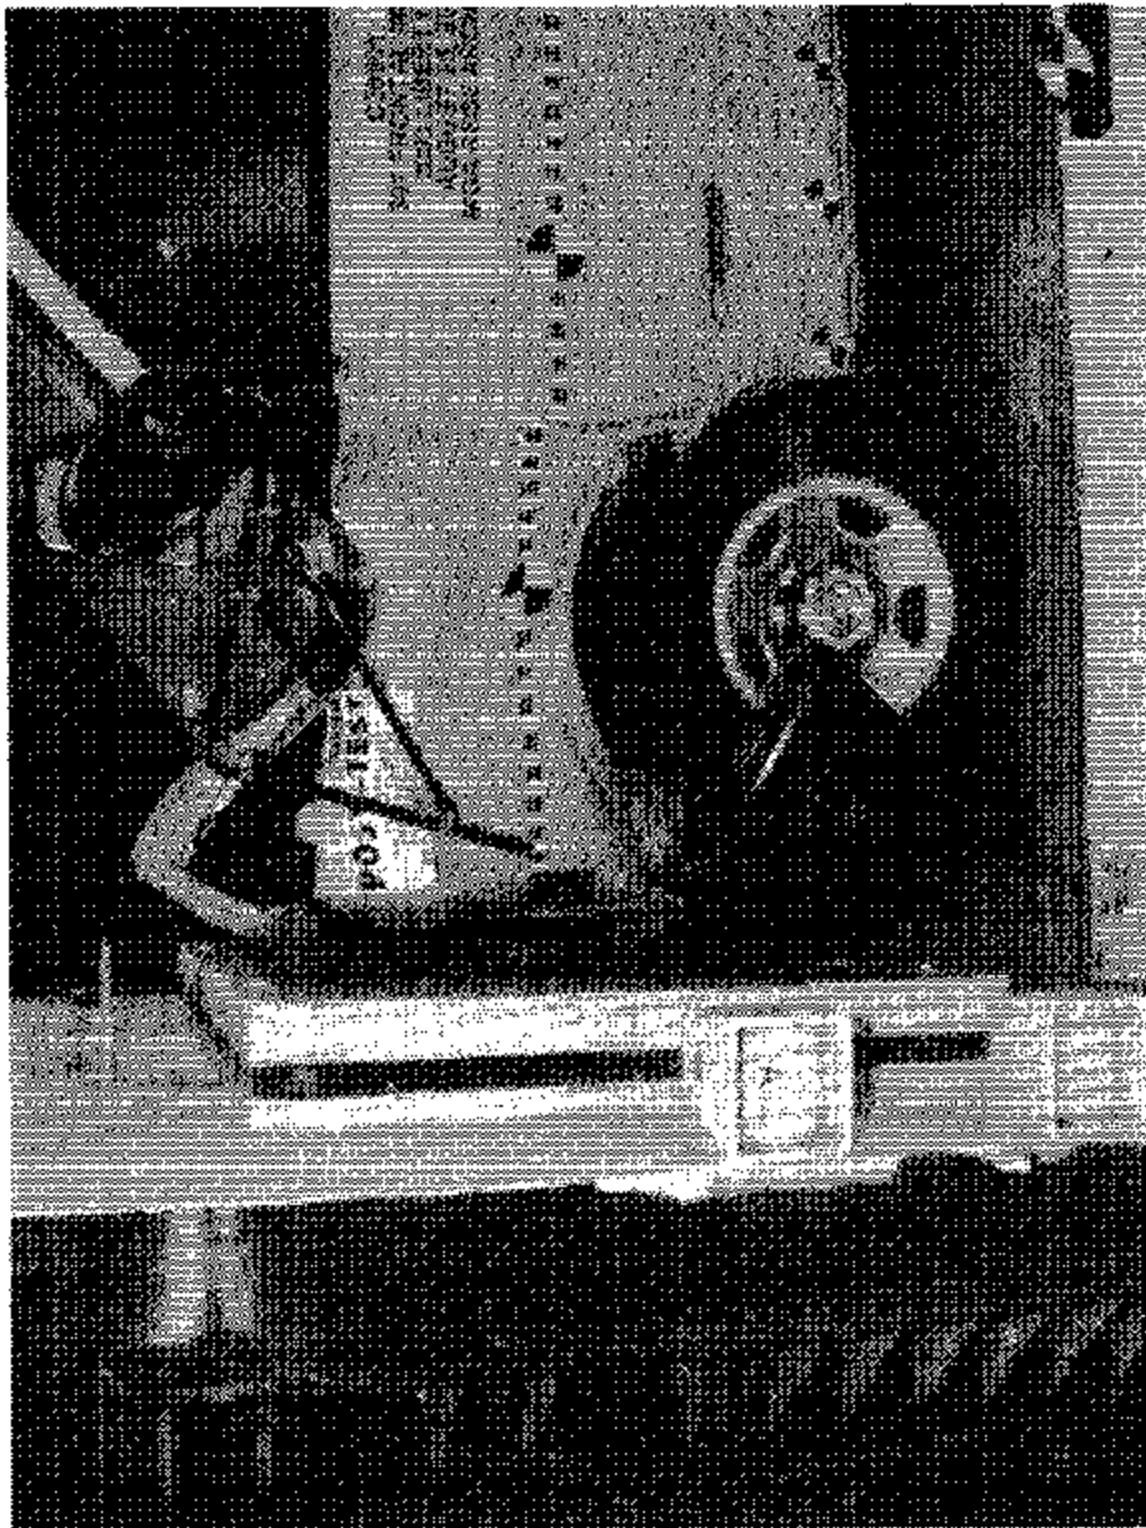
Post-Test (Close-Up) Left Front Side of School Bus

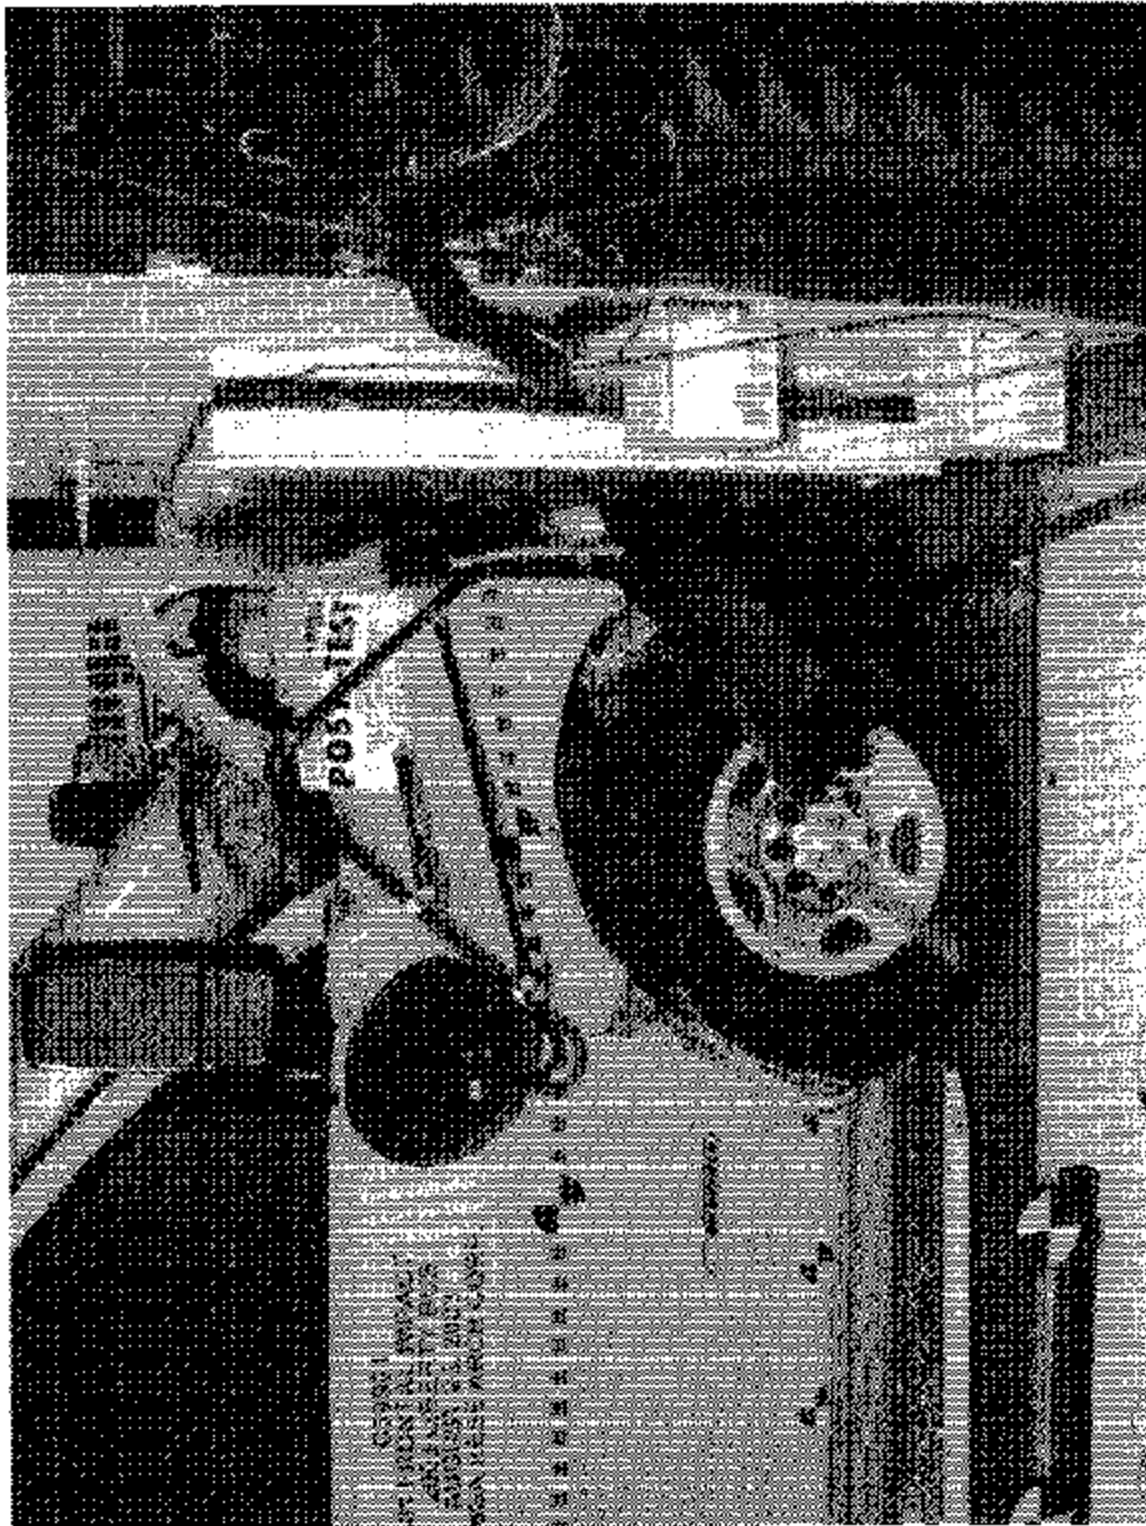
Post-Test (Close-Up) Right Front Side of School Bus

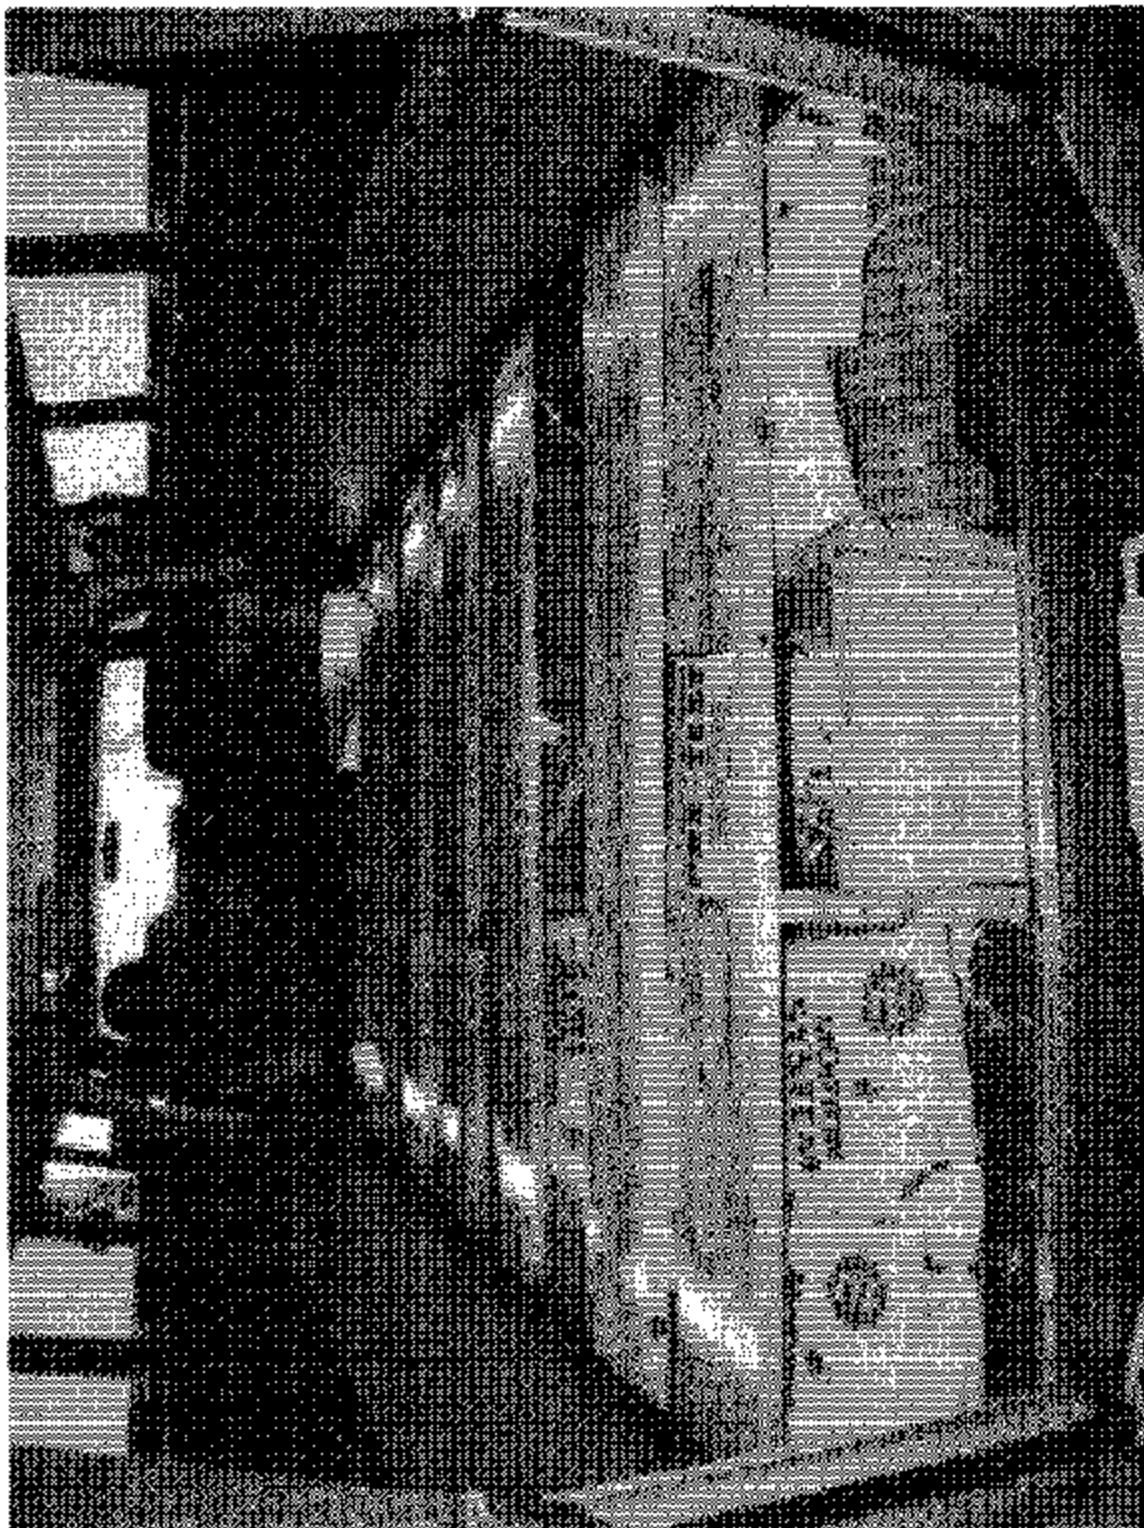
Pre-Test Ballast

COMMENTS: The seats were removed during prior testing. Seat weight and occupant weight was ballast using salt bags to meet the calculated test weight.

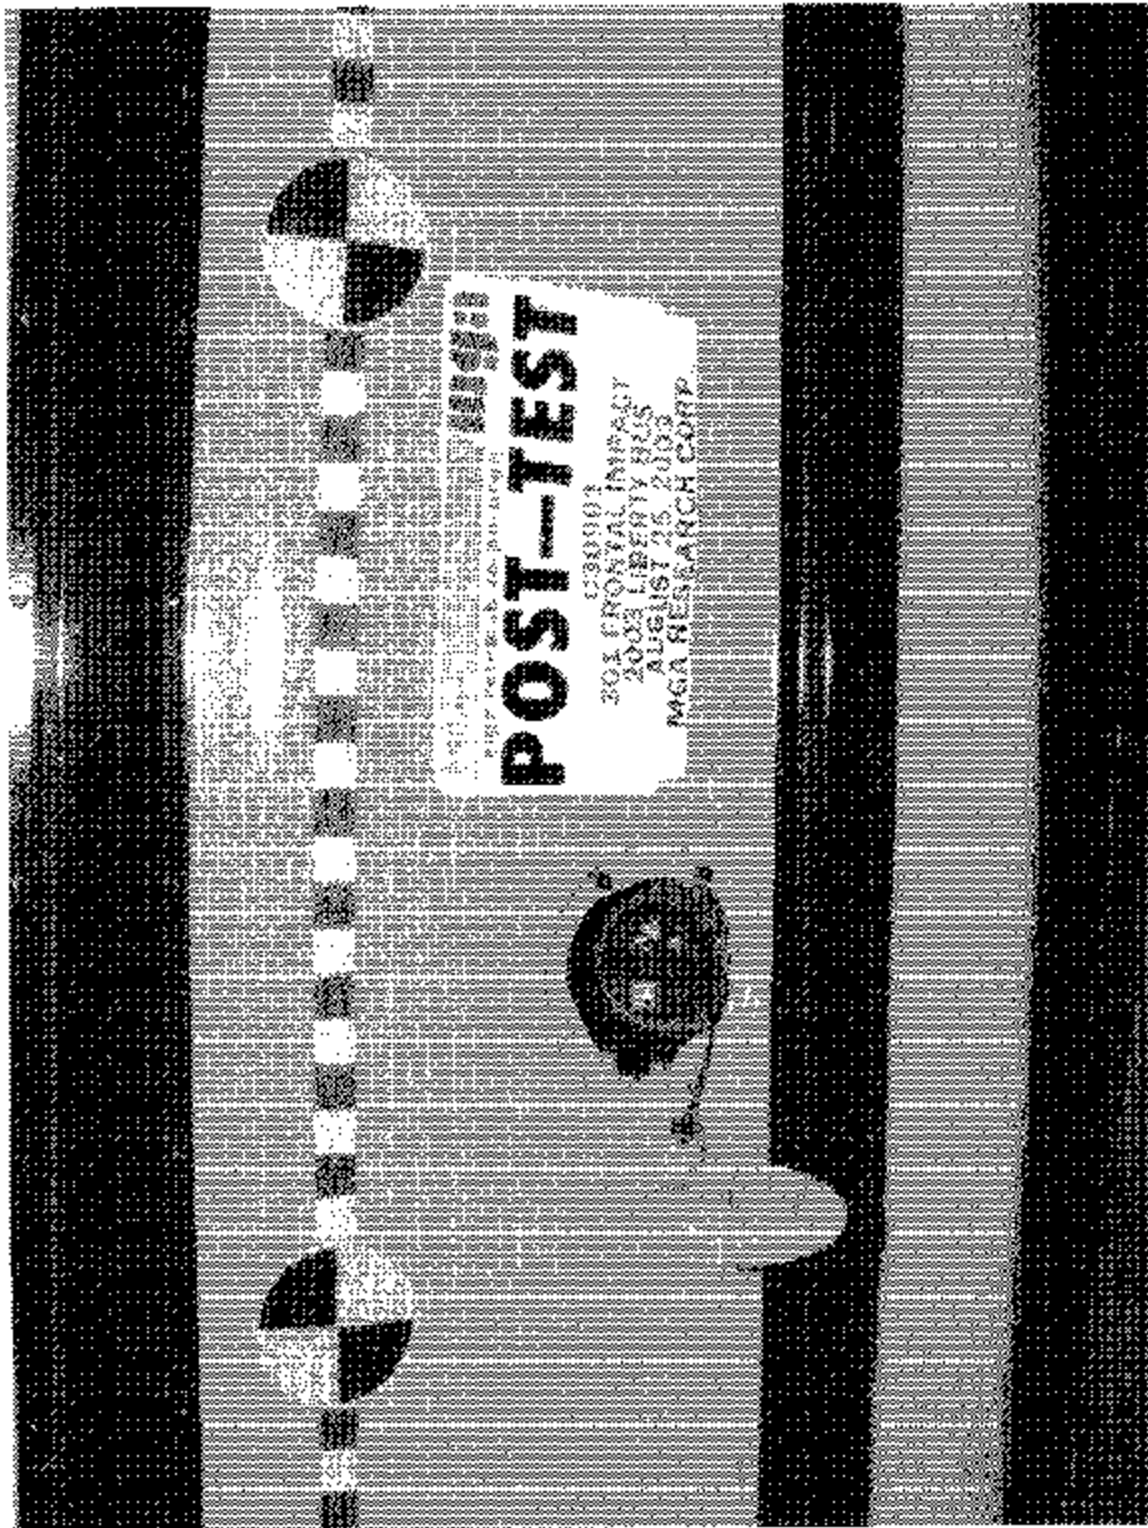
Post-Test of Fuel Cap

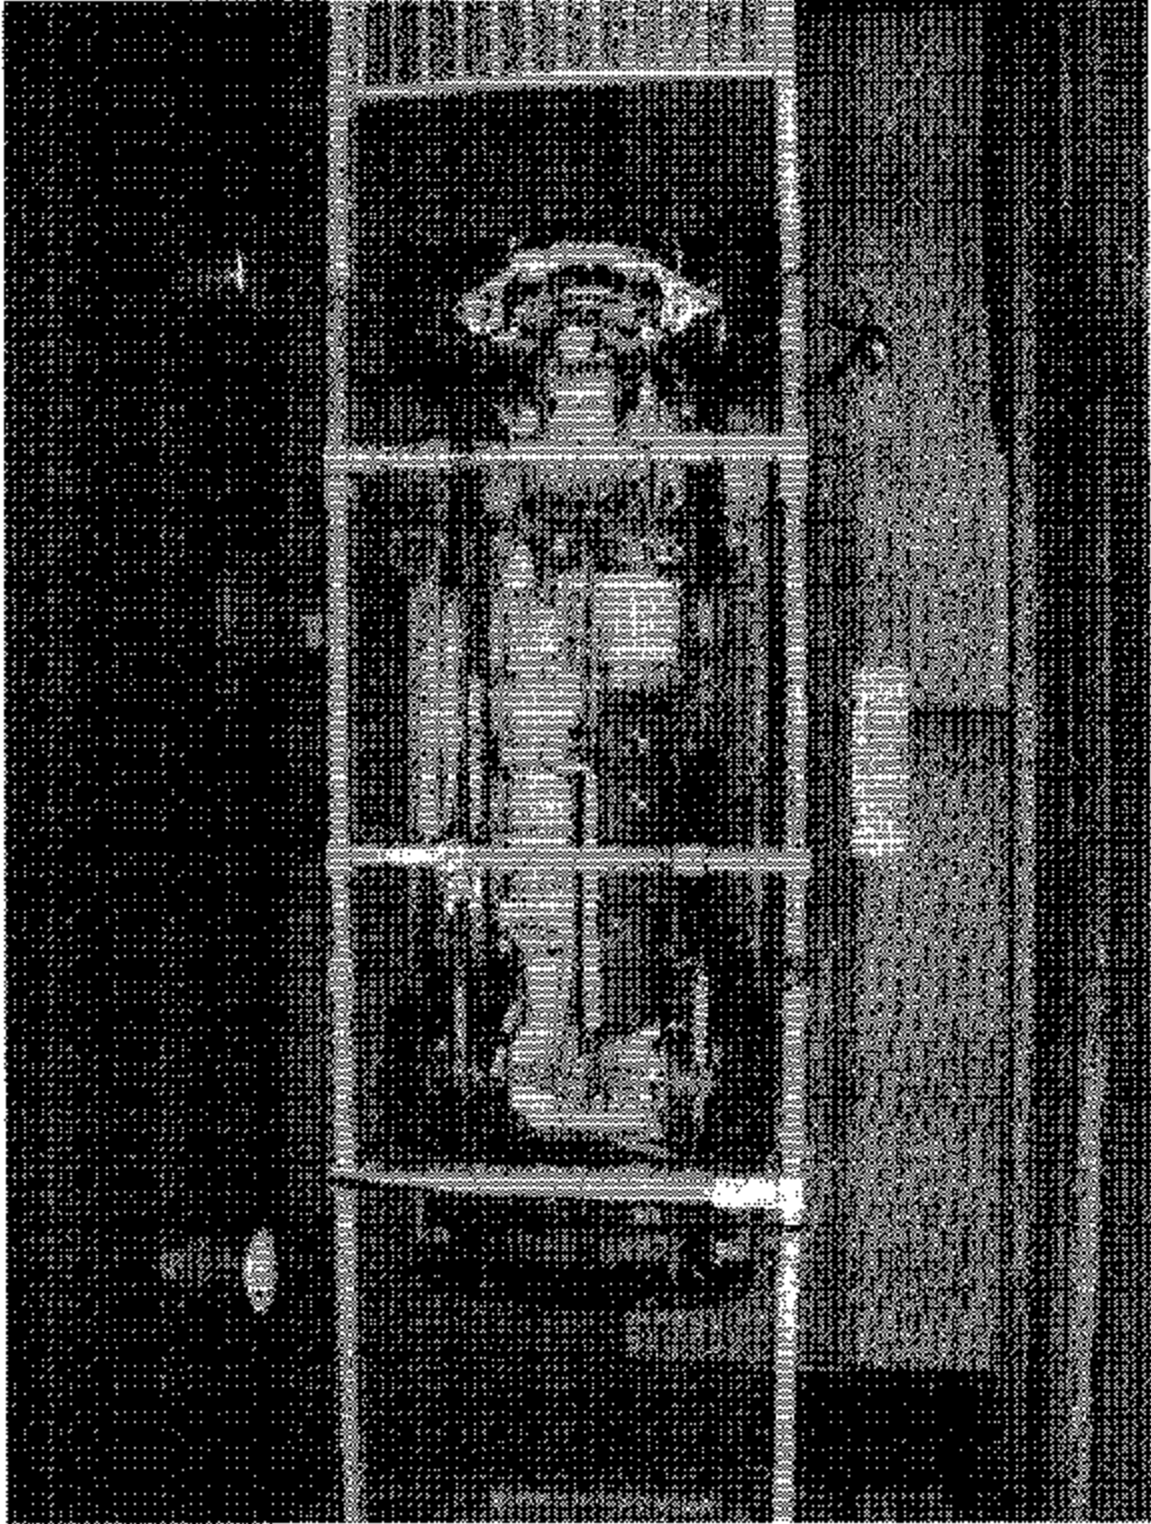
Rollover 90 Degrees

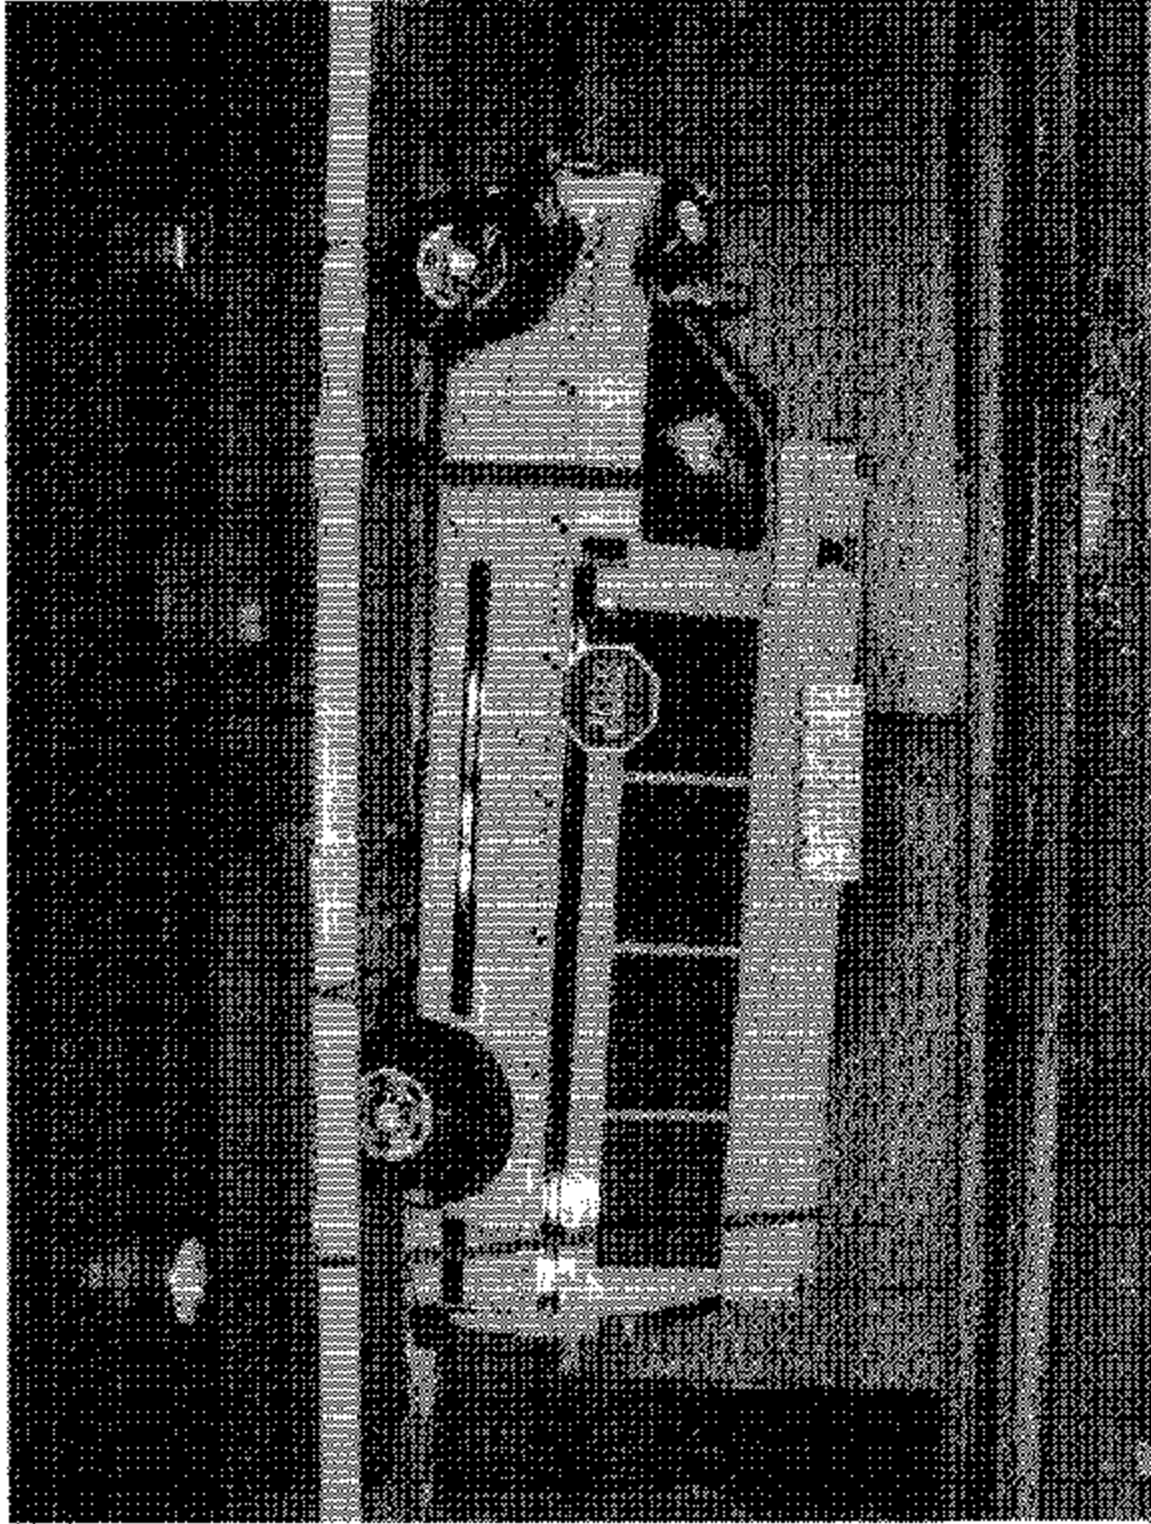
Rollover 180 Degrees

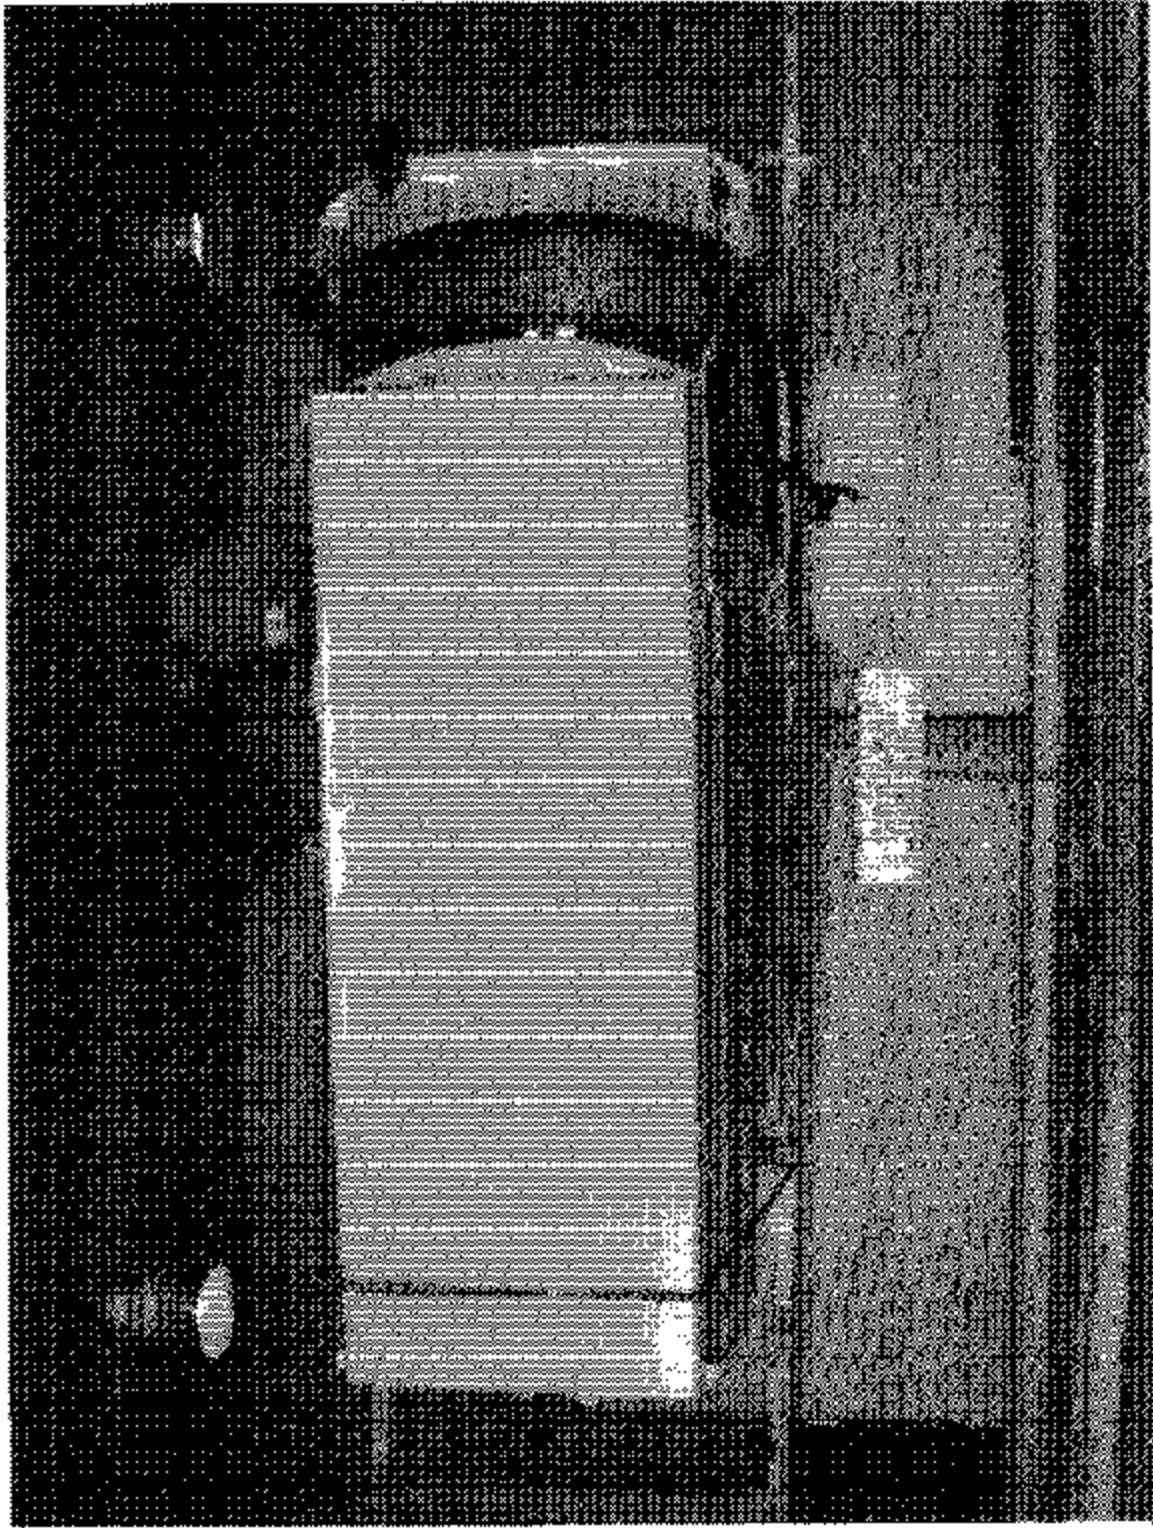
Rollover 270 Degrees

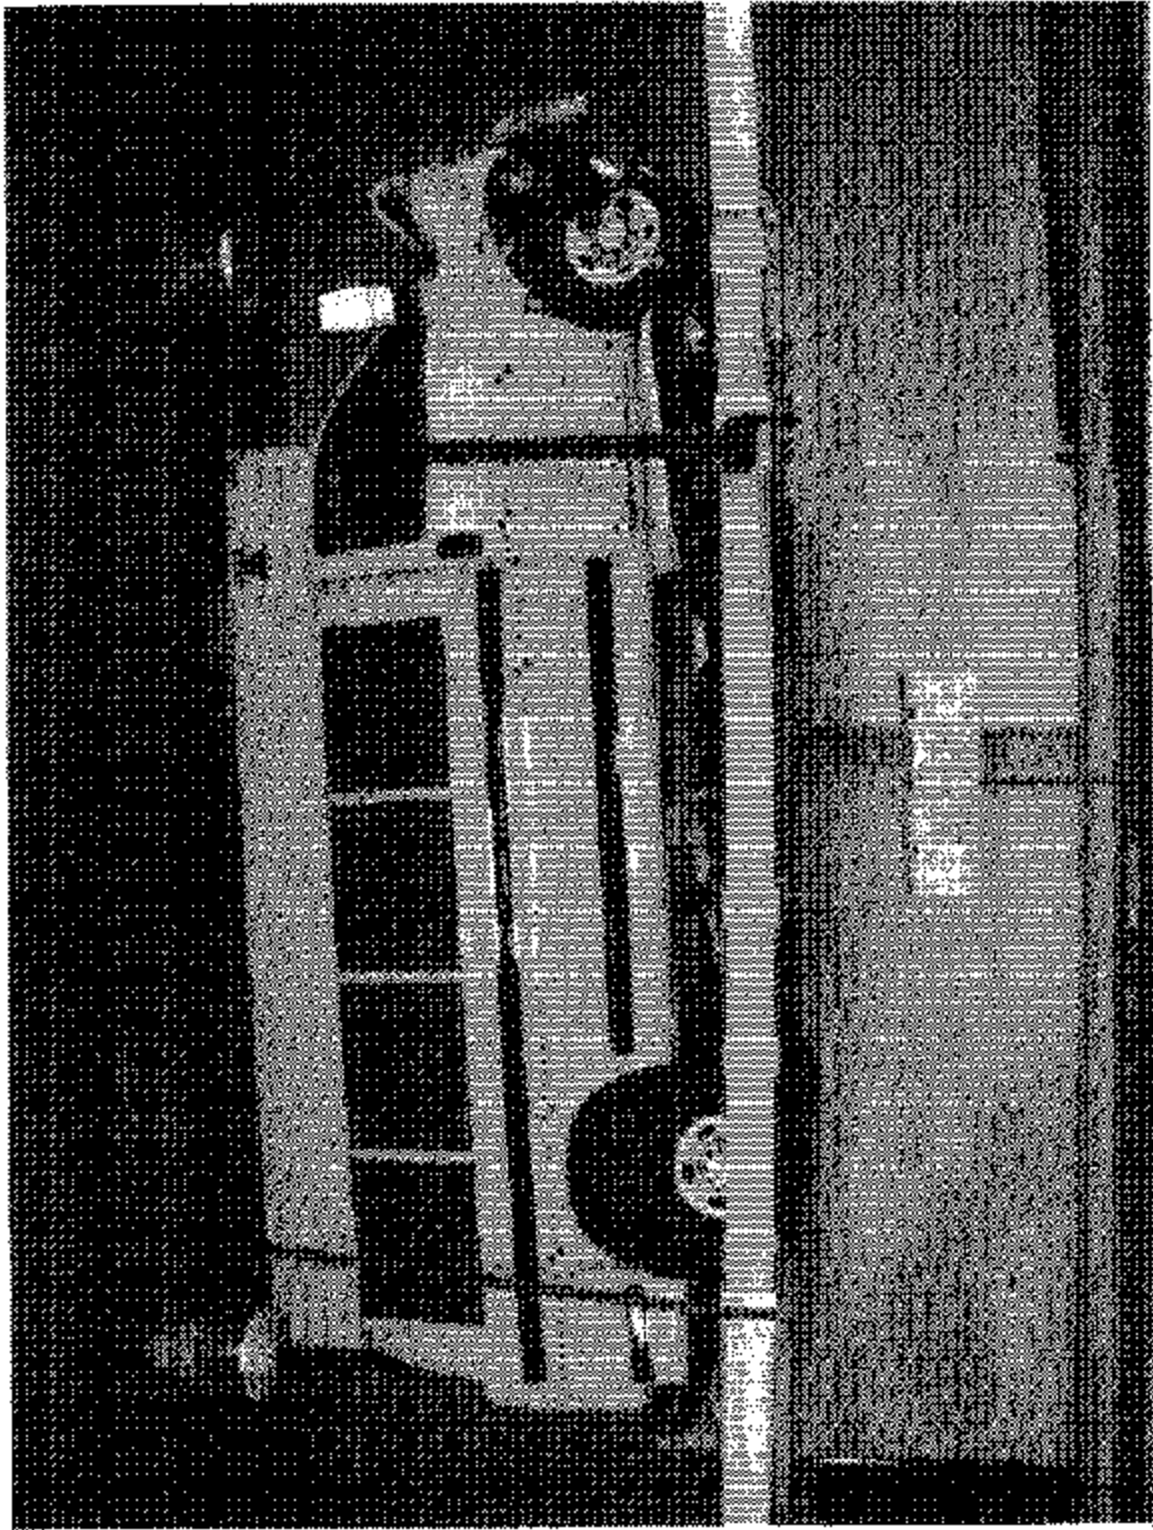
Rollover 360 Degrees

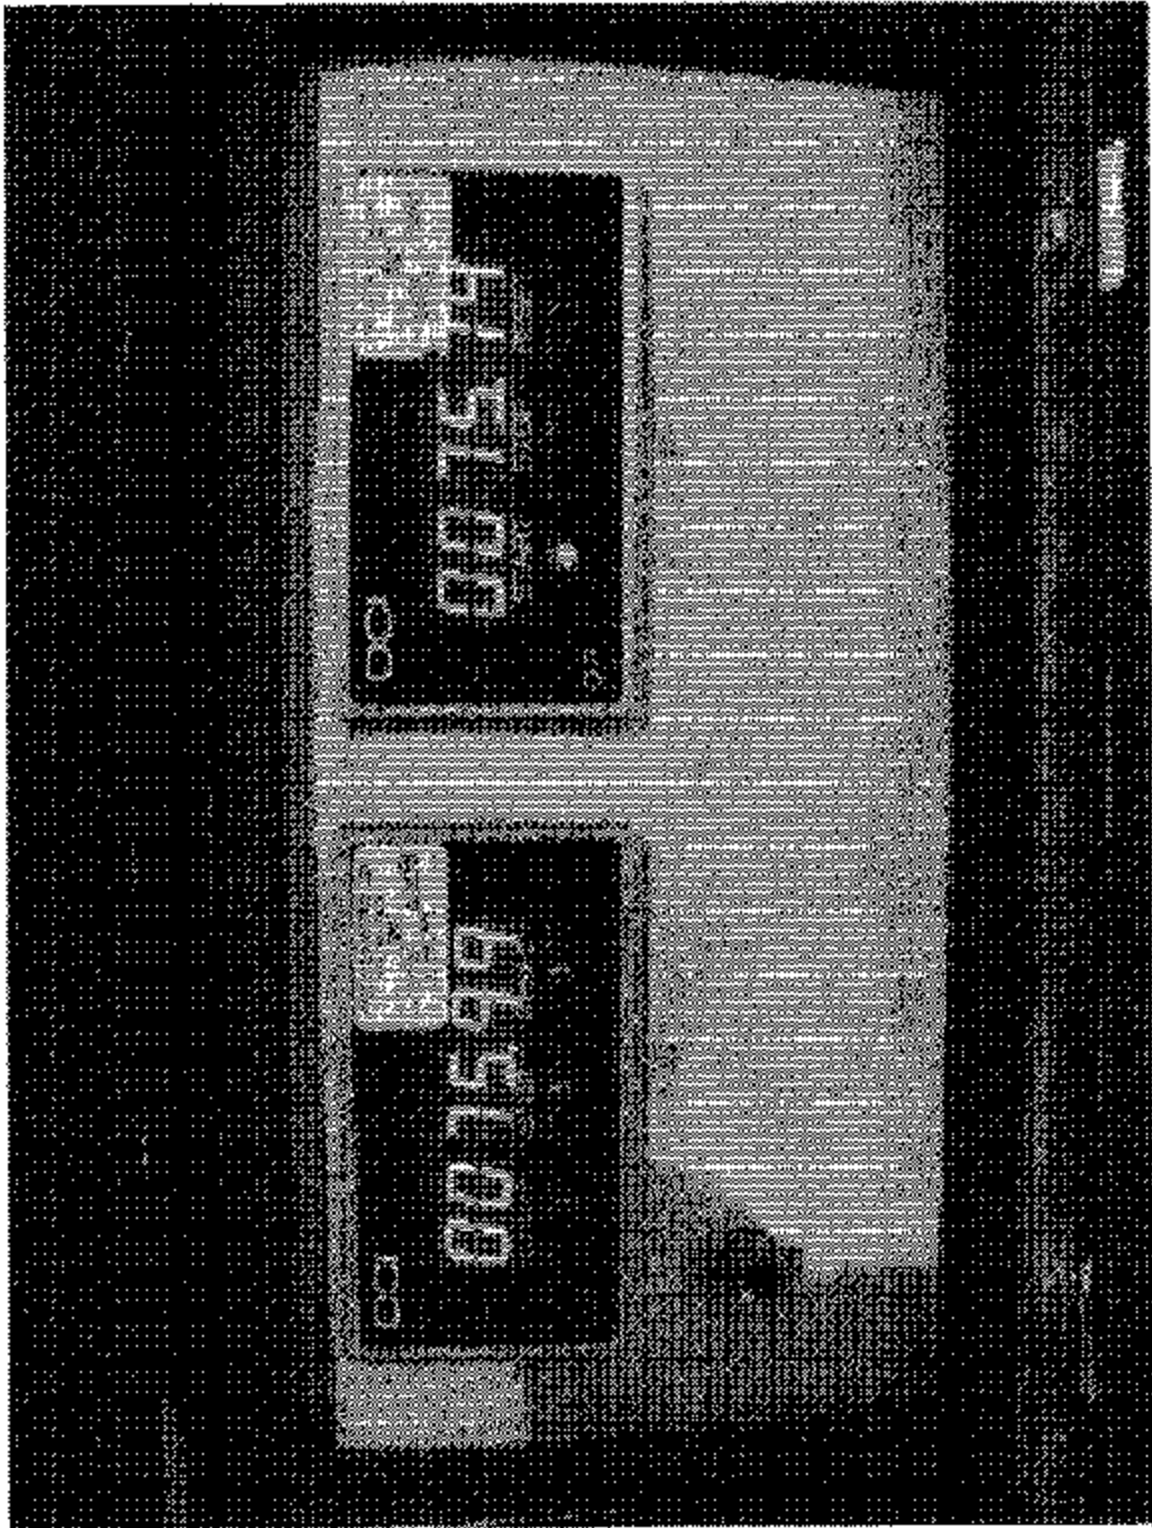
Speed Trap Counter Display

Time of Impact:	11:24 am
Ambient Temperature (°C):	22.4
Barrier Velocity – Speed Trap 1 (kph):	47.5
Barrier Velocity – Speed Trap 2 (kph):	47.3
Vehicle Rebound (mm):	0
